NIST NCSTAR 1-5

**Federal Building and Fire Safety Investigation of the
World Trade Center Disaster**

Reconstruction of the Fires in the World Trade Center Towers

September 2005

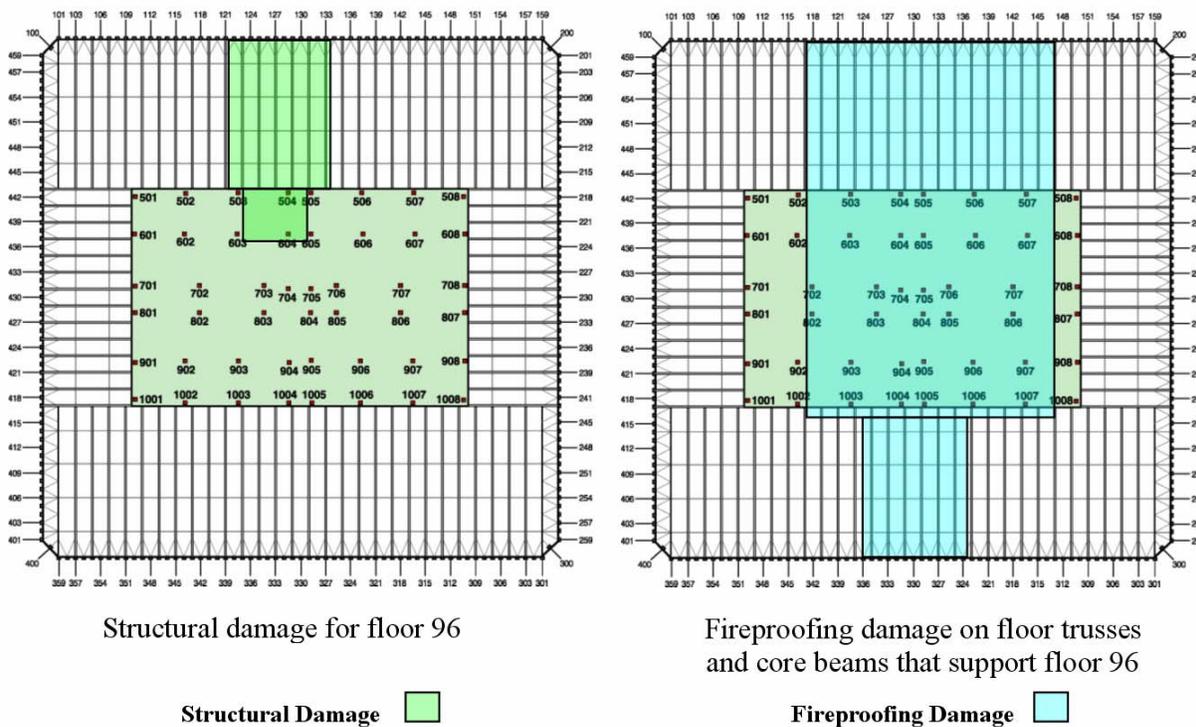
Figure E–3. Structural and insulation damage to floor 96 of WTC 1, Case B.

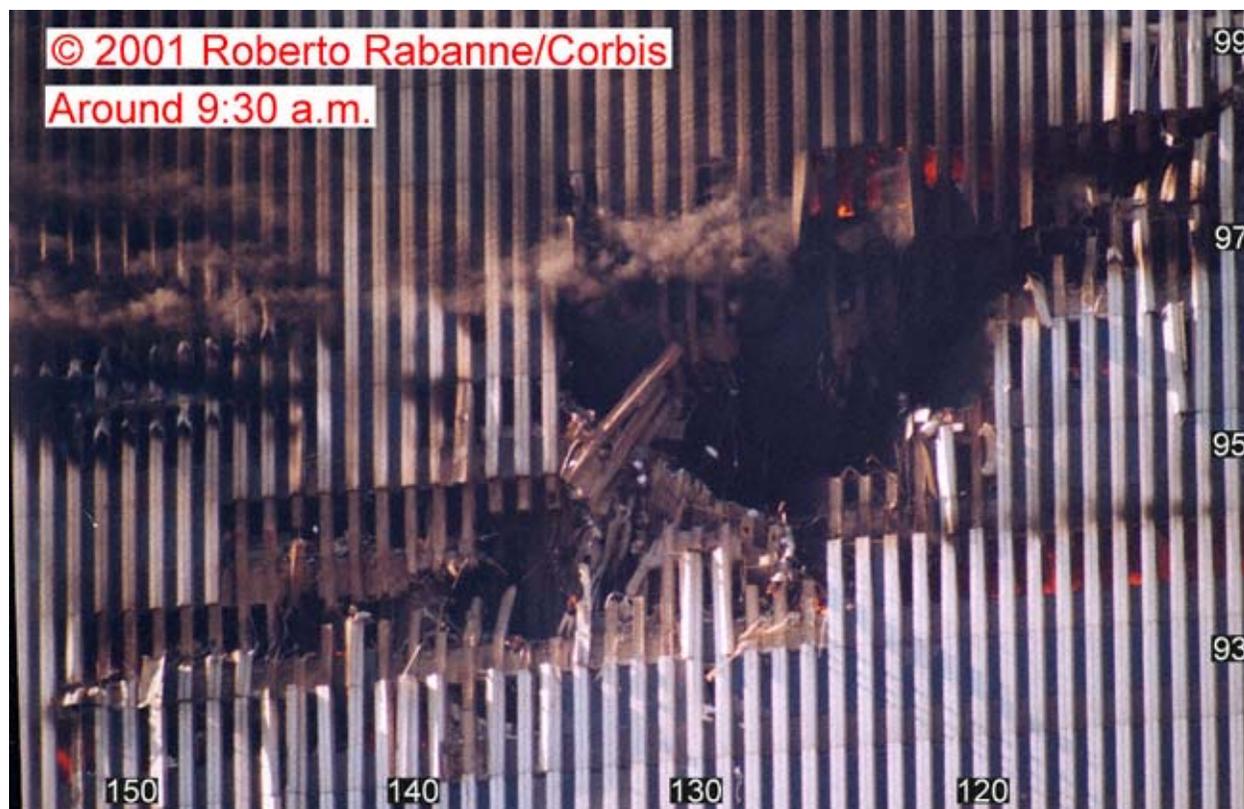
Figure 2–2. Photograph of the north face of WTC 1 around 9:30 a.m. showing the area damaged by the aircraft strike.

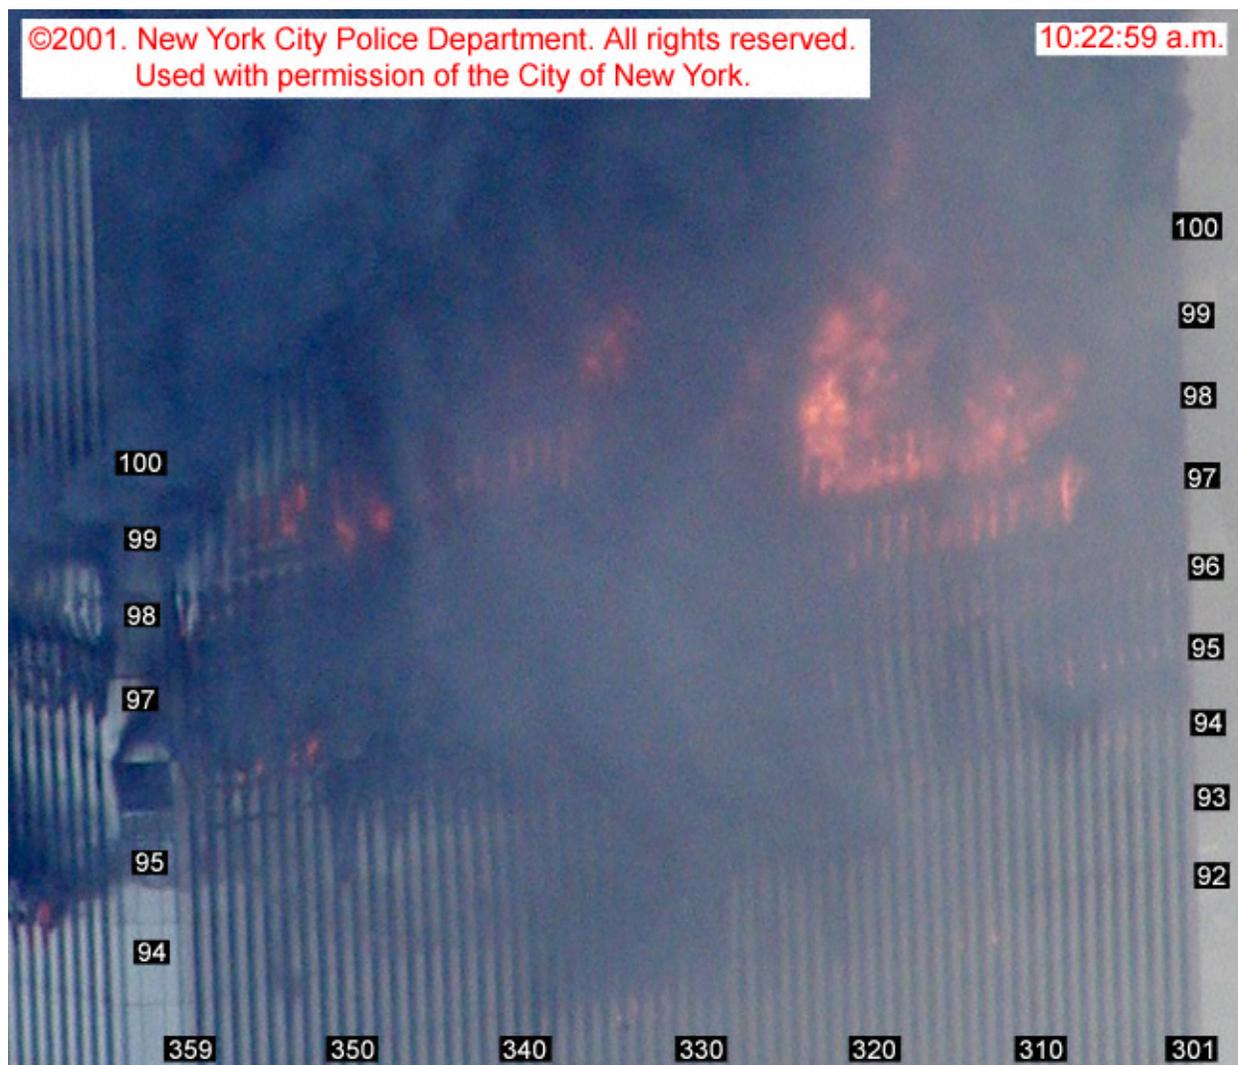
Figure 2–3. View of the south face of WTC 1, cropped from a photograph shot from a helicopter at 10:22:59 a.m. It has been enhanced by adjusting the intensity levels, and column and floor numbers have been added.

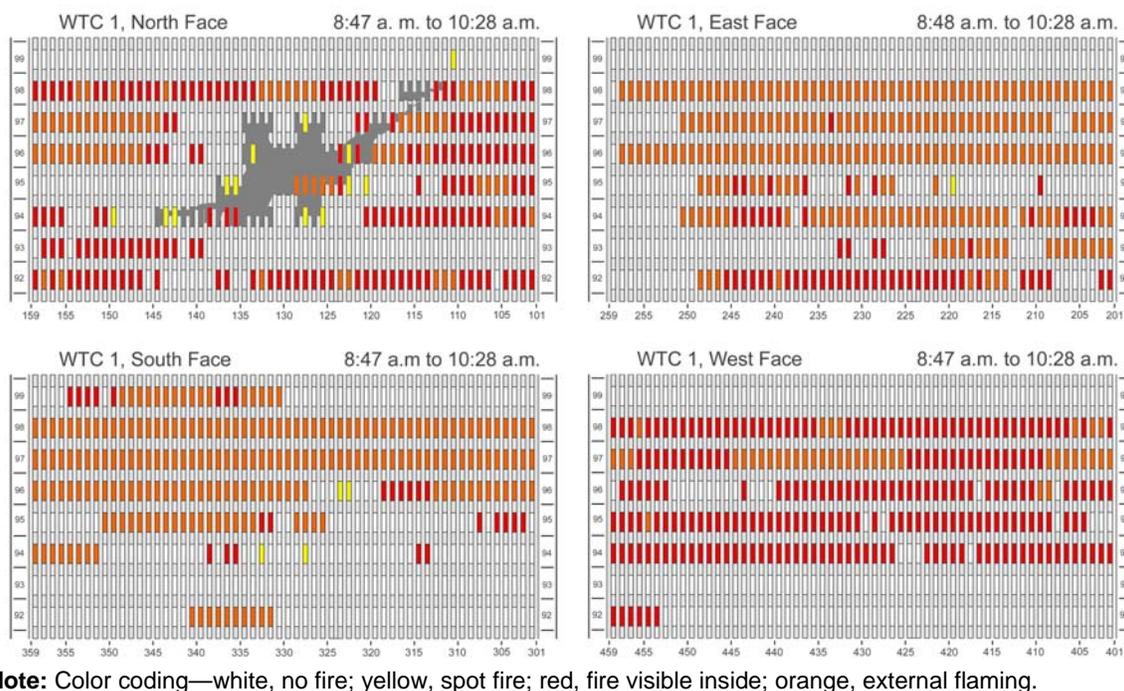
Fire growth and spread in WTC 1 was extensive during the 102 min between the aircraft impact and collapse of the tower. Figure 2–4 shows the results for the four faces of integrating the fire observations over the entire event. Extensive fires were observed from the 92nd to 99th floors. (Note that fires were also present on higher floors, including the intense fire on the south side of the west face of the 104th floor.) Fire seems to have spread over almost all of the 96th to 98th floors, while unburned areas were still present on lower floors. The largest unburned areas seem to have been on the 93rd and 95th floors.

Figure 2–4. Maps of integrated fire observations between 8:47 a.m. and 10:28 a.m. for the four faces of WTC 1.

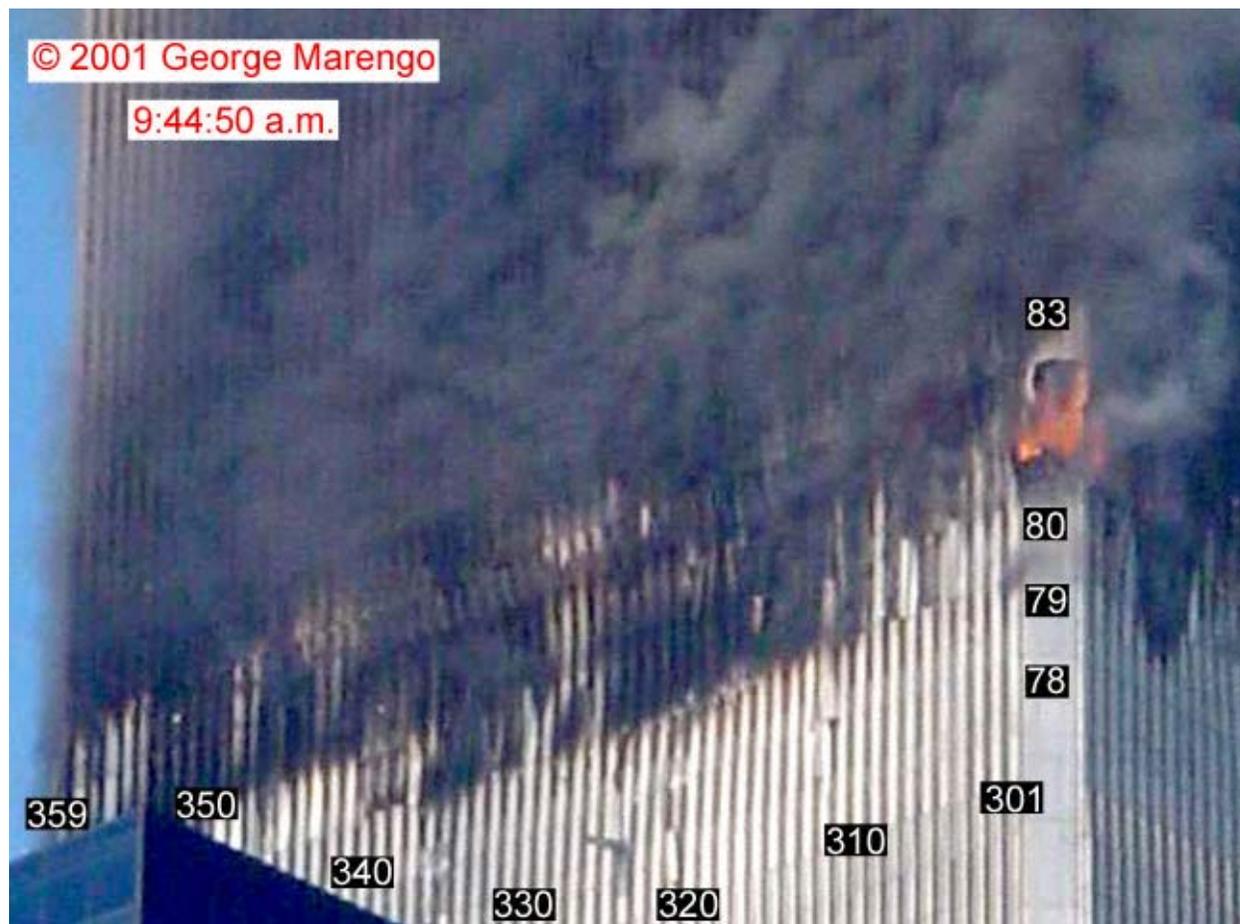
down and that some intermediate portions had disappeared from view. The windows where the object first appeared below the 83rd floor spandrel had moved further toward the edges of the tower on both the north and south ends. Figure 2–10 shows a photograph of the east face taken just before 9:45 a.m. during a period when there was very little smoke flow from the face. Closer inspection reveals that the columns near the center of the east face on the 80th and 81st floors were bowed inward. Similar bowing was identified in other images starting as early as 9:22 a.m.

Figure 2–10. Photograph was shot from the northeast, showing east face of WTC 2 at 9:44:50 a.m. The original intensity levels have been adjusted, and column and floor numbers have been added.

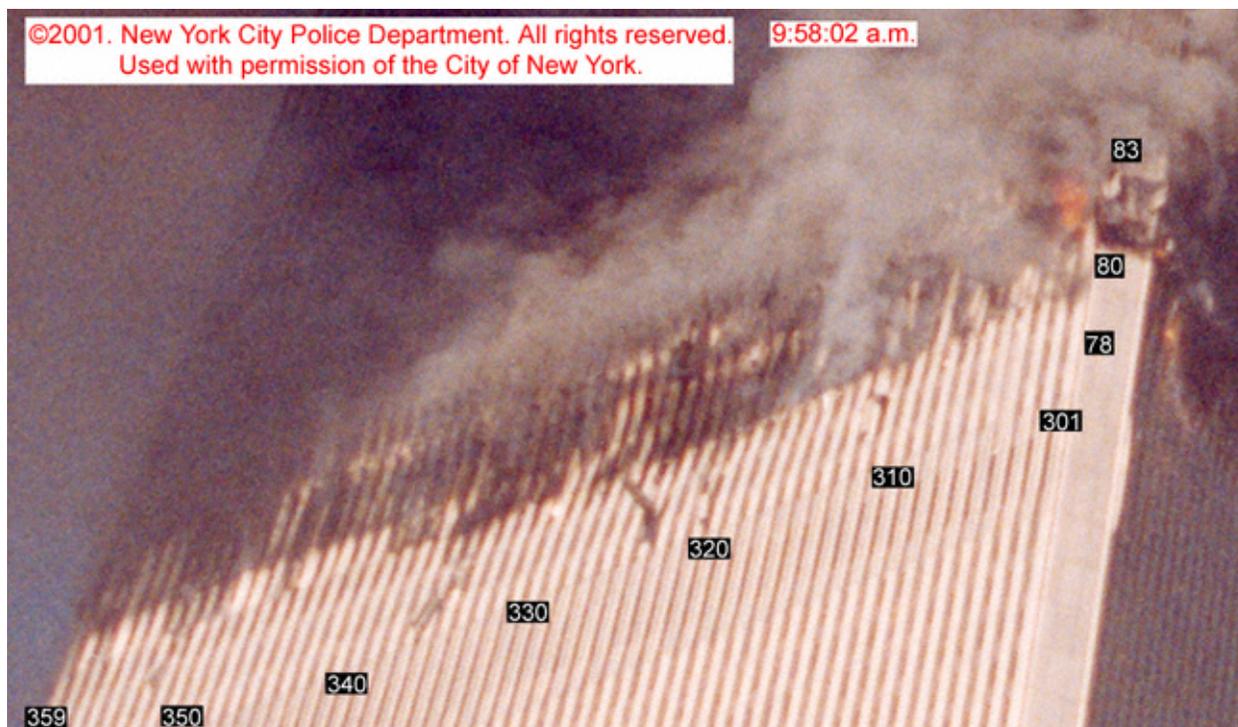
windows on the 82nd floor moved again, with the northernmost window where it first became visible shifting slightly to the north. A prominent feature on the east face during the period was the inward bowing of the outer wall. This can be seen clearly over the 79th to 82nd floors in Figure 2–11, which was taken less than a minute before the collapse started. During the 20 s prior to the collapse a large number of pieces of debris fell from the northern sides of the 80th and 81st floors. The falling debris coincided with a heavy flow of molten metal from the north face. When WTC 2 collapsed very little flame was expelled from the east-face windows. Based on observations elsewhere on the two towers, regions of intense burning would have been expected to generate short-lived jets of flames. Their absence suggests that large fires were not burning near the face at the time of collapse.

Figure 2–11. Cropped photograph of the east face of WTC 2 at 9:58:02 a.m. The intensity levels have been adjusted, and column and floor numbers have been added.

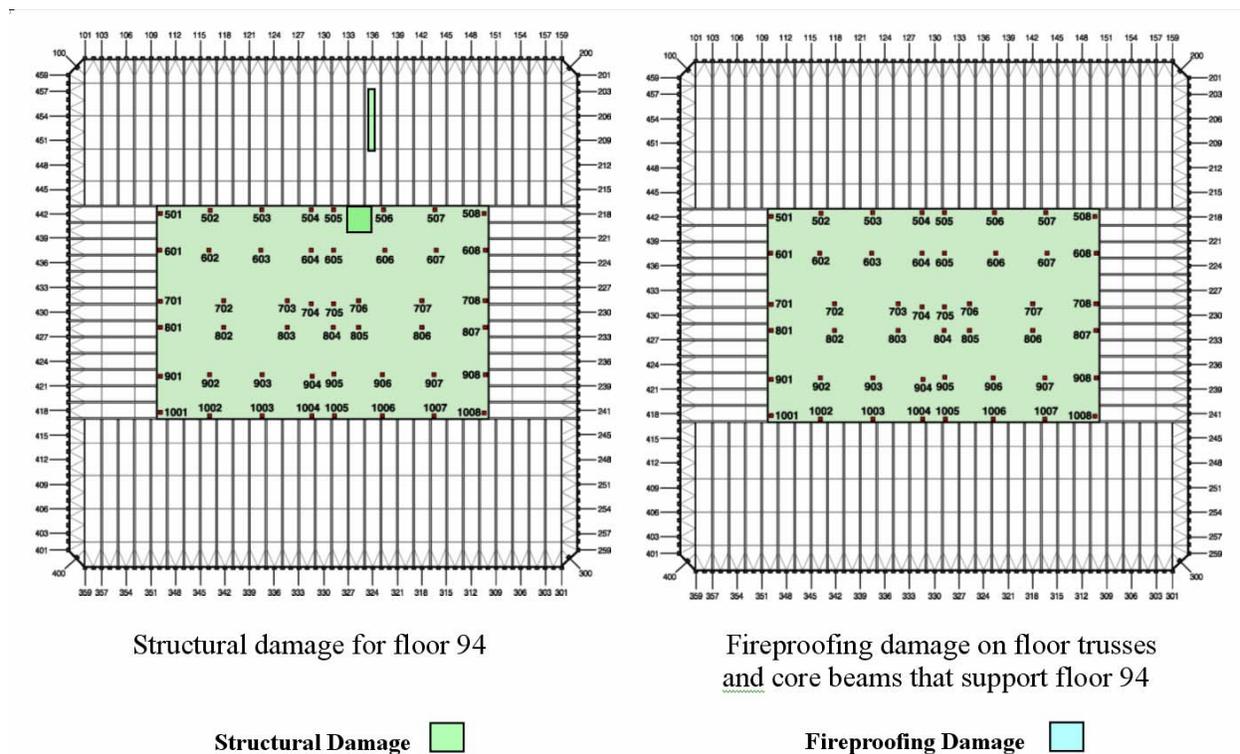
Figure 6–45. Structural and insulation damage to floor 94 of WTC 1, Case A.

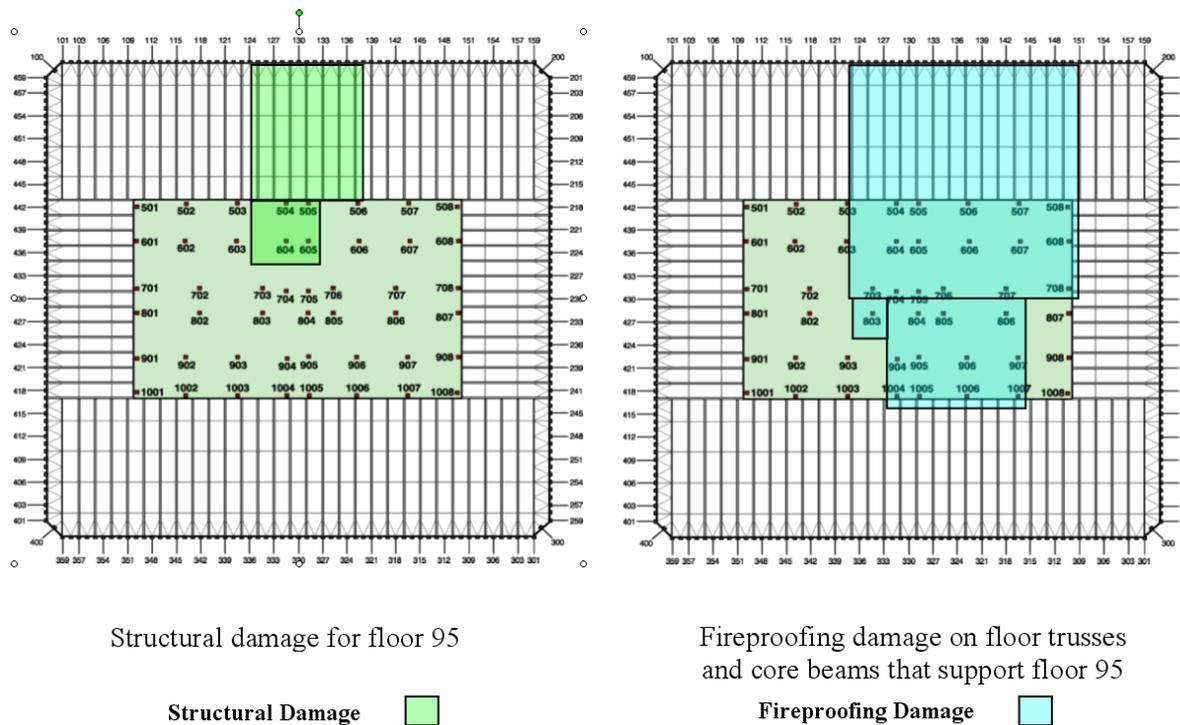
Figure 6–46. Structural and insulation damage to floor 95 of WTC 1, Case A.

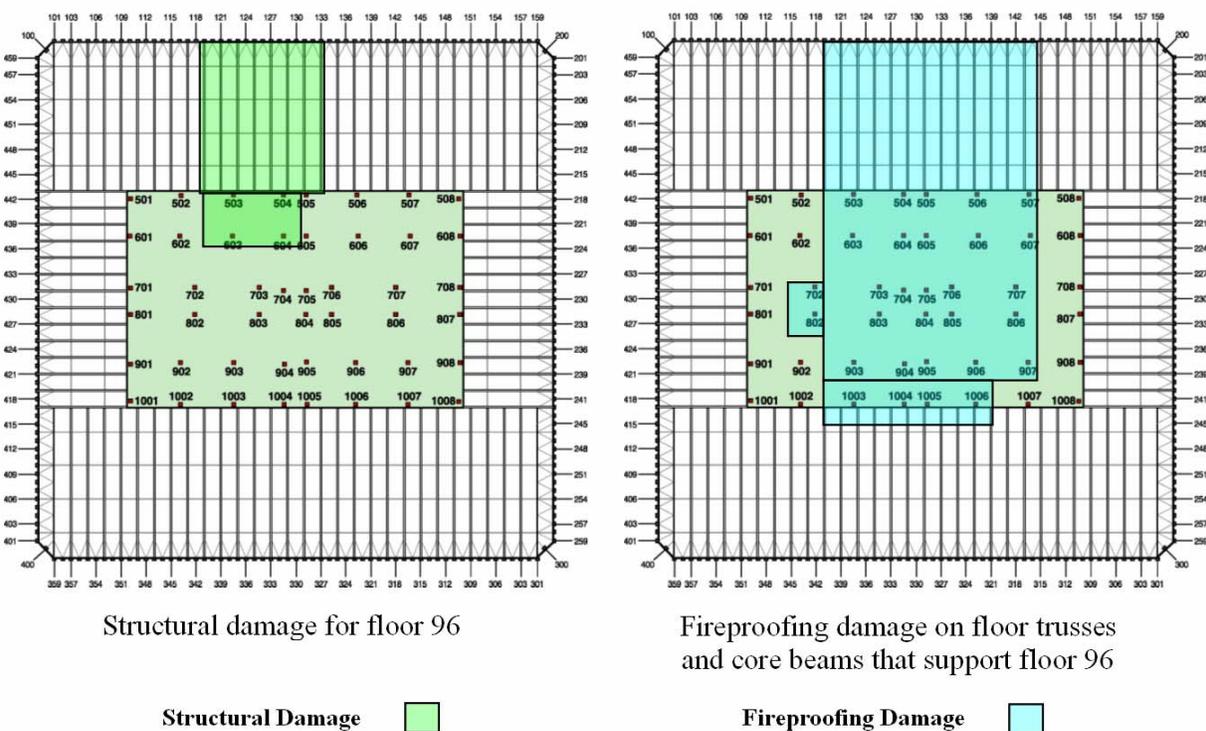
Figure 6–47. Structural and insulation damage to floor 96 of WTC 1, Case A.

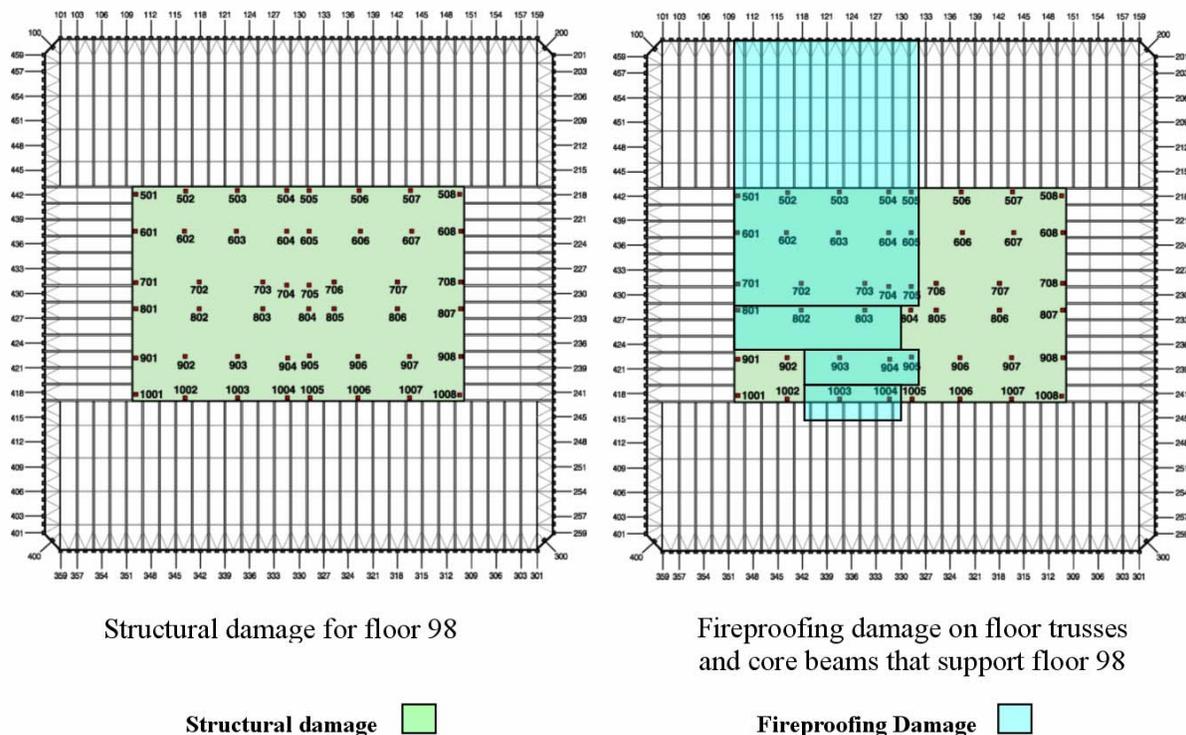
Figure 6–49. Structural and insulation damage to floor 98 of WTC 1, Case A.

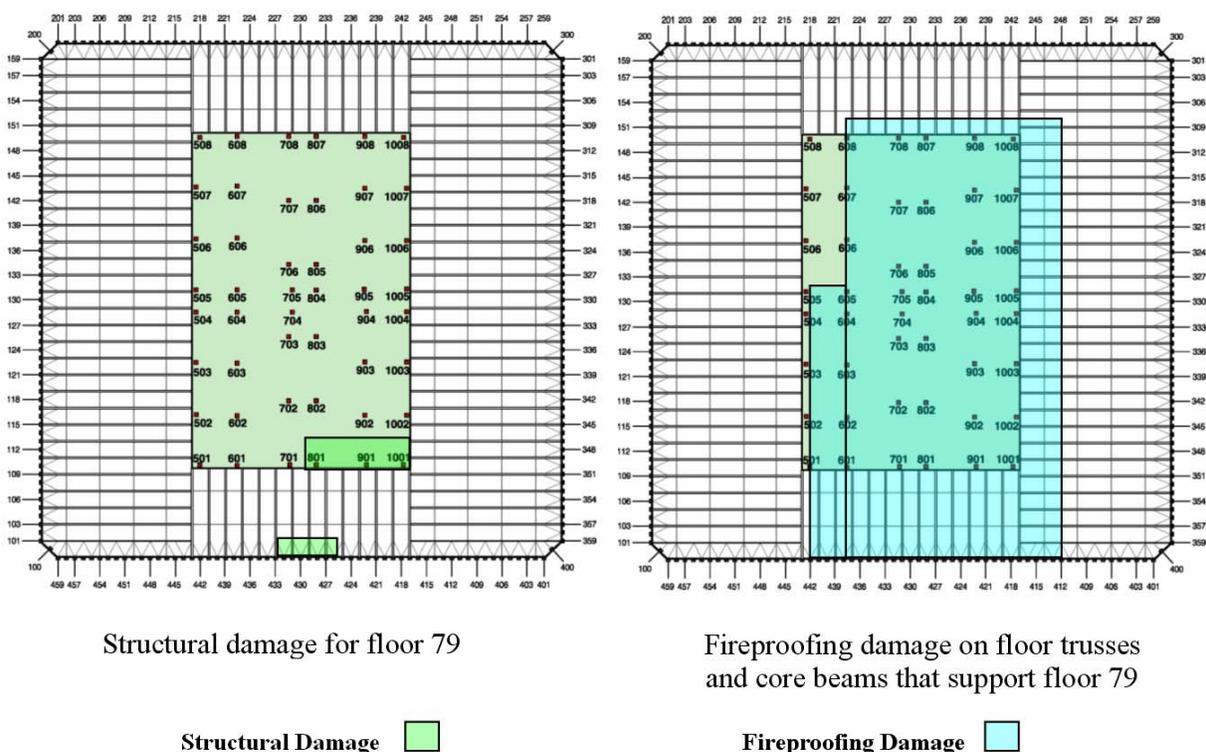
Figure 6–60. Structural and insulation damage on floor 79 of WTC 2, Case C.

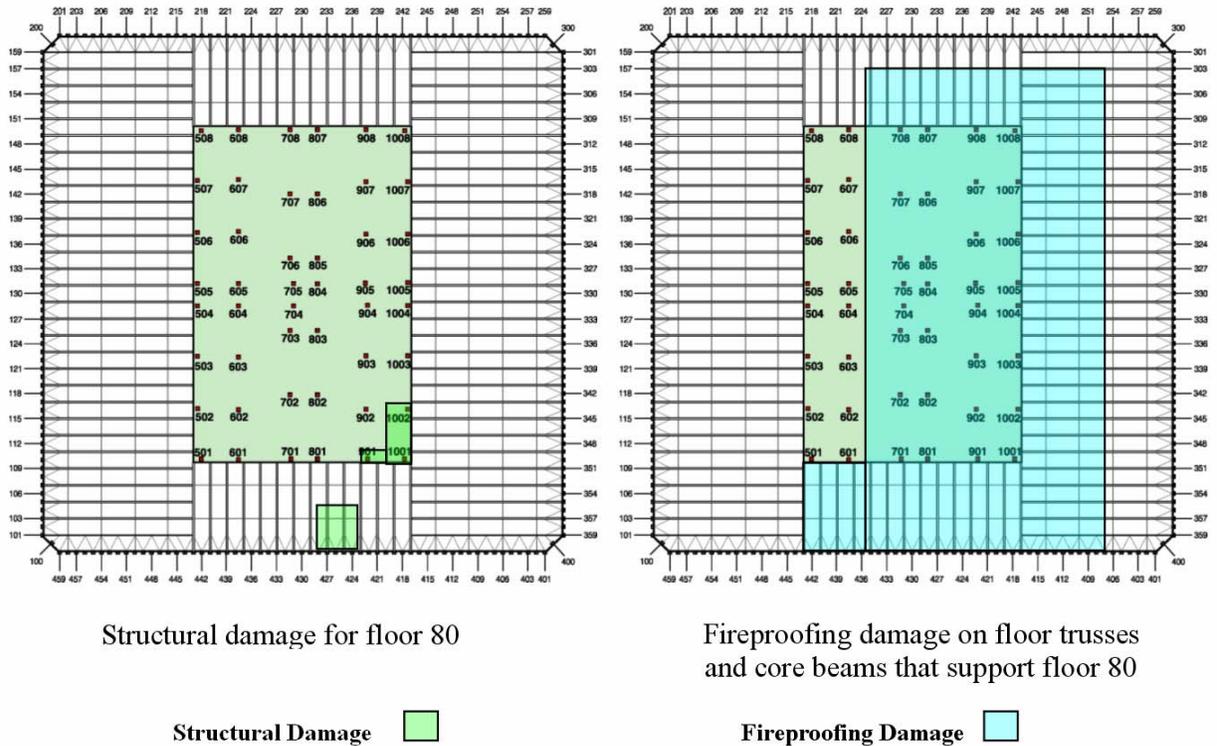
Figure 6–61. Structural and insulation damage on floor 80 of WTC 2, Case C.

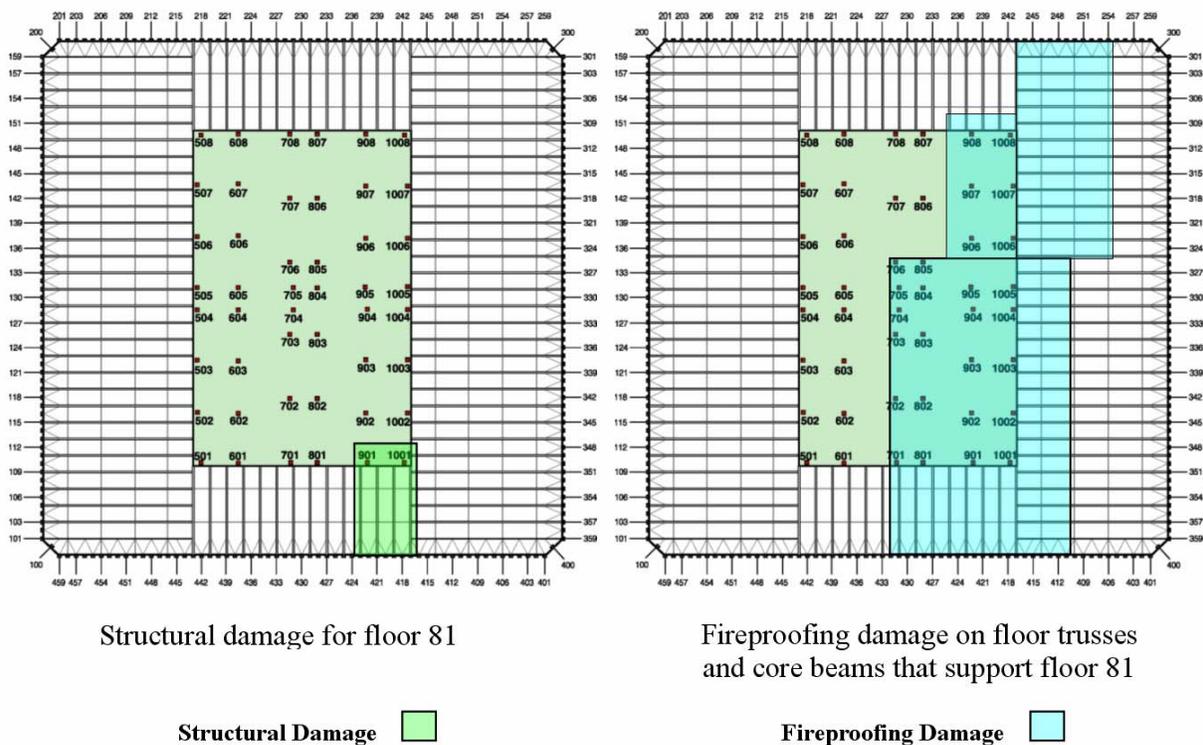
Figure 6–62. Structural and insulation damage on floor 81 of WTC 2, Case C.

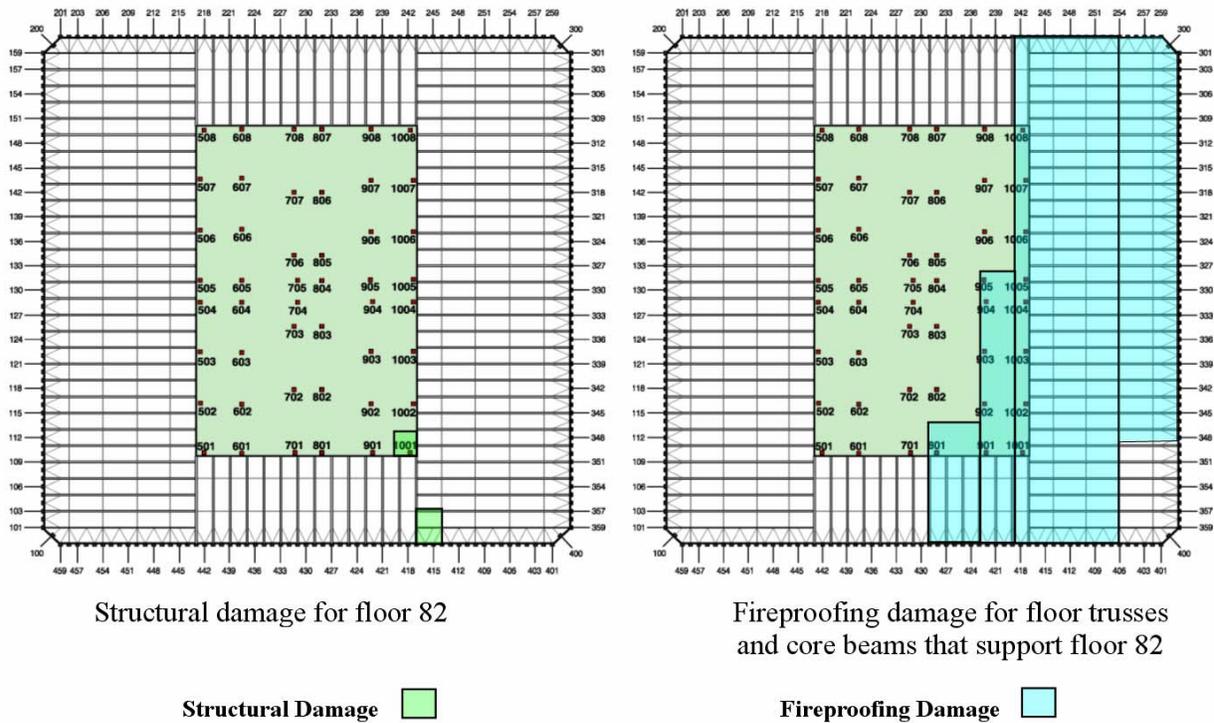
Figure 6–63. Structural and insulation damage on floor 82 of WTC 2, Case C.

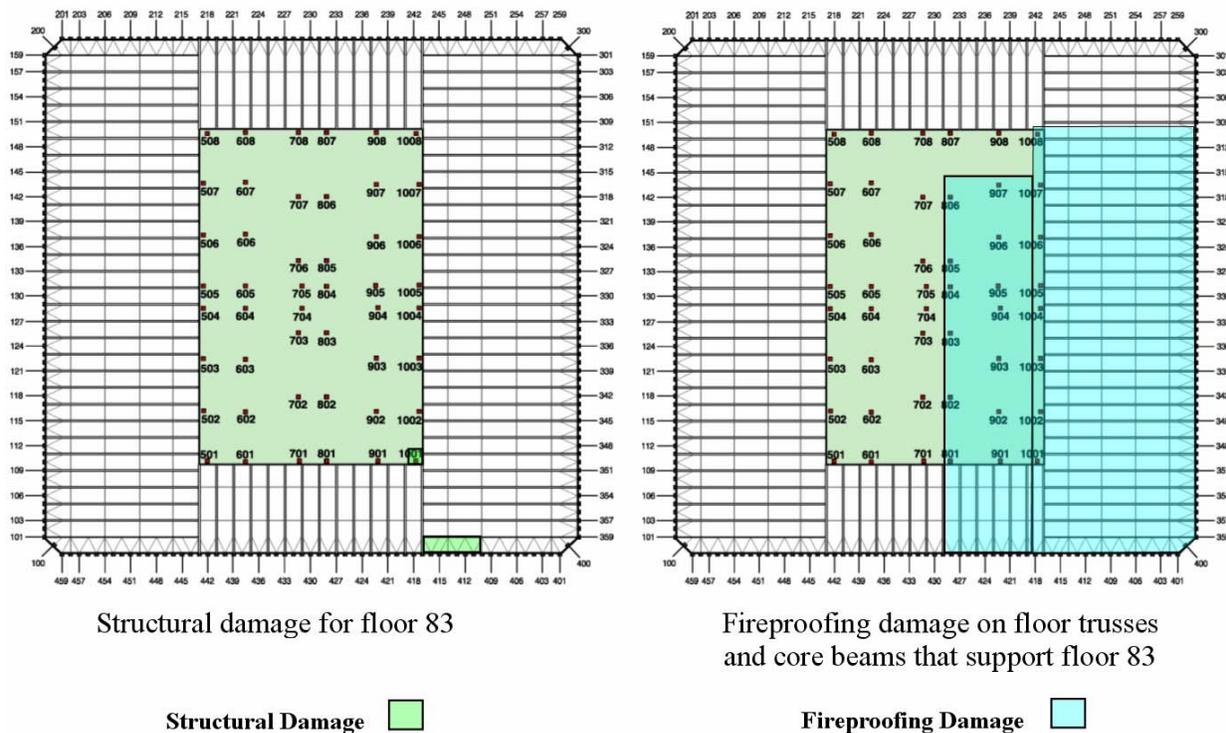
Figure 6–64. Structural and insulation damage on floor 83 of WTC 2, Case C.
