NBS BUILDING SCIENCE SERIES 143

# Investigation of the Kansas City Hyatt Regency Walkways Collapse

R. D. Marshall  
E. O. Pfrang  
E. V. Leyendecker  
K. A. Woodward

Issued May 1982

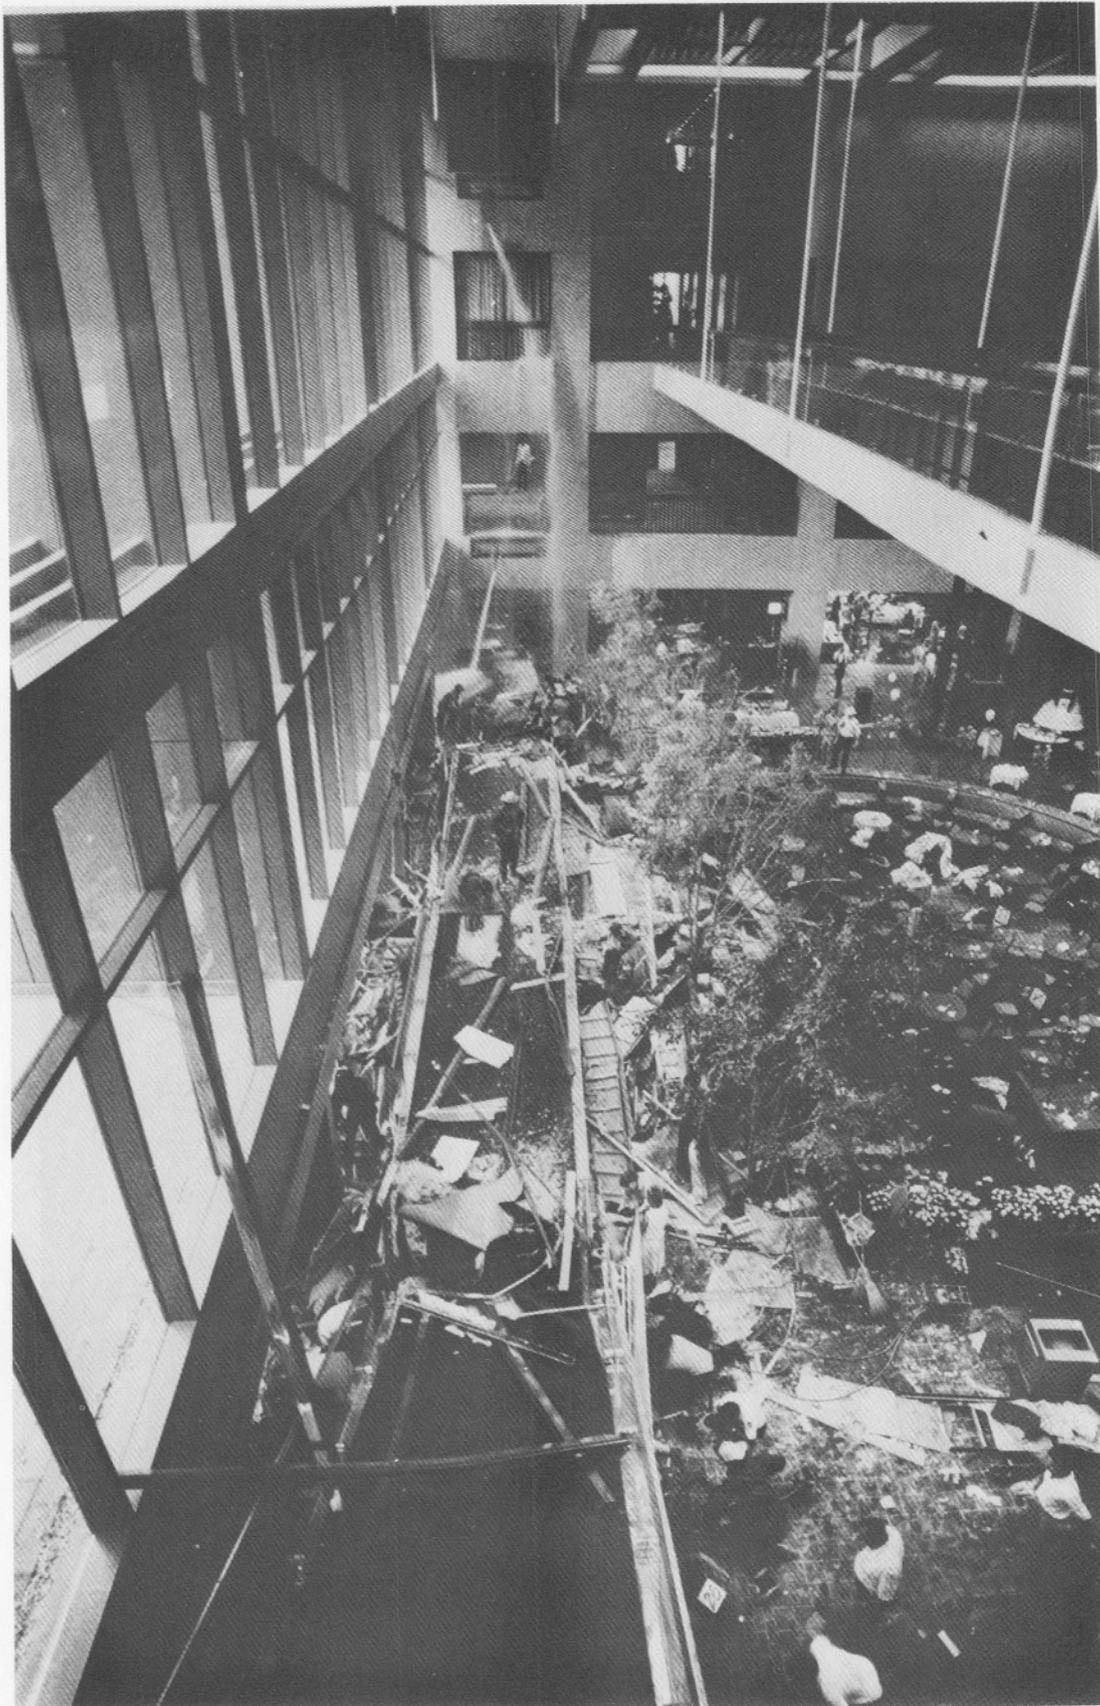
Figure 4.1 Walkways shortly after the collapse. View is to the west-northwest with span U7-8 sloping down and to the right. Spans U8-9 and U9-10 are visible behind the trees. Photo by Greg Smith, reprinted by permission of The Kansas City Times, © 1981, The Kansas City Star Company.

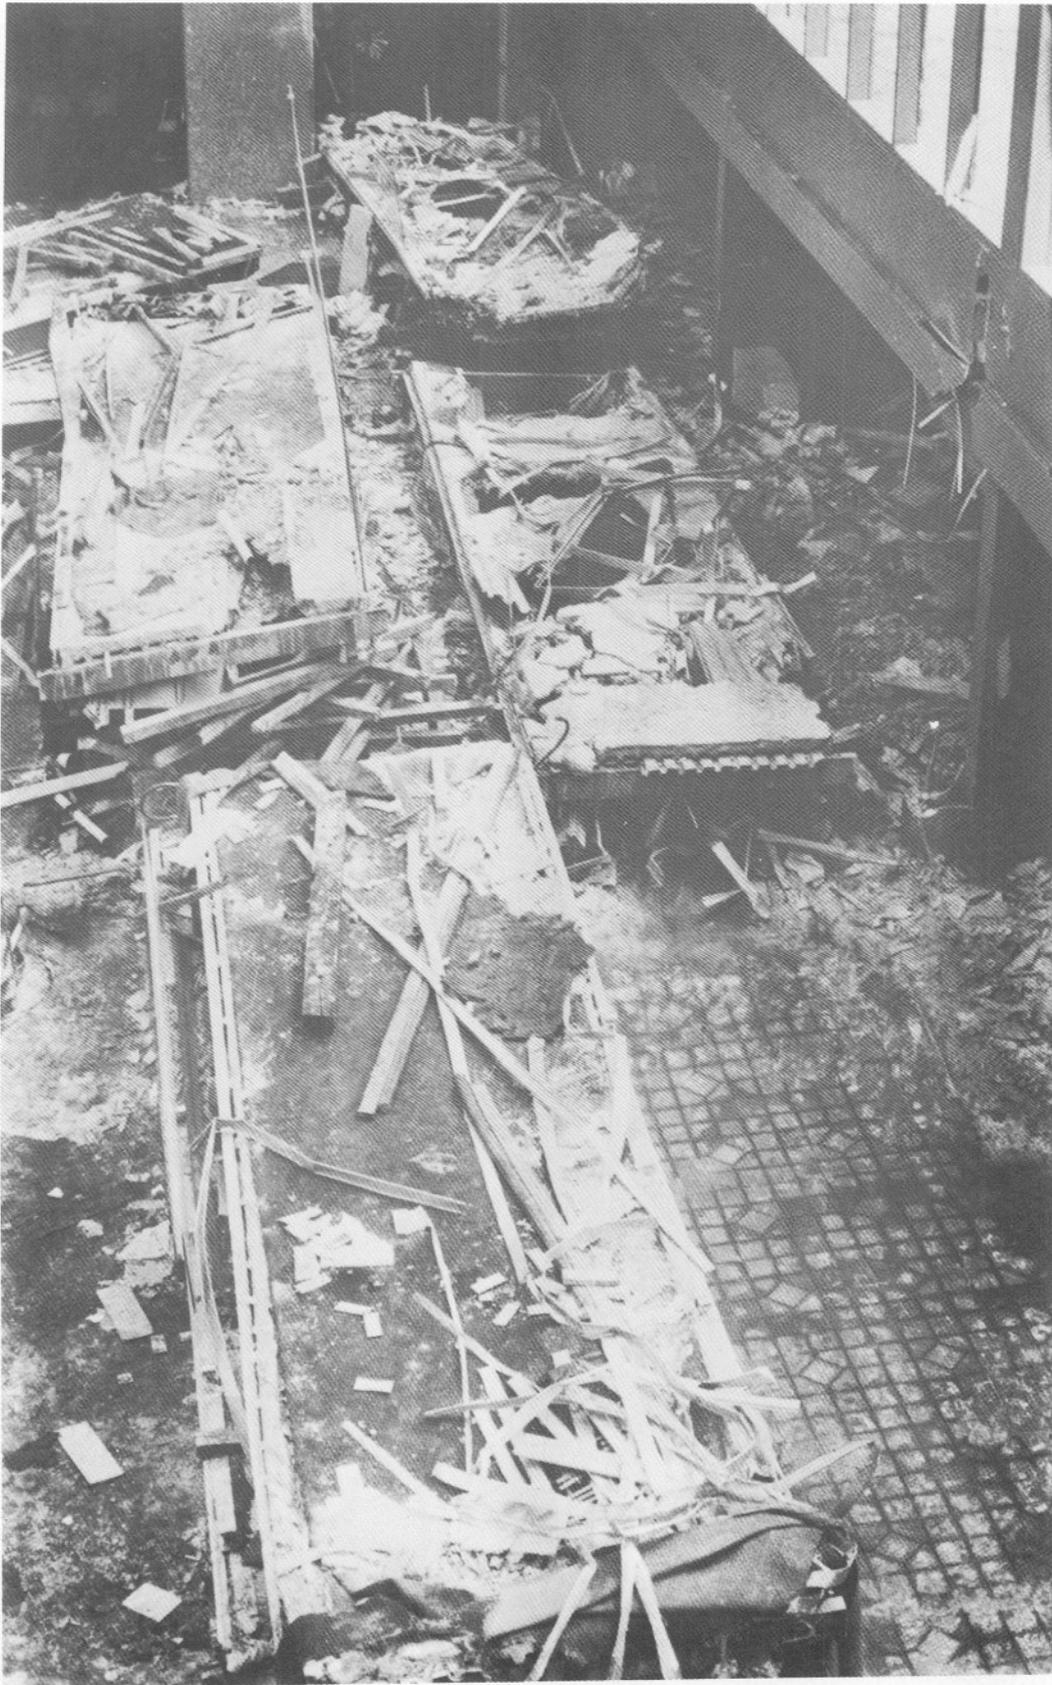
Figure 4.2 Walkways shortly after the collapse. View is directly to the north along the axis of the walkways. Span U7-8 is in foreground and third floor walkway is at upper right. Water is coming from broken sprinkler pipes. Photo by Greg Smith, reprinted by permission of The Kansas City Times, © 1981, The Kansas City Star Company.

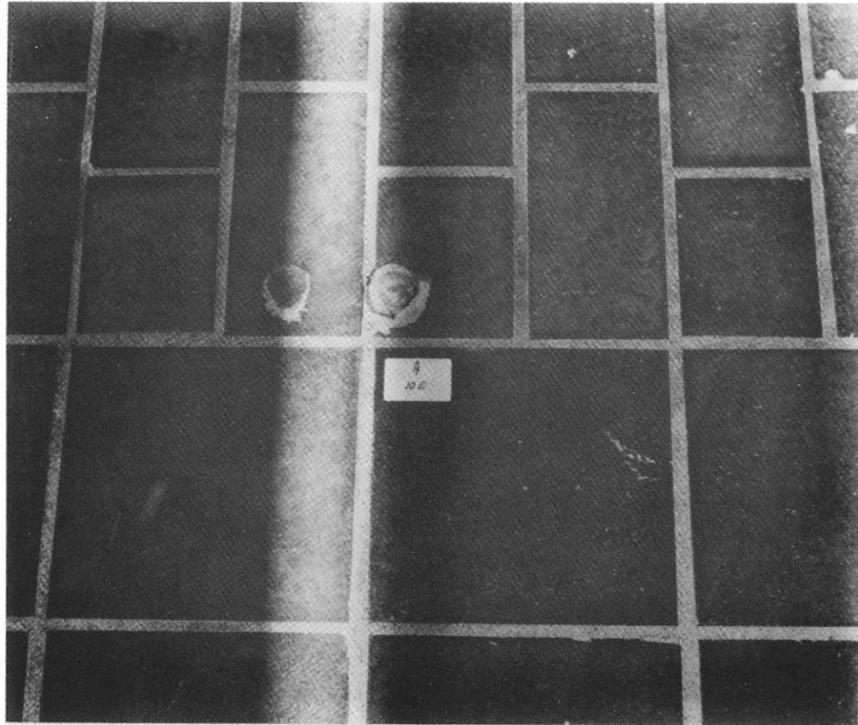
Figure 5.3 Tile damage caused by second floor hanger rod 10E.

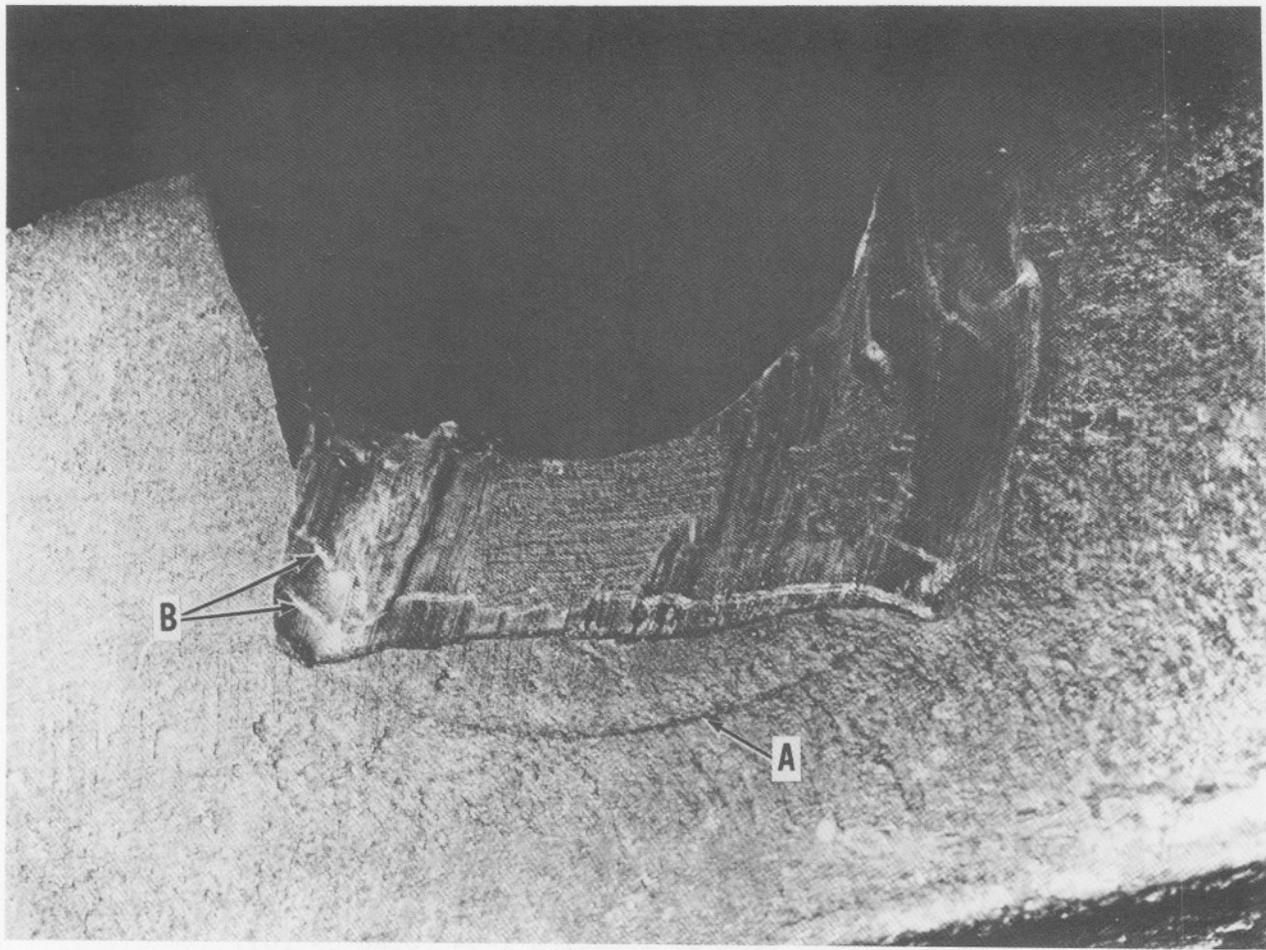
Figure 5.10 Deformation at underside, outer hole, location 9UE due to pull-through of washer/nut assembly. Note imprint of washer (A) and evidence of slip-stick progressive failure (B).

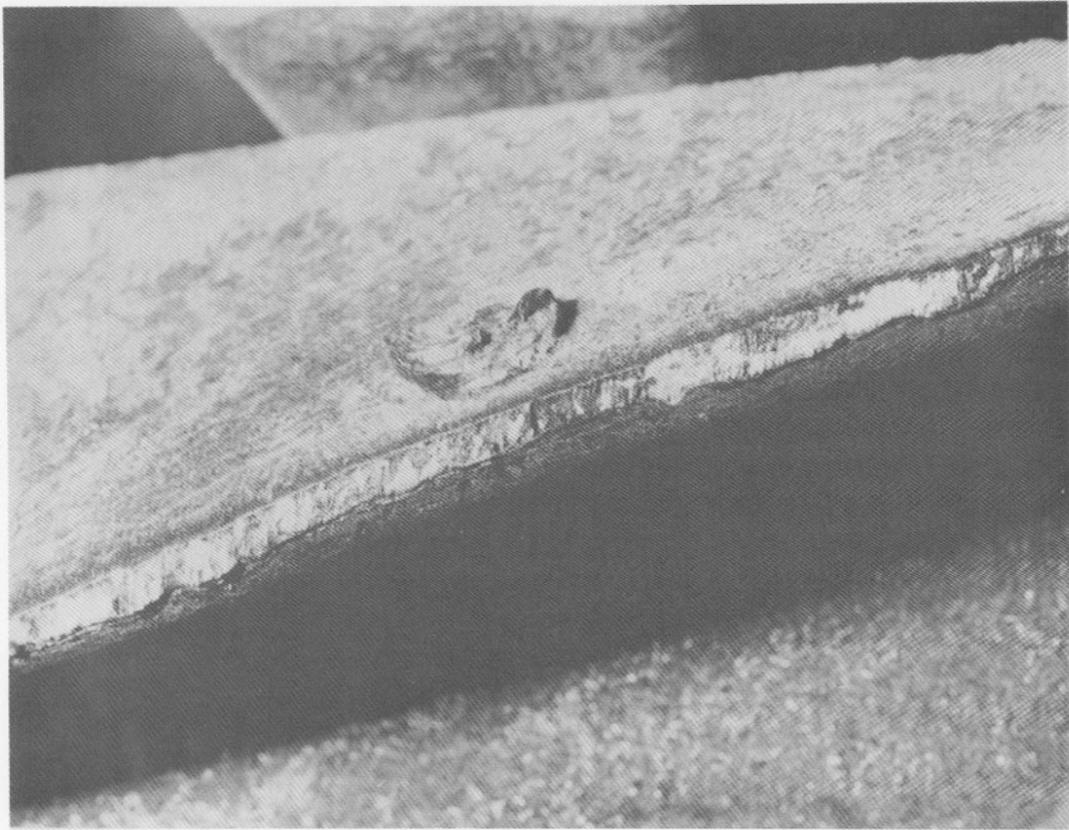
Figure 5.15 Weld penetration at location 8UW, upper flange.

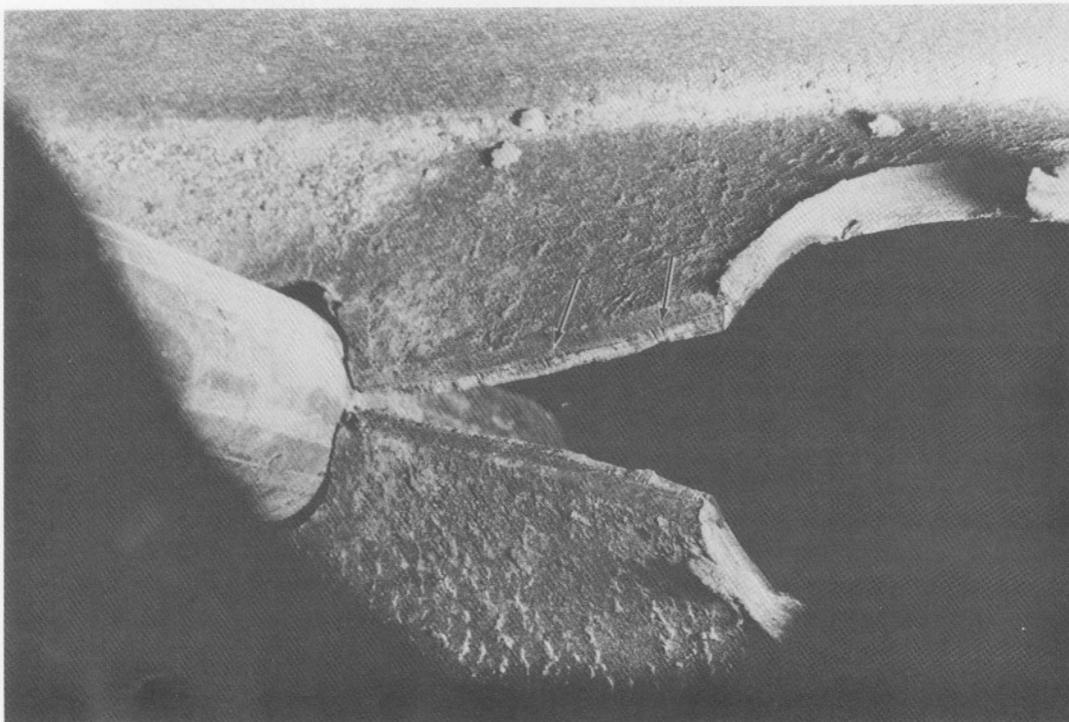
Figure 5.16 Fracture through the weld at location 9UE, lower flange. Weld porosity denoted by arrows.

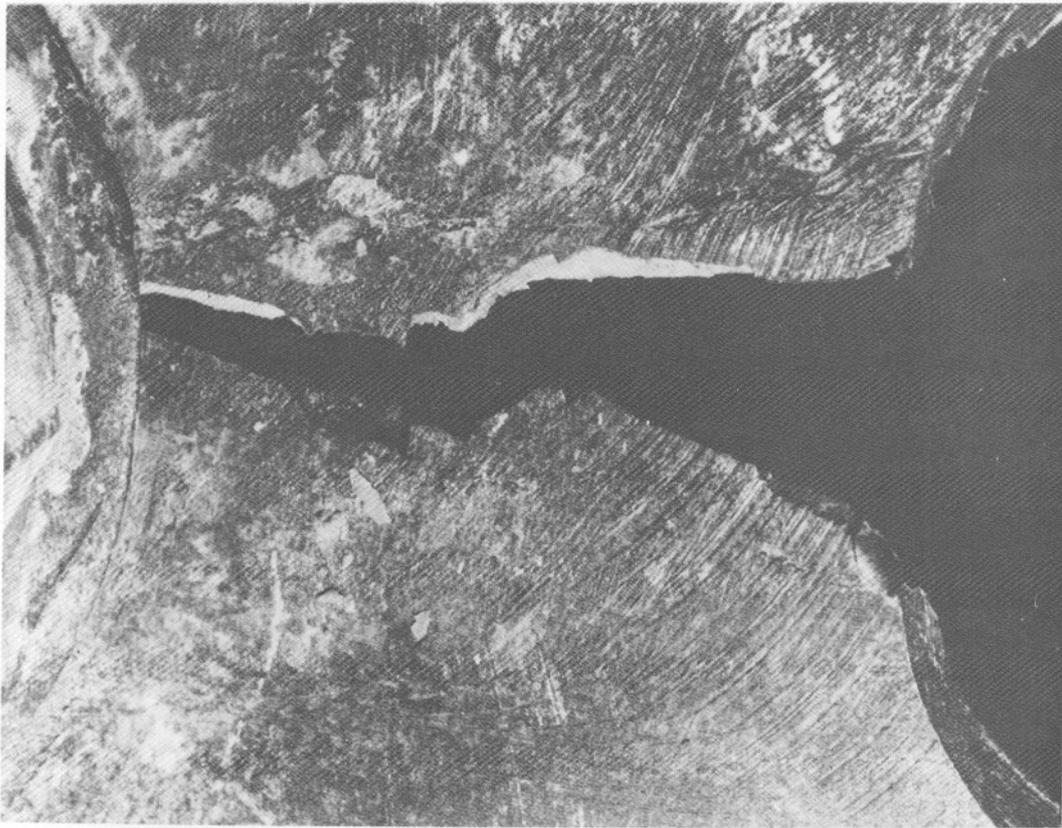
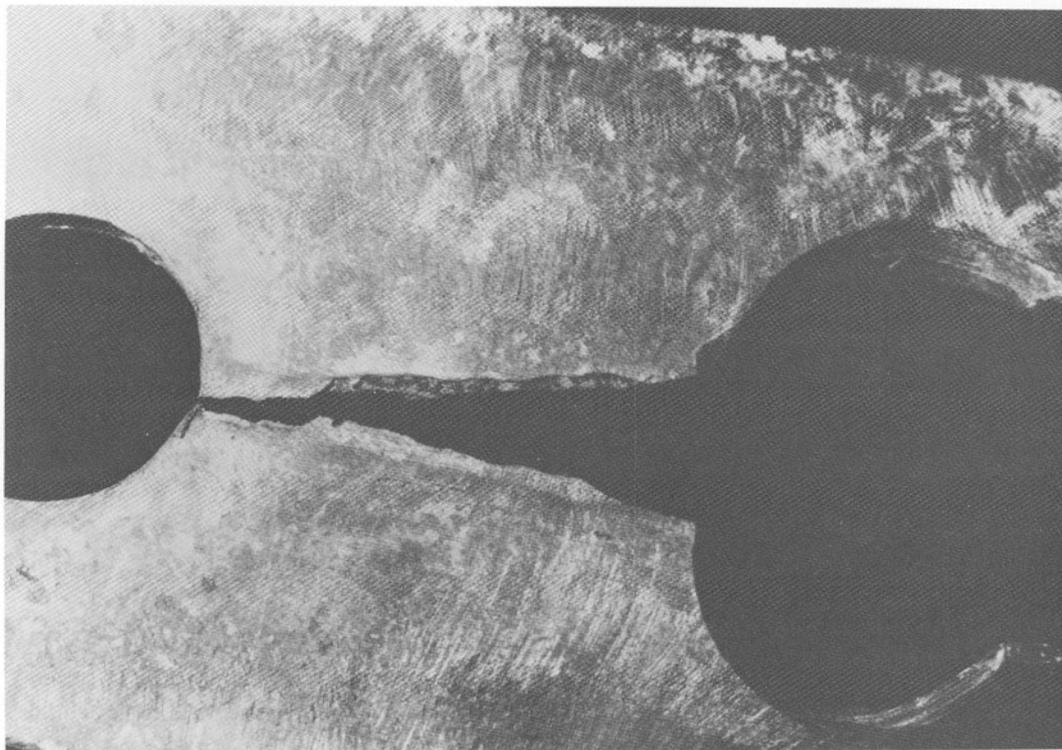
Figure 5.17 Fusion line weld fractures between hanger rod holes, upper flange weld, locations 9UE(a) and 8UE(b).

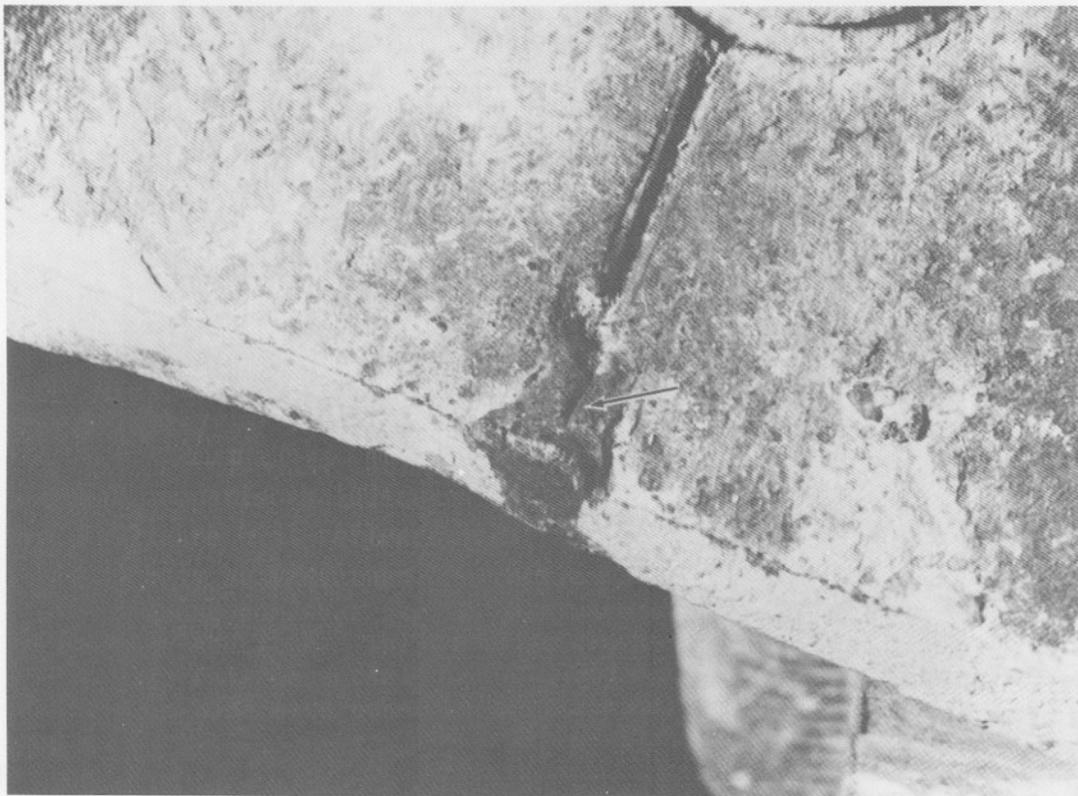
a) Location 8MW. Tack weld crack.

Figure 5.18 Apparent cracks (arrows) in lower welds of box beams in third floor walkway.

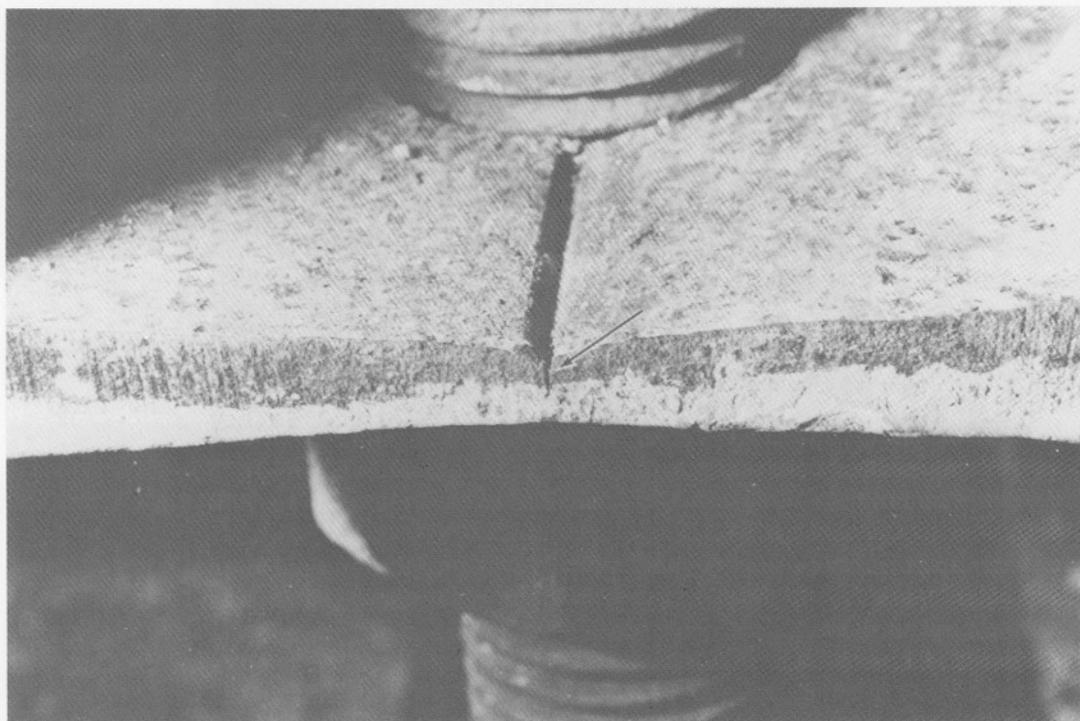
b) Location 8ME. End crack.

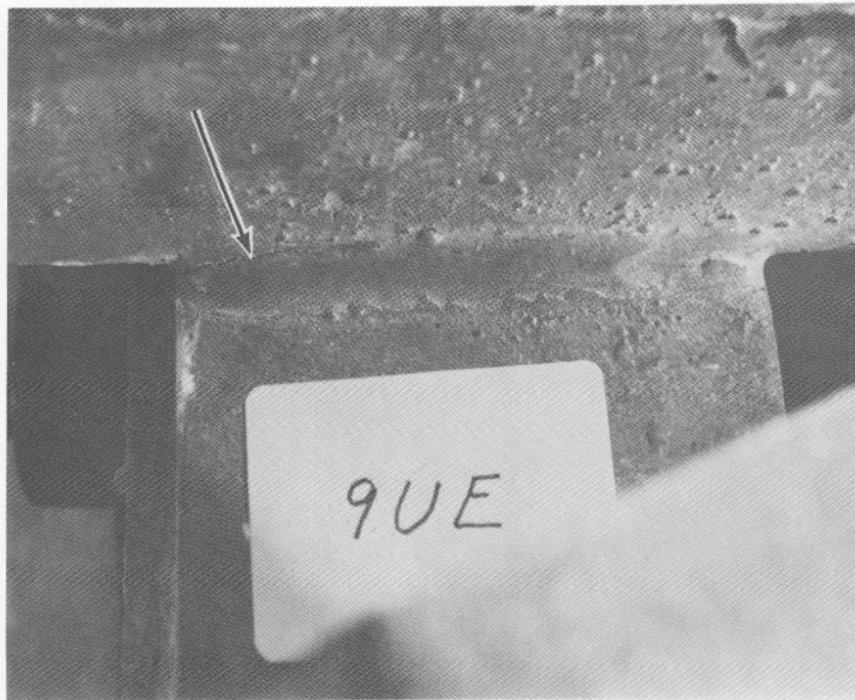
Figure 5.19 Incipient shear failure, bottom fillet weld of intact clip angle, location 9UE, south side.

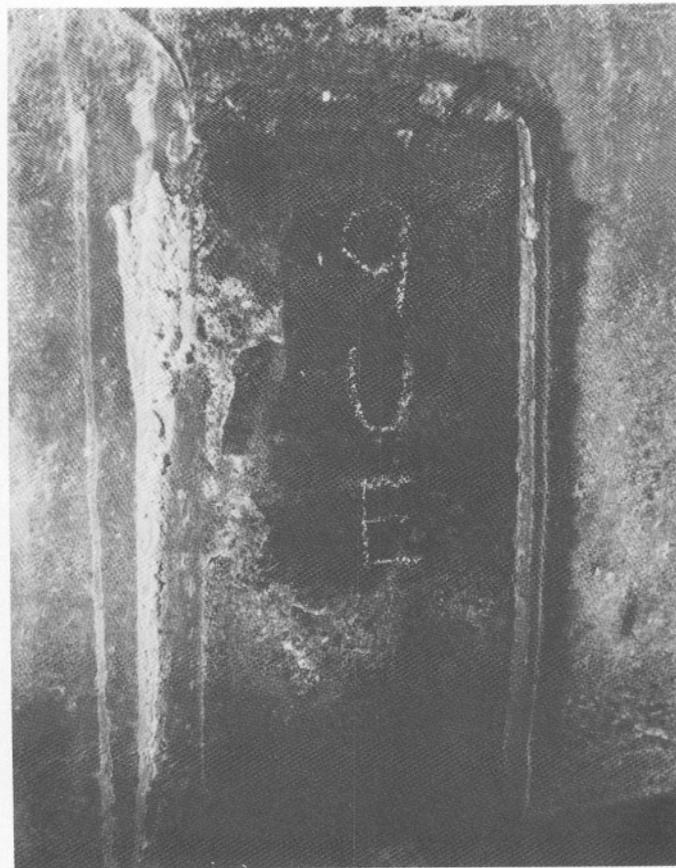
Figure 5.20 Shear failure at bottom and pull-out failure at top of clip angle, location 9UE, north side.

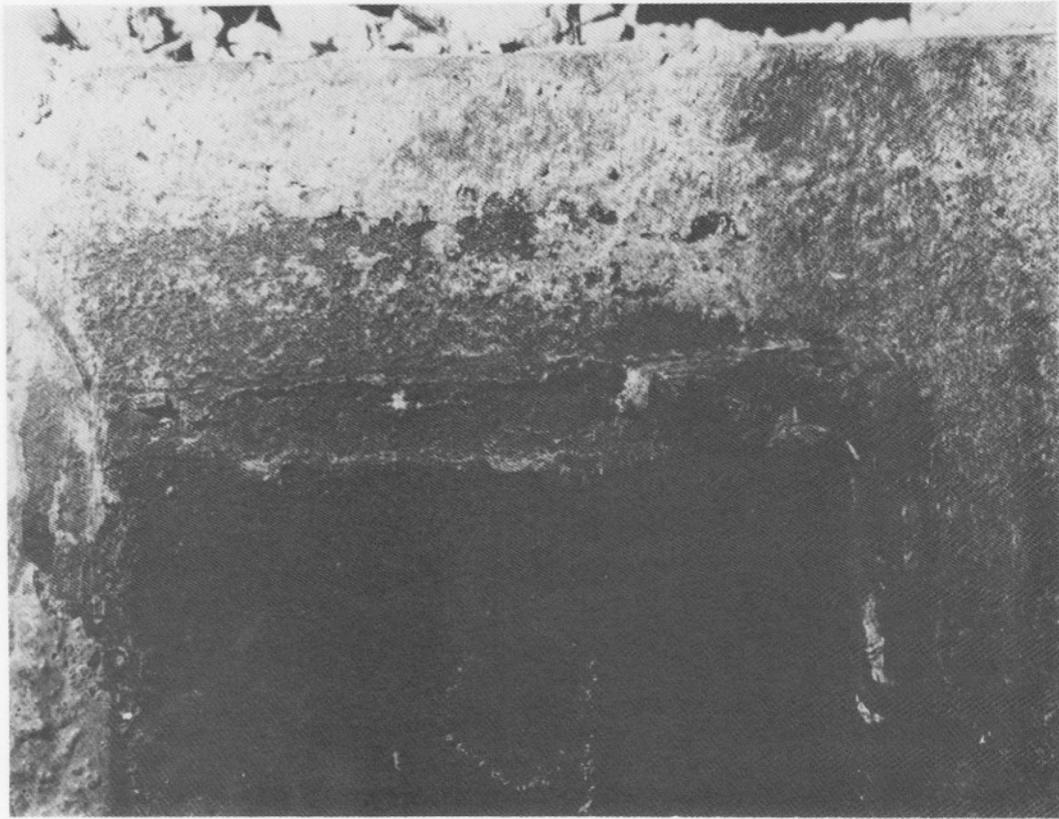
Figure 5.21 Pull-out failure of top fillet weld on box beam web, location 9UE, north side.

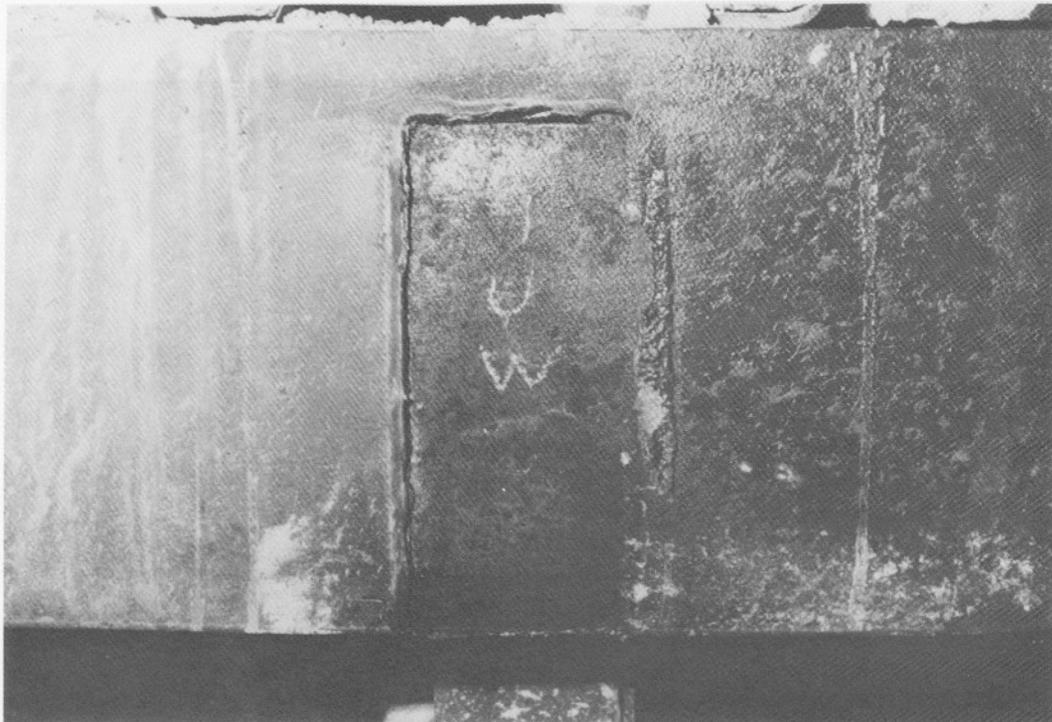
Figure 5.22 Shear failure in clip angle fillet weld at location 9UW, north side. This weld and the corresponding weld at location 9LW did not show evidence of a pull-out (tensile) failure at the top fillet weld.

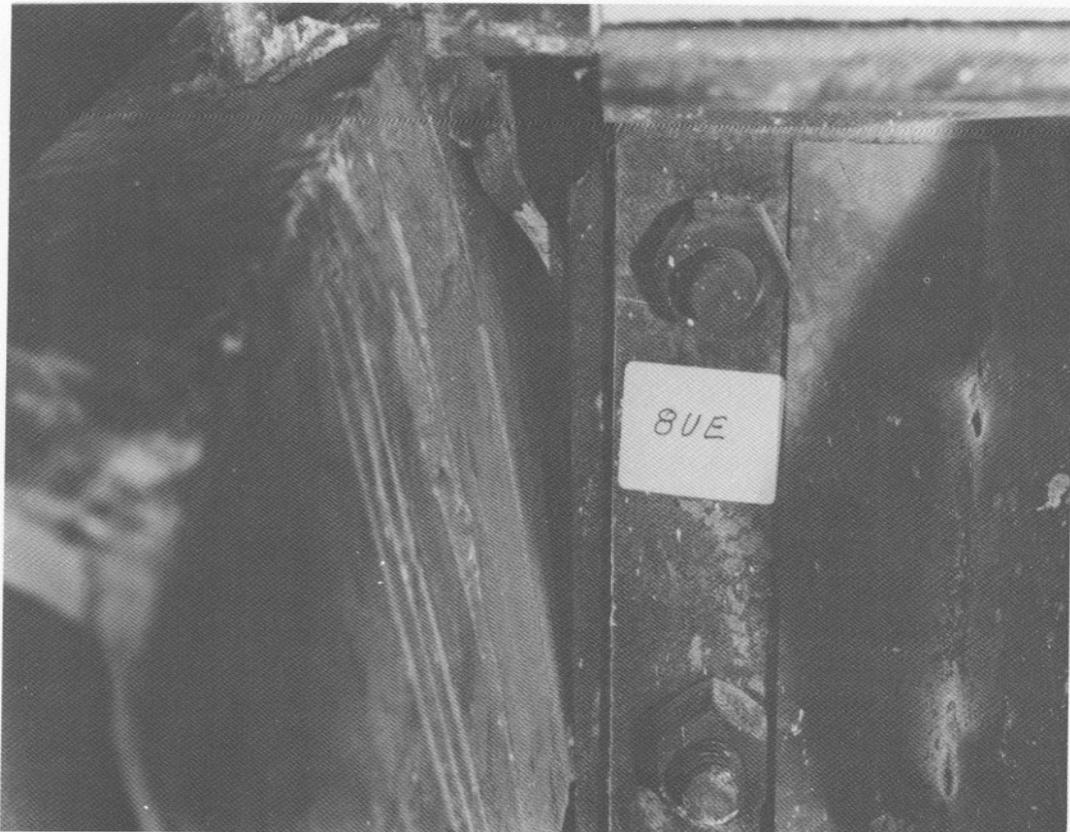
Figure 5.23 Tearing of top end of north clip angle at location 8UE.

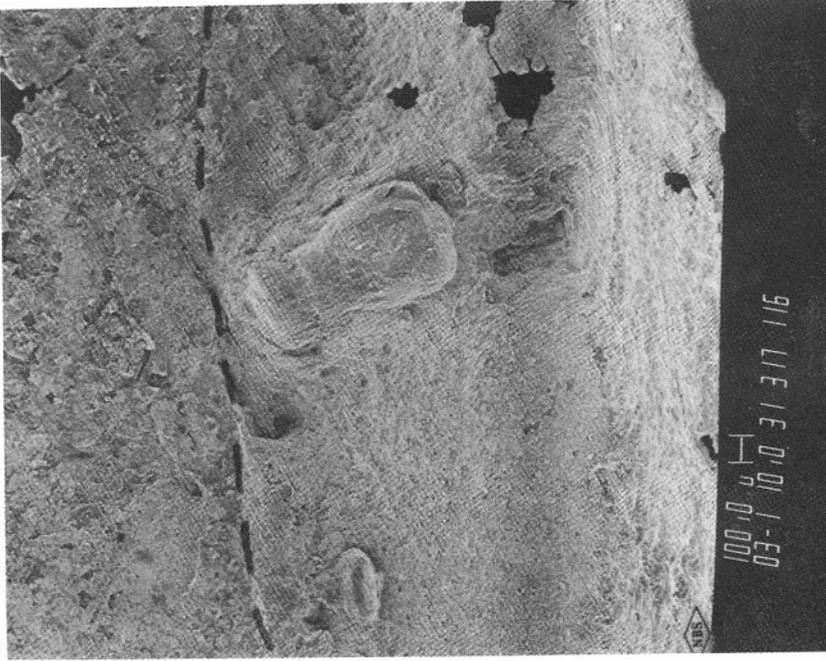
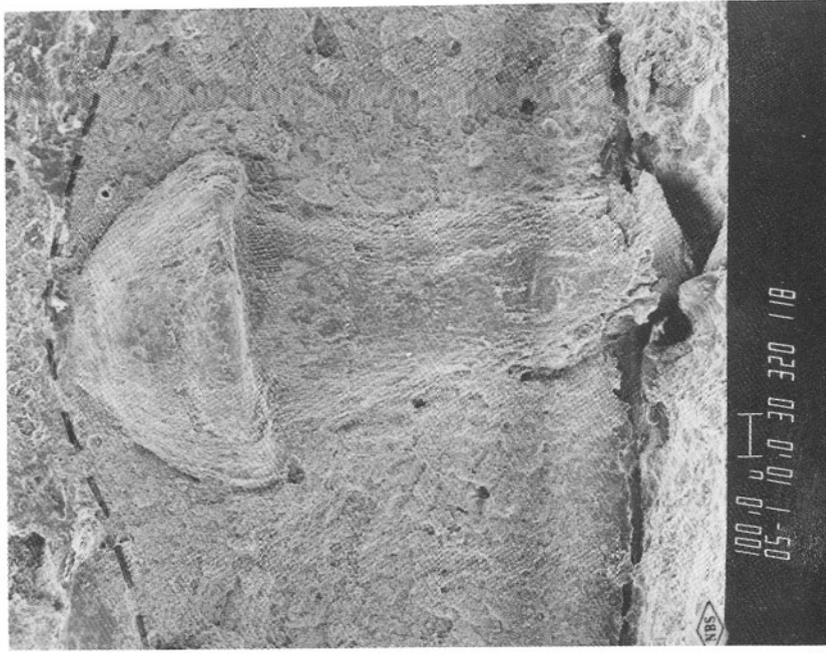
Figure 8.3 Photomicrographs showing that the crack initiated at the root of the weld and propagated to the exterior of the box beam (location 9UE). Figure (a) is located 3 mm from the end of the beam. Crack is propagating downward and slightly to the right. Figure (b) is located 18 mm from end of beam. Magnification (a) X30 and (b) X60.

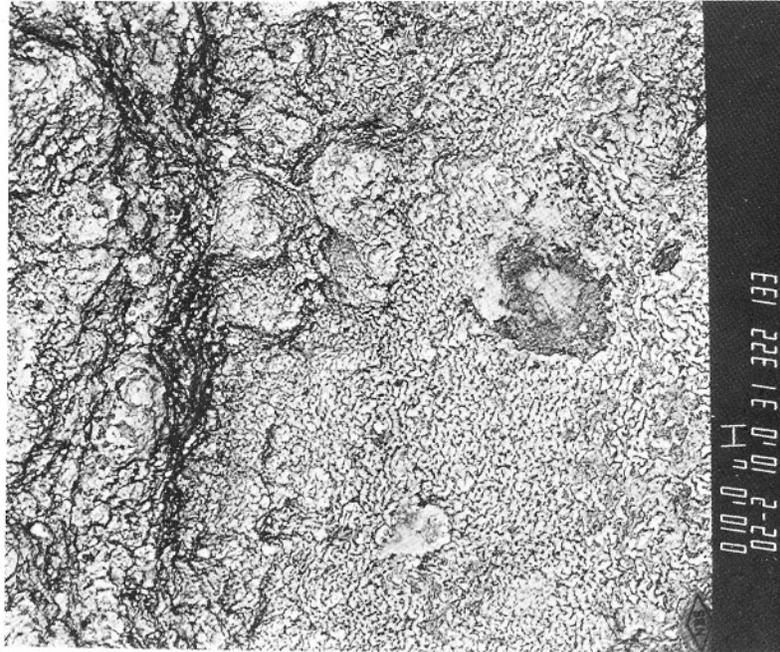
Figure 8.4 Photomicrograph of a replica from the shear lip region at location 8UE. The surface oxidation has removed the fine shear dimpled rupture features in this area. Magnification X250.

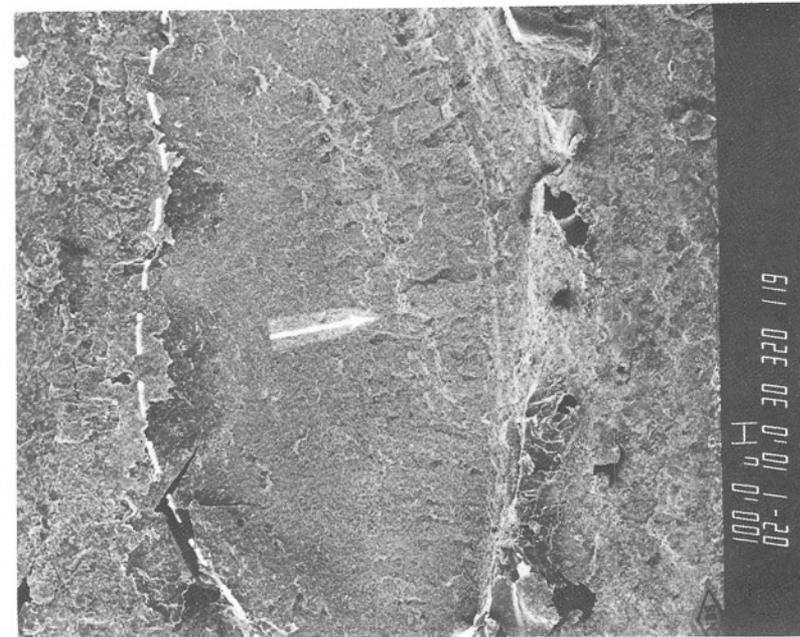
Figure 8.6 Evidence of fracture initiation from upper surface of interior tack weld (dashed line) at location 9UE. Direction of propagation is toward the weld root (arrow) normal to the welding direction. Magnification X25.

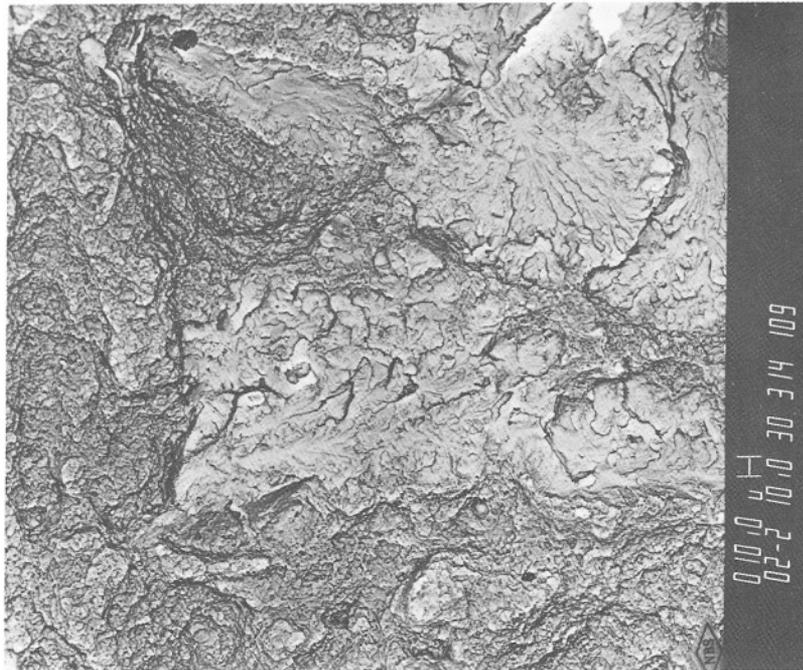
Figure 8.7 Cleavage facets observed at center line of lower exterior longitudinal weld at location 9UW (bright areas). Magnification X250.

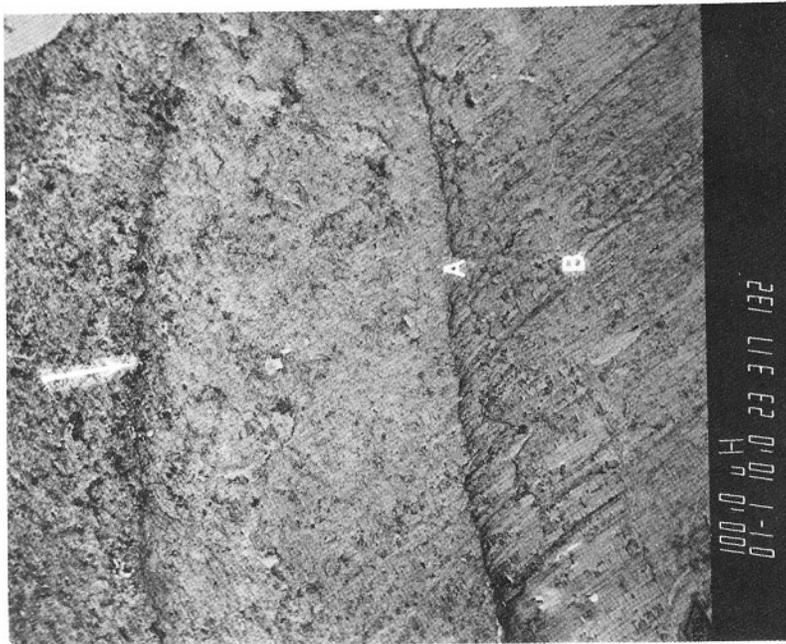
Figure 8.8 Abrasion pattern on bottom flange at location 9UE (north). Arrow denotes initial washer imprint. (A) denotes change in abrasion mechanism. (B) denotes a slip-stick region in progressive failure. Magnification X15.

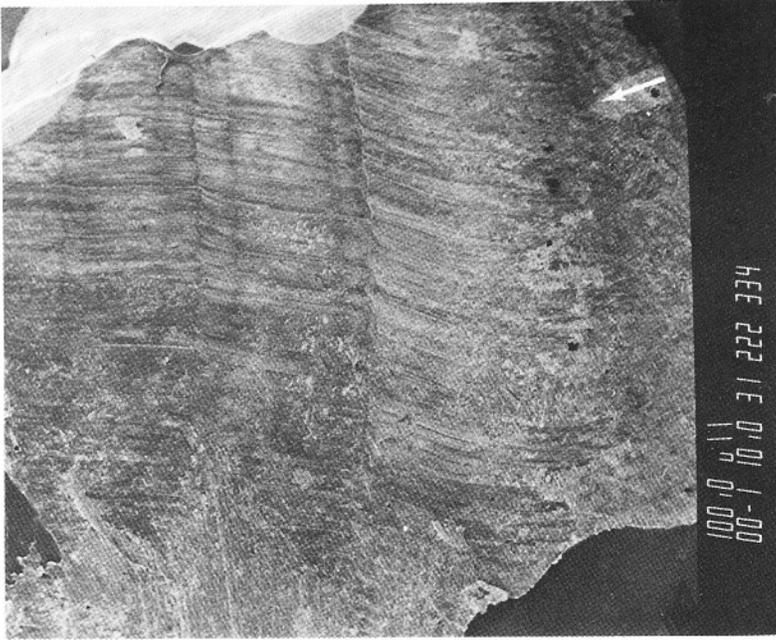
Figure 8.9 Abrasion pattern on bottom flange at location 10UE (south) showing multiple slip-stick regions. Arrow denotes initial washer contact. Magnification X15.

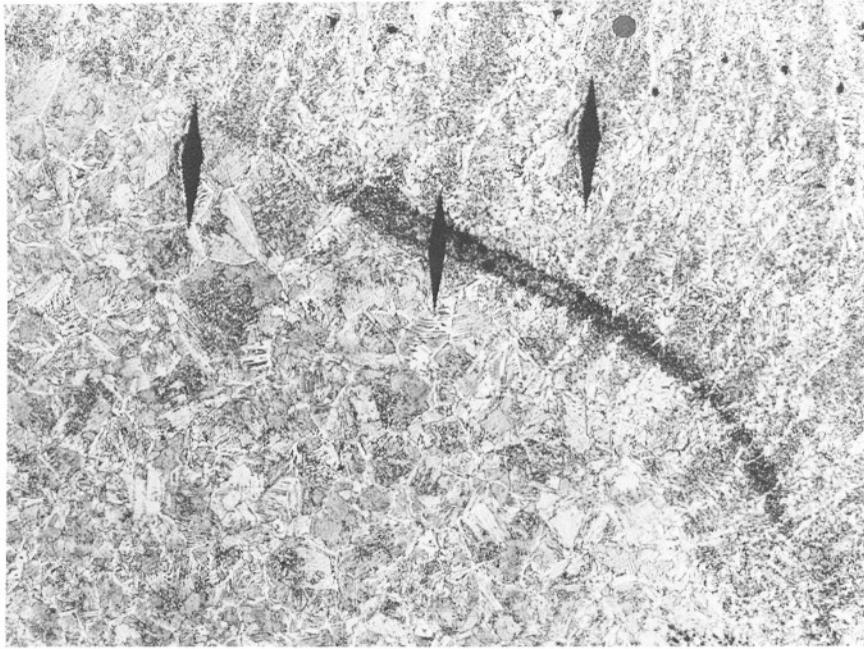
Figure A7.4.1-14 Patch of hard material (dark streak) at the transition from weld metal (top right) to the heat affected zone (bottom left) in section 1BM1. The elongated dark areas are hardness impressions. Etchant: two percent nital. X100

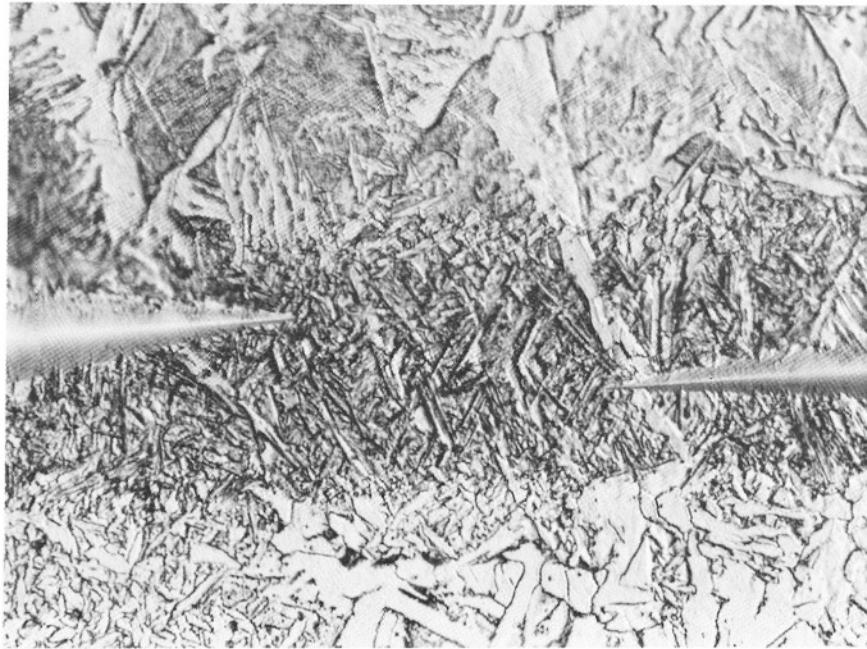
Figure A7.4.1-15 Hard area similar to that shown above, but at higher magnification. The hard area is in the center running from side to side. The microstructure appears to consist of fine grained tempered martensite. Parts of two hardness impressions can be seen at either side of the figure. Etchant: two percent nital. X800
