# Source of Phenol Emissions Affecting the Indoor Air of an Office Building

Jonathan W. Martin  
Franklin R. Guenther  
Tinh Nguyen  
Walter S. Liggett, Jr.  
Eric Byrd  
Lisa Oakley

February 1994  
Building and Fire Research Laboratory  
National Institute of Standards and Technology  
Gaithersburg, MD 20899

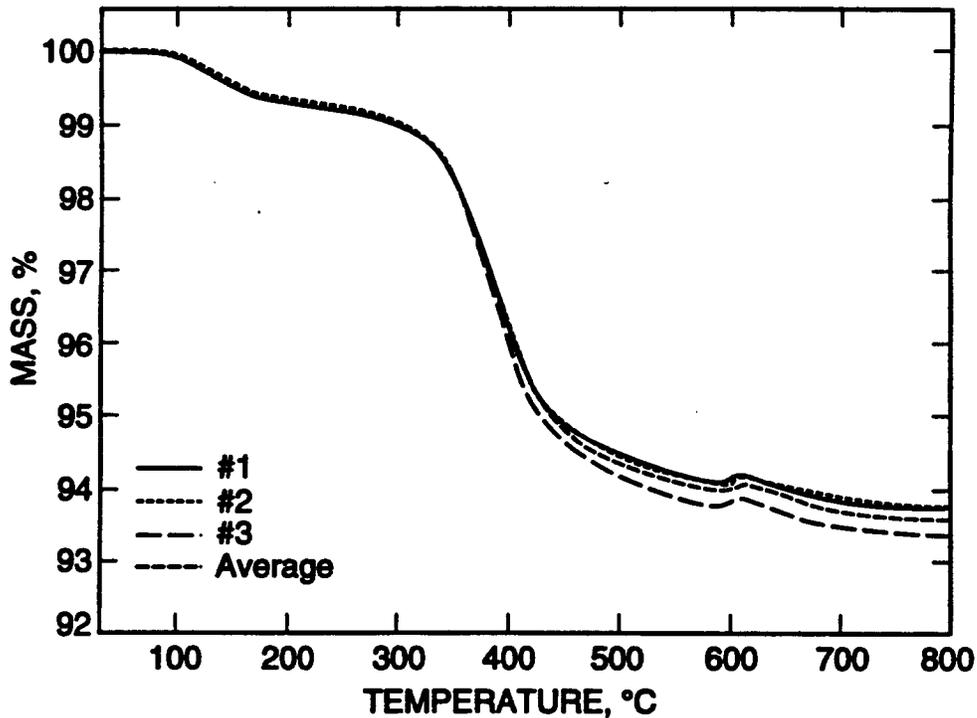
Figure 3. Thermogravimetric curve for one of the fourth floor composite samples heated from room temperature to 800 °C.

materials. (Refer to Table 5 and Appendix A for data on the other samples taken from Floors 2 through 5). At temperatures between 200° C and 800° C, the epoxy binder undergoes thermal degradation causing the epoxy resin to break down into small molecular units by pyrolysis or oxidation which are volatilized along with the high boiling organic compounds, like amines. From the TG curve, the epoxy binder comprised approximately 5.7 % of the total mass of the leveling material (Figure 3). The remaining 0.8 % of the volatile material (100 % - 93.5 % - 5.7 % = 0.8 %) was volatilized between room temperature and 200° C. This would include volatile organic compounds like phenol which might contribute to the indoor air quality complaints in SSMC-1. Of this 0.8 %, between 0.1 and 0.2 % was water<sup>2</sup>.

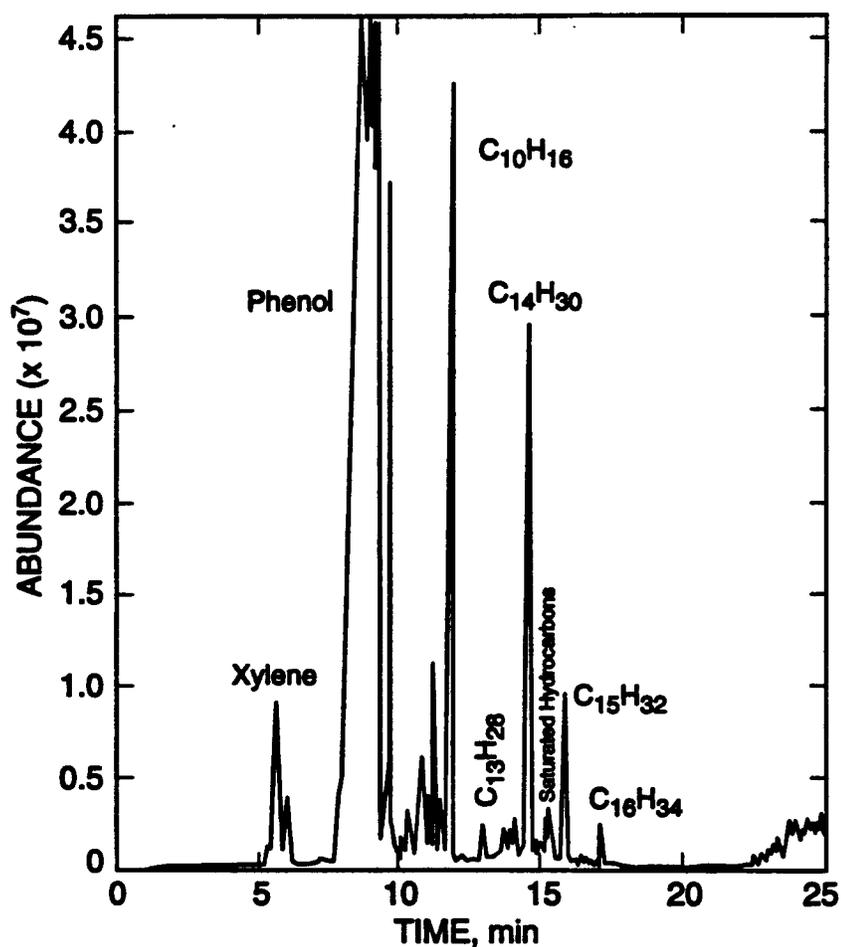
Figure 4. GC/MS spectrum of the epoxy floor-leveling material taken at 100 °C.

In the GC/MS experiment (see Appendix B), a one-gram sample of granulated floor-leveling material was placed in a stream of nitrogen which could be sampled by GC/MS. The volatile organic emissions from the leveling material were monitored at room temperature and 100° C. A GC/MS spectrum taken at 100° C is presented in Figure 4. The GC/MS spectrum at room temperature is similar to the one shown in Figure 4, except that the areas under the peaks are less. From this analysis, it was concluded that **phenol** is emitted from the leveling material along with smaller quantities of **xylene, ethyl benzene, and higher molecular weight hydrocarbons, such as terpenes**. These volatile organic compounds are the same as those reported by Carnow I [5].

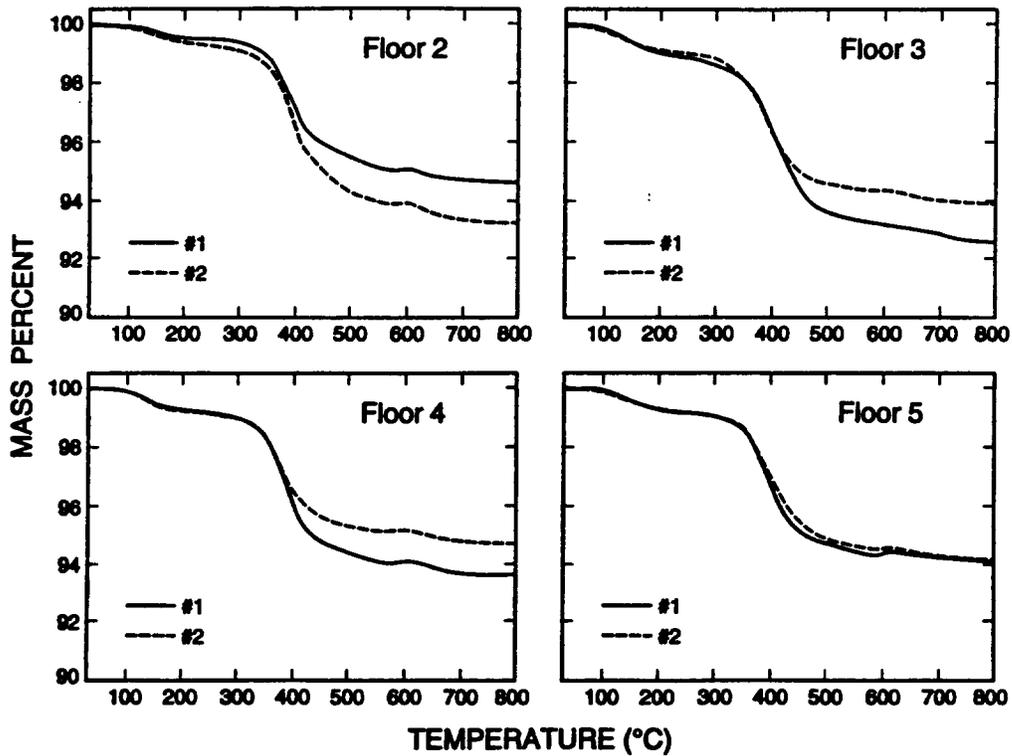
Figure A1. Thermogravimetric curves heated to 800 °C for composite samples made from core samples taken from Floors 2 through 5.

For temperatures between 200° C and 800° C, the epoxy binder undergoes thermal degradation in which the epoxy resin breaks down into small molecular units by pyrolysis or oxidation; the small molecules are volatilized along with high-boiling organic compounds, like amines. The average percent of the total mass of material which consisted of less-volatile organic materials was 5.4 %. As before, a one-way analysis of variance was performed at a 0.05 level of significance to determine if the mass fractions of the less-volatile organic compounds from the different floors were significantly different; it was concluded that the mass fraction of "stable" organic compounds were not significantly different as shown in Figure A3.
