NIST GCR 03-846

**Early Warning Capabilities
for Firefighters:
Testing of Collapse Prediction
Technologies**

Ziyad H. Duron
*Harvey Mudd College
Department of Engineering
301 E. 12th Street
Claremont, California 91711*

February 2003

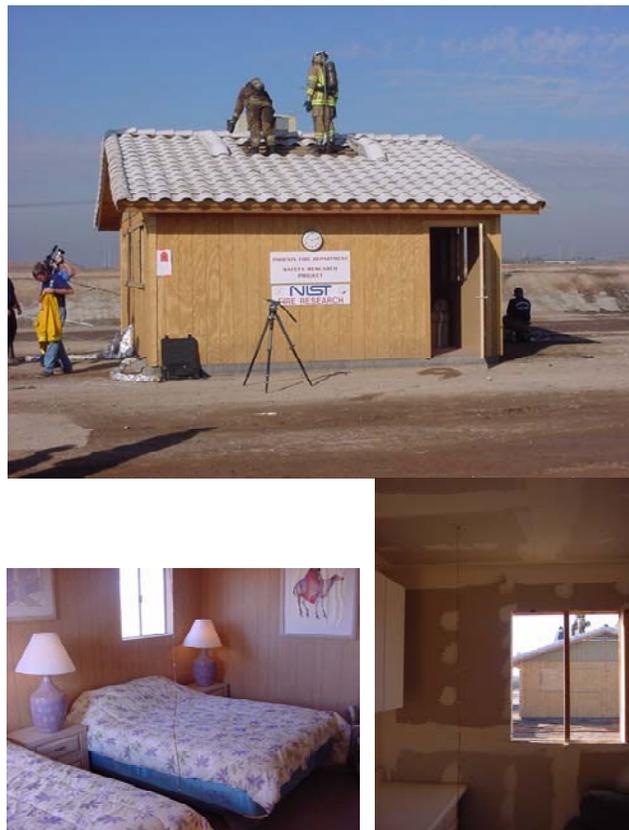
Figure 2 – One of four two-room wood frame structures burned to collapse during training exercises conducted by the Phoenix Fire Department and NIST.

The structure was outfitted with typical furnishings and walls were covered using drywall or wood paneling. Although somewhat difficult to see from the bottom pictures, a vertical strand of thermocouple wiring is shown in the bedroom and front room of the structure.

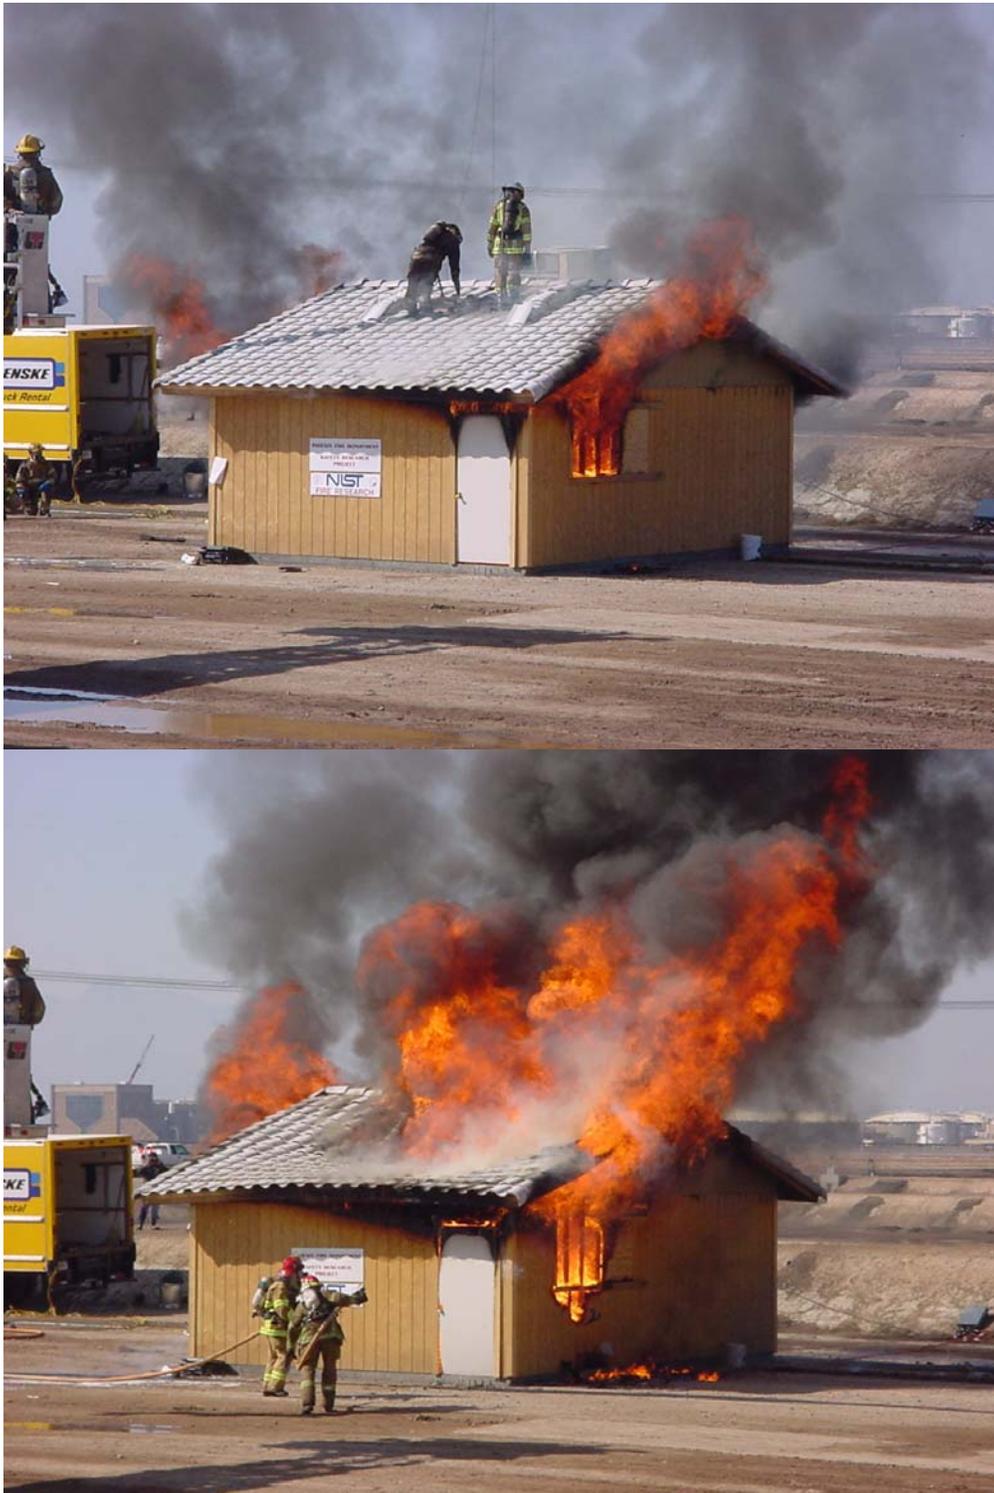
Figure 3 – Phoenix Fire Department burn test of one of the four structures. The top picture shows the mannequins and HVAC on the roof early in the burn, and the bottom picture was taken after roof collapse and prior to firefighting operations.

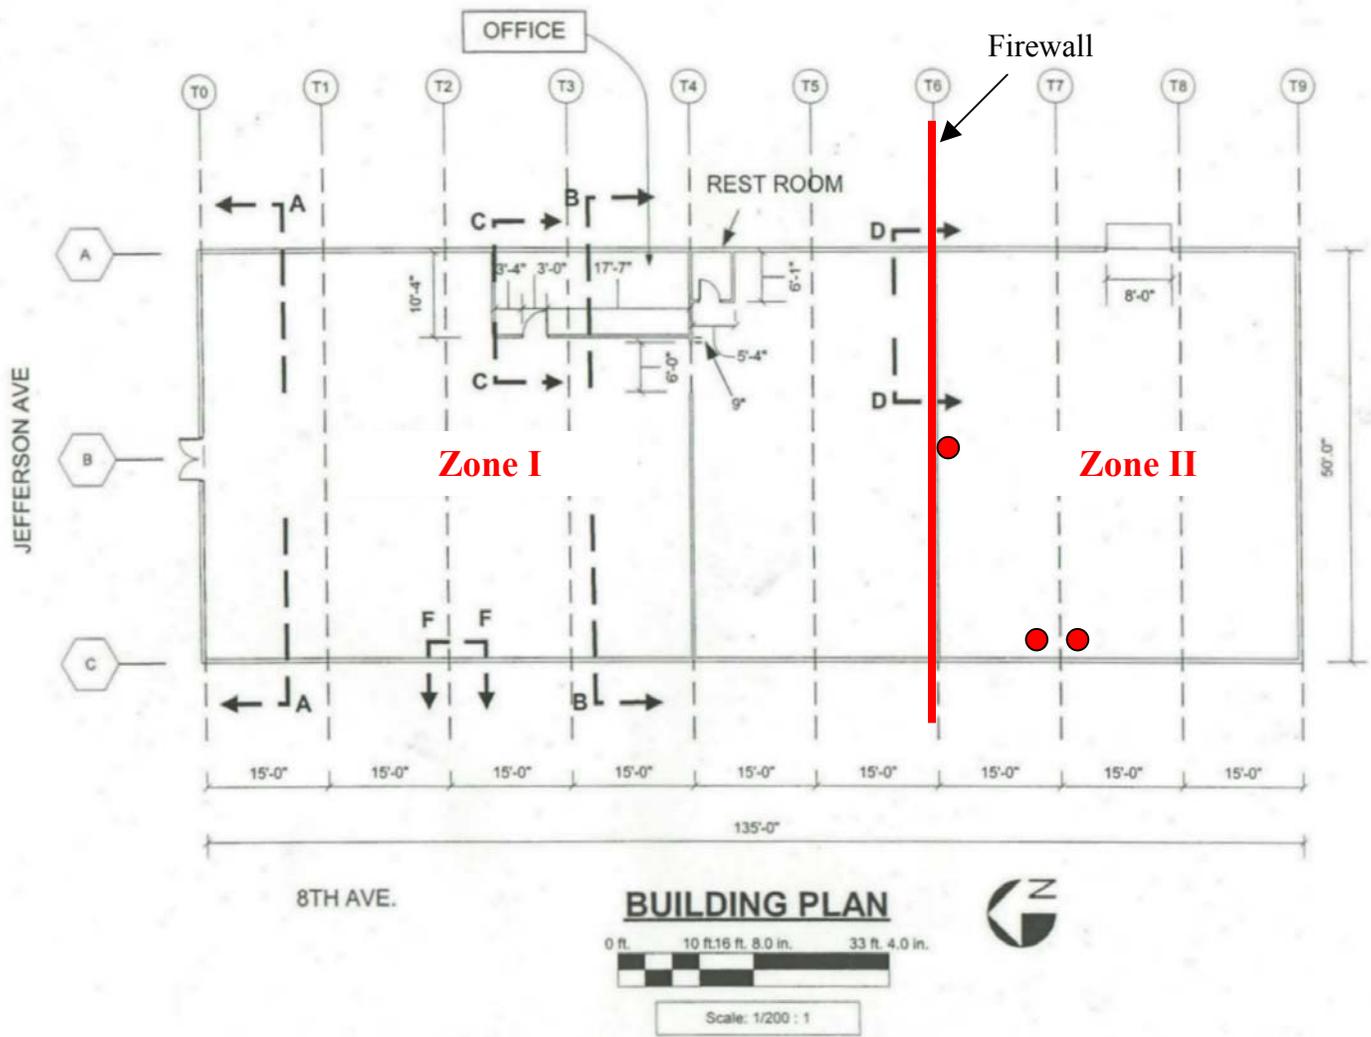
Figure 11 – Building plan of the Phoenix warehouse.

During the first burn, fire was ignited in Zone I and was allowed to burn until roof collapse but was prevented from entering Zone II. Fire-induced responses were acquired at locations in Zone II denoted by the solid red dots. A second burn test was conducted by igniting a fire in Zone II, however, no additional measurements were acquired during this test.

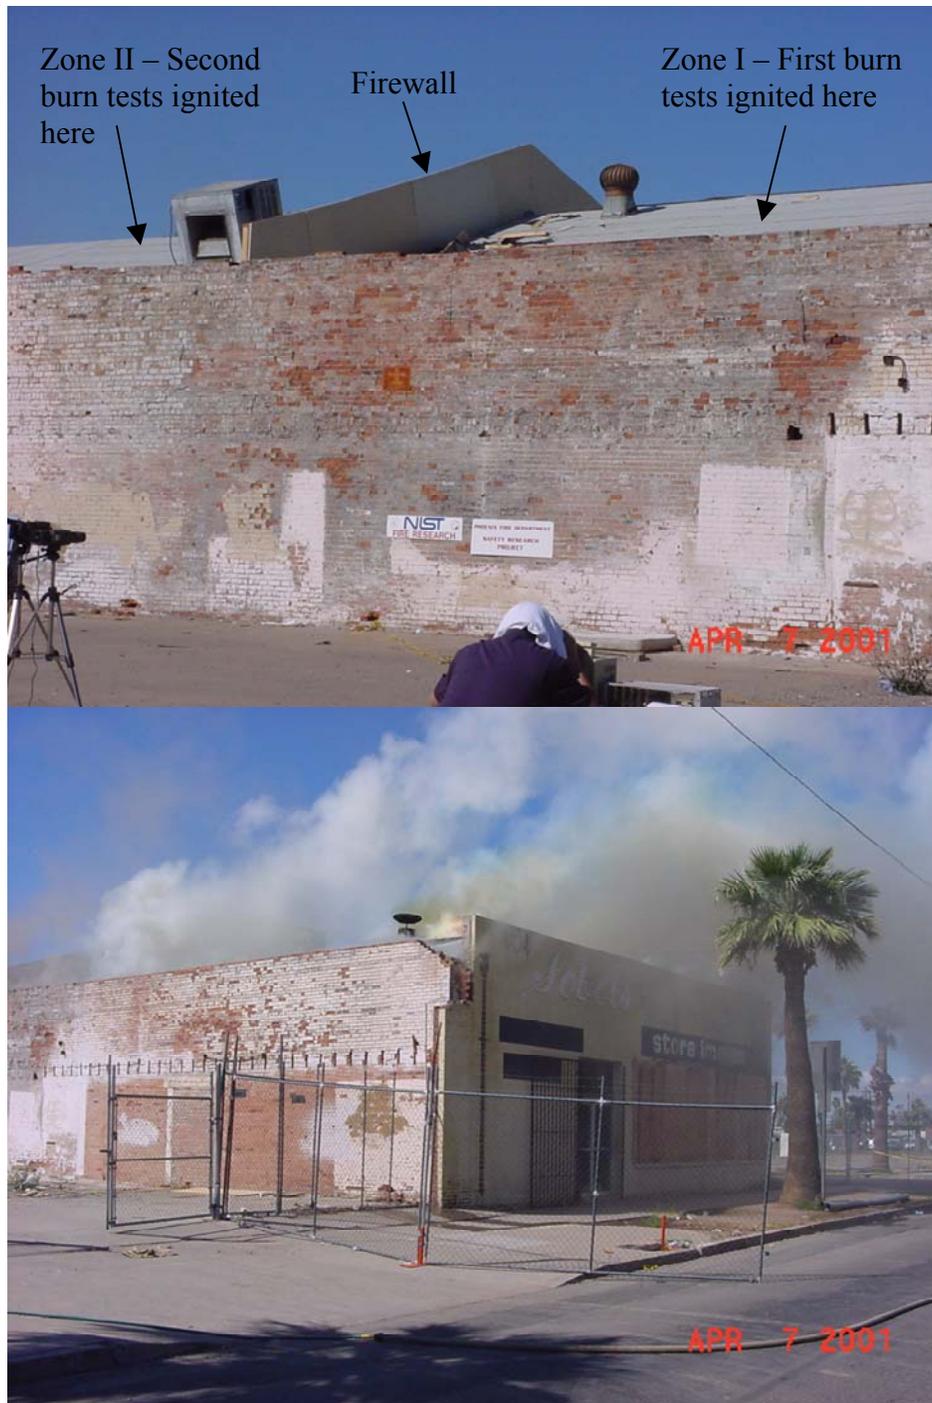
Figure 12 – Phoenix warehouse burn test.

The top photo was taken during preparations and shows the firewall built (extending beyond roofline) to allow two separate burn zones in the warehouse. The bottom photo was taken shortly after ignition.
