# TORNADO AFTERMATH: QUESTIONING THE TOOLS

The aftermath of a destructive 1997 Texas tornado suggests that we need a new way to measure storm intensity. The engineering profession should be part of the effort.

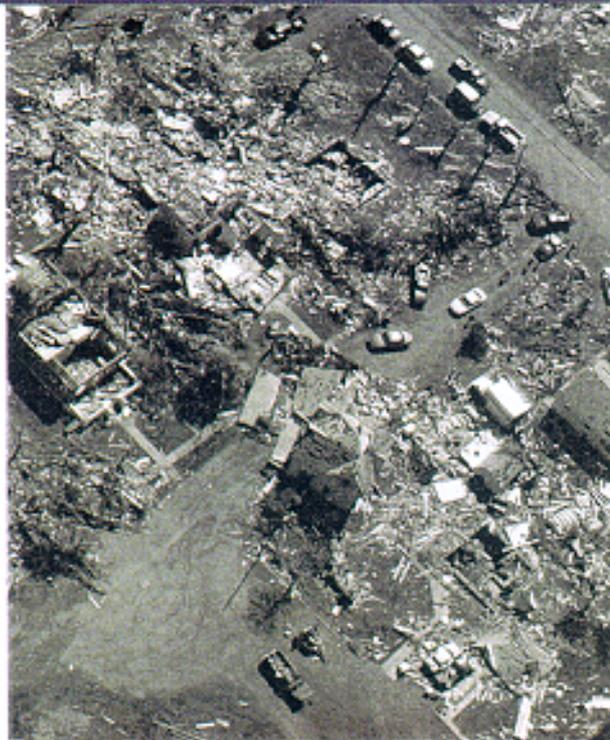
Engineers tracked the path of the May 27, 1997, tornado near Jarrell, Tex., using GPS. The tornado destroyed 40 single-family, wood-framed homes built on slabs, like those above, and killed 27 people. In Williamson County, the twister caused a light steel-framed culvert plant to collapse, while an adjacent, similar plant sustained only minimal damage (below).

The Office of the Federal Coordinator for Meteorological Services and Supporting Research assembled the poststorm survey team, which included author Long Phan of the National Institute of Standards and Technology and Brian E. Peters of NWS. We conducted ground surveys on May 29 and June 1 and participated in two aerial surveys with the Texas Wing Civil Air Patrol station in Waco: one on May 30 using a fixed-wing aircraft flying at between 760 and 910 m and a second on May 31 using a helicopter flying at 150 to 300 m. We used a commercial global positioning system to obtain the coordinates defining the tornado path (Fig. 1).
