NISTIR 6030

**THIRTEENTH MEETING OF THE UJNR
PANEL ON FIRE RESEARCH AND SAFETY,
MARCH 13-20, 1996**

PROGRESS REPORT ON FIRES FOLLOWING THE NORTHRIDGE EARTHQUAKE

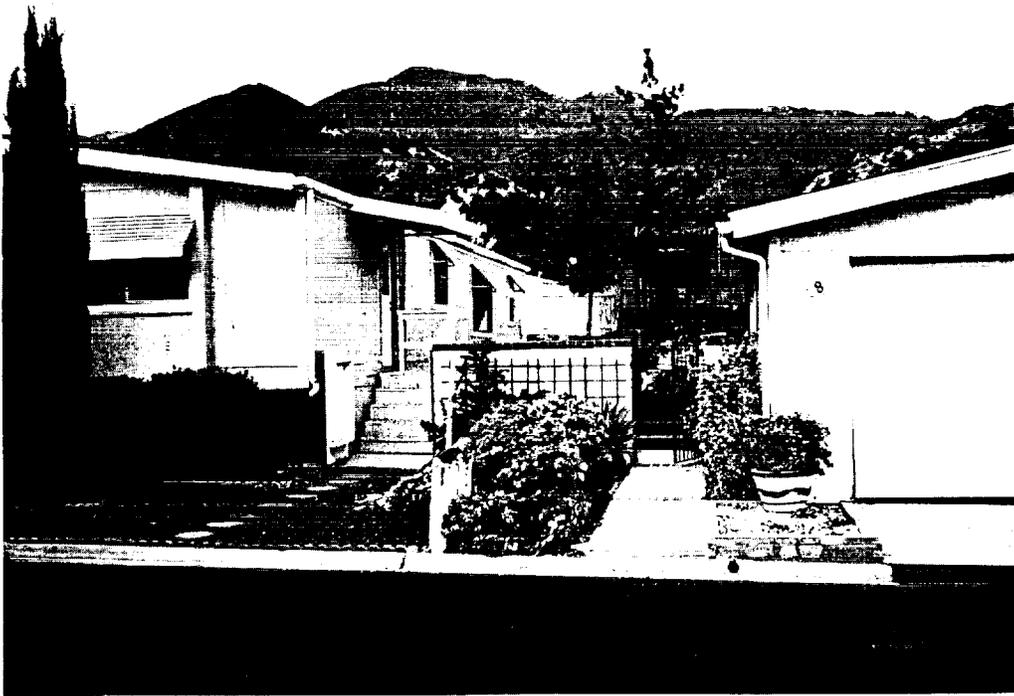
Figure 1. Typical unit spacing in a manufactured housing development.

Building-to-building fire spread was limited to three manufactured housing developments (mobile home parks). Figure 1 shows the typical spacing between units in one of these developments. Figure 2 shows an area of the development destroyed by fire. The Building and Fire Research Laboratory staff investigated these areas in detail during the week following the earthquake. Particular attention was paid to areas where the building to building spread of fire was prevented.

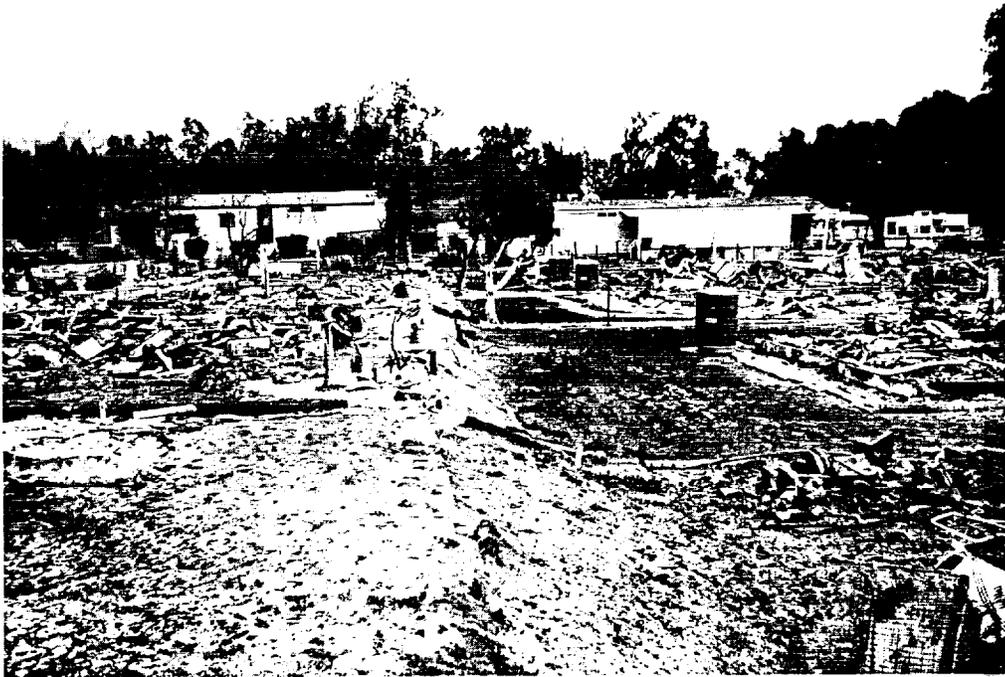
Figure 2. Impact of a multiple unit fire in manufactured housing development.

Observations made at one of the manufactured housing developments after the fires indicates the method of unit-to-unit fire spread was primarily through windows. Once a unit became completely involved in fire, the thermal radiation was sufficient to cause either the breakage of windows in an adjacent unit or ignite combustibles within the unit directly through window openings. The fire department reported low water pressure in the area, which combined with multiple independent fires and limited resources
