NBS BUILDING SCIENCE SERIES 120

Guidelines for Stair Safety

John Archea
Belinda L. Collins
Fred I. Stahl

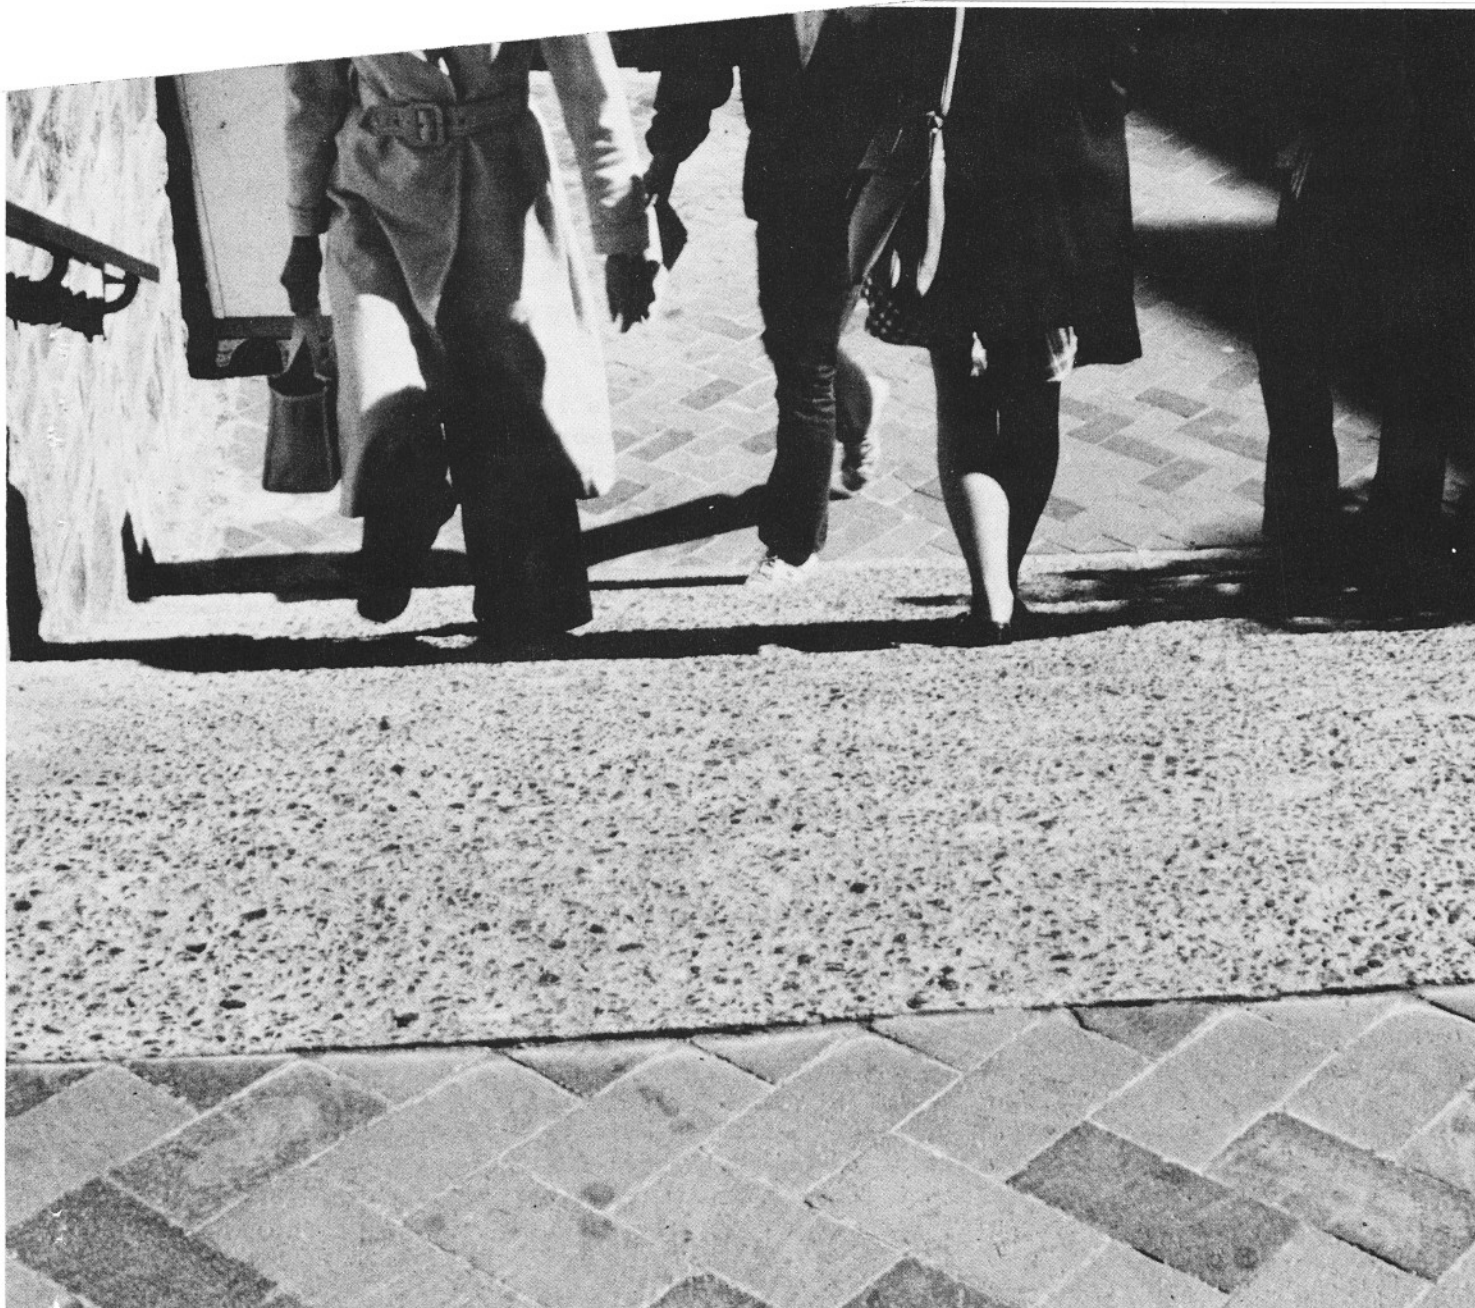
Facing page: The appearance and texture of stair surfaces frequently make it difficult to see the tread edges.

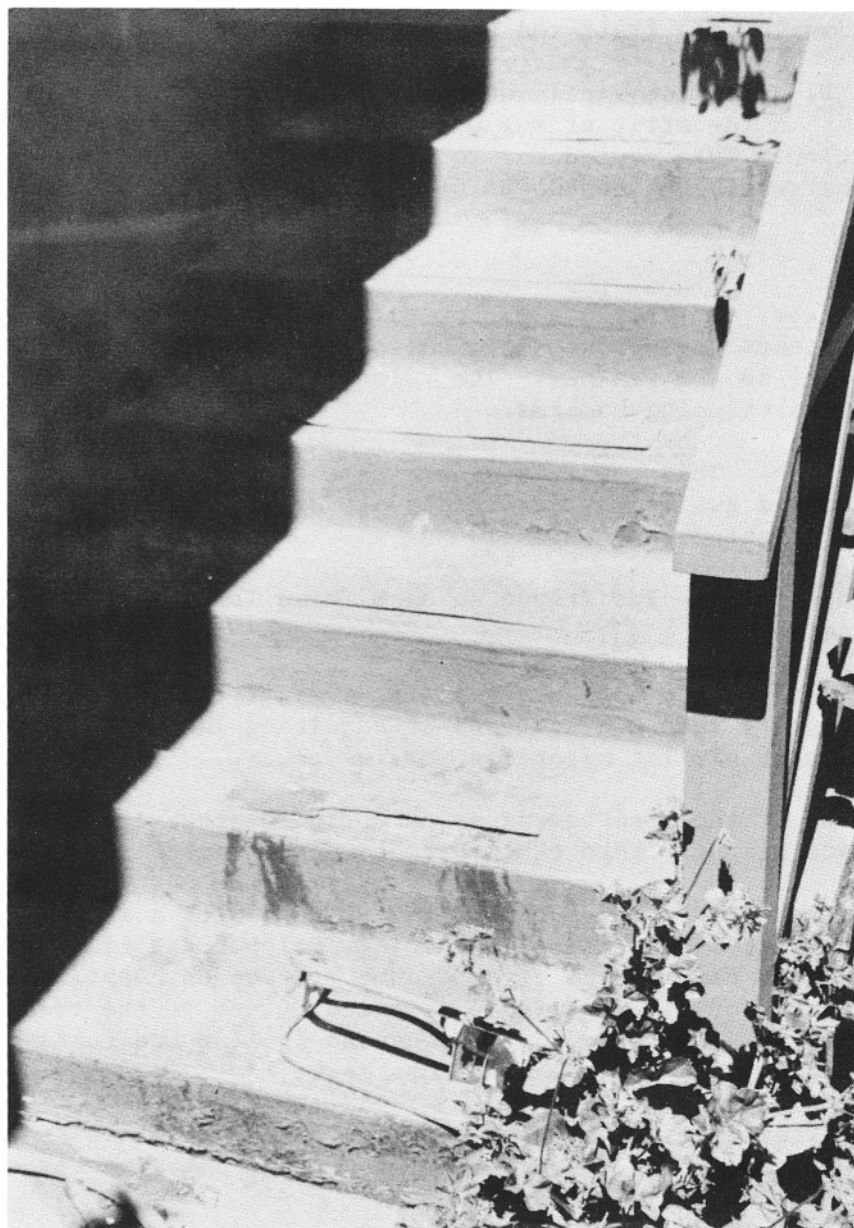
Figure 2.1.3a

COMMENTARY - The distribution of body forces in walking up or down stairs creates less likelihood of slipping on stairs than on level floors. Yet sudden changes in slip-resistance from tread to tread or the insufficient surface resistance of worn, smooth treads can cause problems.

Carson, et al., (1978) found no statistical relationship between the type of surface material used and accident rates. They found that lower accident rates correlated with lower coefficients of friction. These

investigators caution, however, that the coefficient of friction of ordinary materials does not appear to be a primary causal factor determining accident rate (except in extreme cases, e.g., ice, or the opposite condition in which the foot is constantly locking against the surface material).

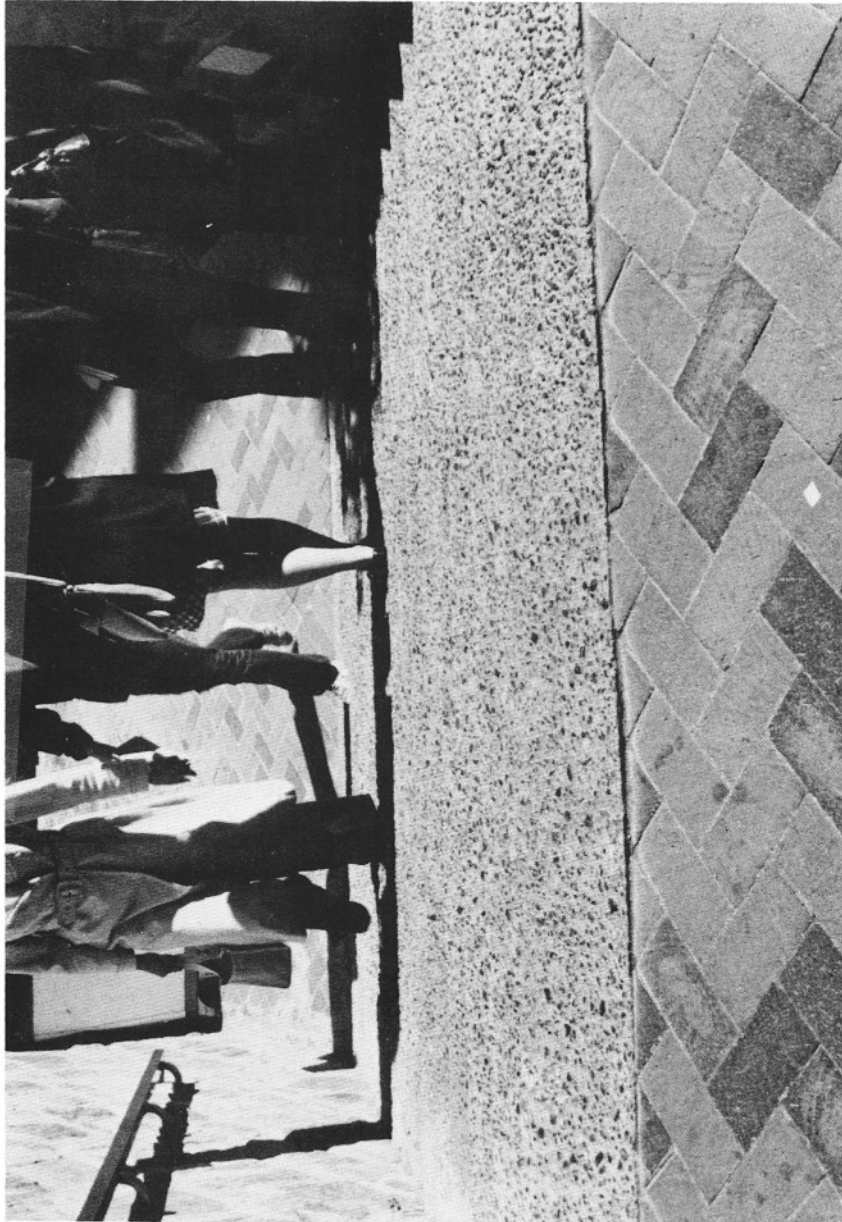
IF: the height or effective depth of any single riser or tread (except winders) varies by more than 1/4 in. across the width of the stair...

THEN: refinish the edge of every tread in the flight with a clearly visible strip of color, or illuminate the flight so that the

highlighted nosings will produce a visual pattern of edges which accentuates the location of each irregularity.

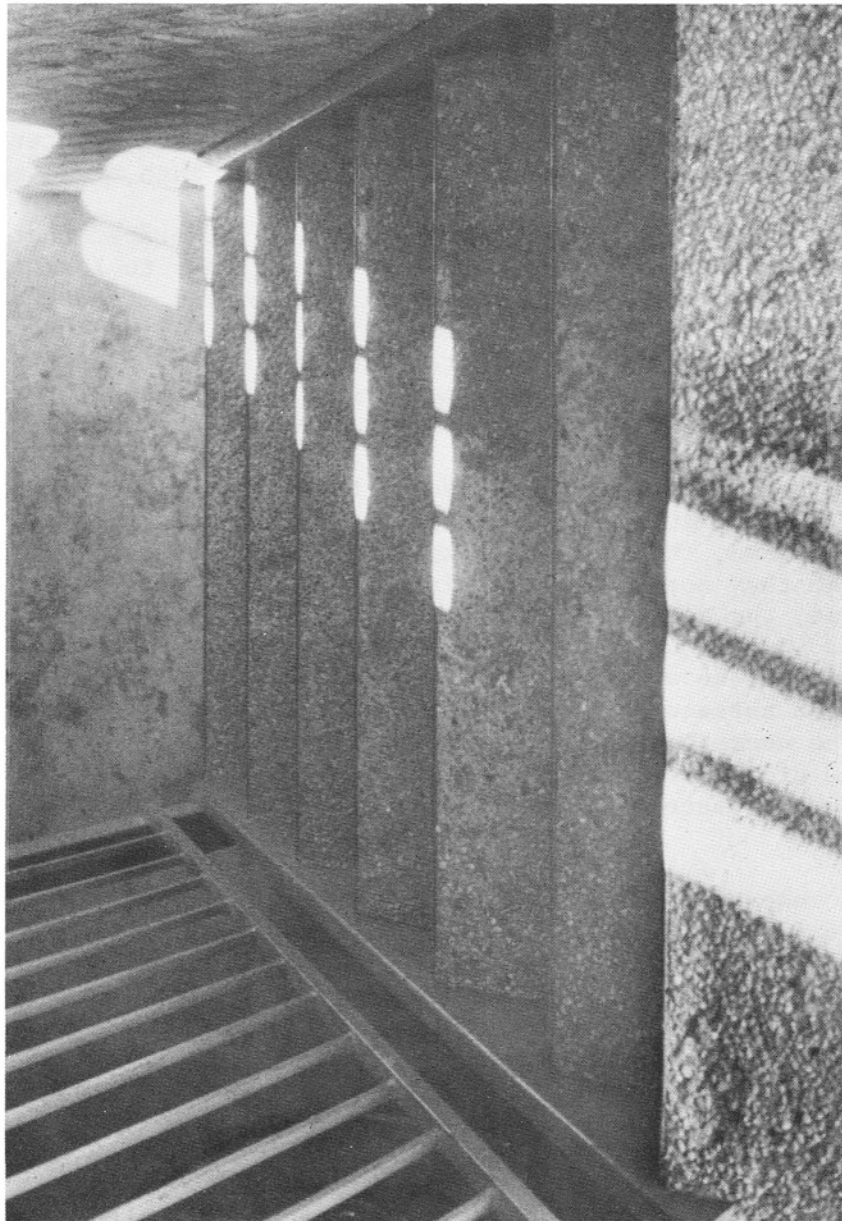
Figure 2.2.2

Figure 2.2.2. The second tread on this stair is more than one inch out of alignment with the other treads (note that the sunlight misses the second tread altogether). The third tread from the bottom is also slightly out of alignment (note a narrower band of sunlight than on adjacent treads).

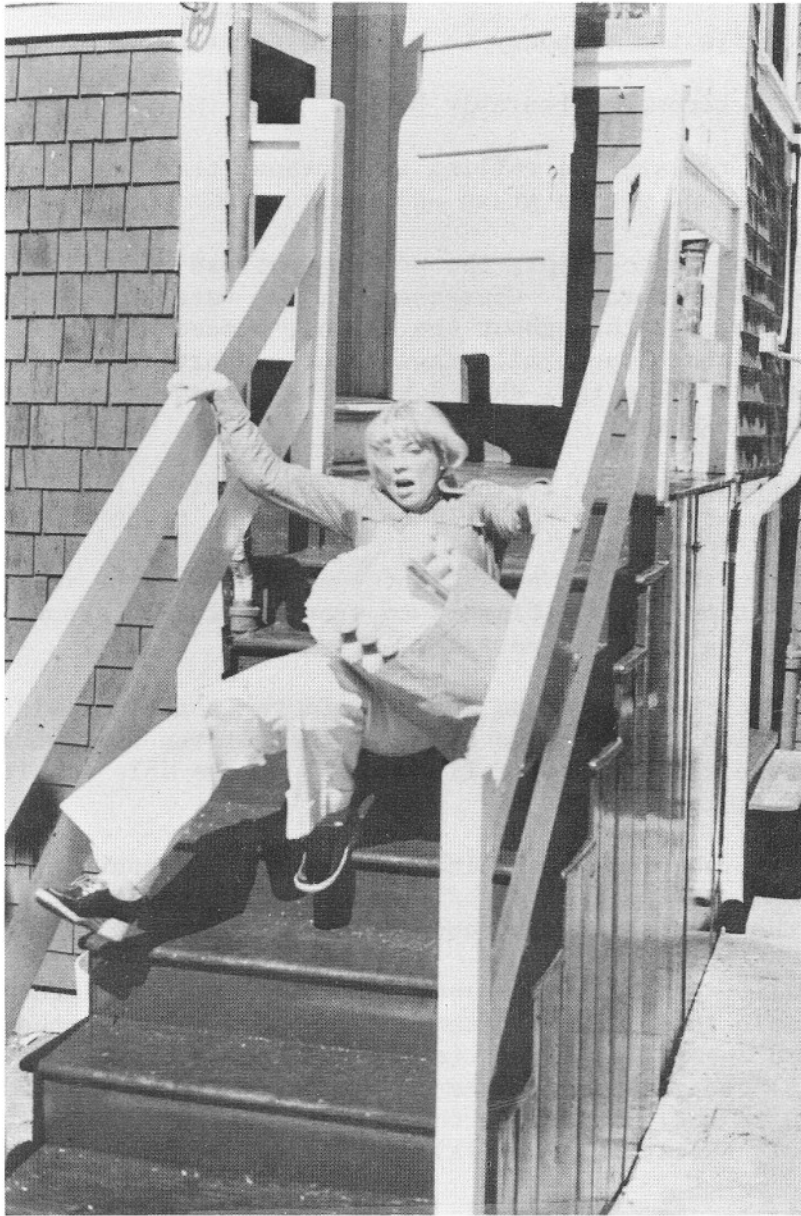
Figure 2.3.1

IF: a handrail cannot be grasped by a typical user such that his thumb and index finger form a shape similar to the letter 'C', or...

IF: a handrail is positioned such that the user's fingers rub against a wall, mounting bracket, or other element when grasping the railing in the manner described above, or...

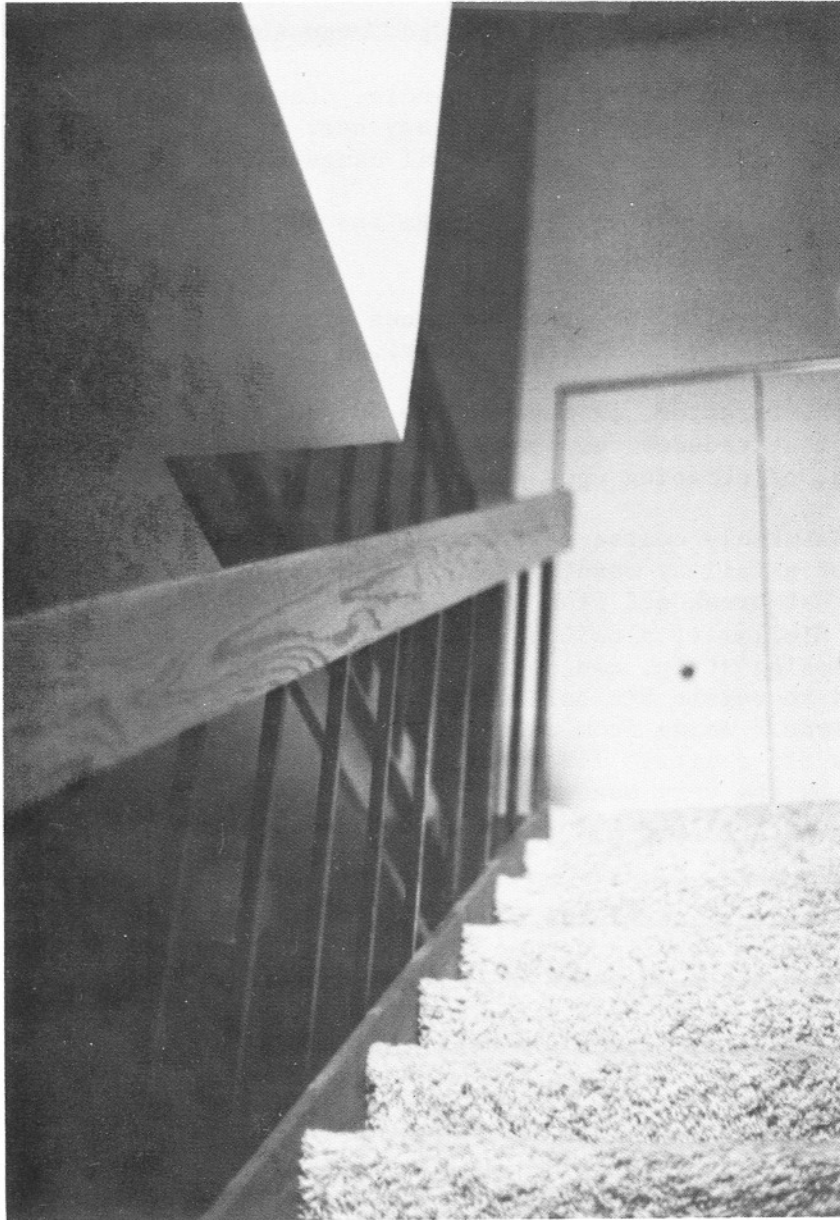
Figure 2.4.4

Accident A. The 36-year old housewife was returning up the tilted and uneven wooden stair when she lost her balance midway up the flight. When she extended her right hand to steady herself, it landed on a protruding nail which severely lacerated the tip of the fourth finger. (NEISS)

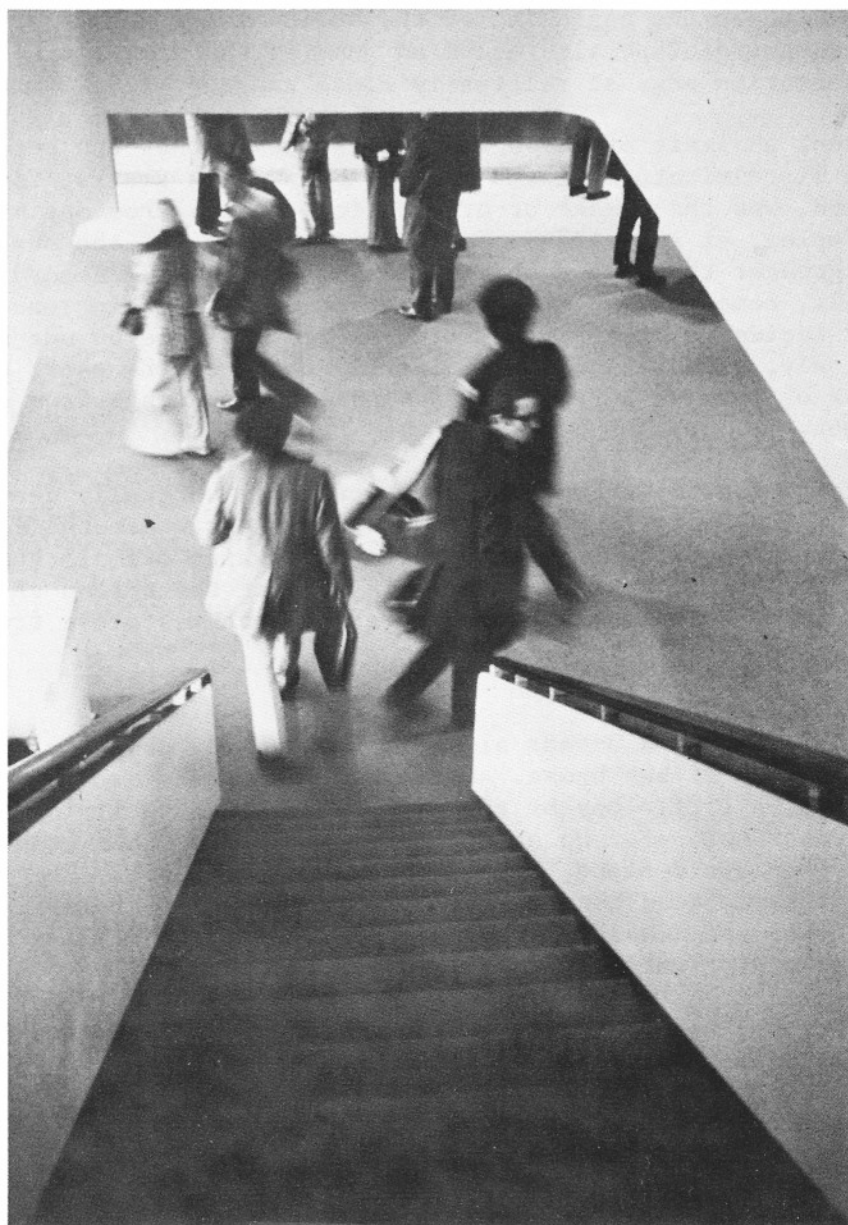
Figure 2.5.2a

Figure 2.5.2a. As users approach this stair from above, they must first descend into an enclosure which completely obscures their view of the scene below. At the top of the flight, the enclosure ends, creating a

view of the floor below. This scene is exposed to descending users at precisely the point where their attention should be directed toward the stair itself.

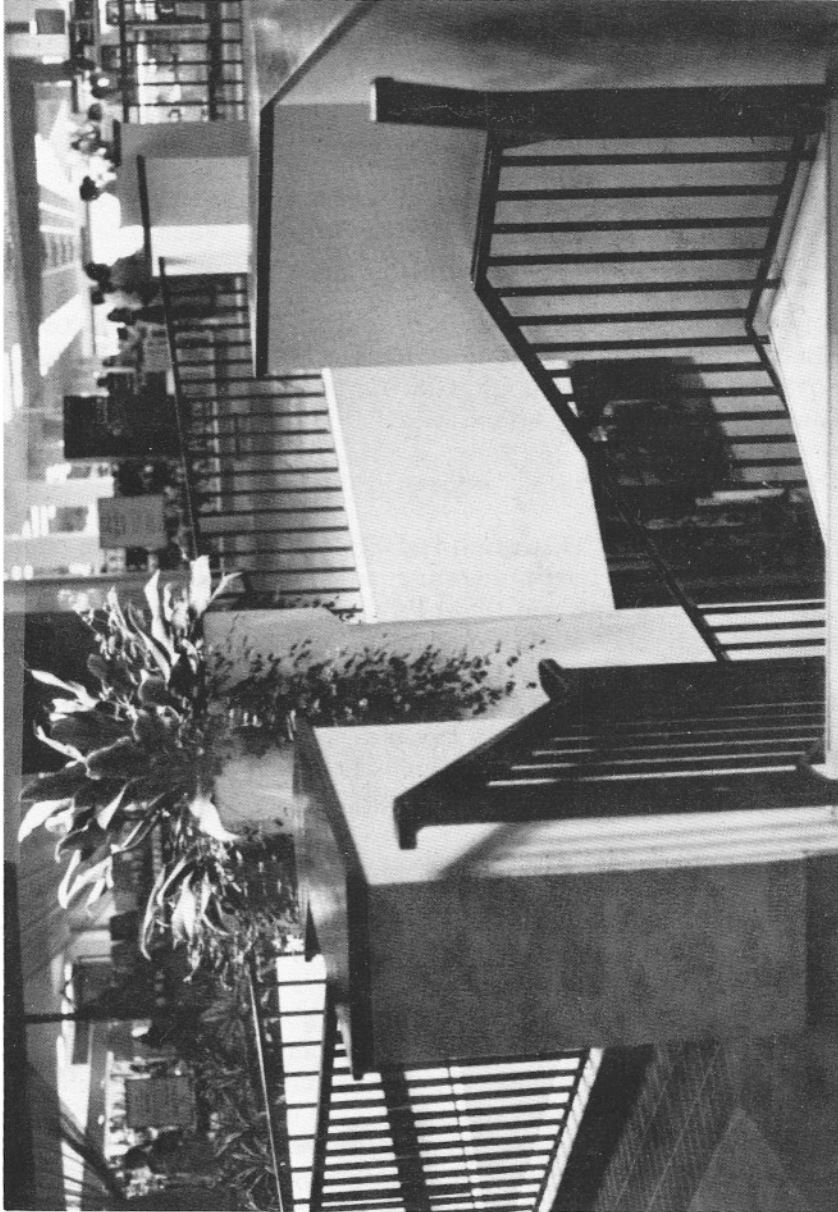
Figure 2.5.2b

COMMENTARY - The potential for being distracted by a view through an open riser is a variation of the "orientation edge" problem. Here again, the primary issue is whether the stair itself or something in the surrounding is a more compelling focus for the user's visual attention. The only additional hazard associated with views through open risers is related to the interference or flicker introduced by the stair treads which appear to move across the foreground while the user ascends the stairs. The resulting discontinuous view through the open risers may induce the user to neglect the stair itself, because he must concentrate on overcoming the repeated disruption created by each passing tread.

If the user stops to scrutinize the scene before resuming his ascent, he could block traffic and be a potential hazard on heavily traveled stairs.

Furthermore, once stopped, the stair climber will have to repeat the process of getting onto the stair in a manner much like his original transition from level walking to stair walking. Since the user's vulnerability to accidents seems greatest while making such a transition, all such conditions should be avoided.

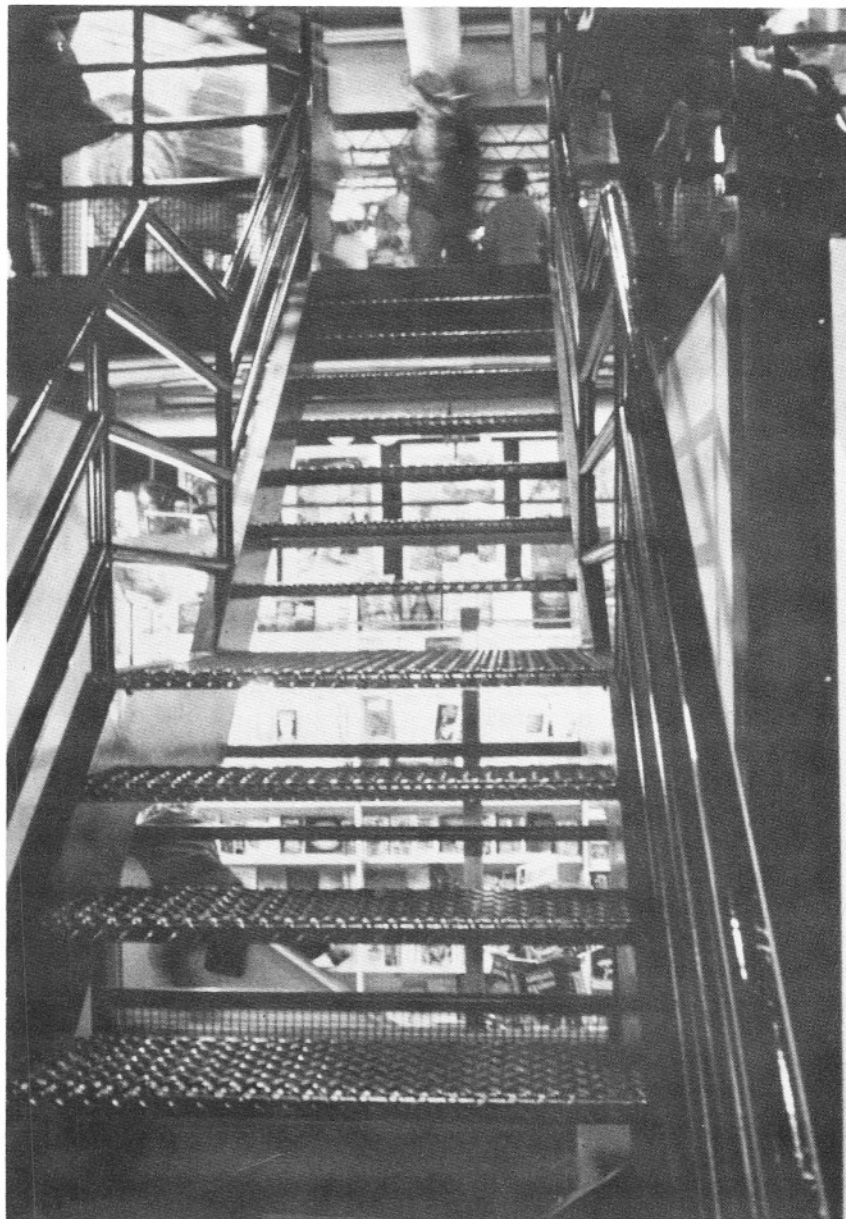
Figure 2.5.3

THEN: either (a) block the source of glare with translucent or opaque shades or screens, (b) reduce the reflectance of any surfaces which reflect bright lights or (c) move the offending bulb or fixture beyond the range of the user's functional visual field.

COMMENTARY - The total amount of light on the treads and handrails is one of the critical factors in the user's ability to detect prevailing stairway conditions. However, an adequate quantity of light does not ensure that the quality of illumination is particularly good on a given flight of stairs. If the angles of incidence and of reflectance combine with highly reflective surfaces to produce glare when the user looks at the treads, increases in light level could actually diminish his ability to acquire useful information. Finally, when the source of illumination falls within the user's visual field while looking at the stair, there is a distinct possibility that the intense brightness in one portion of the visual field may actually reduce the user's ability to acquire useful information from the remainder of the visual surroundings.

On many residential flights of stairs, the fixture which illuminates the stairway is clearly visible when the user is looking toward the stairs in descent. This condition may not only reduce a person's ability to discern details, but could also produce an afterimage which makes it difficult to process any visual information for several seconds afterward. Glare from overhead light sources, and the resulting afterimage, becomes even more critical for the elderly and visually handicapped (Pastalan, et al., 1973; Weale, 1963). During ascent, similar glare problems can arise from lights over an upper landing or from decorative lighting beneath stair treads.

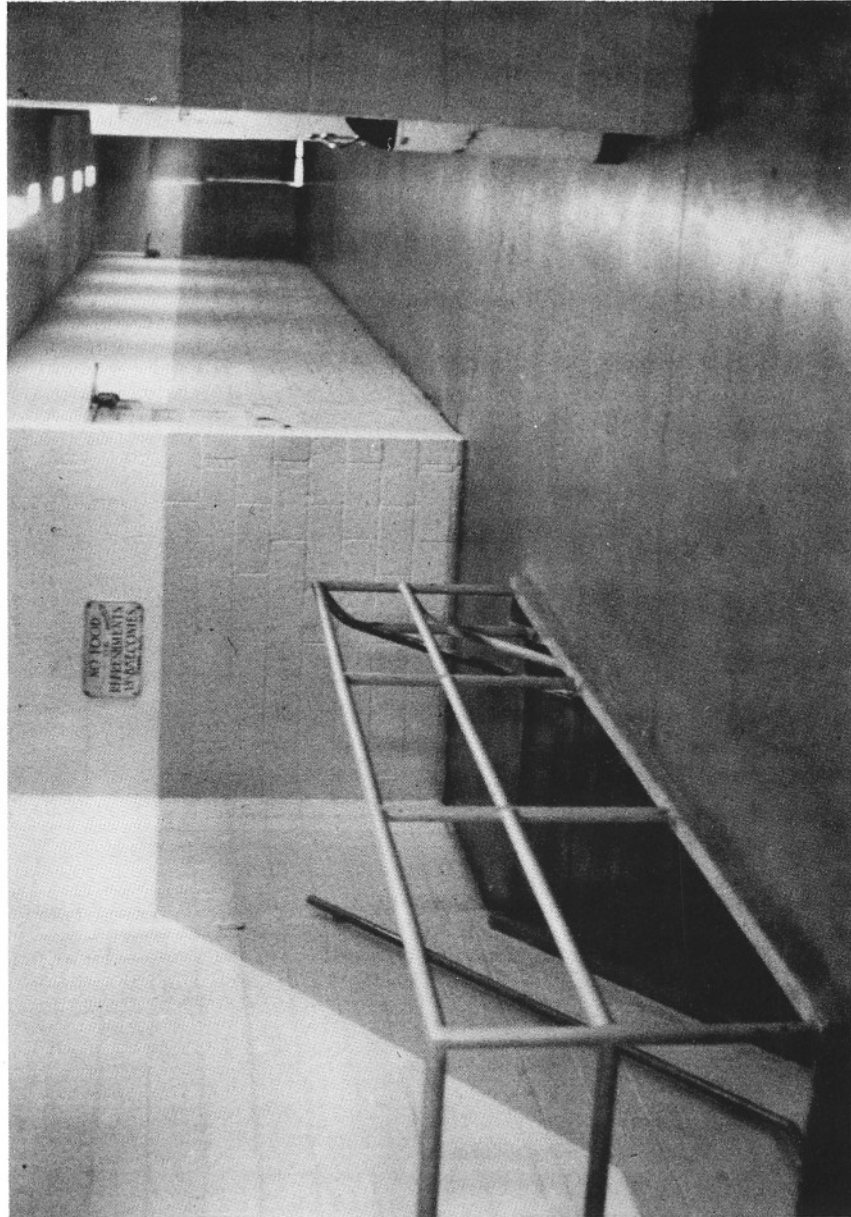
Figure 2.7.5

COMMENTARY - The analysis of the NBS videotapes indicated that detection of the first step was a critical component in the transition from level walking to stair movement (Templer, et al., 1978). This analysis further indicated that the detection process involves both a visual and a tactile-kinesthetic component. When the visual component is eliminated or reduced by some sort of handicap, then the tactile-kinesthetic component should be accentuated, through changes in texture on the floor, or the walls. Provision of changing auditory cues is also possible. It is important to ensure that these non-visual cues do not interfere with the non-handicapped person's use of the stairs.

Although the use of tactile cues on the floor or the wall has been recommended in some instances for the visual handicapped (Agate, 1966), there is no consensus about the most effective means of alerting users about

potential dangers or changes in elevation in their path. Nevertheless, the use of auditory or tactile cues appears to be a good means of alerting all users to change in their immediate path of travel.
