NISTIR 7393

A Study of Metal Truss Plate Connectors When Exposed to Fire

Harman, K. A.
Lawson, J. R.

January 2007

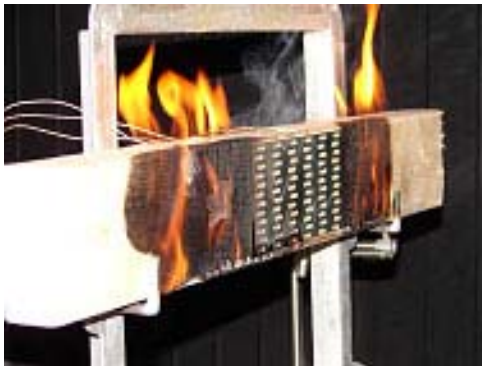
Figure 6 – One minute after ignition

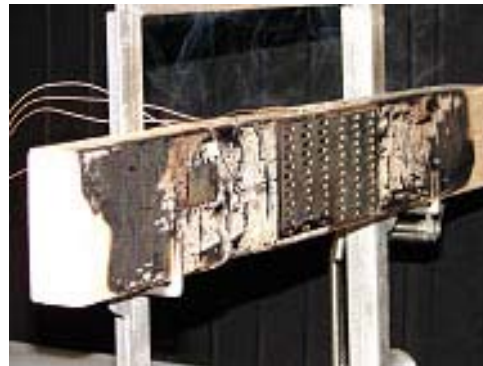
Figure 7 – Thirty minutes after ignition
