## Appendix 4 - Presentations

### Presentation by James R. Lawson – National Institute of Standards and Technology

### Radio Communications

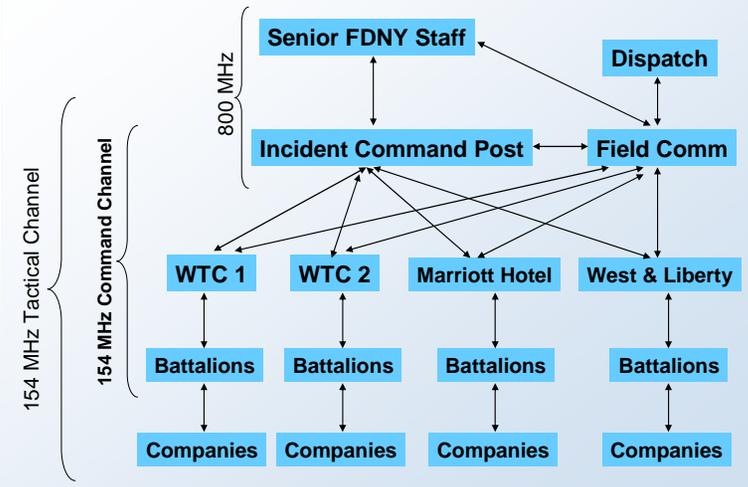
## FDNY Radio Communications System

FDNY Operations - Simplex for command channel and tactical operations  
- Duplex through their dedicated WTC FDNY high-rise repeater.  
- Cross-band through the Battalion Car repeater.

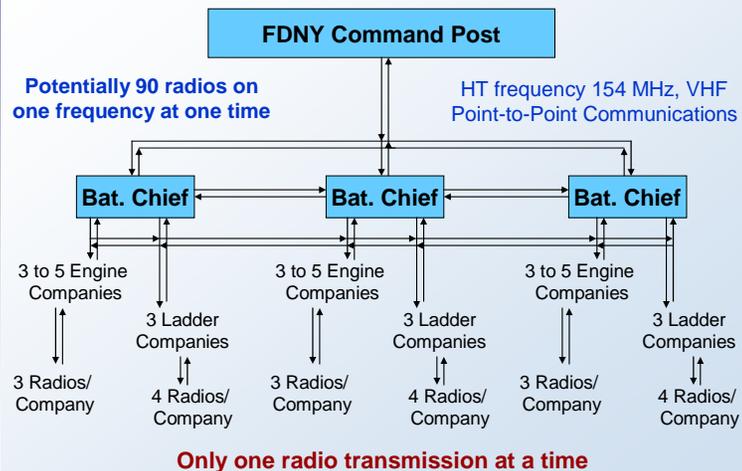
## Example: Handie-Talkie Radio System Structure

**Simplex Communications** - direct point-to-point, HT-to-HT, or HT-to-Base Station (HT = Handie-talkie)

**Duplex Communications** - transmissions are channeled through a radio repeater.

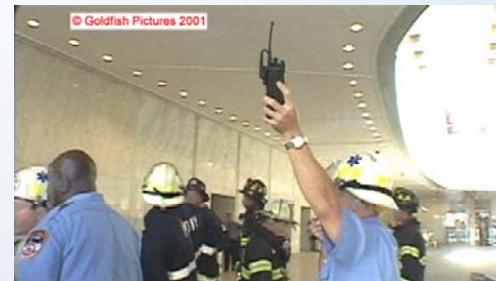
Video image of EMS responder attempting to improve communications from inside the lobby of WTC 1 by lifting his radio above head level.

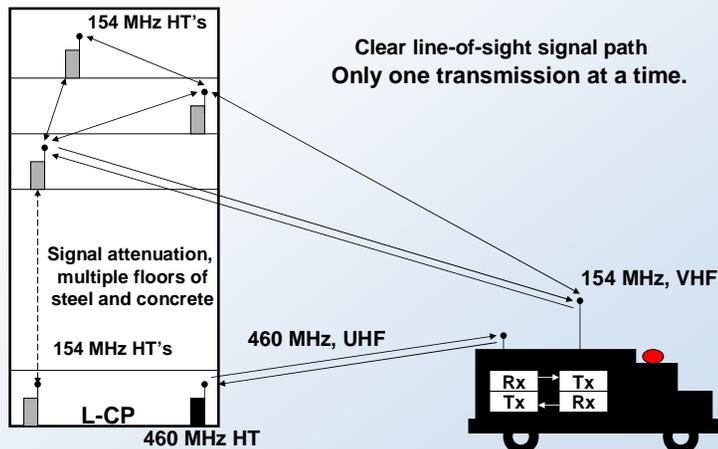
## Example: Battalion Car Cross-band Repeater

Drawing by NIST base on document by Battalion Chief Orio J. Palmer and original drawing by FF Bill Kristoff, FDNY, WNYF, Repeater Systems, 3<sup>rd</sup> 1998.

- Even though the Battalion Car Cross-band Repeater was turned on at approximately 9:07 a.m. and was to be delivered to the WTC 2 lobby command post, there is no record that FDNY used the cross-band repeater at the WTC site. All known personnel that may have used the repeater died with the collapse of WTC 2.
- FDNY radio protocol specified that **only one Battalion Car cross-band repeater was to be used at any incident**. This was to prevent multiple repeaters at one site from interfering with each other.
- There is no evidence that the WTC 1 lobby Command Post used either the FDNY/ WTC high-rise channel 7 repeater or the cross-band repeater to communicate with other personnel up inside the tower.

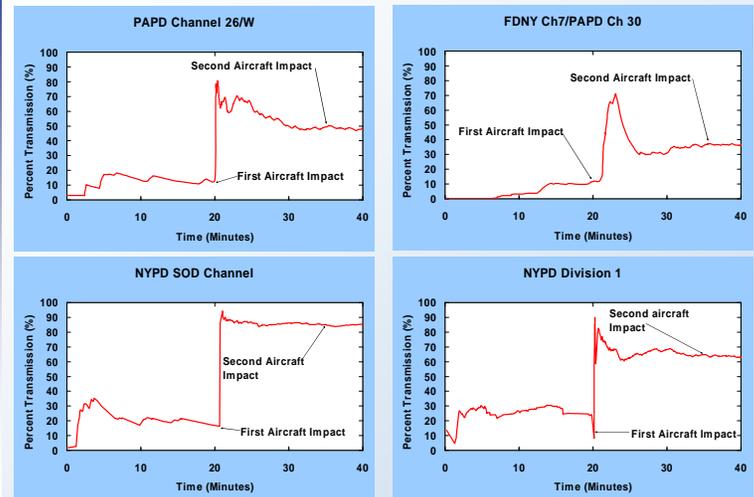
## Radio Traffic Volume – $T\% = 100(\text{Transmission Time}/\text{Total Time})$

1. After the first aircraft struck WTC 1, there was an approximate **factor of 5 peak increase in traffic level** over the normal level of emergency responder radio communications, followed by an approximate **factor of 3 steady increase in level of subsequent traffic**.
2. A surge in communications traffic volume made it more difficult to handle the flow of communications and delivery of information.
3. Analysis of radio communications records indicates that **roughly 1/3 to 1/2 of the radio messages during surge conditions were not complete nor understandable**.

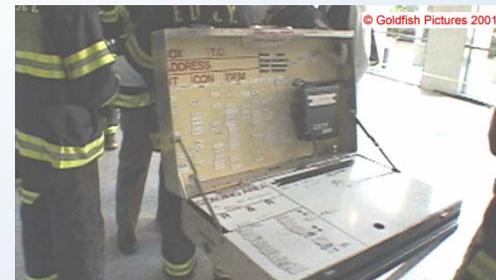
## FDNY Command Board Located in the Lobby of WTC 1

- FDNY command and control was seriously affected by the lack of good communications.
- FDNY's system for maintaining records of unit assignments at each command post was not capable of managing the numbers of units and personnel being assigned to the incident.
- FDNY, NYPD, and PAPD: there was no means to back-up the unit assignment records generated at the command posts.
