NISTIR 7468

Evaluating Positive Pressure Ventilation In Large Structures: High-Rise Fire Experiments

Stephen Kerber
Daniel Madrzykowski

November 2007

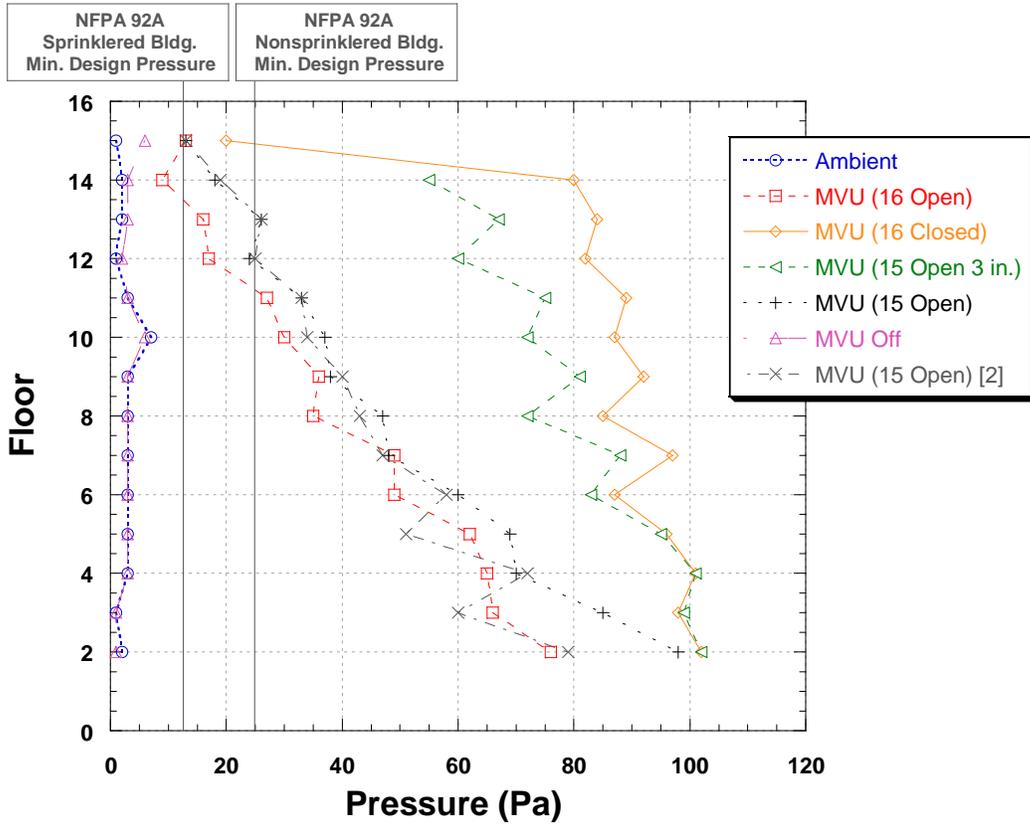
Figure 52. Pressure vs. Floor with MVU at front door for fire in apartment 1503 (Uncertainty $\pm 10\%$)

The pressure measurements versus time graphs are located in the appendices B through G. The experiment time lines are integrated into the graphs to display the pressure changes after the configuration changes. The pressures were quasi-steady for the different configurations. These pressures are graphed versus the floor number for the different configurations in Figures 52 through 57 for the six experiments. Detailed lines are located at the NFPA minimum design pressures. Floors that are missing a data point had a malfunctioning pressure transducer or the door was open providing no differential pressure.

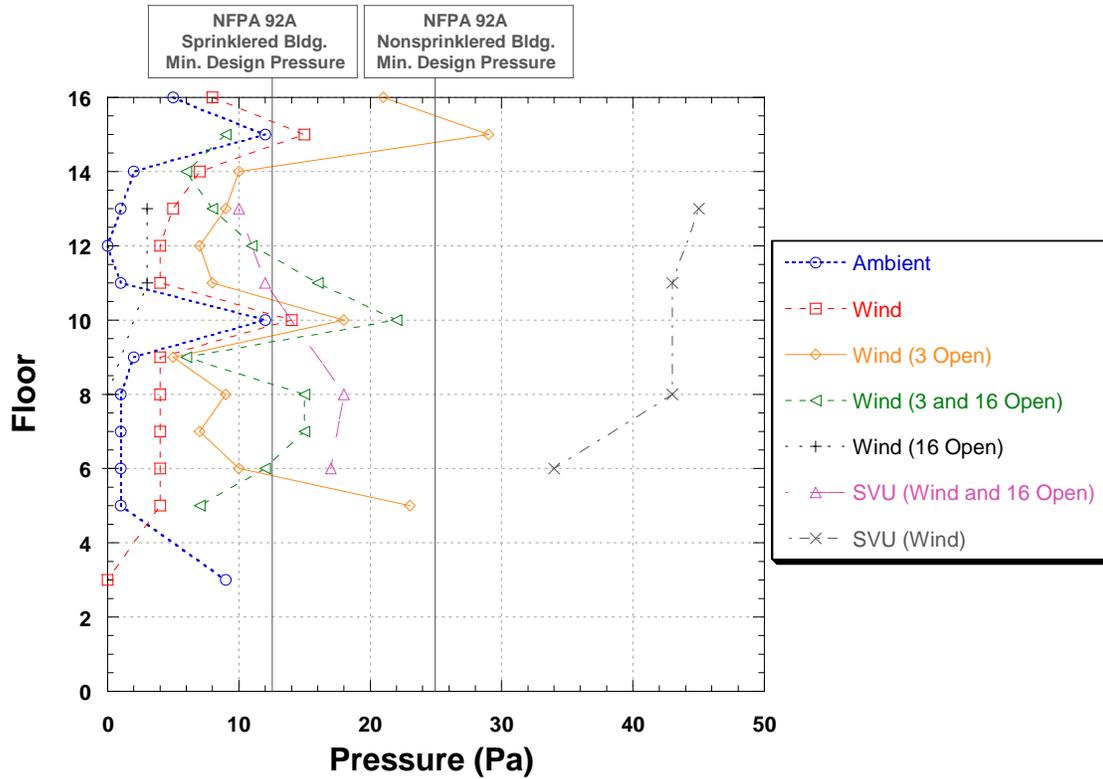
Figure 57. Pressure vs. Floor with SVU at front door and MVU simulated wind fore fire in apt. 304 (Uncertainty $\pm 10\%$)

Average pressures from the configurations during the experiment in apartment 304 are shown in Figure 57 and Table 14. This experiment also had a simulated wind, but it was created by the MVU instead of the SVU used for the experiment in apartment 303. The SVU was used at the front door to pressurize the stairwell against the effects of the simulated wind on the fire. Ambient differential pressures were approximately 10 Pa to 12 Pa on the enclosed floors and less than 5 Pa on the other floors before the experiment began. The addition of the wind through the fire apartment decreased the third floor pressure to zero and increased the rest of the stairwell by 3 Pa to 5 Pa. The third floor door was opened allowing the wind to flow into the stairwell and the pressures increased as much as 20 Pa on the fifth floor. With the simulated wind still impacting the fire apartment, the SVU was activated at the front door. With the SVU running and the 16th floor door open, pressures increased to above 10 Pa throughout the stairwell. After the 16th floor door was closed, the pressures increased to above 33 Pa.

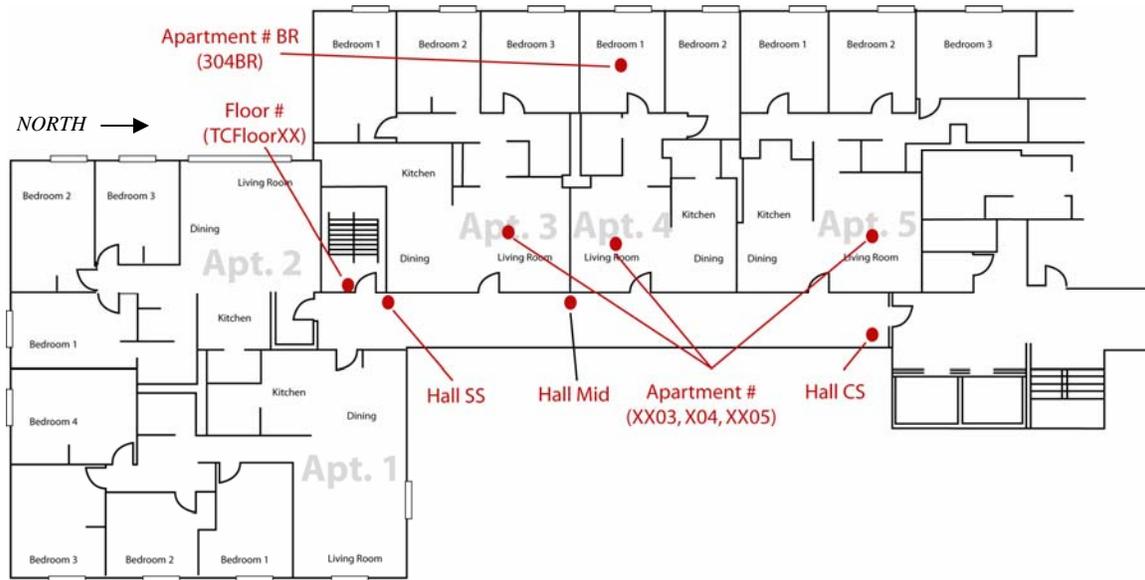
Figure 58. Thermocouple tree locations

Temperature measurements at each of the instrument locations are graphed versus time in the appendix. These graphs include lines to detail the events and configuration changes that occurred during the experiments. The thermocouple locations that correspond to those in the graphs are shown in Figure 58. The temperatures for each of the thermocouple locations at the ceiling and at 0.9 m (3 ft) from the floor are shown for each of the six experiments in Figures 59 through 70. The largest observed temperatures were typically located at the ceiling, while temperatures at 0.9 m (3 ft) would be more representative of what a fire fighter experiences. Table 15 shows the maximum temperatures at the ceiling and at 0.9 m (3 ft) for each experiment.

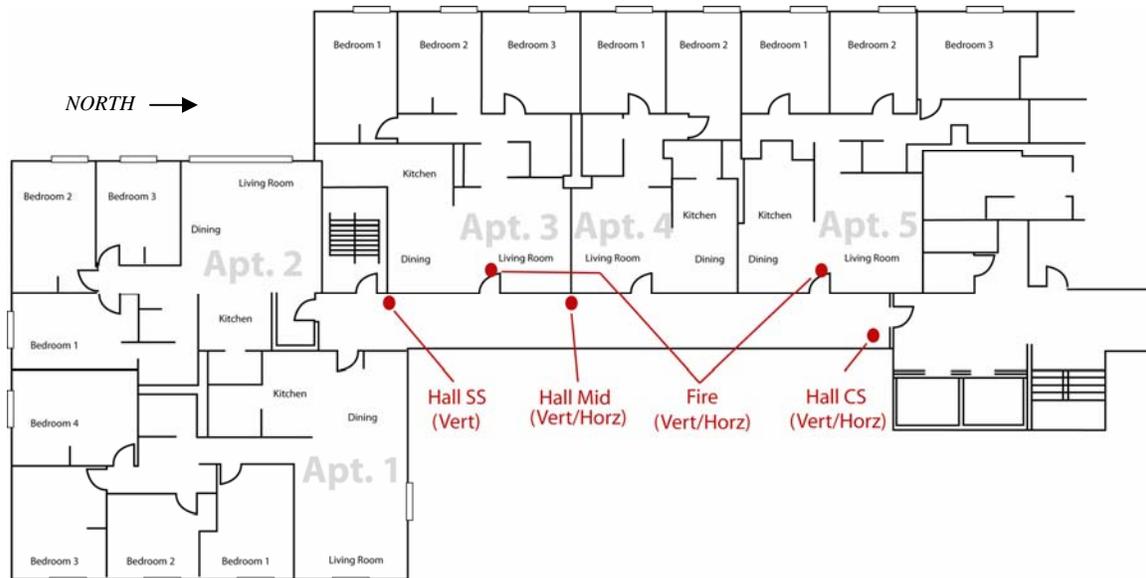
Figure 71. Heat flux gauge locations

The maximum heat fluxes observed during each experiment are in Table 15. Heat flux measurements at each of the instrument locations are graphed versus time in the appendix Figures. These graphs include lines to detail the events and configuration changes of the experiments. The heat flux gauge locations that correspond to those in the graphs are in Figure 71.

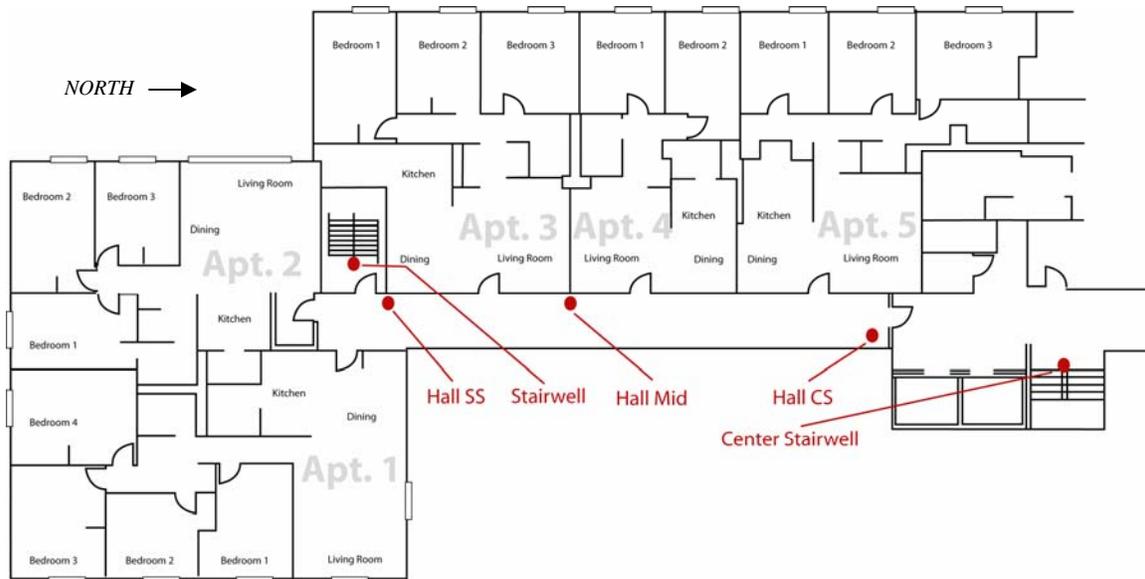
Figure 72. Carbon monoxide meter locations

Carbon monoxide (CO) measurements at each of the instrument locations are graphed versus time in the appendix of each respective experiment. These graphs include lines to detail the events and configuration changes of the experiments. The CO meter locations that correspond to those in the graphs are in Figure 72. The CO meters were the same models as those typically available for fire department use. The sensors had a maximum upper limit that was less than the range of CO created during the experiments. The calibrated range of the CO meters was 0 ppm (0 %) to 750 ppm (0.075 %). At values above 750 ppm (0.075 %), the chemical sensors were saturated and the reported values probably under-report actual gas concentrations. All of the graphs have values above the maximum that the meters can read and are depicted as a flat line.

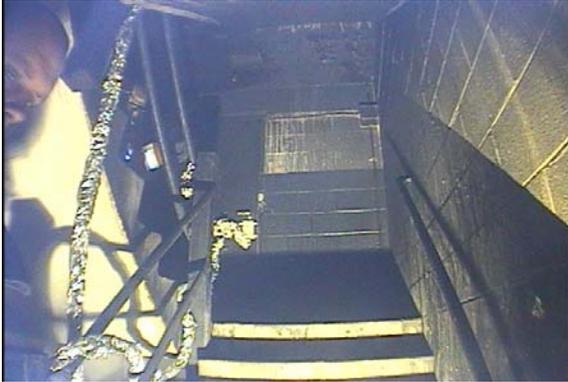
Figure 74-a

The video frame captured in the south stairwell before ignition of the experiment in apartment 1505 is in Figure 74-a. Smoke leaked around the door with one 0.7 m (27 in) fan placed at the base of the stairwell (Figure 74-b). A second 0.7 m (27 in) fan was added at the 13th floor and the smoke was vented out of the 16th floor doorway (Figure 74-c). Figure 74-d shows that with two portable fans running the smoke was kept out of the stairwell with the fire floor door open 0.08 m (3 in). The door was then opened completely and the smoke was still kept out of the stairwell. The wall of smoke at the doorway is shown in fire 74-e. The door to floor 14 was opened and a little bit of smoke can be seen intermittently flowing into the stairwell (Figure 74-f). The smoke flow into the stairwell seen in Figure 74-g is a result of turning both fans off. Figure 74-h was captured 20 seconds after the fan on floor 13 was turned back on. The fan was turned off and the stairwell quickly filled with smoke again (Figure 74-i). Both fans were turned back on and the smoke was pushed back into the fire floor (Figure 74-j).

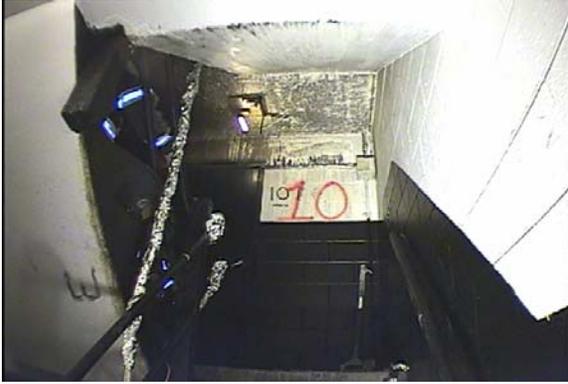
Figure 75-a shows the doorway to the fire floor prior to ignition of the experiment in apartment 1003. After ignition but prior to the door being opened, the smoke enters the stairwell around the cracks of the door and a layer begins to form (Figure 75-b). The door on floor 10 was opened and the black smoke quickly began to fill the stairwell (Figure 75-c). The 16th floor door was opened and two 0.7 m (27 in) fans were turned on at floors 1 and 8. After less than 60 s, the stairwell was cleared of any smoke (Figure 75-d). The fans were turned off (Figure 75-e) and the smoke entered the stairwell. The fans were turned back on and the smoke was vented again. After ventilation the 16th floor door was closed, the fans were able to maintain a stairwell free of smoke (Figure 75-f).

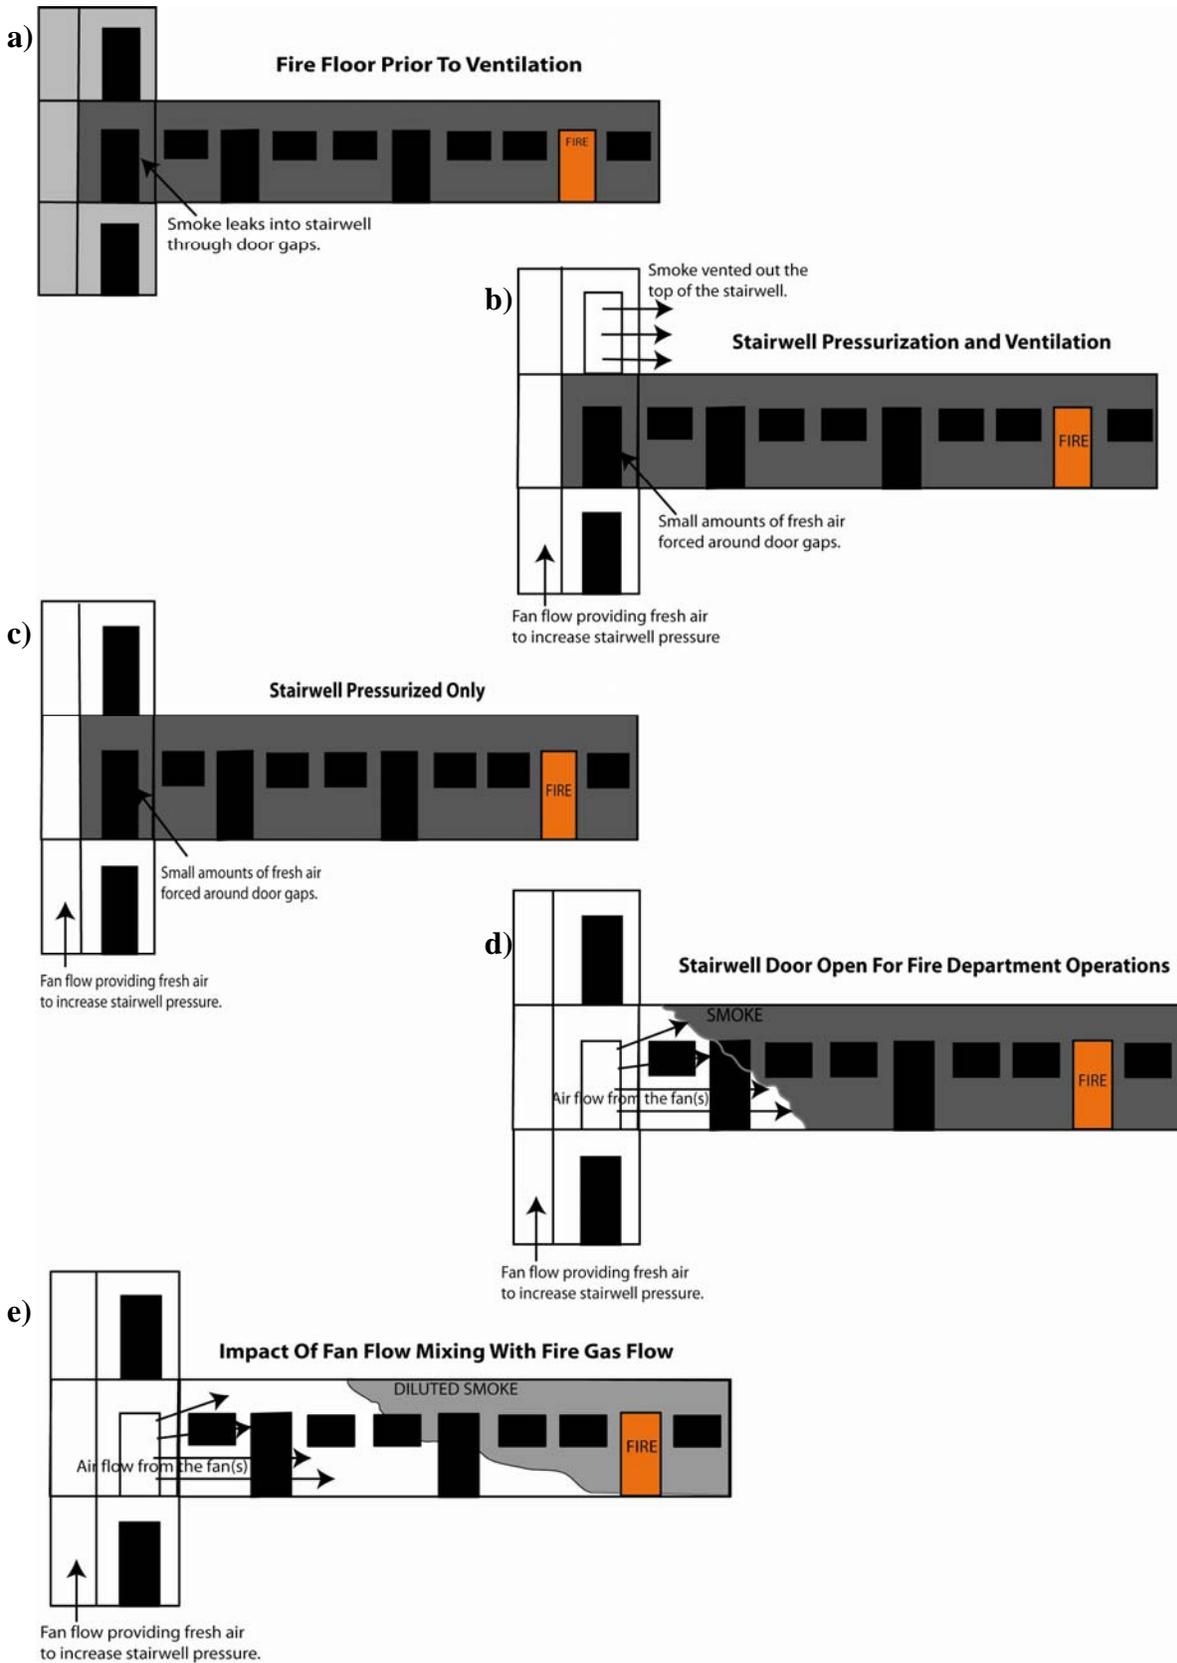
Figure 79. Diagrams for process of providing oxygen to the fire

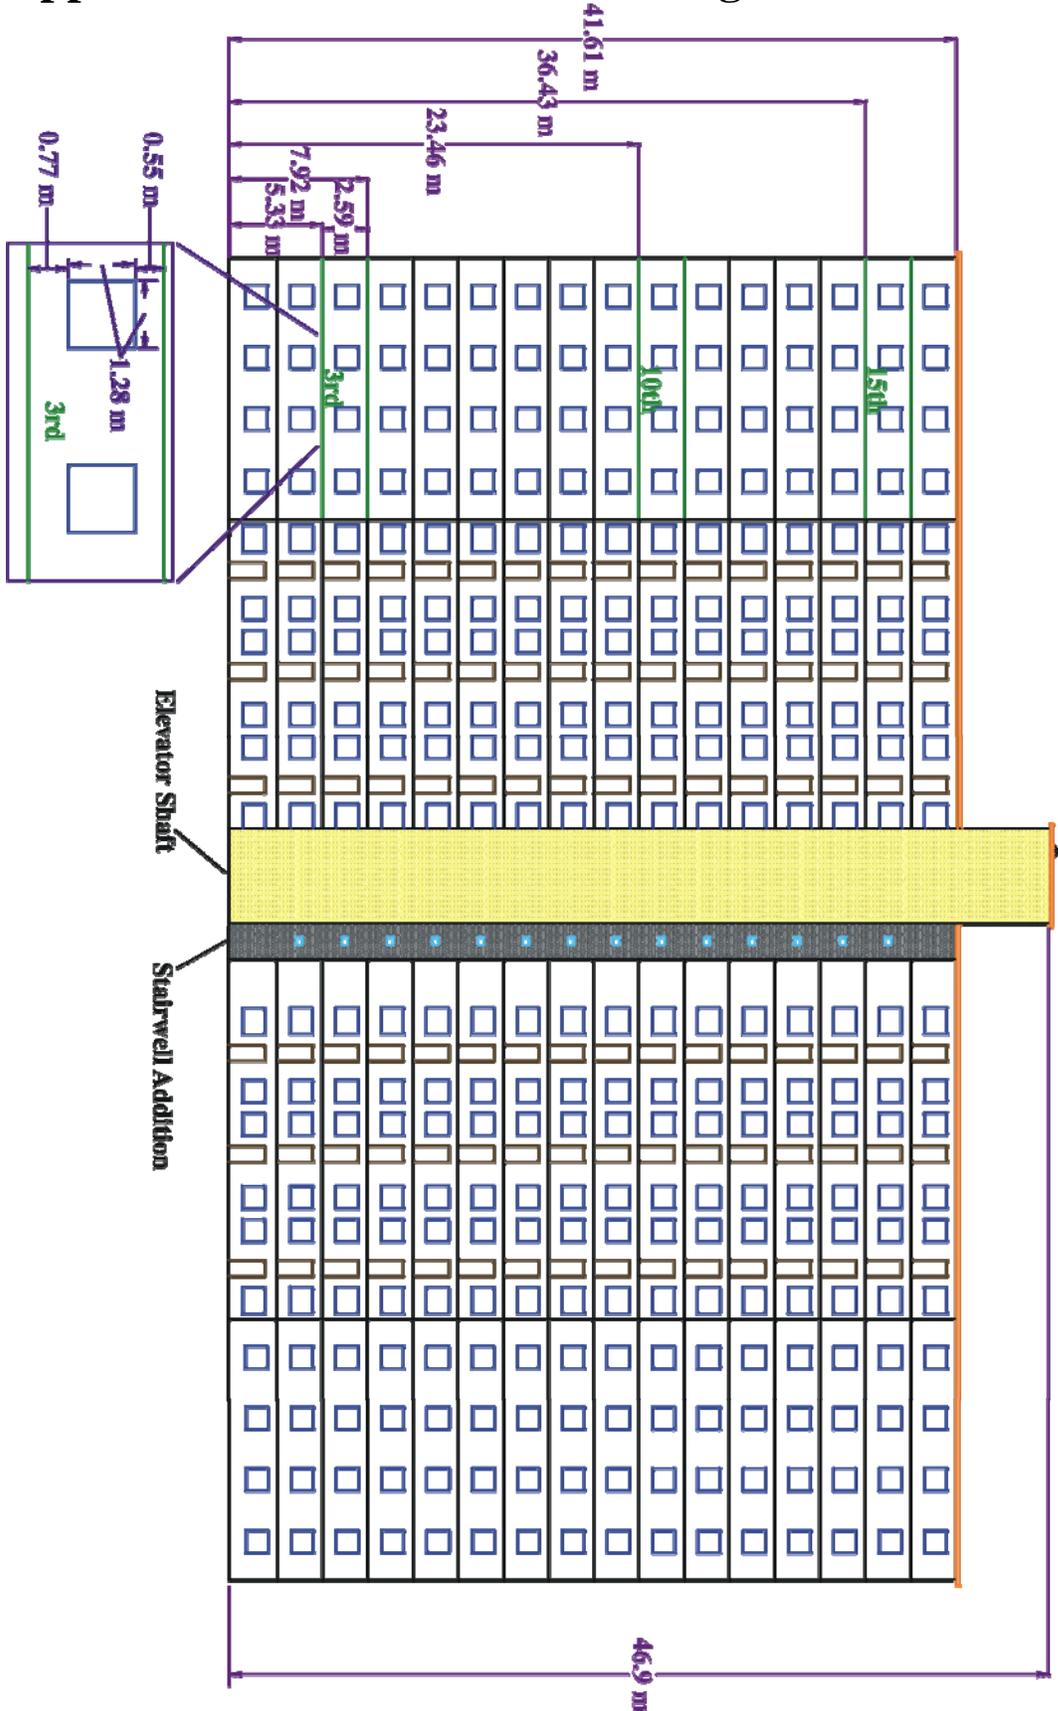
Figure 1. Front elevation

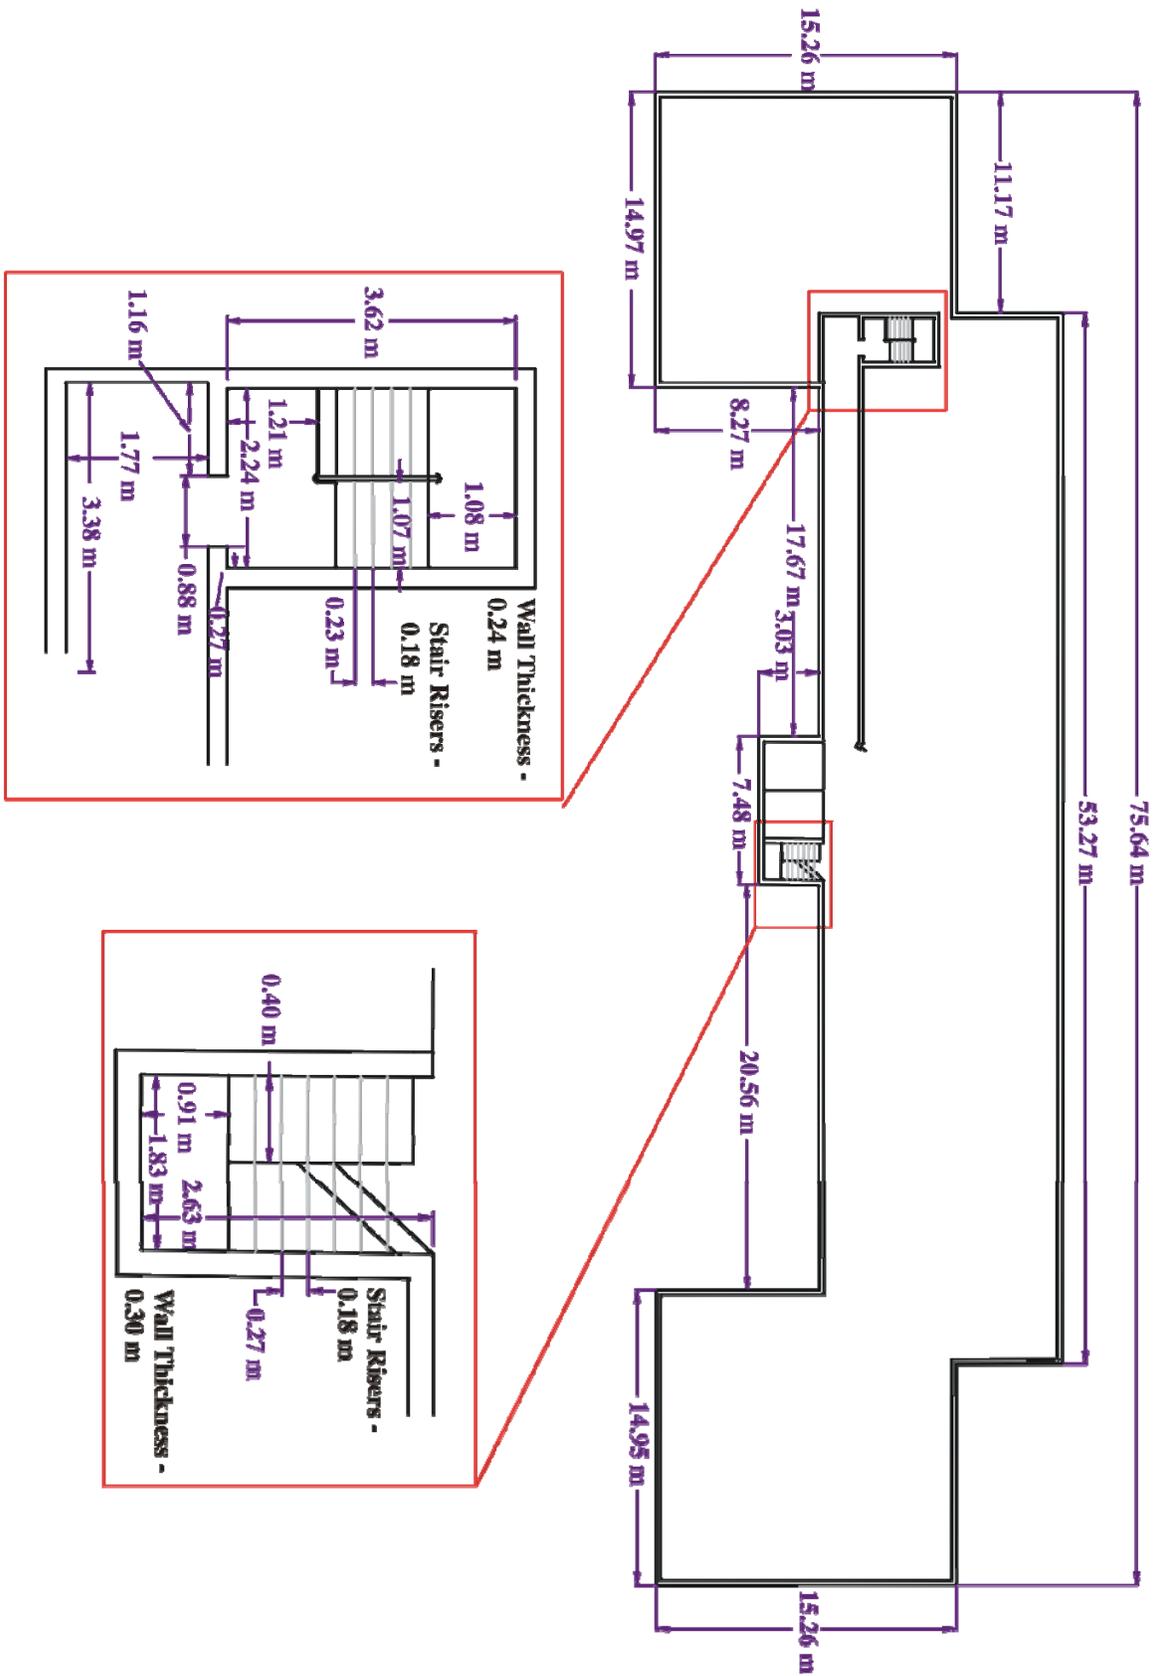
Figure 2. Overall dimensions with stair detail

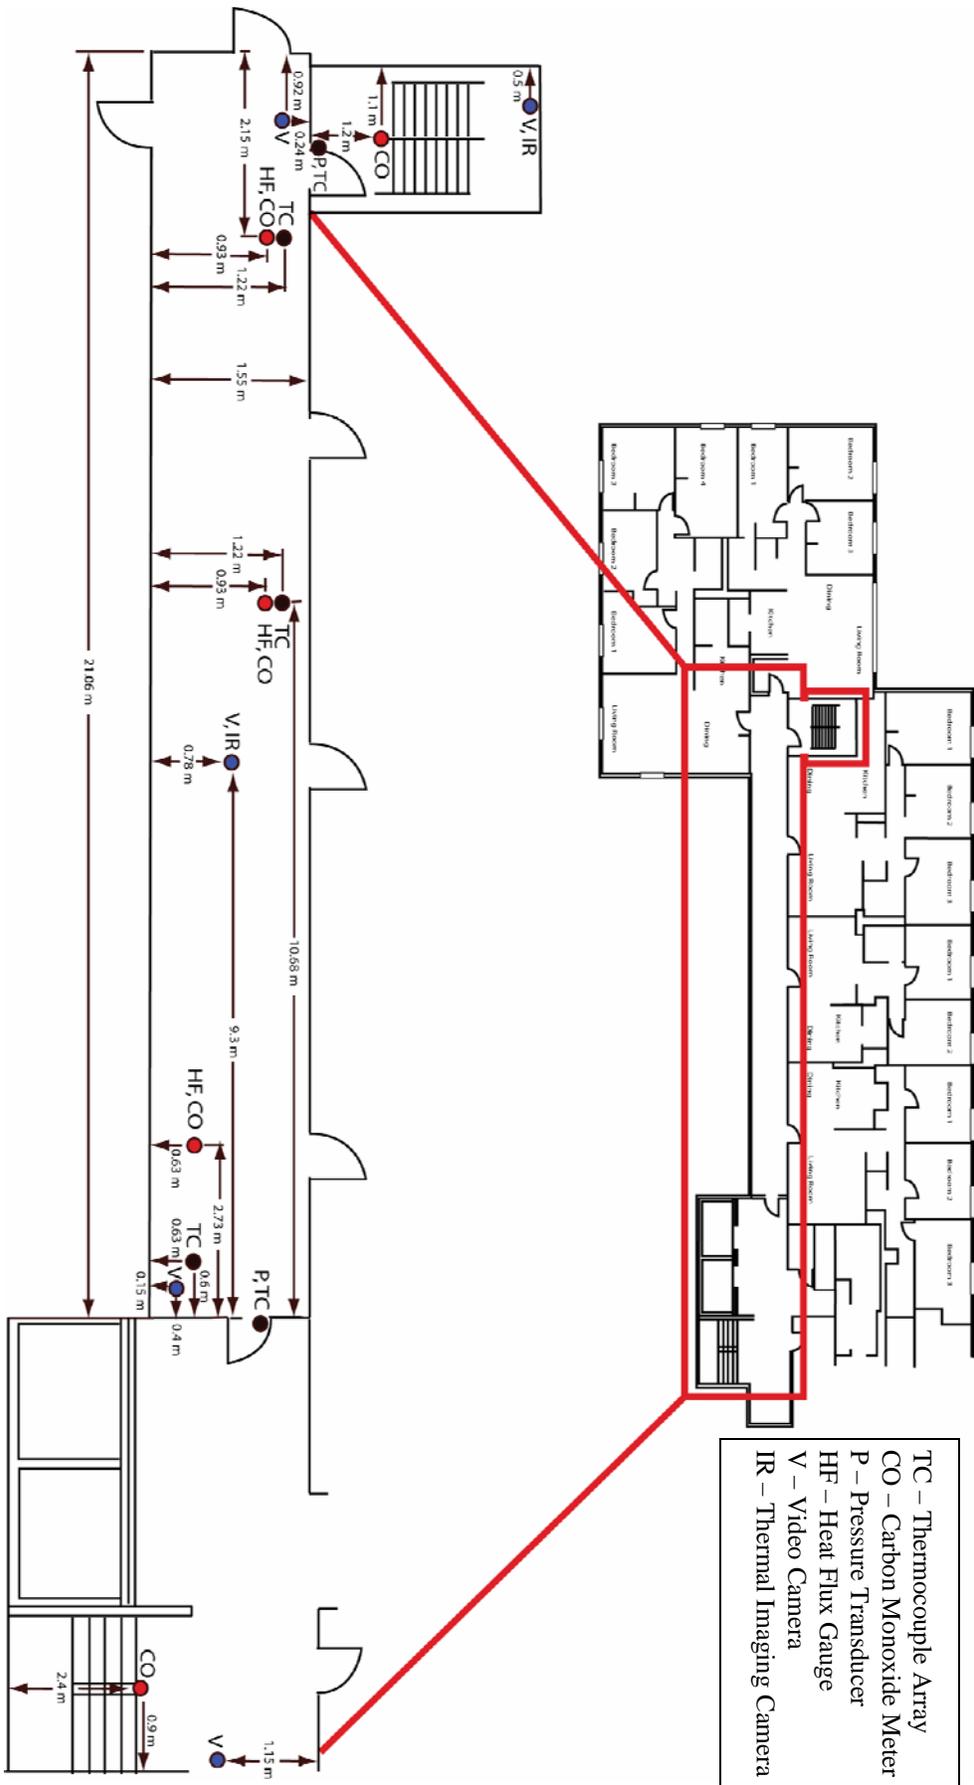
Figure 4. Hallway and stair instrument locations

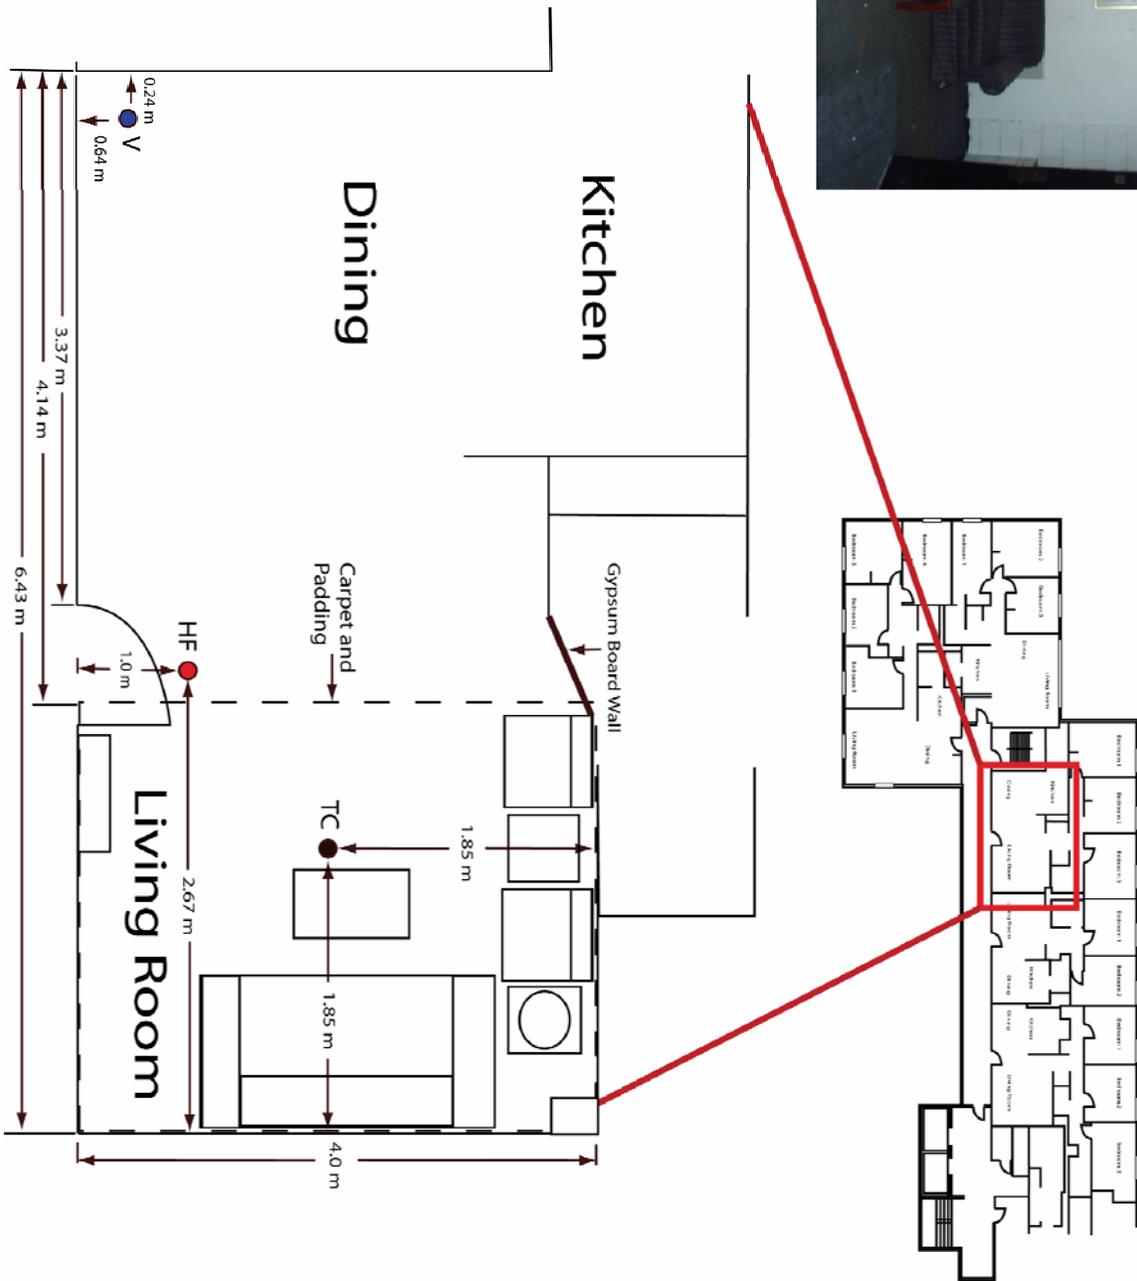
Figure 5. Apartment 1503 dimensions and instrument locations

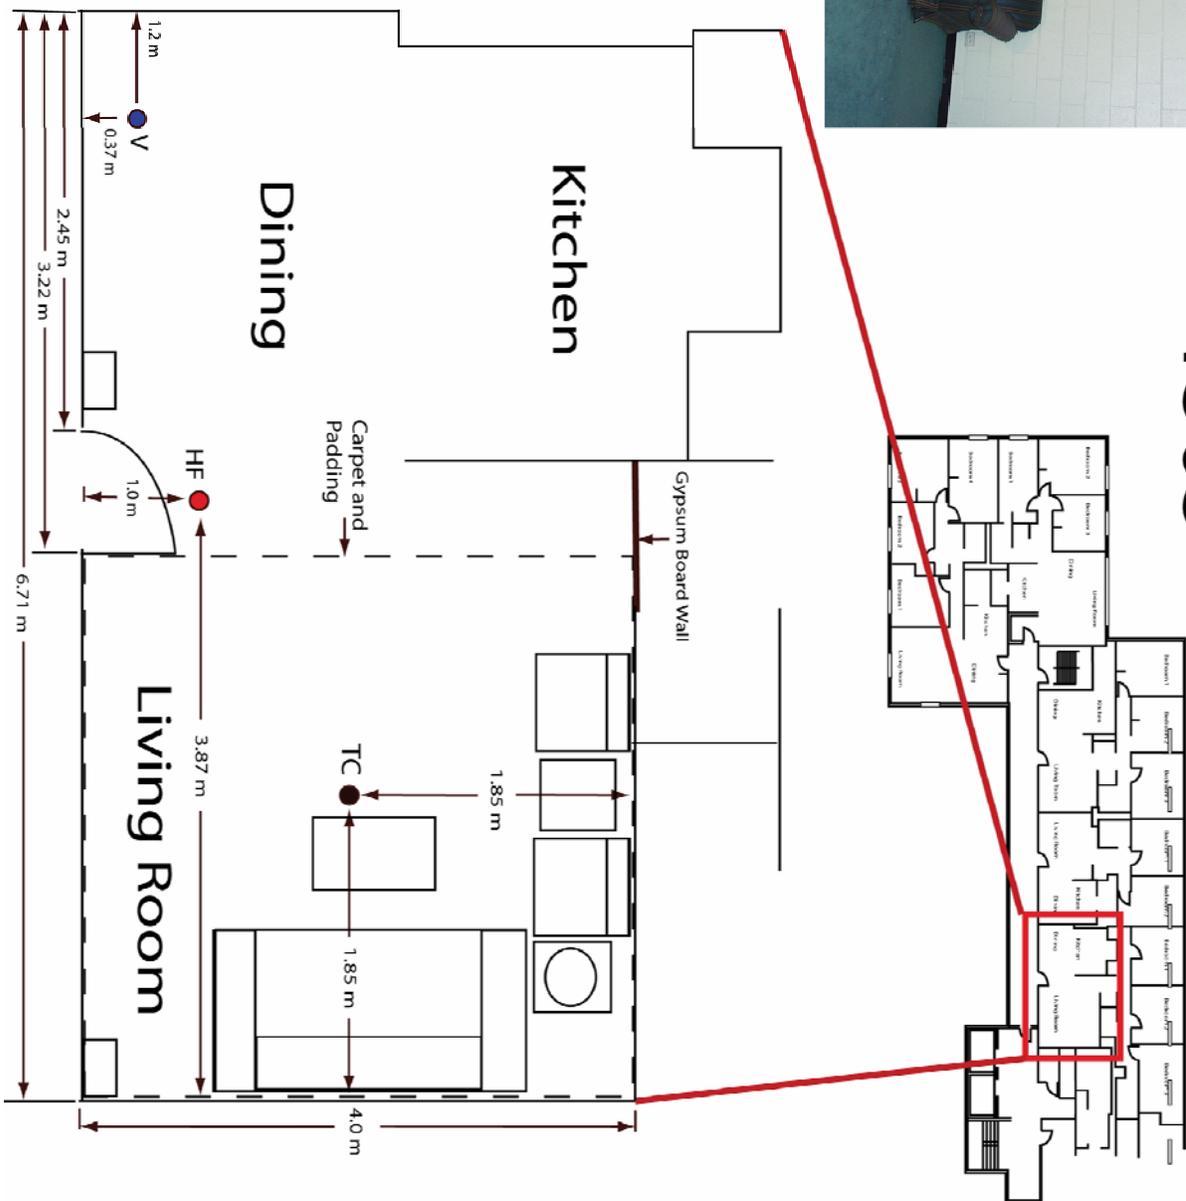
Figure 6. Apartment 1505 dimensions and instrument locations

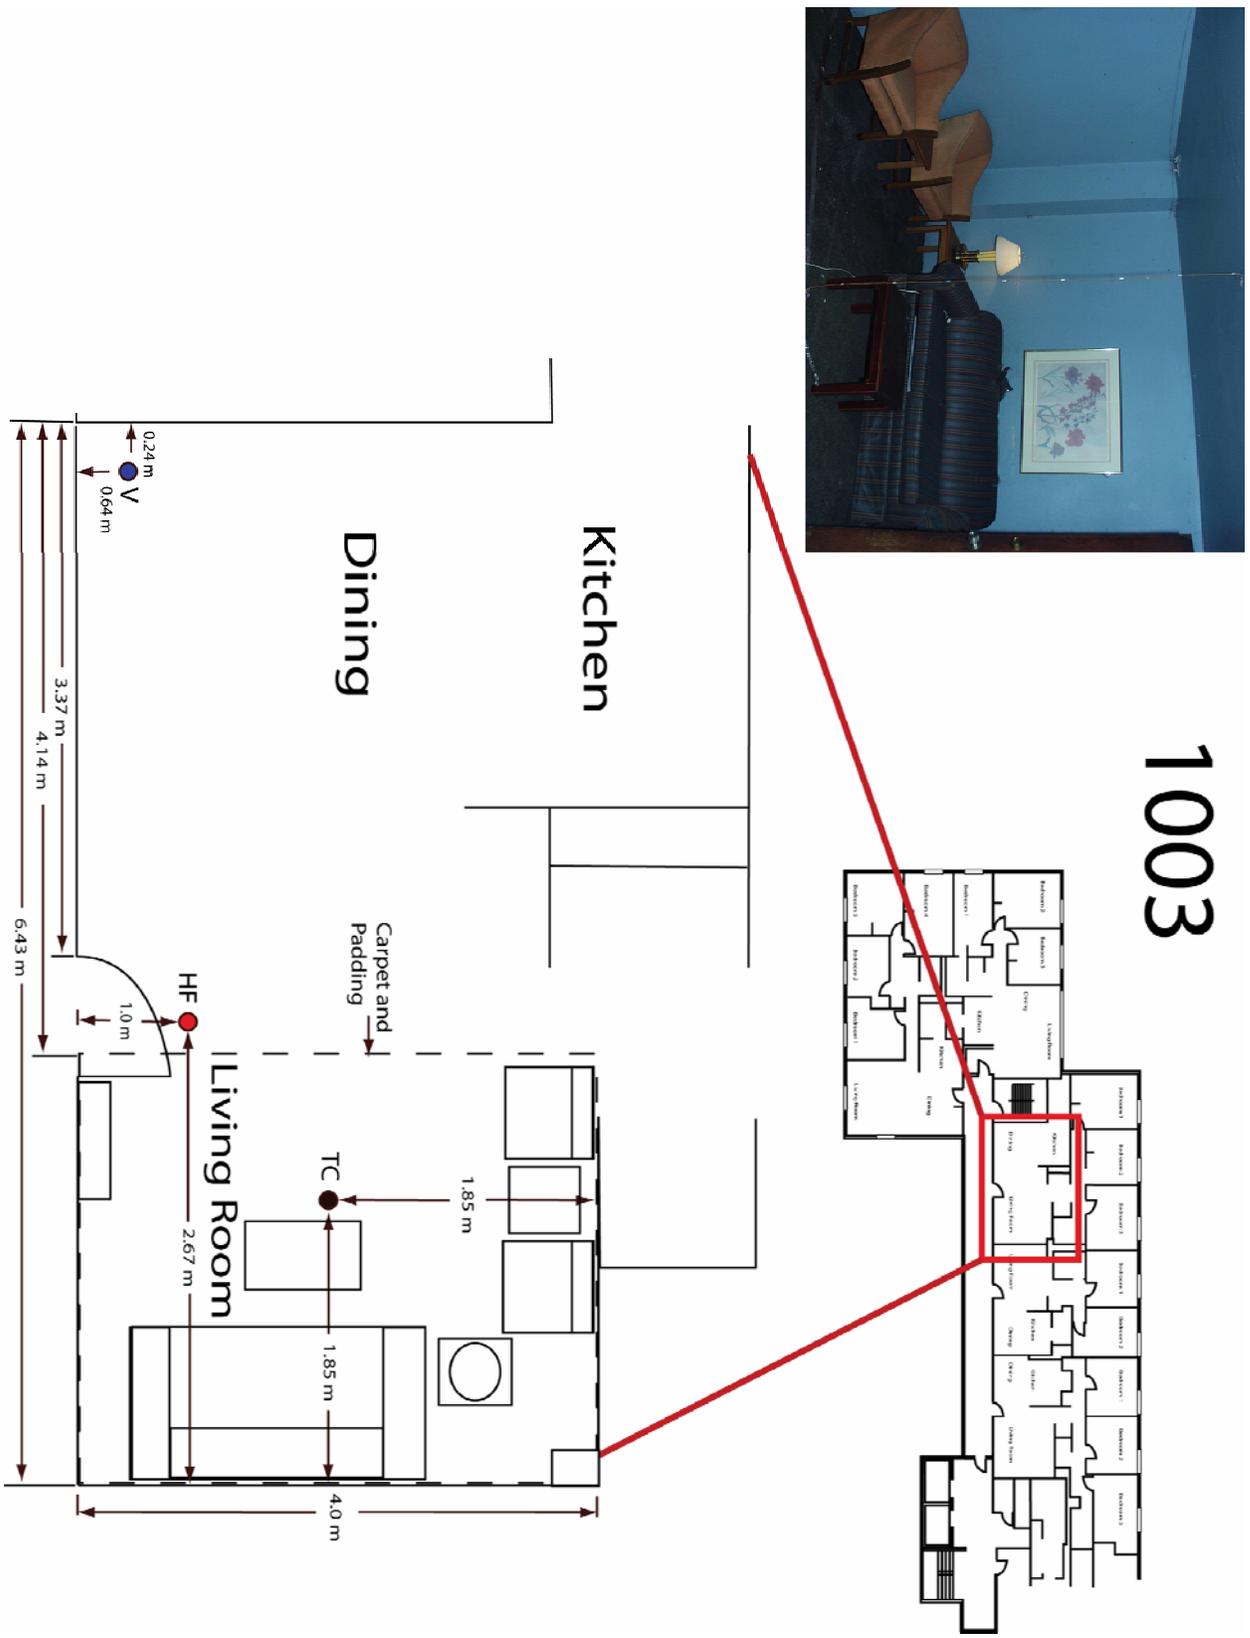
Figure 7. Apartment 1003 dimensions and instrument locations

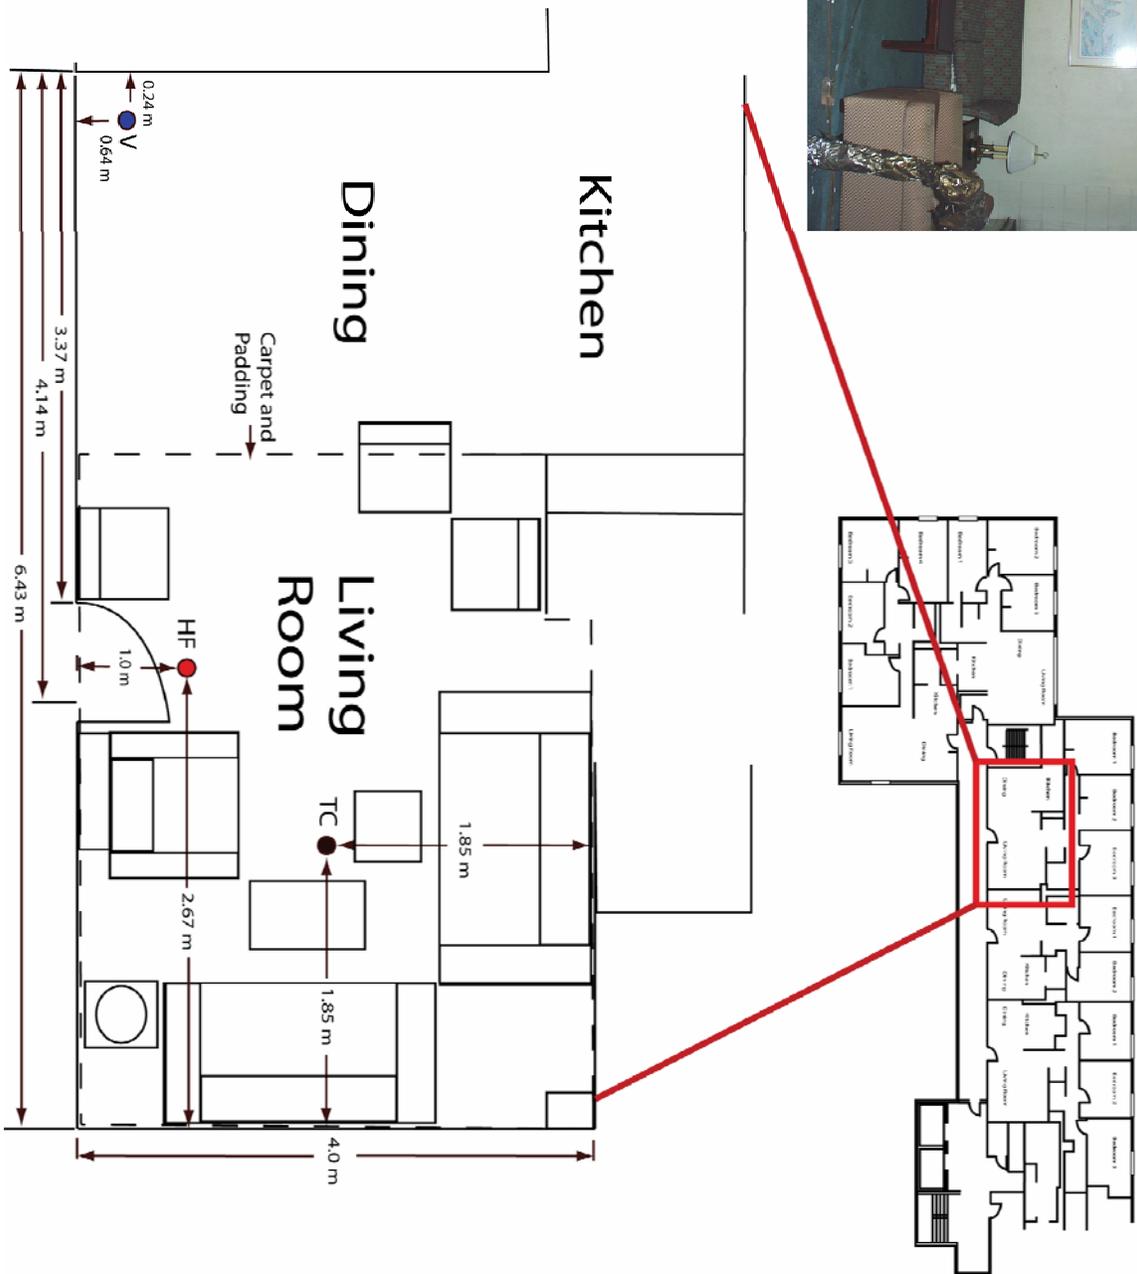
Figure 9. Apartment 303 dimensions and instrument locations

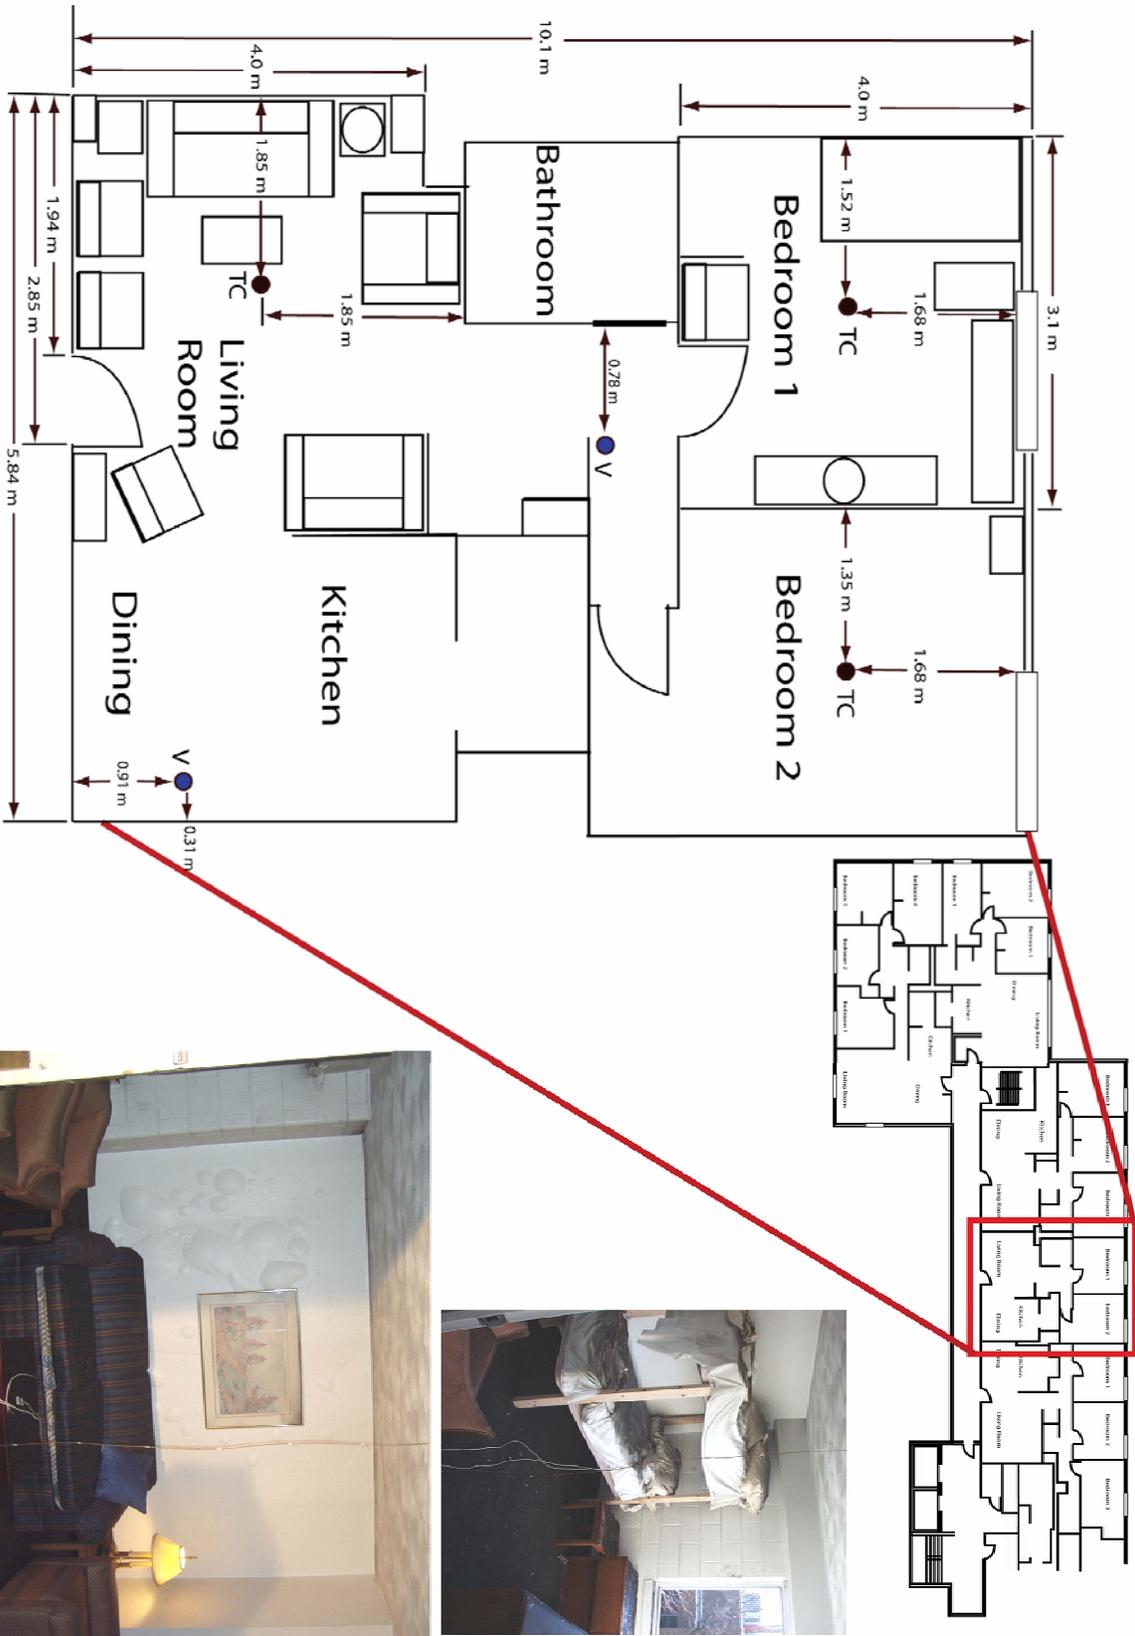
Figure 10. Apartment 304 dimensions and instrument locations
