NISTIR 7468

Evaluating Positive Pressure Ventilation In Large Structures: High-Rise Fire Experiments

Stephen Kerber
Daniel Madrzykowski

November 2007

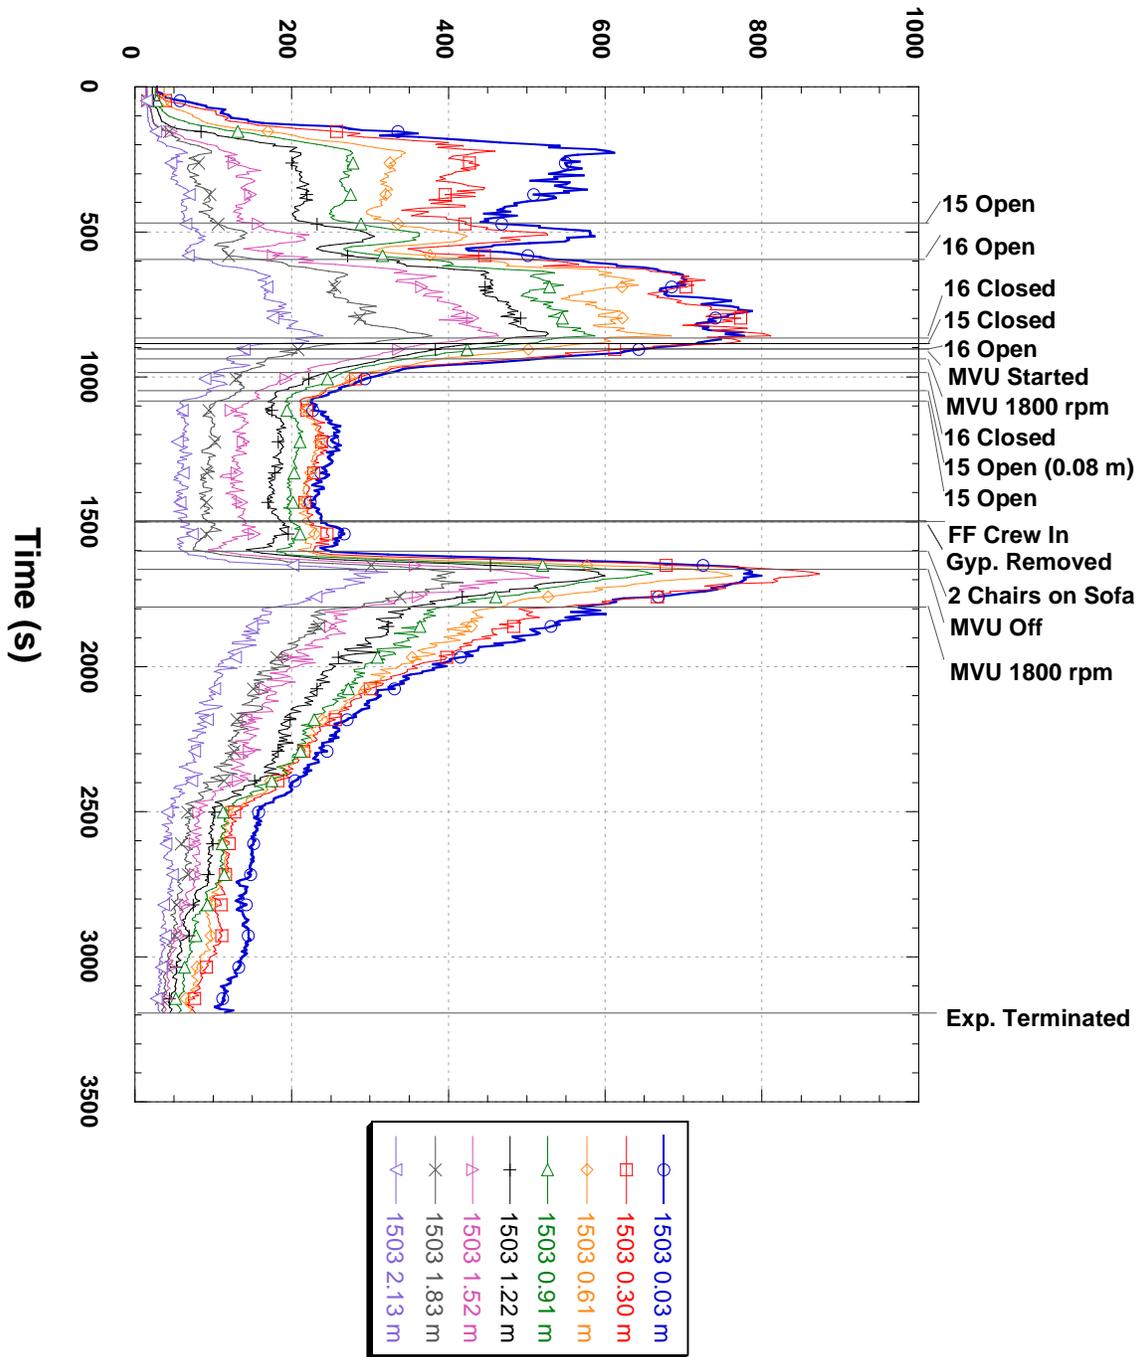
Figure 1. Detailed temperature vs. time for 1503 living room

Experimental temperatures in apartment 1503's living room reached 800 °C (1470 °F) at the ceiling and 500 °C (930 °F) at 0.9 m (3 ft) from the floor. The fire became ventilation limited at approximately 850 s based on the video and infrared views and the temperature fell to between 150 °C (300 °F) and 250 °C (480 °F). The MVU was turned on and the 16th floor was opened to vent the stairwell. The temperatures in the stairwell of up to 100 °C (210 °F) decreased down to near ambient. Later in the experiment, the rear of the apartment was ventilated and two chairs were added to the burning sofa. The MVU was turned off and the temperatures in the hallway and stairwell climbed back up to near 200 °C (390 °F). The MVU was turned on again with the fire floor door open and the temperatures declined rapidly.

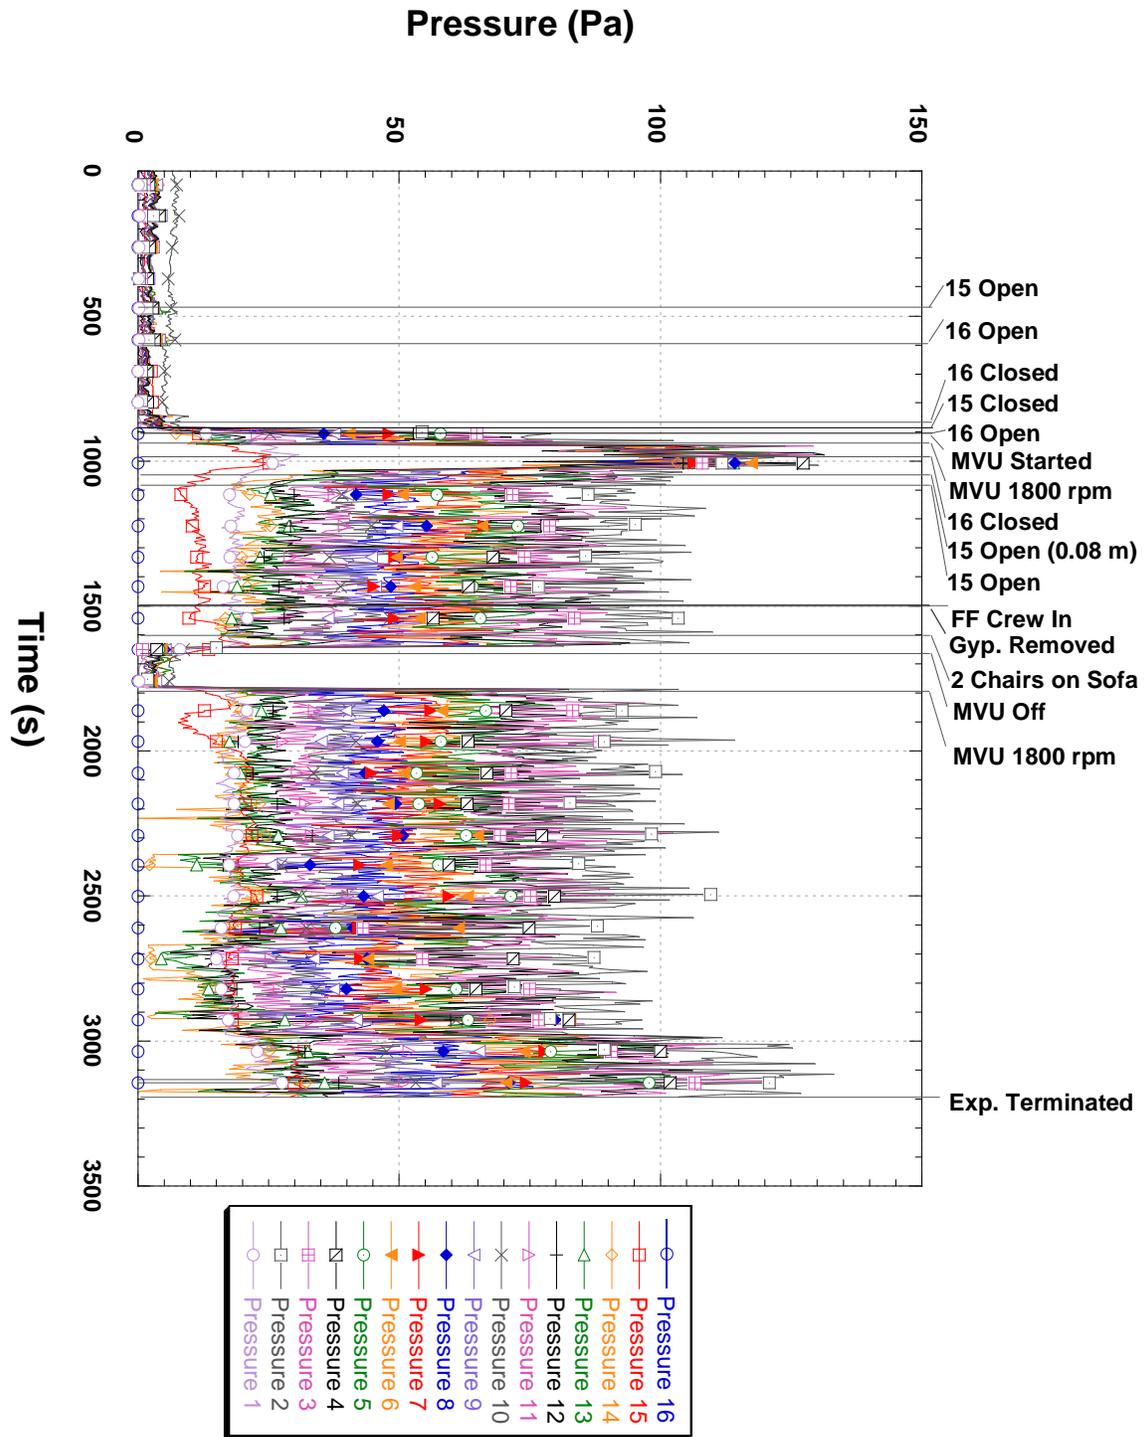
Figure 6. Detailed pressure vs. time for 1503 south stair

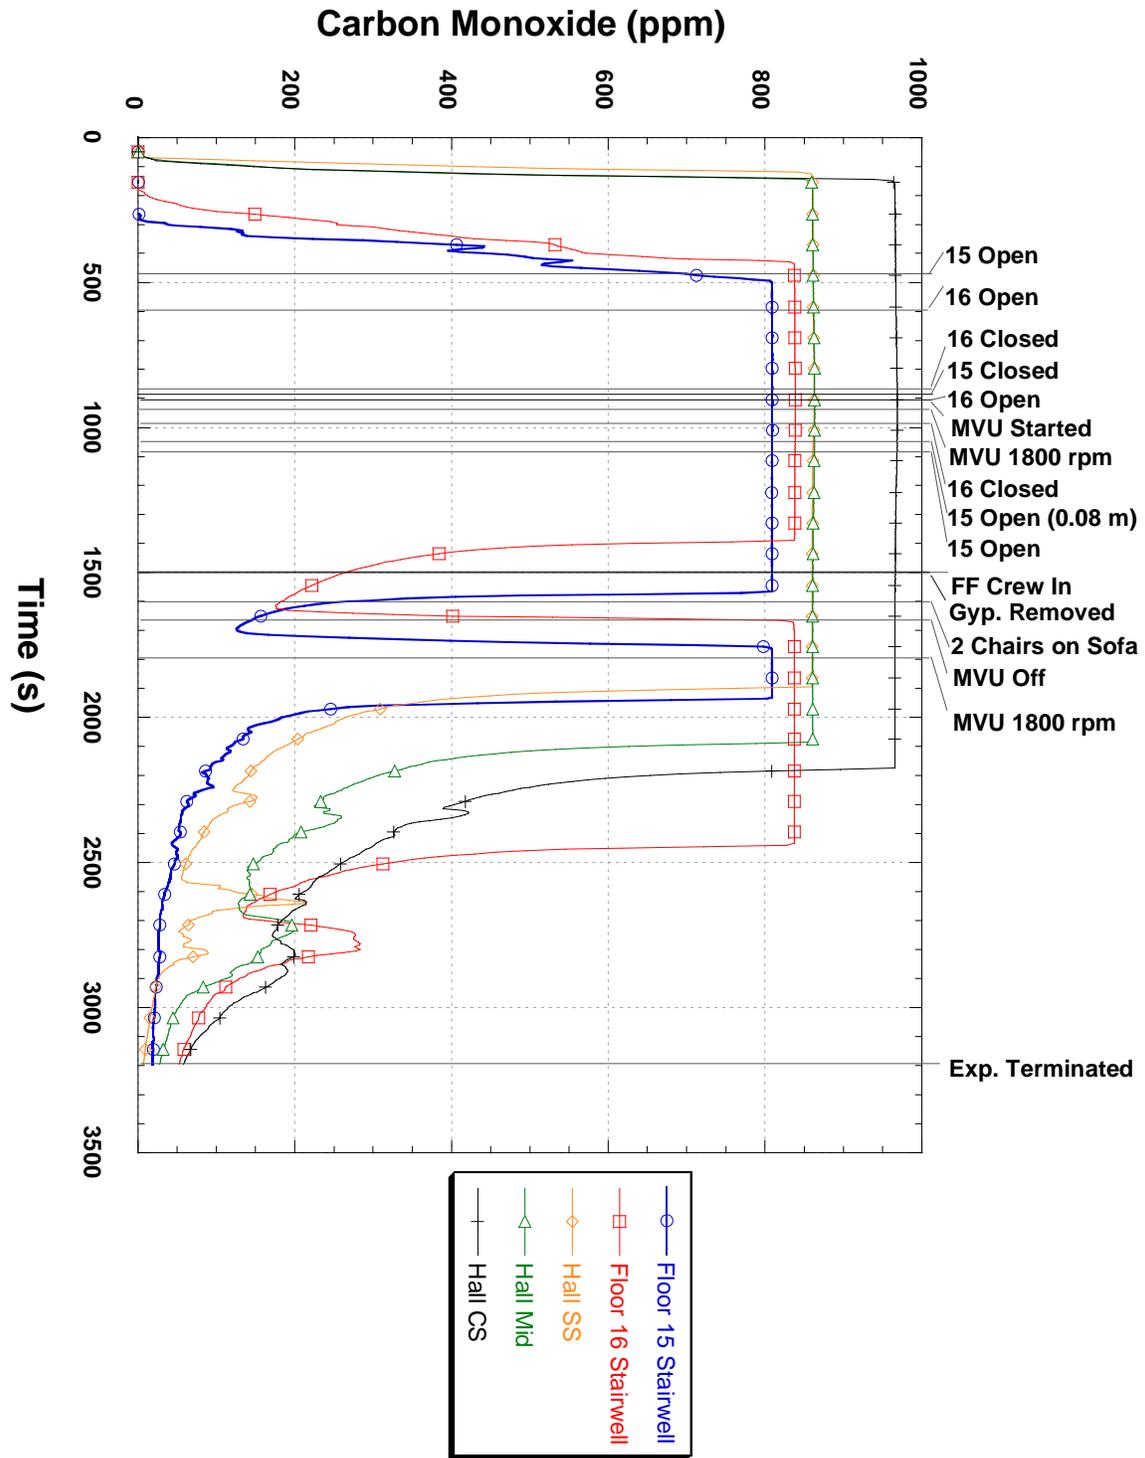
Figure 8. Detailed carbon monoxide vs. time for 1503

CO readings in the hallway during the experiment in Apartment 1503 quickly reached a maximum value above 800 ppm (0.08 %) and remained there until the fire burned out and the fans ventilated the hallway. Prior to ventilation of the stairwell, the stairwell CO values exceeded 800 ppm (0.08 %), on both the 15th and 16th floors. During ventilation of the stairwell CO levels dropped below 200 ppm (0.02 %) and recovered to above 800 ppm (0.08 %) when the fan was turned off. Towards the end of the experiment, the levels dropped rapidly with ventilation by the MVU.

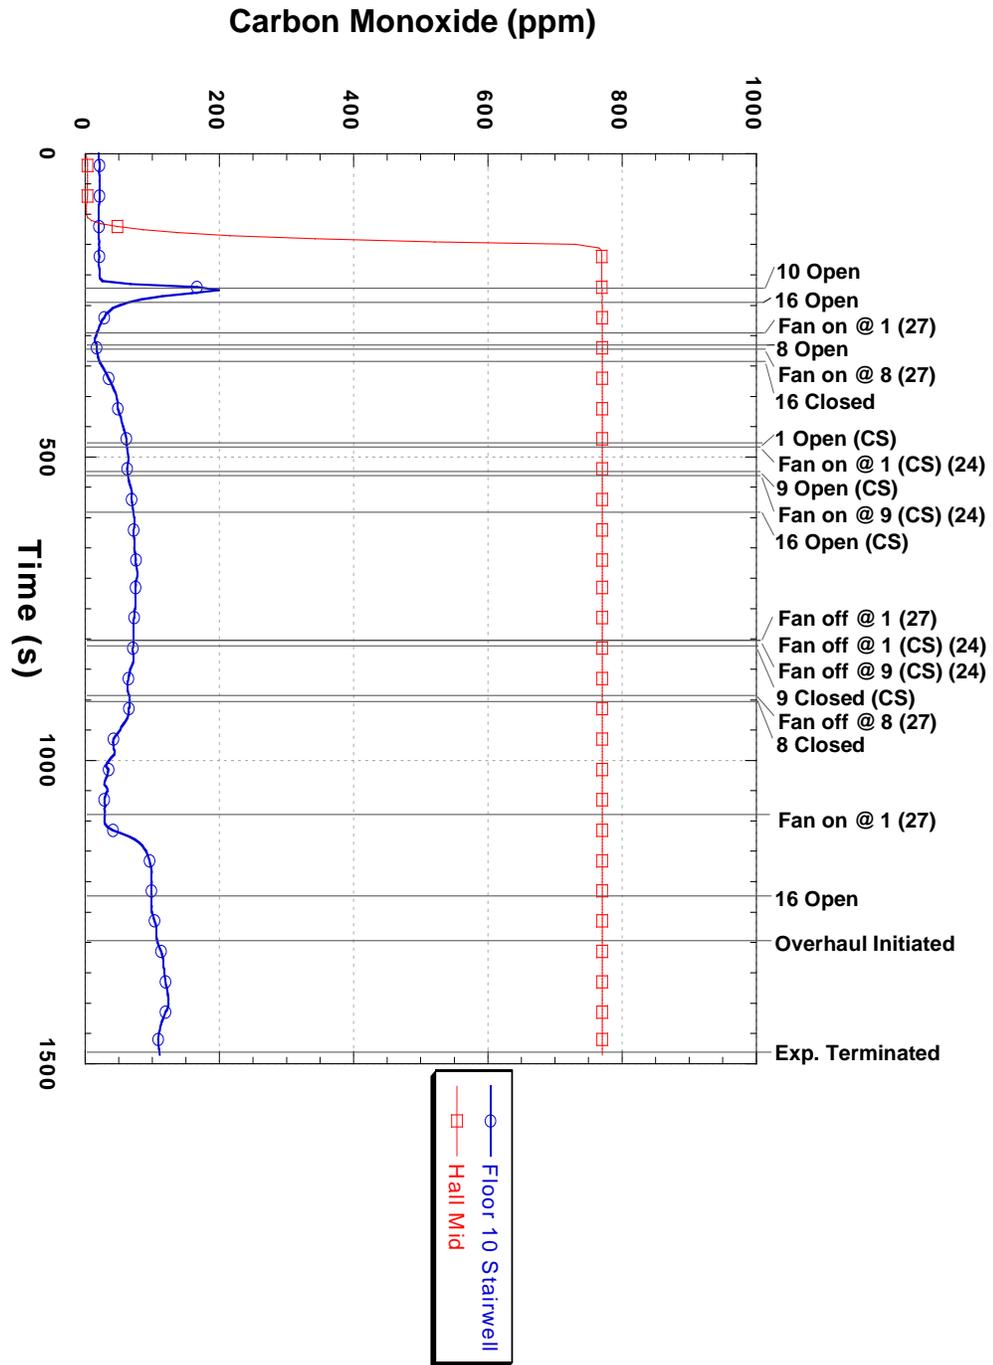
Figure 8. Detailed carbon monoxide vs. time for 1003

The experiment in Apartment 1003 had a number of CO meters fail to operate properly early in the experiment. Two meters functioned as intended during the entire experiment. The CO level in the hallway reached the maximum of 750 ppm (0.075 %) early in the experiment and remained at the maximum during the entire experiment. The CO meter in the south stairwell on the 10th floor reached as high as 200 ppm (0.02 %) when the fire floor door was opened, but declined to below 100 ppm (0.01 %) during ventilation.

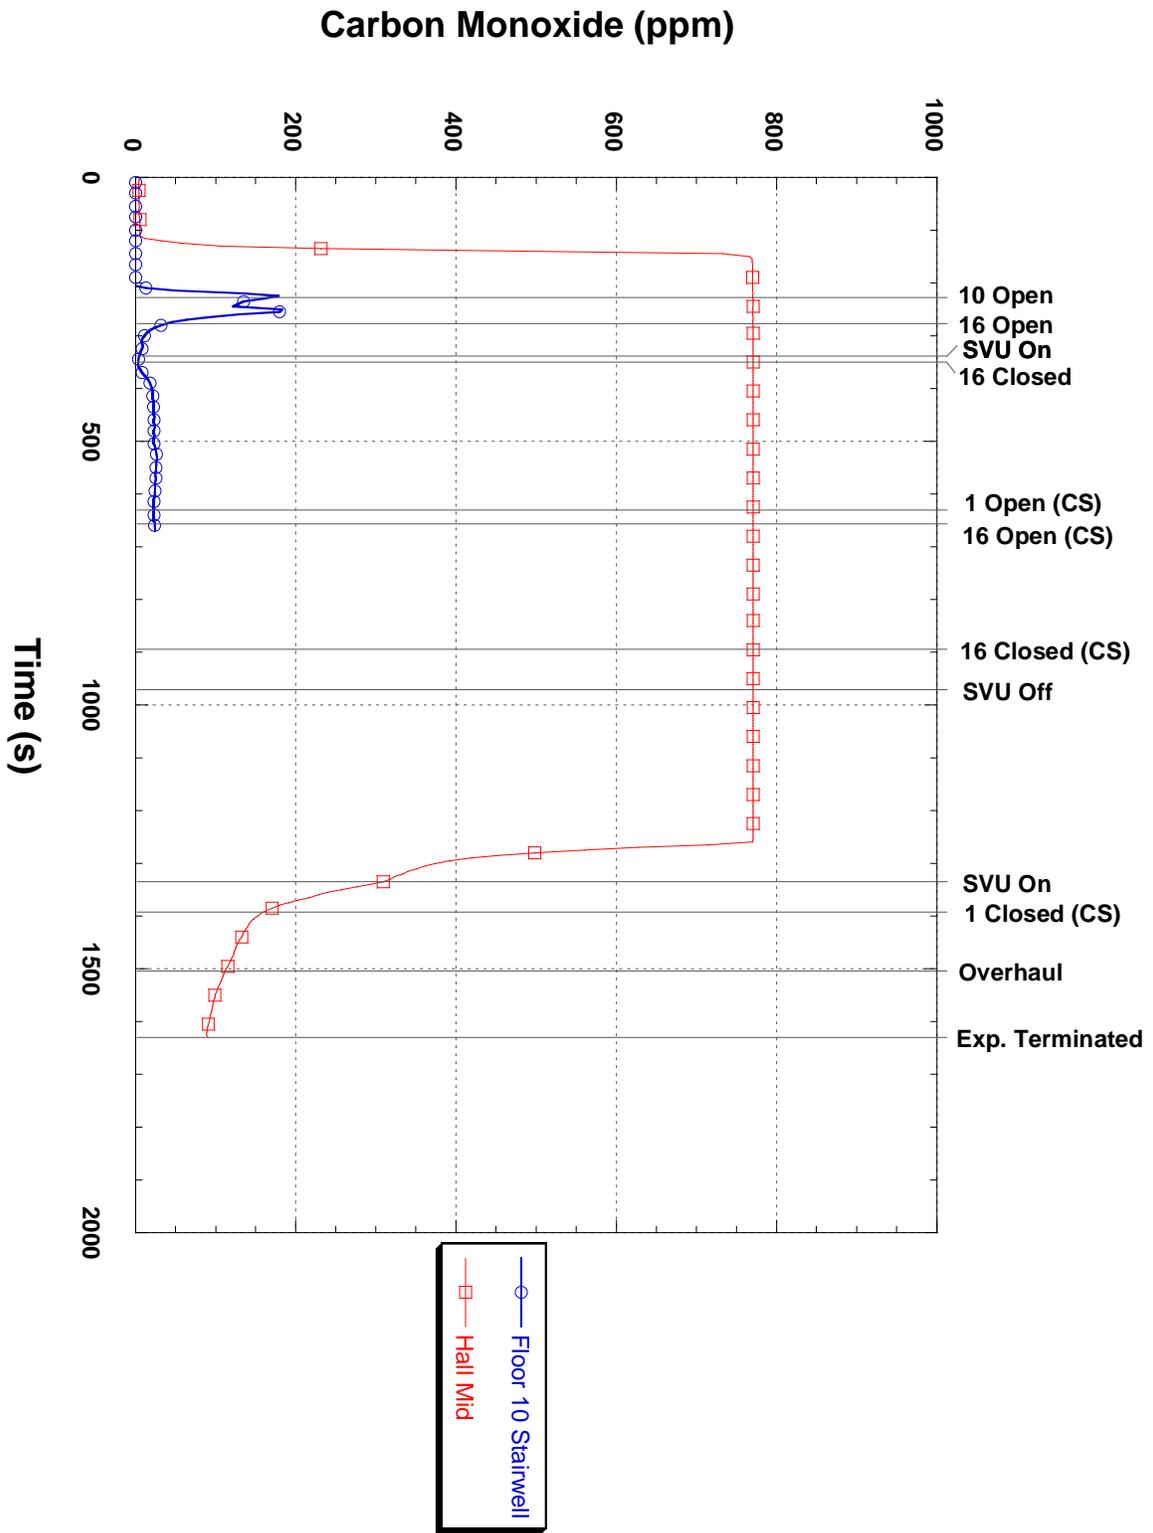
Figure 8. Detailed carbon monoxide vs. time for 1005

The experiment in Apartment 1005 also had similar CO meter malfunctions. The CO level in the hallway reached the maximum of 750 ppm (0.075 %) early in the experiment and remained at the maximum for most of the experiment. The CO meter in the south stairwell on the 10th floor reached as high as 180 ppm (0.018 %) when the fire floor door was opened, but declined to below 50 ppm (0.005 %) during ventilation until it also failed at 660 s.

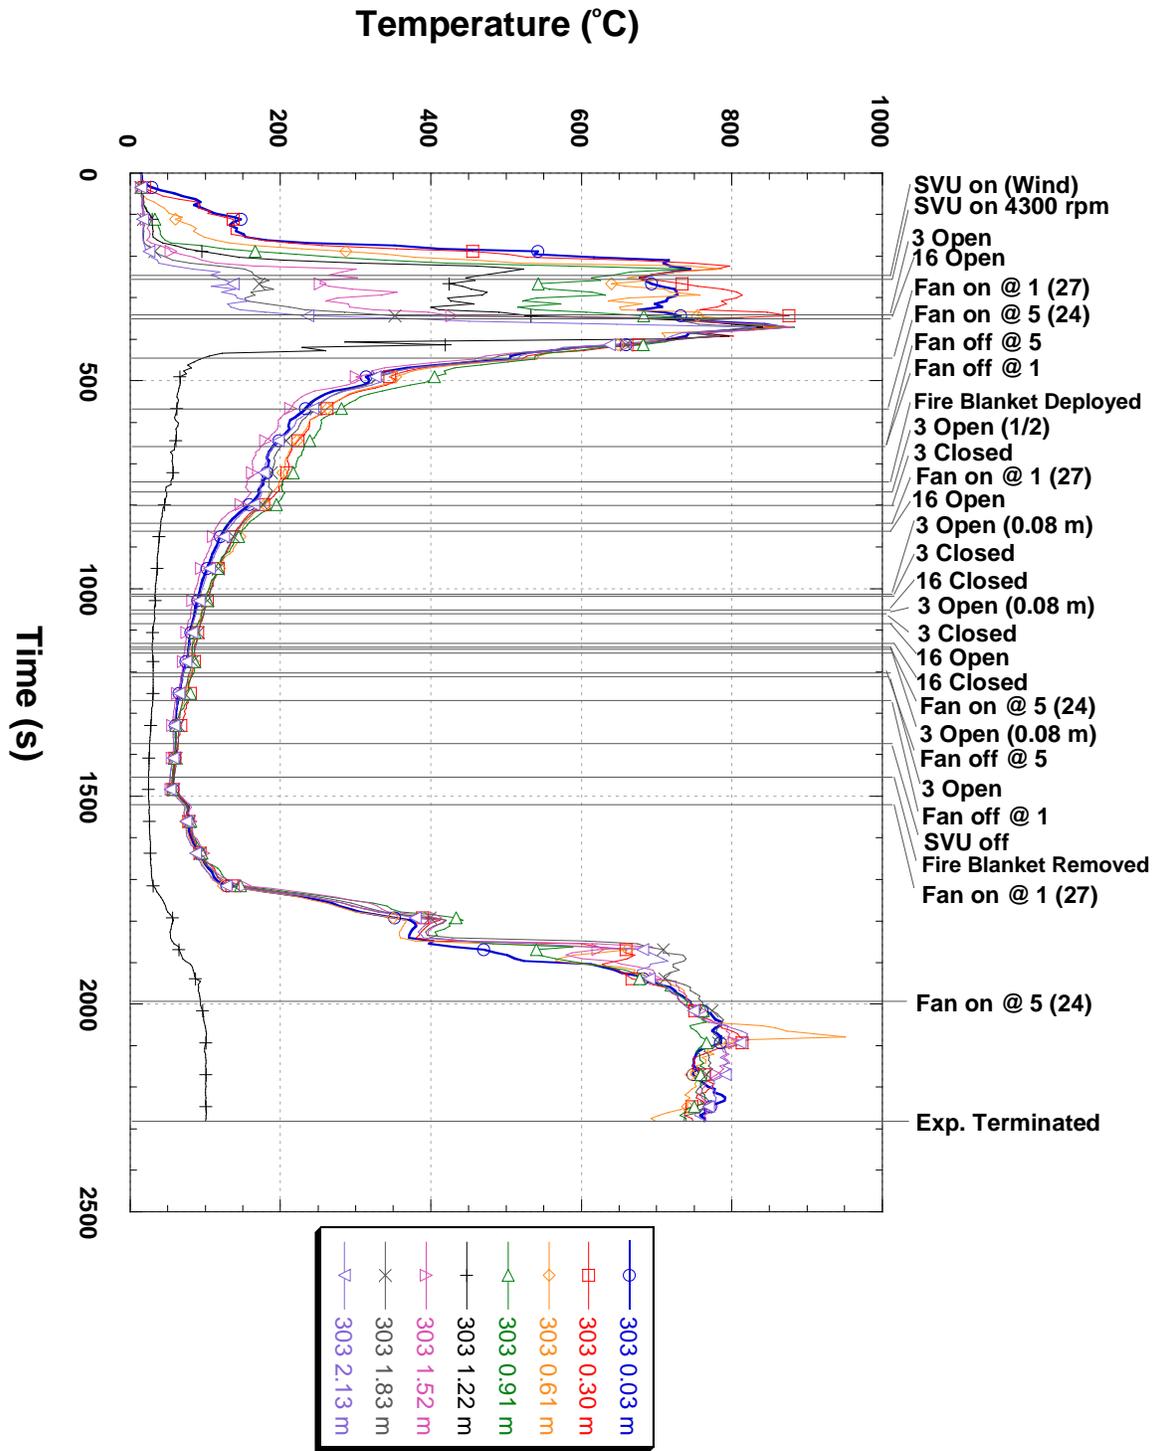
Figure 1. Detailed temperature vs. time for 303 living room

Temperatures during the experiment in Apartment 303 were greatly influenced by ventilation. A simulated wind was introduced through a bedroom window which caused temperatures to reach as high as 900 °C (1650 °F) in the living room. Temperatures as high as 600 °C (1110 °F) were reached in the hallway and the temperature in the stairwell peaked at 250 °C (480 °F) on the floor above the fire floor. A fire blanket was deployed to block the effects of the wind and the temperatures were held below 200 °C (390 °F) everywhere on the floor until the blanket was removed. The remaining fuel in the room began to burn causing temperatures to rise back up to 800 °C (1470 °F).
