NIST NCSTAR 1-6B

Federal Building and Fire Safety Investigation of the World Trade Center Disaster

Fire Resistance Tests of Floor Truss Systems

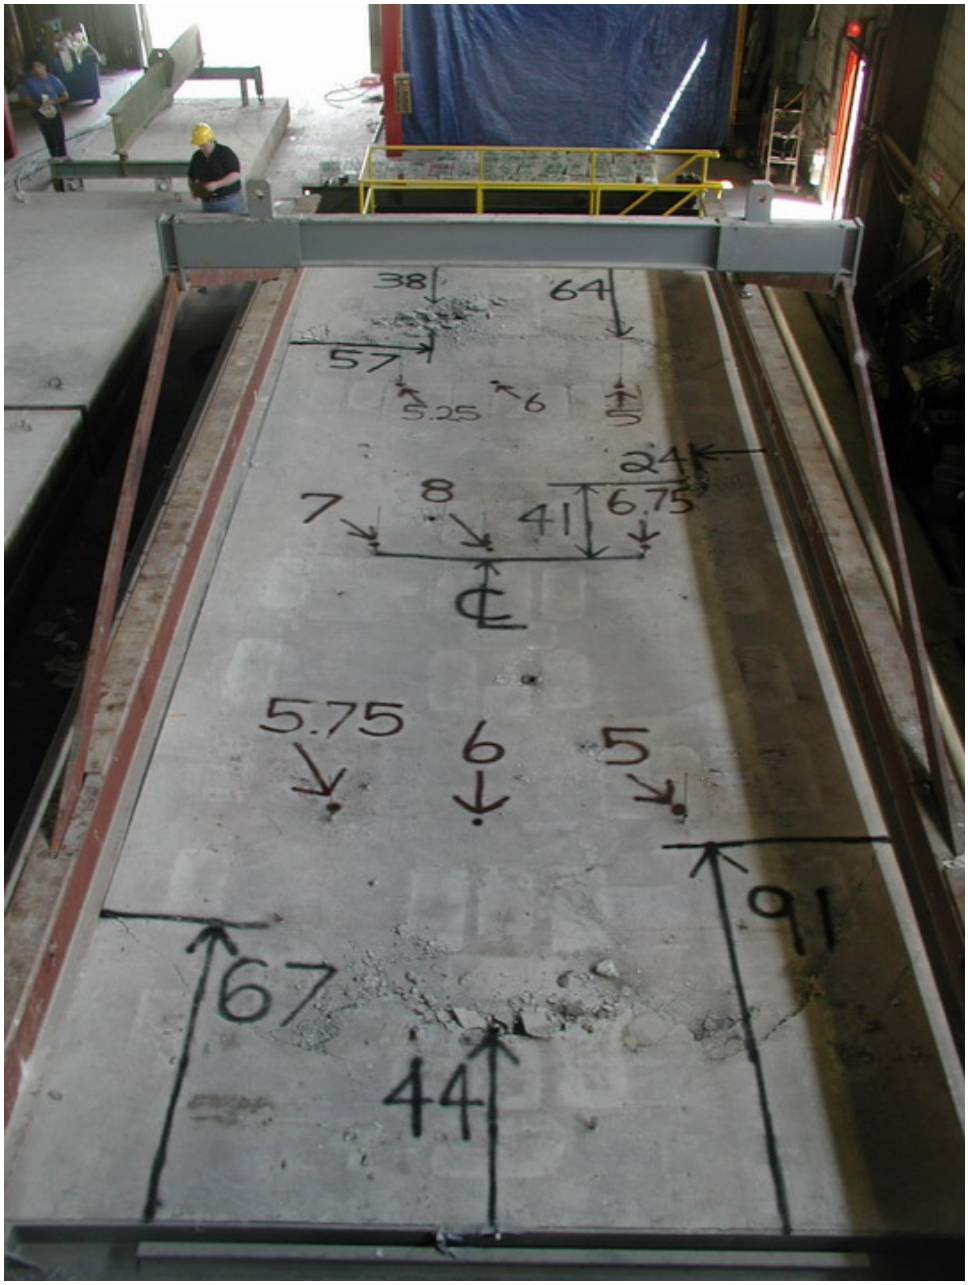
Figure 5–13 shows the unexposed surface of the assembly after all loading equipment had been removed (view looking east). Numbers shown at the centerline and quarter points are vertical deflections after cooling. All other numbers are reference dimensions as measured from the edge of the slab.
Figures 5–14 through 5–19 are additional views of the top of the specimen, showing the cracked and spalled concrete, and of the underside, showing bulging of the metal deck and deformations of the steel trusses after the test specimen had cooled and had been removed from the furnace. To confirm the spalling of the bottom side of the concrete slab and to quantify the depth of spalling, sections of the slab were cut using a diamond concrete wet saw (see Fig. 5–20). The depth of the delamination spalling varied but was on the order of 2 in. as seen in Fig. 5–21.

Figure 5–13. Unexposed surface of Assembly No. 1 after loading equipment was removed.

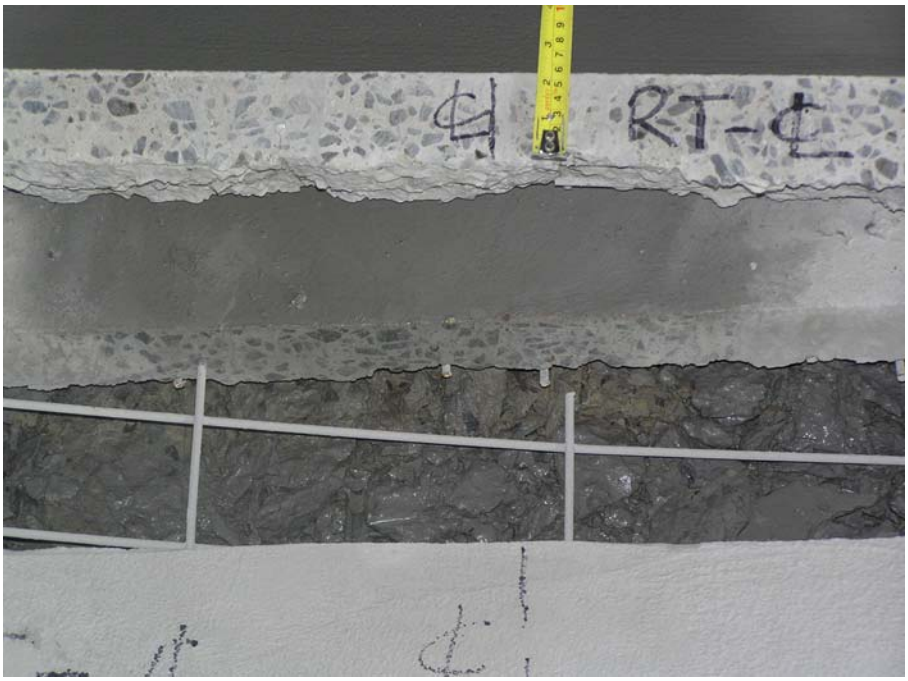
Figure 5–21. Measurement of depth of delamination spalling.

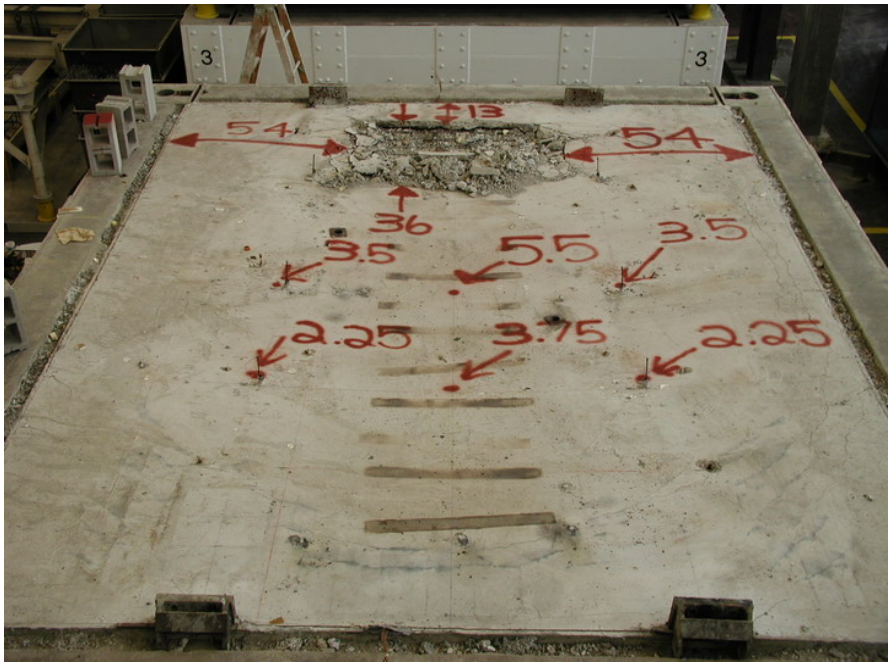
Figure 5–50 shows the unexposed side of floor assembly No. 3 after all loading equipment had been removed (view looking north). Numbers shown at the centerline and quarter points are vertical deflections after cooling. All other numbers are reference dimensions as measured from the edge of the slab. Figures 5–51 through 5–53 are additional views of the post-test condition of the test specimen.

Figure 5–50. Unexposed surface of Assembly No. 3 after loading equipment was removed.

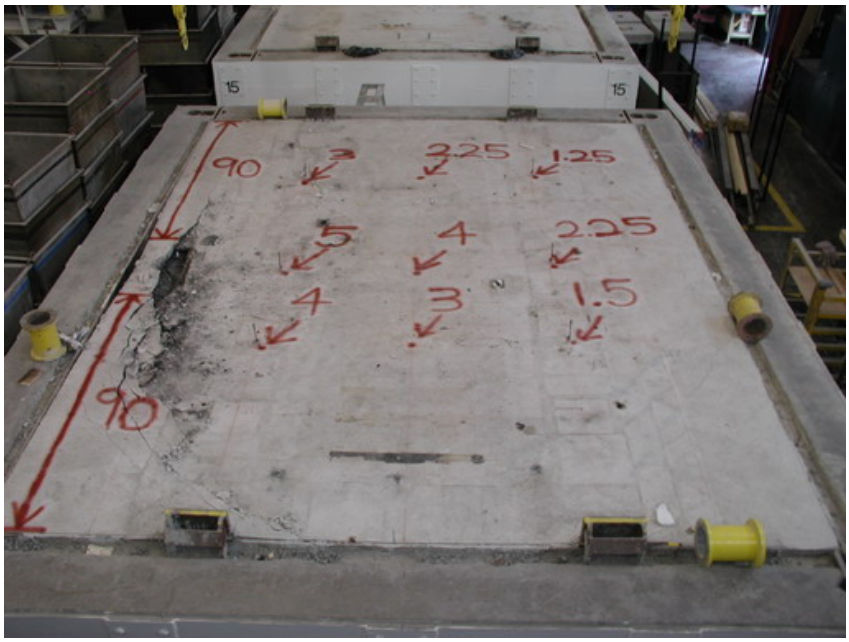
Figure 5–66 shows the unexposed side of the assembly after all loading equipment was removed (view looking north). Numbers shown at the centerline and quarter points are vertical deflections after cooling. All other numbers are reference dimensions as measured from the edge of the slab. Figures 5–67 through 5–70 are additional views of the post-test condition of the test specimen.

Figure 5–66. Unexposed surface of Assembly No. 4 after loading equipment was removed.

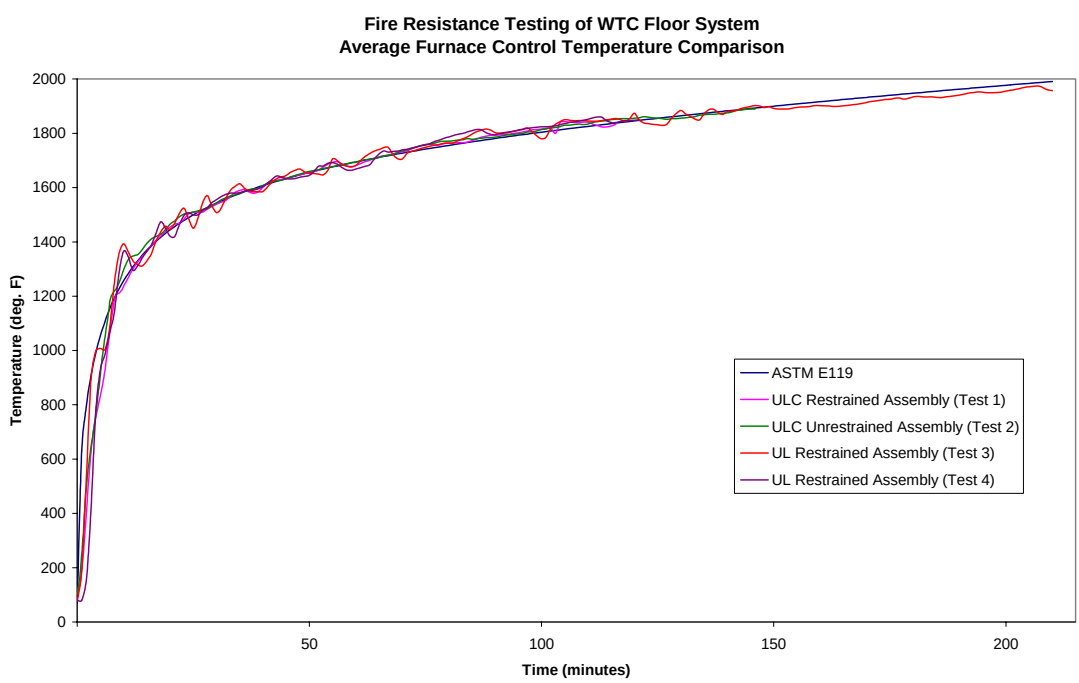
Figure 6–1. Comparison of average furnace control temperatures.

The average furnace temperatures during all four tests and the target time-temperature relationship prescribed by ASTM E 119 are shown in Fig. 6–1. It is seen that the average furnace control temperatures were very similar and indeed met the requirements of ASTM E 119.

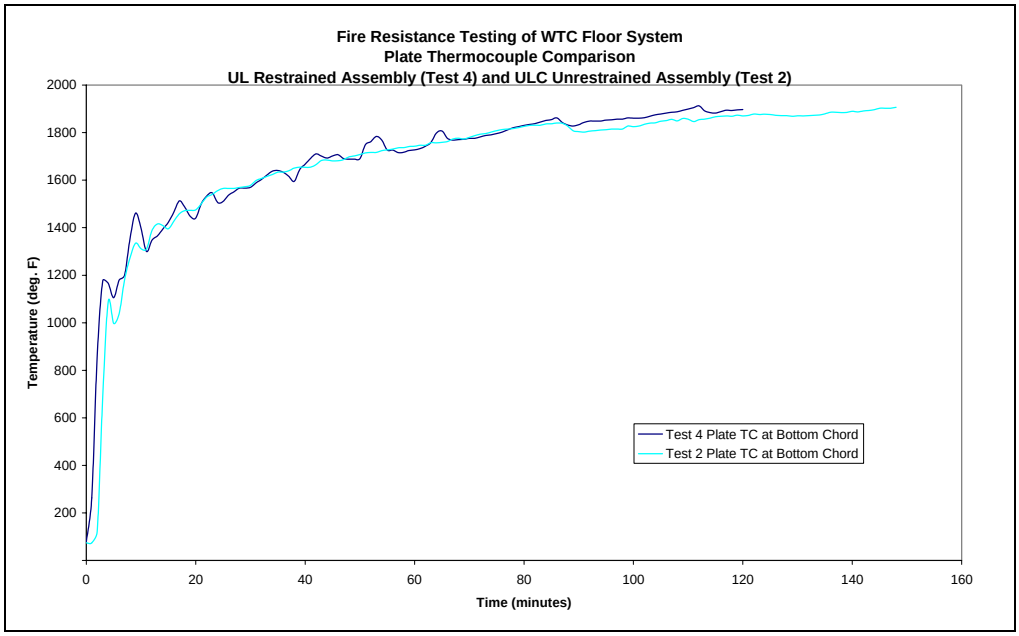
Figure 6–2. Temperatures measured at the bottom chord by the plate thermocouple in the ULC furnace (Test No. 2) and ULN furnace (Test No. 4).

Figures 6–2 and 6–3 show temperatures recorded by the plate thermocouples for Test No. 2 (ULC furnace) and Test No. 4 (ULN furnace). Temperatures recorded at the bottom chord are presented in Fig. 6–2, and those recorded at the underside of the metal deck are shown in Fig. 6–3. These two plots show that temperatures measured at two locations are very similar between the two furnaces. Note that the plate TC at the metal deck in Test 4 (ULN) gave unreliable data after approximately 50 min. This time is consistent with observations of very loud report and visible steel deck deflection recorded at 51 min (see Table 5–4). This plate TC was dislodged from its initial position, relative to the metal deck, and readings beyond 50 min cannot be interpreted.

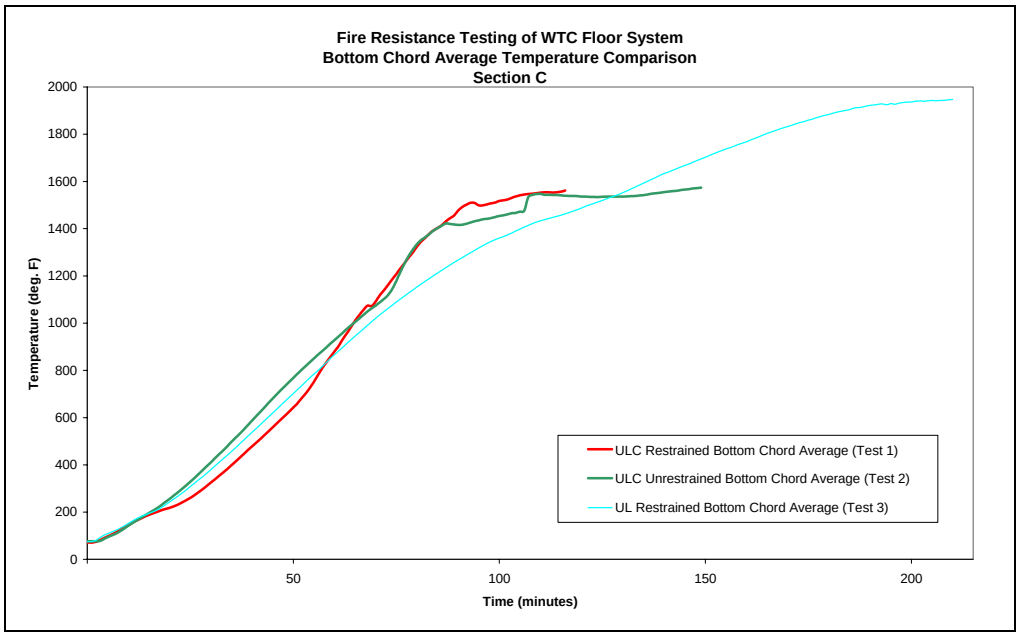
Figure 6–4. Average temperatures of the bottom chord for Test Nos. 1, 2, and 3 (3/4 in. thick SFRM).

Figure 6–4 shows a comparison of the average temperature of the bottom chord for the three tests in which the thickness of the SFRM was ¾ in. Temperatures are seen to be very comparable up to about 75 min, which is around the time when SFRM began to dislodge.

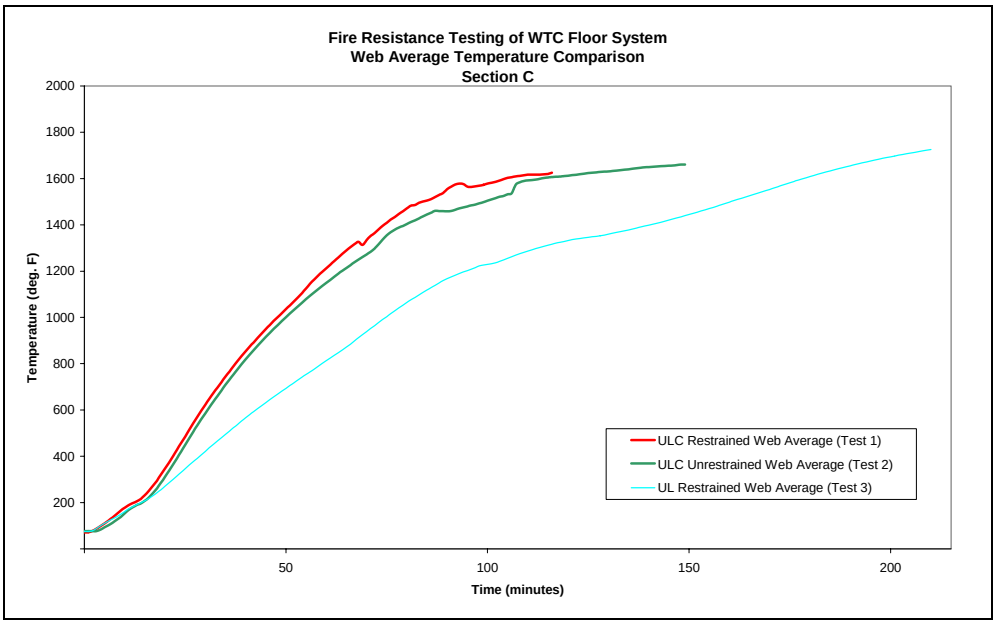
Figure 6–5. Average temperature of web diagonals for Test Nos. 1, 2, and 3 (3/4 in. thick SFRM).

Figure 6–5 presents a comparison of temperatures of the truss web diagonals for the three tests in which the thickness of the SFRM was ¾ in. The web temperatures for the two full-scale tests (35 ft span assemblies) were greater than those for the reduced-scale test (17 ft span assembly) after about 15 min. The reason for this difference is not clear but is possibly due to the relationship between the SFRM thickness and scale of the steel trusses. Comparison of Figs. 5–35 and 5–53 illustrates the difference in the buildup of SFRM at the intersections of the webs and chord members between the full- and reduced-scale test specimens, which may affect the rate of heating of the truss web diagonals. These results illustrate that thermal scaling is an issue that needs to be addressed.

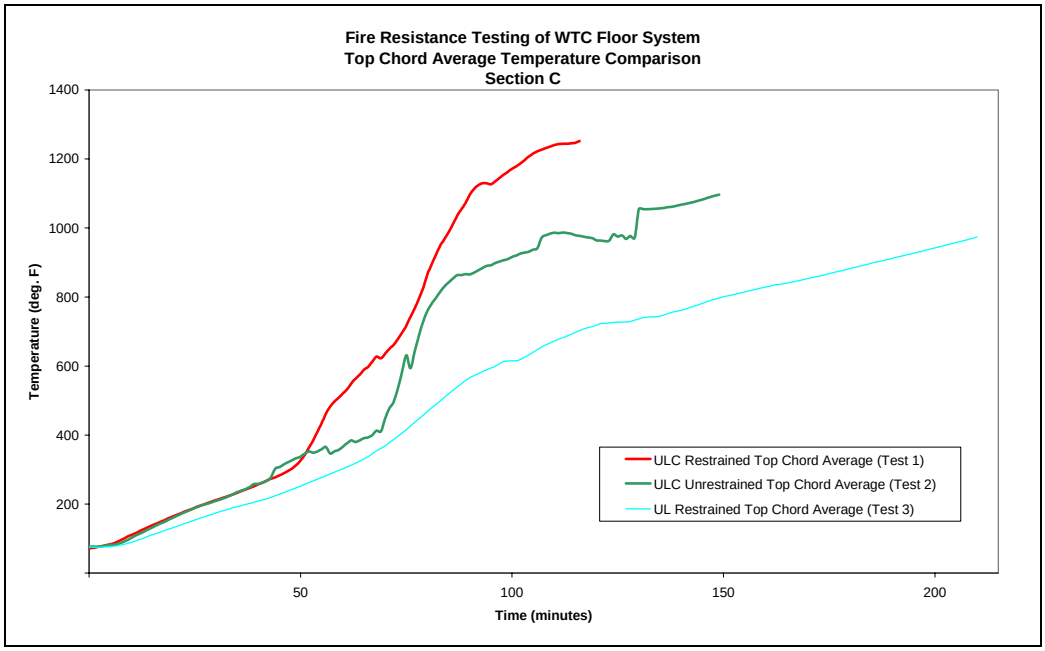
Figure 6–6. Average temperature of the top chord for Test Nos. 1, 2, and 3 (3/4 in. thick SFRM).

The average temperature of the top chord is plotted in Figure 6–6 for the three test assemblies with ¾ in. of SFRM. The average top chord temperature for the two full-scale tests (35 ft span test assemblies) was greater than the average temperature recorded for the reduced-scale test (17 ft span assembly) after about 50 min. Because of the comparatively abrupt changes in average temperature beginning around 50 min, the difference may be explained by sudden changes such as the onset of spalling of concrete and attendant loss of fire protection. However, since the steel temperatures in the reduced-scale test generally tend to be lower than in the full-scale test, this trend may be explained by a scale-related factor such as the difference in the buildup of SFRM affecting the rate of heating of the steel as noted above. Further, it is possible that the overspray on the metal deck was greater for test Specimen No. 3 than for the other two tests since the lower chord is closer to the metal deck. This, too, would be a geometrical scaling effect.

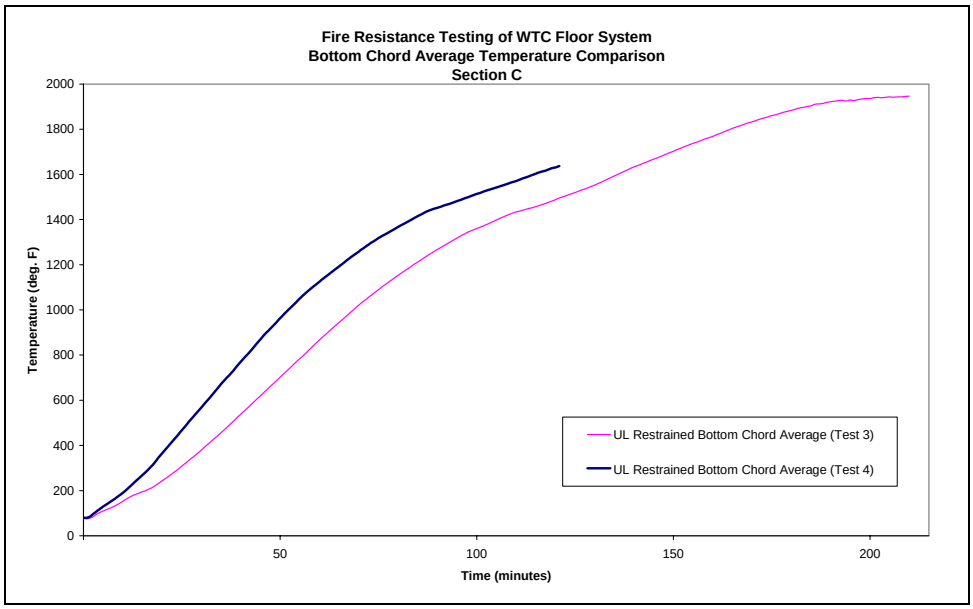
Figure 6–7. Average temperature of the bottom chord for Test No. 3 (3/4 in. thick SFRM) and No. 4 (1/2 in. thick SFRM).

Average temperature of the bottom chord at Section C (center of west truss) for Test No. 3 (¾ in. thick SFRM) and Test No. 4 (½ in. thick SFRM) is plotted in Fig. 6–7. As expected, the steel temperatures for the specimen with ½ in. of SFRM were higher than those for the specimen with ¾ in. of SFRM. Here, the same furnace (ULN) was used for the comparison.

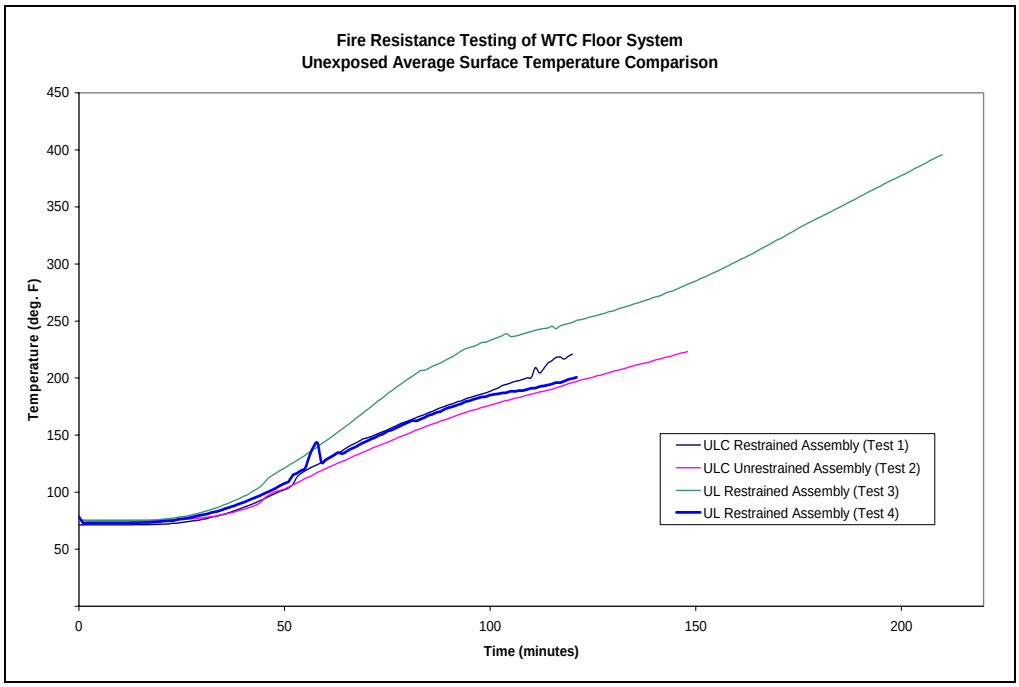
Figure 6–8. Average temperature of the unexposed surface for all four tests.

The temperature of the unexposed surface of the floor assemblies is plotted in Fig 6–8. It is observed that the unexposed surface temperatures of all four test assemblies were similar prior to the onset of significant concrete spalling at around 50 min. In Test 4, the surface-mounted TC on the west edge near the center of the span was affected by the explosive failure of the slab and recorded hot gas temperatures.

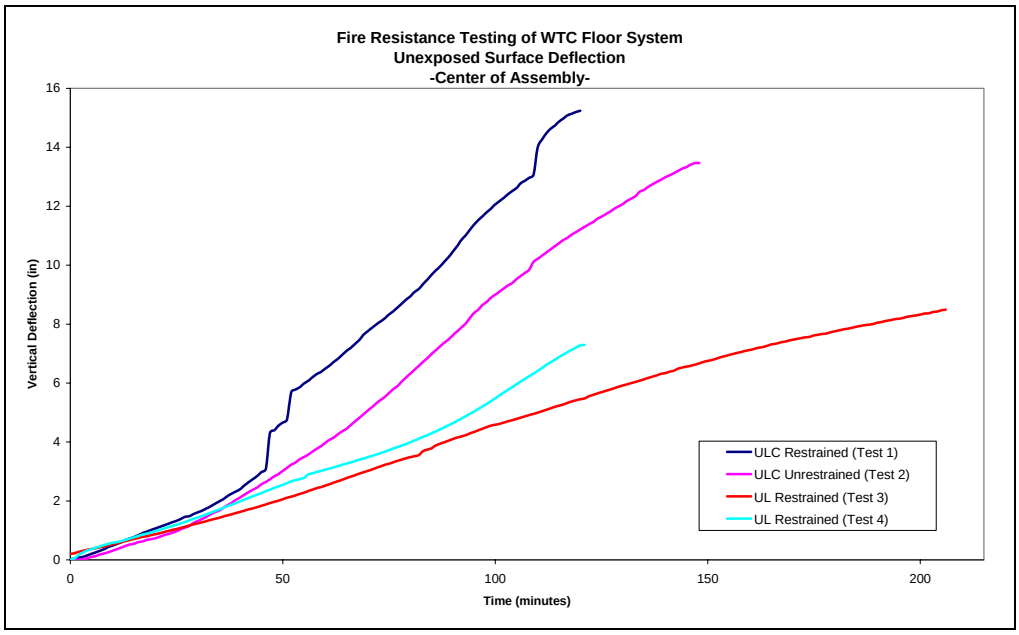
Figure 6–9. Deflection measured at the center of each assembly.

The following plots show the vertical deflection measured at the center of each assembly. Figure 6–9 shows the deflection, while Fig. 6–10 shows a plot of the deflection normalized by the span. It is seen that test Assembly No. 1 experienced a significant increase in vertical deflection at 49 min, which corresponds directly to a loud report and visible deflection noted in the test observations. Figure 5–13 shows the damage to the top side of the concrete slab that occurred with the sudden increases in deflection. The normalized curves show good agreement throughout the duration of the tests.
