Engineering Analysis of the Fire Development in the Hillhaven Nursing Home Fire, October 5, 1989

September 1991

Harold E. Nelson and King-Mon Tu
Building & Fire Research Laboratory
National Institute of Standards & Technology
Gaithersburg, MD 20899

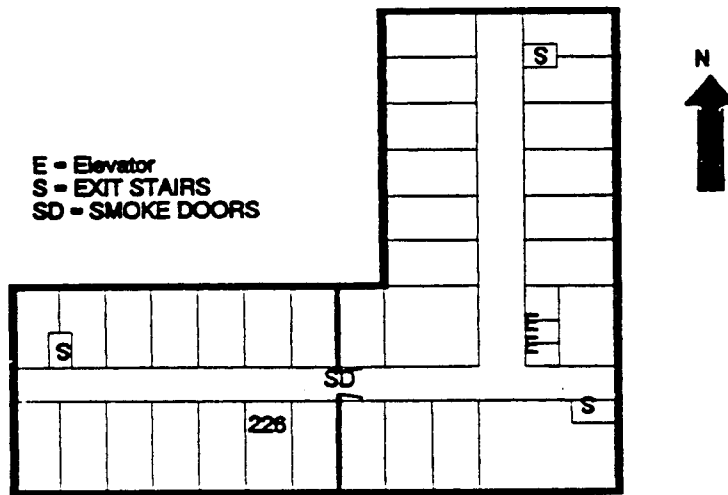
Figure 1. Second Floor Plan

The second floor (See Figure 1) was occupied entirely as a nursing unit and contained bedrooms located on opposite sides of an 2.4 m (8 ft.) wide corridor. The floor also contained a nurses station, a lounge, and several support rooms. The rooms were separated from the corridor by one-hour gypsum wallboard on steel stud partitions. The doors to each room were solid core wood doors equipped with roller latches but not closers.

The floor was divided into two smoke zones by a smoke barrier separating the 14 rooms at the west end of the floor from the rest of the floor. Room 226 was in the west wing one room removed from the smoke barrier.

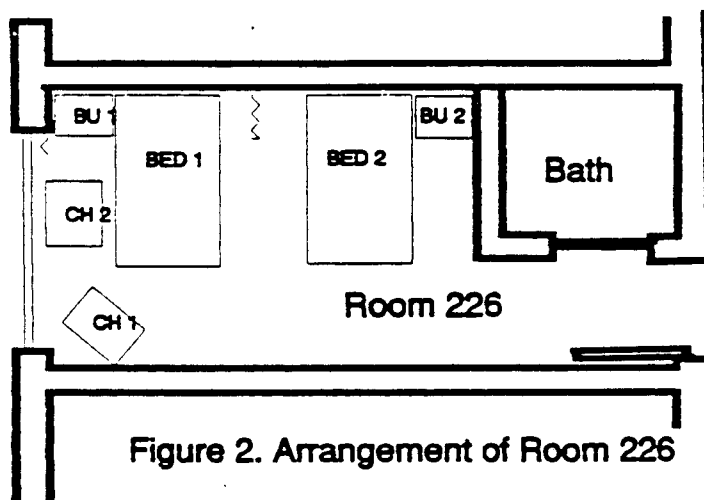
Figure 2. Arrangement of Room 226

Figure 2 is an approximate layout of the arrangement of Room 226 at the time of the fire. It was typical of other rooms in the building. The room contained 2 beds, 2 wooden bureaus, 2 chairs each having separate seat and back cushions and wooden frame. Similar chairs that survived the fire were padded with a urethane material. In addition to the material shown in Figure 2, there were curtains on the windows, a privacy curtain between the beds, 2 hospital type bed tables, and a television set mounted towards the ceiling over the position shown for chair one. The east (long) wall of the room was finished with a vinyl fabric wallpaper. The other walls in the room were painted directly on top of the gypsum board. The door to the bathroom was a hollow core wooden door. The door to the corridor was a solid core wooden door.

The free burn Test discussed above did not include the wooden head or footboard on the beds in the Hillhaven facility nor did it include the chair shown as chair 2 in Figure 2 located an estimated 6 inches from the side of the bed. The actual fire must have involved all of these. Chair 2 is believed to be virtually identical to a chair previously tested by NIST [1][3]. In that test, a peak burning rate of 285 kW was reached after 130 seconds of exposure. Based on the size, the footboard was estimated as having a maximum rate of heat release of approximately 75 kW. This was based on a footboard approximately 0.3m (12 inches) high by 1m (39 inches) long (approximately 0.3 sq. meters of surface) burning at the rate of approximately 150 kW per square meter. This assumes that both sides of the footboard became involved. A similar calculation for the headboard produces a value of approximately twice this level.

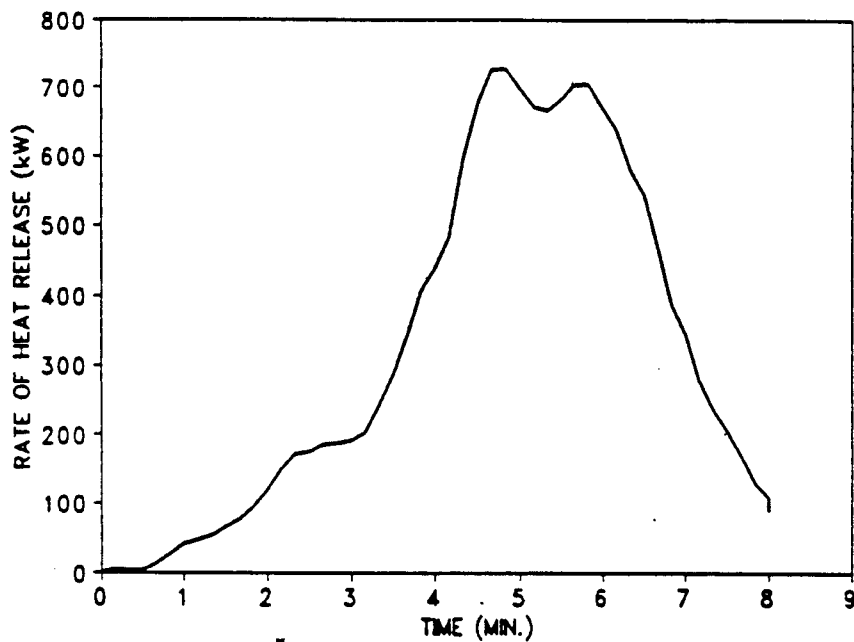
Figure 3. Free Burn Rate of Heat Release

An instrumented burn test was conducted under the large hood at the facilities of NIST. The sample burn consisted of one of the mattresses obtained from the Hillhaven facility with a decubitus pad, fitted sheet, draw sheet, cotton cover, and a pillow. The arrangement for ignition was the same as the third scenario in the ignition sequence (free hanging bedding). The fire progressed rapidly, reaching a peak of approximately 775 kW. Figure 3 is a plot of the rate of heat release measured in this test.

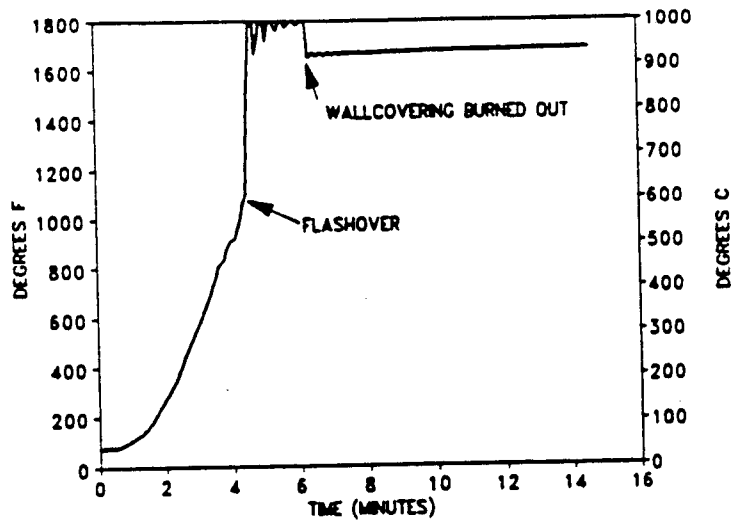
Figure 4. Rate of Heat Release Input into Model

The fire model, FIRE SIMULATOR, contained in FPETOOL [2] was executed using the resulting accumulated fire curve. The purpose of this run was to identify the point at which room temperature would rise sufficiently to impact on the rate of heat release estimated from the NIST tests and the adjustments made using the routine FREEBURN. As pointed out by Parker [3], this enhancement takes place if the ceiling gases become sufficiently hot. The exact temperature for enhancement is not established but is in the neighborhood of 450°C (850°F). This test run indicated that such enhancement would start to occur at about the point where the rate of heat release curve reached 900 kW. To account for this, a new fire input curve was developed progressively increasing the rate of heat release above 900 kW to a point approximately one minute later where the predicted rate of heat release was doubled. This is felt to be a reasonable accommodation for the combination of enhancement and the spread to additional fuels such as the draperies and privacy curtains. Figure 4 shows the relationship of the various rate of heat release curves starting with the NIST test involving only the mattress and bedding and including the adjustment made by the program FREEBURN to include head and footboard and the chair adjacent to the bed. Finally, Figure 4 shows the increased curve reflecting the enhancement produced by the hot smoke and other factors. This final enhanced curve was then used as the source term for modeling fire conditions in Room 226.

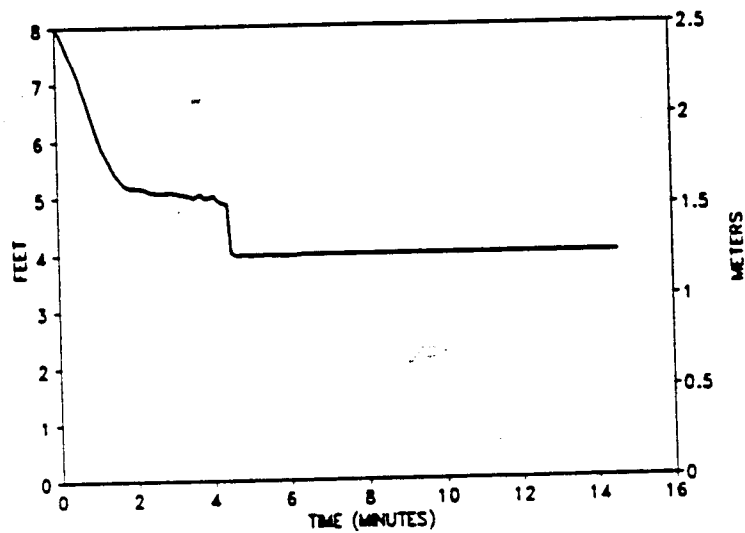
Figure 5. Smoke Temperature in Room 226

The model FIRE SIMULATOR from FPETOOL [2] was then used to produce estimates of the conditions in Room 226. The detailed print out from FIRE SIMULATOR for ROOM 226 is contained in Appendix B. The model estimates that flashover occurred at 267 seconds following ignition. In view of the estimates required for input factors and uncertainties in the model, this should be taken as somewhere between 4 and 5 minutes. Figures 5, 6, and 7 depict results developed by this model. Following flashover the model estimates are based on full involvement of the wall covering materials lasting approximately 2 minutes until the combustible material (vinyl wall covering on the east wall and the paper facing of the gypsum board on the other walls) was consumed. Following that the residual fuel was considered to consist of the furniture in the room and the wood faces of the corridor and bathroom doors.

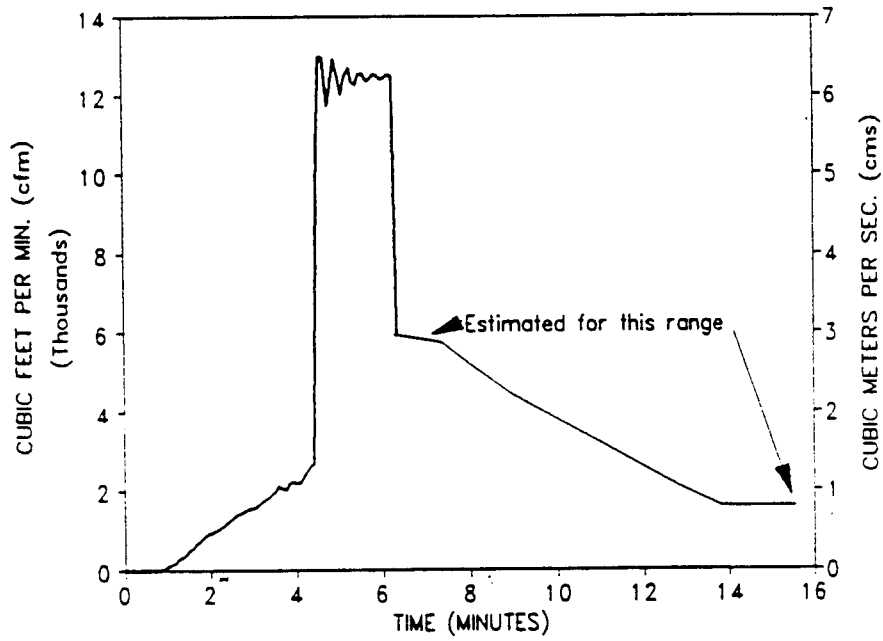
Figure 8. Smoke Flow from Door of Room 226

Figure 8 depicts the rate of flow of smoke from Room 226 into the corridor and Figure 9 depicts the total enthalpy (i.e. sensible heat of the fire gases plus the potential energy contained in yet unburned fuel) carried in that smoke as calculated by FIRE SIMULATOR as a part of the analysis of conditions in room 226.[5] Prior to flashover the rate of smoke flow grew gradually reaching a level of around 1 cms (2000 cfm) while the total enthalpy rose only slightly. With the advent of flashover, there was a sudden rise to an estimated 6-7 cms (12-13,000 cfm) of smoke flow having a total enthalpy in the range of 13-14 MW. Fortunately, most of that energy was never released. Since the smoke cloud containing the energy was nearly devoid of oxygen only that portion of the unburned fuel in the smoke that could gather air from the corridor space was able to actually burn.

[5] That portion of the curves plotted in Figures 8 and 9 covering the conditions after 6 min. are labeled as estimated. This is to recognize the depletion of oxygen in the corridor, a condition that could not be recognized by the FIRE SIMULATOR evaluation of Room 226.

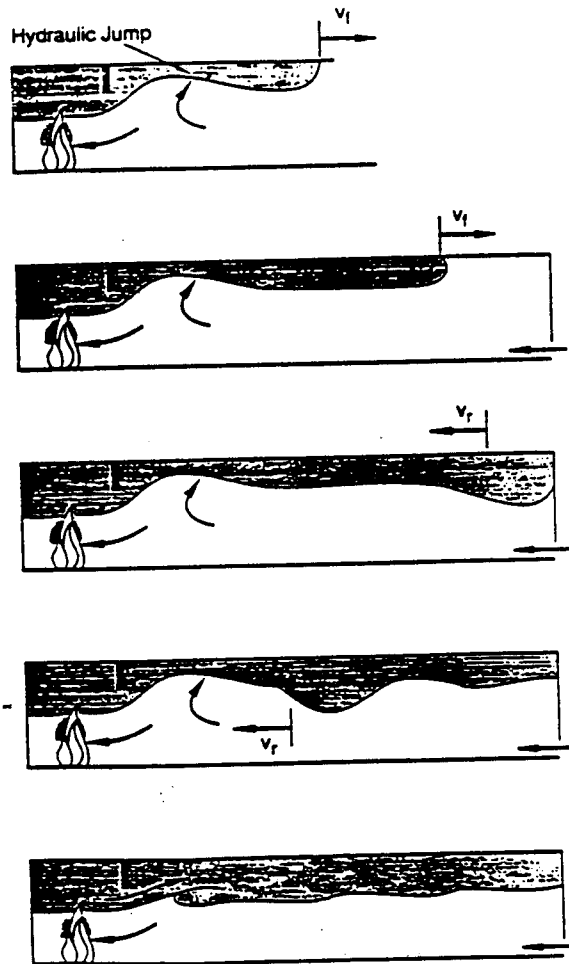
Figure 10. Corridor Wave Flow

The movement of the smoke in the corridor was calculated using the procedures proposed by Steckler [4] for modeling fire induced flows in corridors. During the initial post flashover stages a wave front such as that diagramed in Figure 10 (abstracted from Steckler's report) flowed to the end of the corridor and back. While the actual physics of smoke flow in corridors is only partially codified, the procedures suggested by Steckler are considered to give a reasonable view of conditions. Figures 11, 12, and 13 depict results obtained from the corridor calculations.

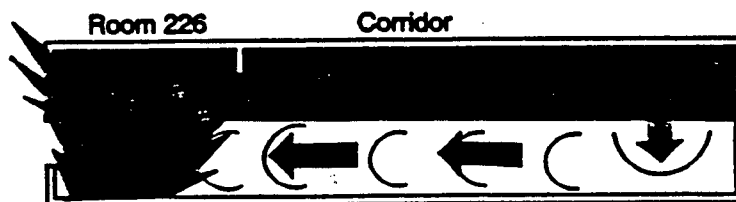
Figure 13. Position of Smoke Wave Front

Based on the above, it would be expected to take slightly less than 1 minute after flashover to fill the west corridor to a depth about 1.7 m (5.5 ft.) above the floor and to about 0.9 m (3 ft.) above the floor within another minute as a result of the return wave. Once the smoke doors closed the carbon monoxide laden smoke and fire gases would extend to near the floor in about another minute. As shown by Figure 13, it would be expected that the temperatures in the immediate area of Room 226 would remain high but would drop rapidly along the length of the corridor. The contents of the smoke would be close to that expelled from Room 226 (i.e carbon monoxide concentrations in the range of 3.8% (38,000ppm) and oxygen depleted to virtually 0.)

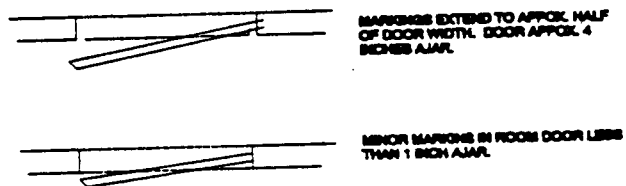
Figure 15. Patient Room Door Openings

In each room where victims were found, there were smoke marks above the door indicating the door had been ajar. Matching the door to the smoke marks indicated that the degree of openness of these doors varied from about 1 to 4 inches. This is graphically depicted in Figure 15. The locations of the victims are shown in Figure 16. The procedure for estimating smoke flow through an opening contained in FPETOOL [2] was used to evaluate the initial smoke flow into the individual patient rooms as a result of the filling of the corridor. The flow rates range from approximately 0.06 cms (130 cfm) for a situation of a 25 mm (1 inch) crack located where temperatures were in the range of 60°C (140°F) to approximately 0.5 cms (about 1000 cfm) for a door 100 mm (4 inches) ajar with a smoke temperature in the corridor at 540°C (1000°F)[6] Because the smoke and gases entering the patient rooms were at an elevated temperature, it is expected that the incoming smoke formed a descending layer filling the room from the top down, with little dilution of the carbon monoxide concentration. At 0.06 cms (130 cfm) it would take about 9 minutes for the layer to descend to the head height of a patient in bed. At 0.5 cms (1000 cfm) this is reduced to less than 2 minutes.[7] Once the layer reached a patient, that individual would be subjected to the full concentration of the fire product gases. The rate of uptake of carbon monoxide and the resulting increase in caboxihemo-globin (COHb) by humans is variable depending on factors including the weight of the individual, their lung capacity, and their breathing rate. Several researchers have, however, produced procedures for quantifying the relationship between carbon monoxide exposure and COHb accumulation. That

MARKINGS EXTEND TO APPROX. HALF
OF DOOR WIDTH. DOOR APPROX. 4
INCHES AJAR.

MINOR MARKINGS IN ROOM DOOR LESS
THAN 1 INCH AJAR.

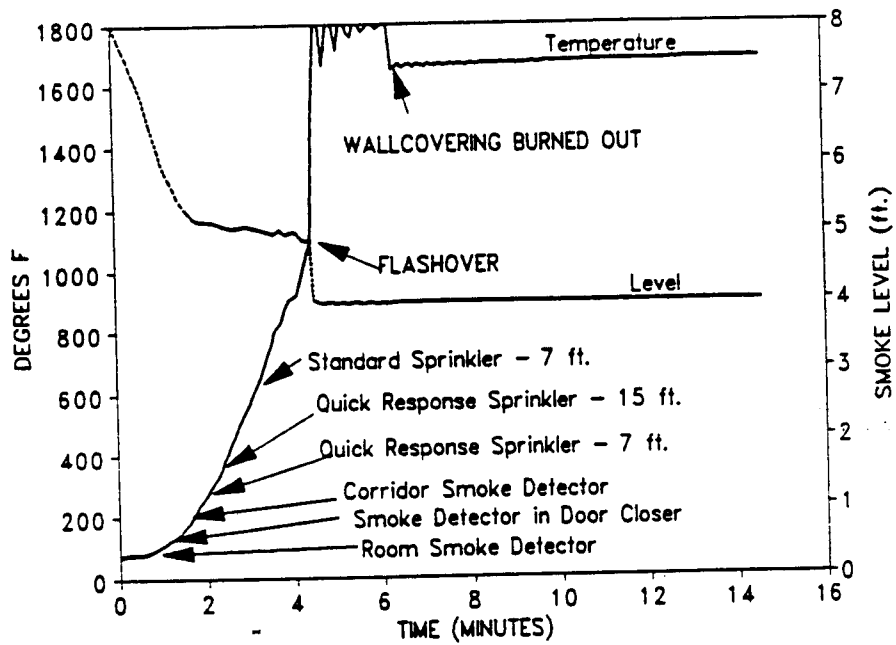
Figure 17. Potential of Sprinklers and Detectors

FIRE SIMULATOR was used to estimate the different course that might have occurred had the facility been equipped with automatic sprinklers, smoke detectors, or smoke detector operated door closers. The response of sprinklers and detectors is compared to the temperature conditions in Room 226 in Figure 17.

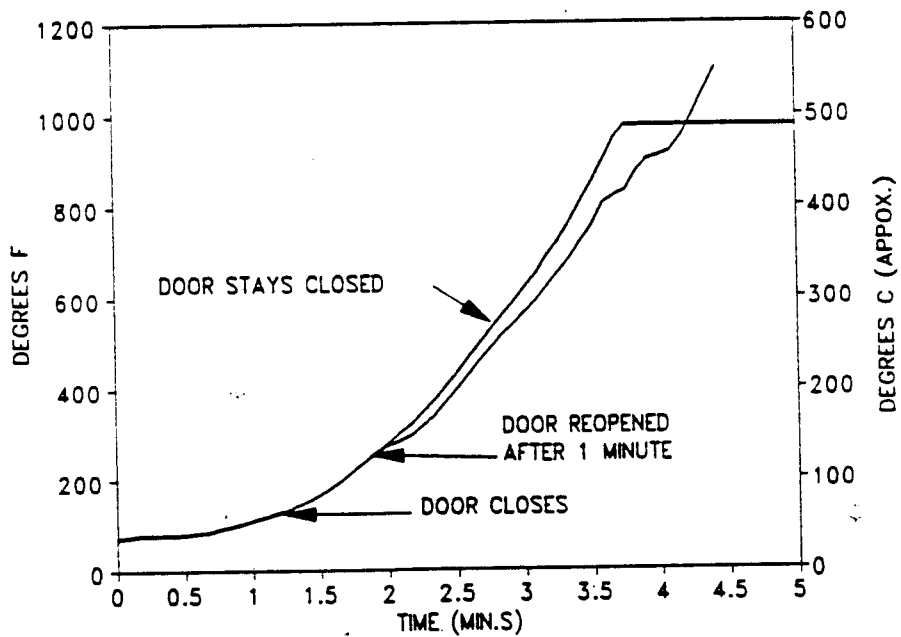
Figure 18. Temperature in Room 226 if Door had been closed

Two additional runs of FIRE SIMULATOR were made to investigate the impact of having the door to Room 226 close at 56 seconds (the estimated time for response of a smoke detector mounted in a door closer for Room 226.) The estimated resulting temperature conditions in Room 226 are shown in Figure 18. Print outs of these runs are contained in Appendix B.

In the first run the door was closed when the detector activated and allowed to remain closed until FIRE SIMULATOR calculations indicated that the oxygen had been consumed and the fire smothered, assuming that the window did not break. Since FIRE SIMULATOR indicates that the resident air in Room 226 would result in a peak temperature of about 525°C (975°F) there is a significant possibility that the window would break out and the fire progress into flashover. In any case FIRE SIMULATOR estimates that the conditions behind the closed door would have become intolerable in about 2 minutes following the closing of the door.

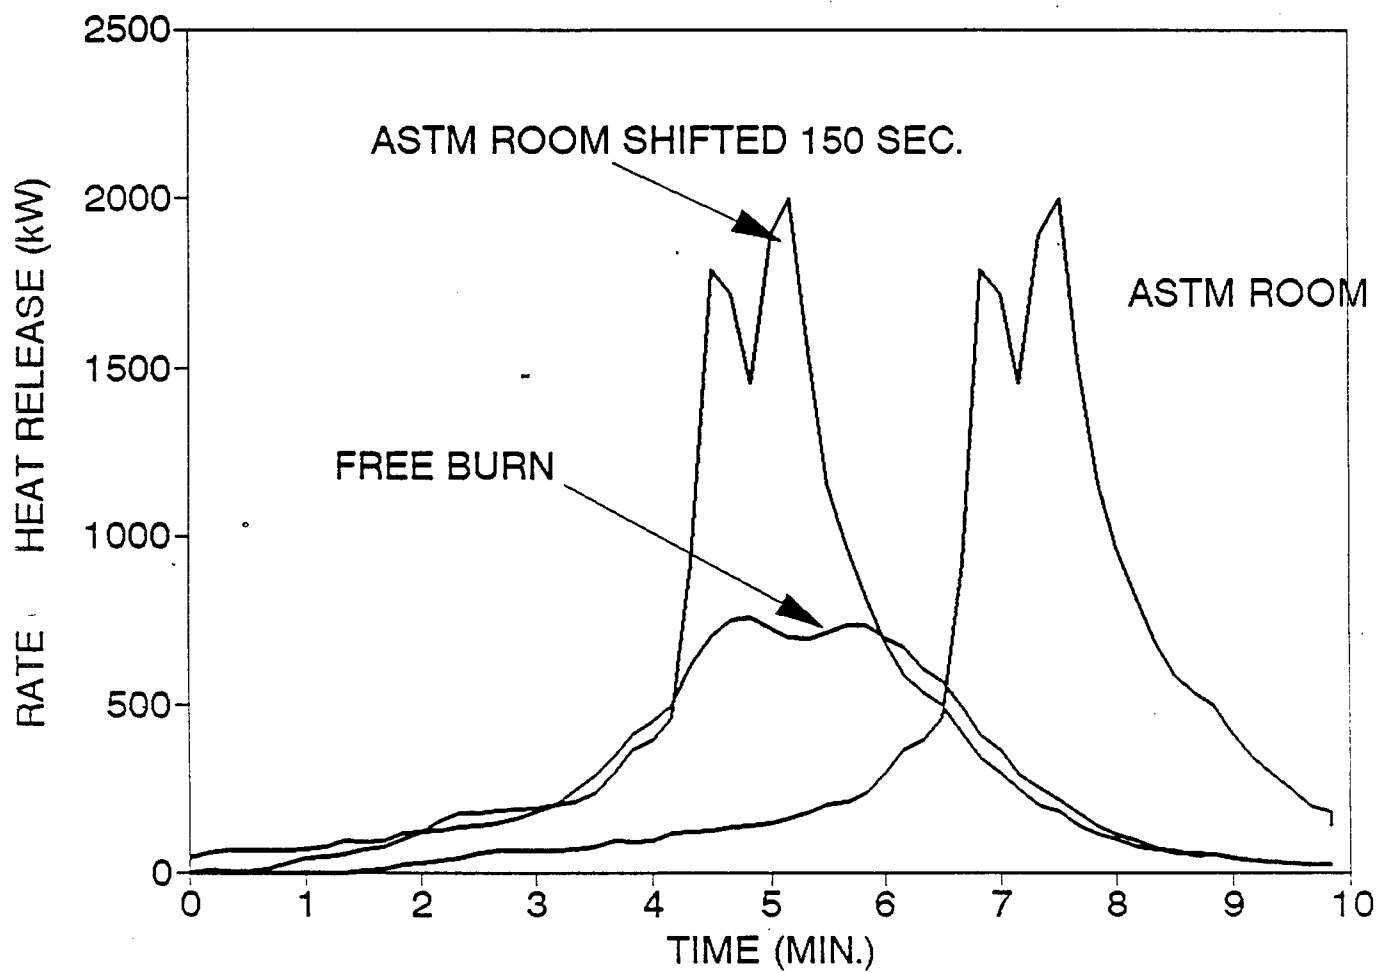
Figure A-3. Rate of Heat Release - Free Burn verses ASTM Room

of the complete assembly) and 5 (the same arrangement in the ASTM room). In addition, it shows the data from test 5, time shifted about 150 seconds to overlay test 3. In test 5, an obvious and complete flashover occurred. The increased rate of heat release shown in test 5 appears to almost exactly equal the additional energy produced by burning the paper facing off the gypsum board in that room.

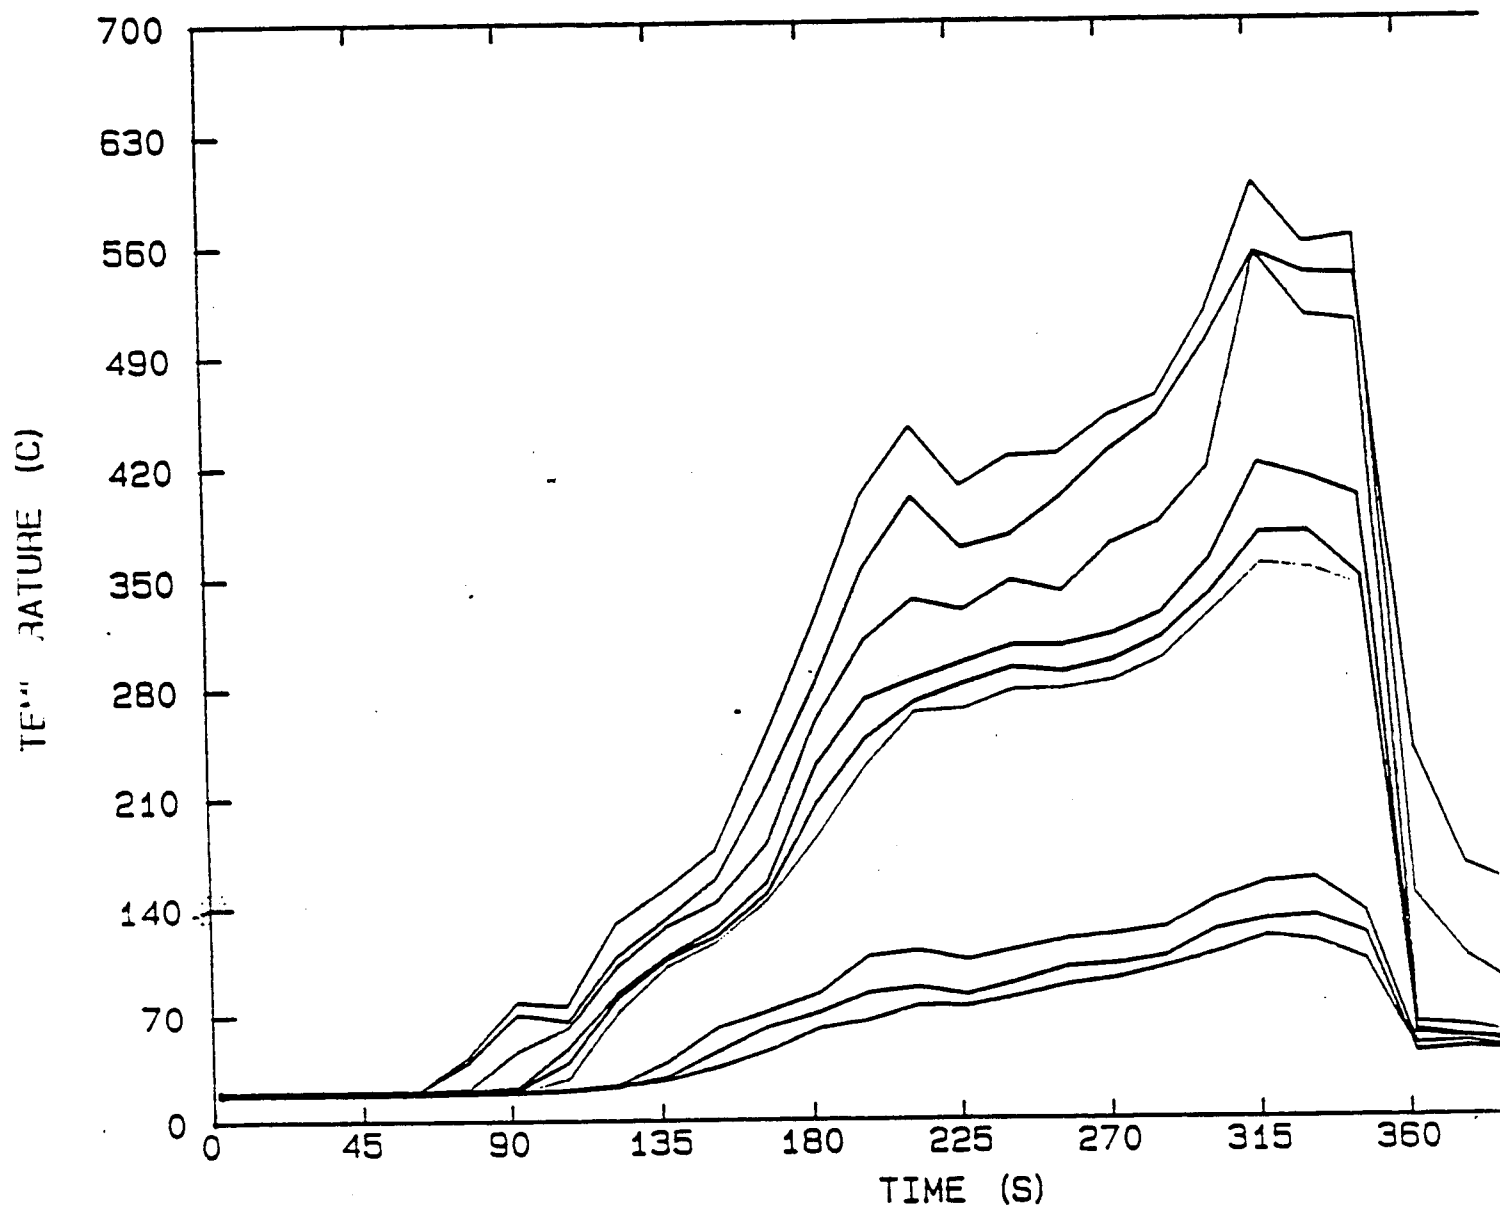
Figure A-4. Temperatures Observed in Patient Room Tests

Figure A-4 plots a thermocouple tree near the middle of the test room in test 6. While the peak temperatures near the ceiling reached conditions usually indicative of flashover, the average temperature in the upper smoke layer did not reach this level and the fire fell slightly short of triggering a flashover condition. The sudden decrease in temperature at 350 seconds was caused by the application of water from a sprinkler head. This was done to terminate the test.
