NIST NCSTAR 1-5

**Federal Building and Fire Safety Investigation of the
World Trade Center Disaster**

Reconstruction of the Fires in the World Trade Center Towers

September 2005

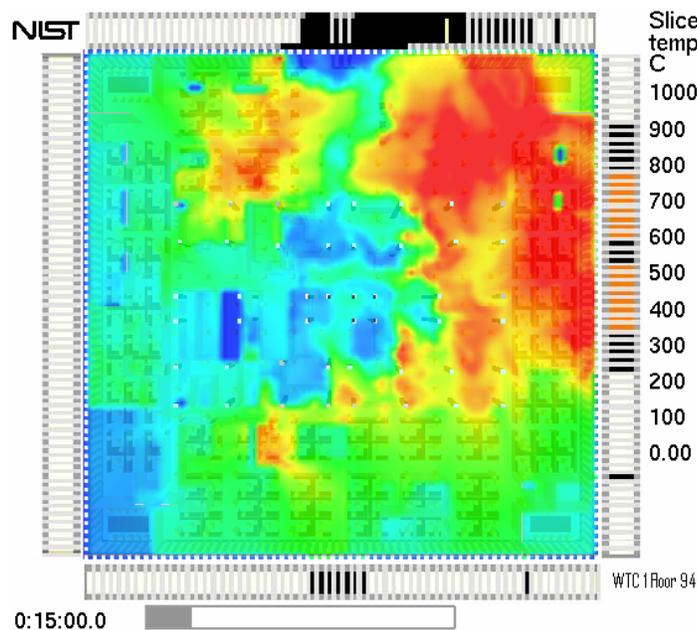
The results of the FDS simulations of the perimeter fires were compared with the fire duration and spread rate as seen in the photographs and videos. A sample of the basis for such a comparison is shown in Figure E–1. This depicts the room gas temperature 0.4 m below the ceiling slab (in the “upper layer” of the compartment). Surrounding this are “stripes,” each representing a window on that floor. Black stripes denote broken windows, orange stripes denote windows where flames have extended outward from the building, and yellow stripes denote fires that were seen inside the building. Fires deeper than a few meters inside the building could not be seen because of the smoke obscuration and the steep viewing angle of nearly all the photographs.

Figure E–1. Upper layer temperature of WTC 1, floor 94, 15 min after impact.

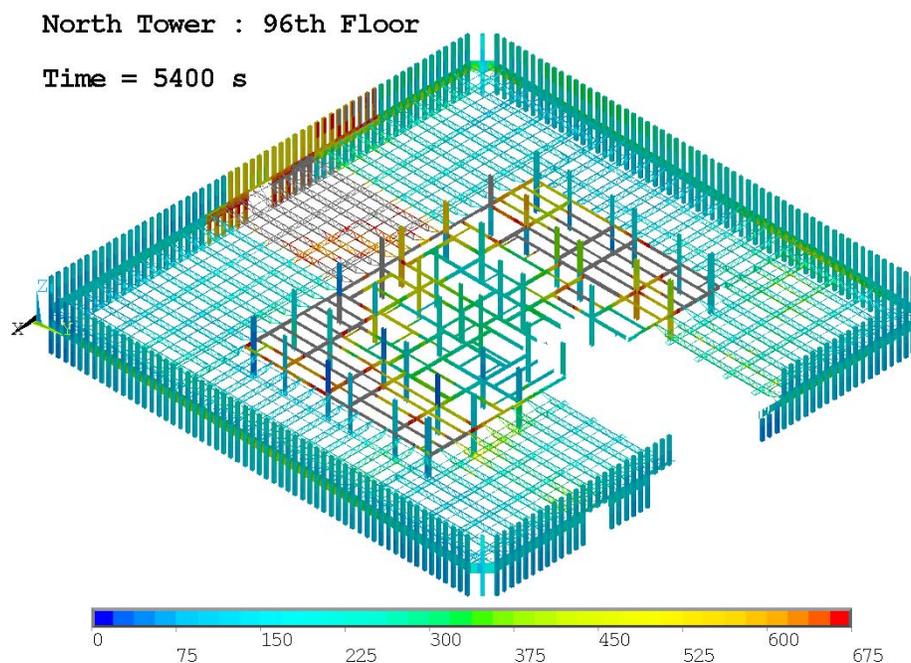
Figure E-4. Thermal response of floor 96 of WTC 1 at 5,400 s after impact, Case B.

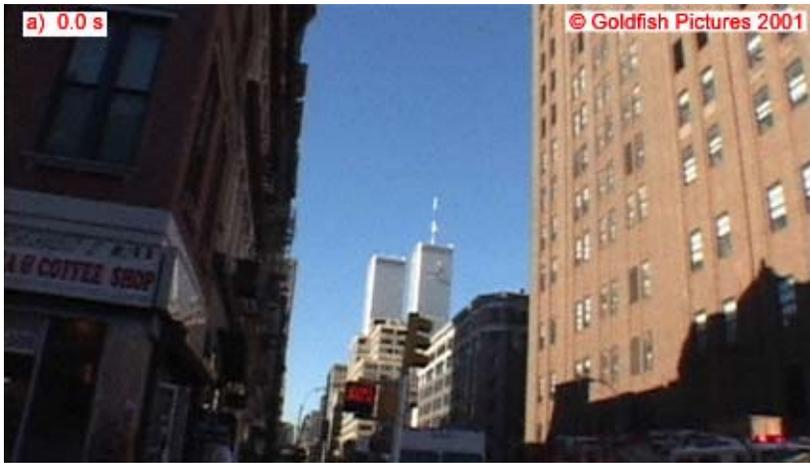
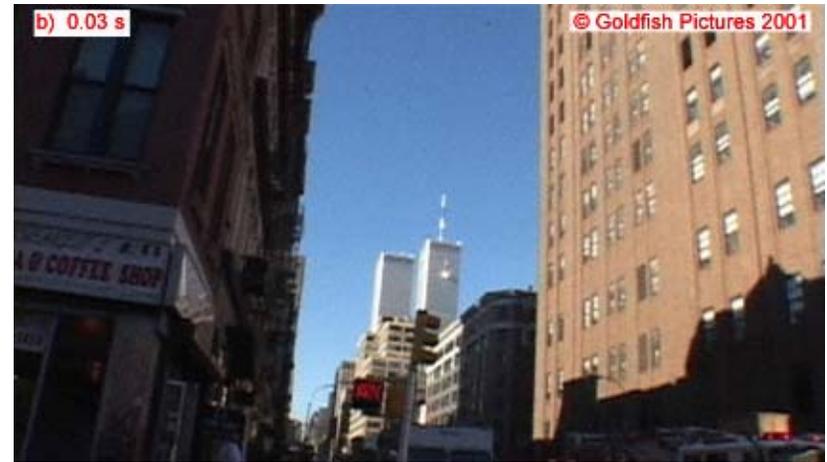
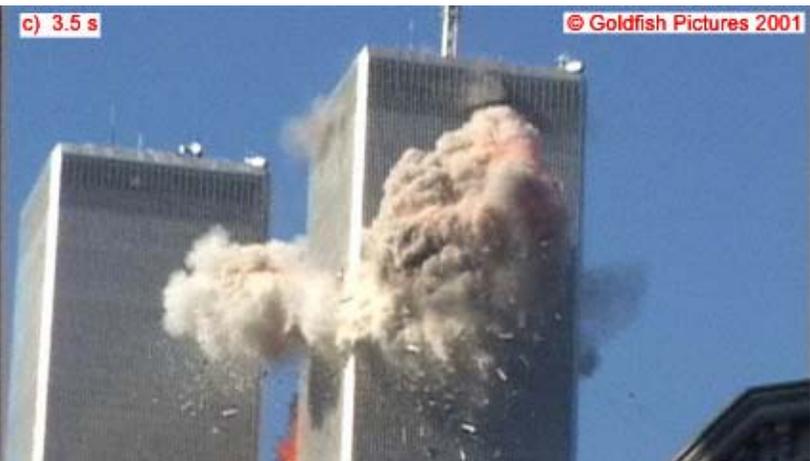
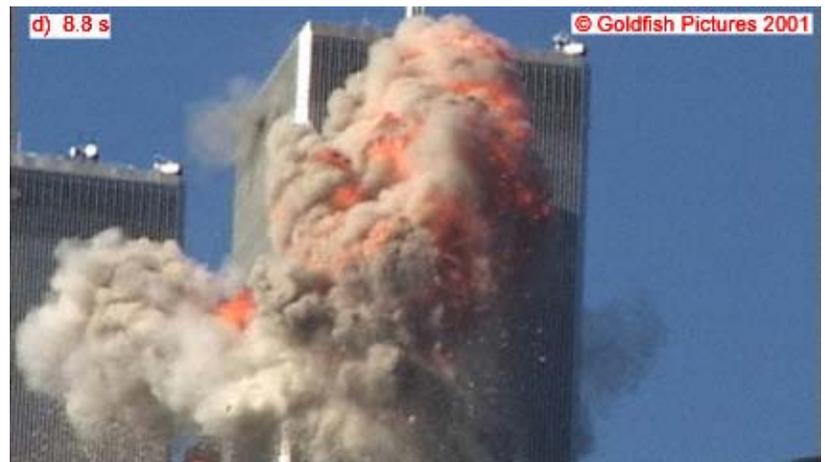
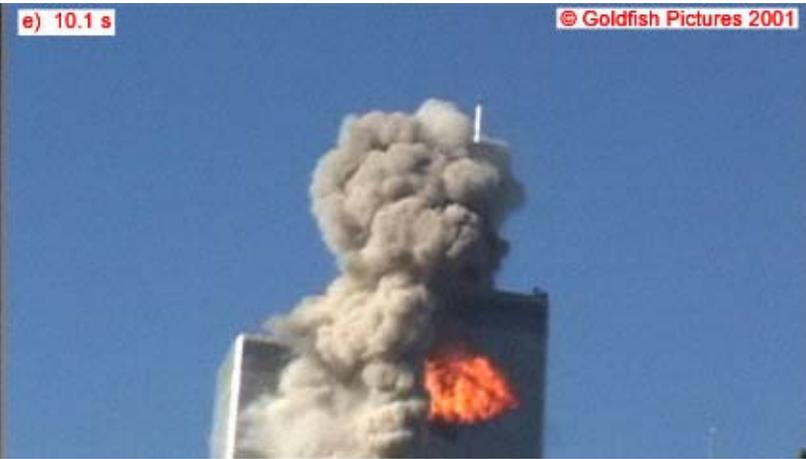
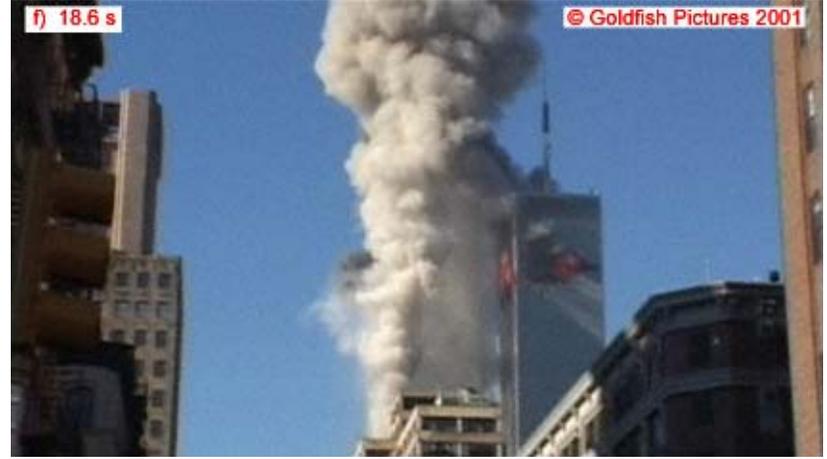
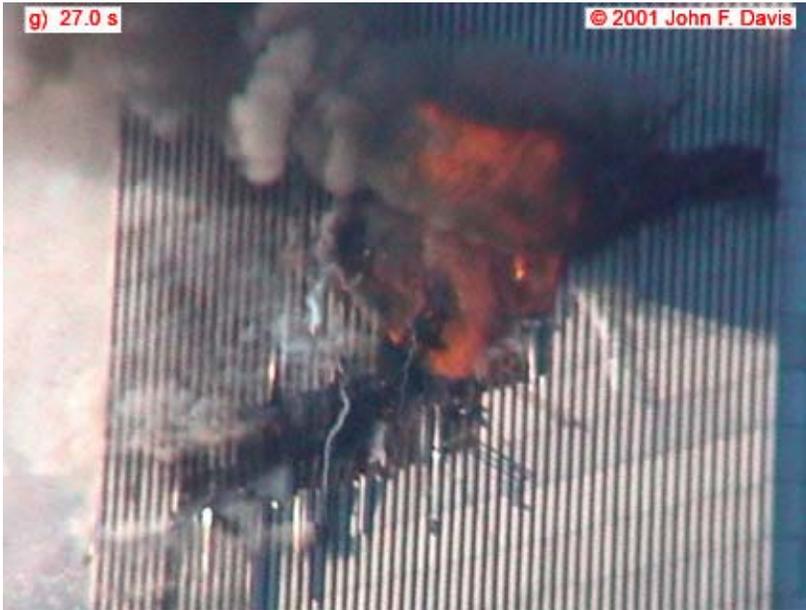
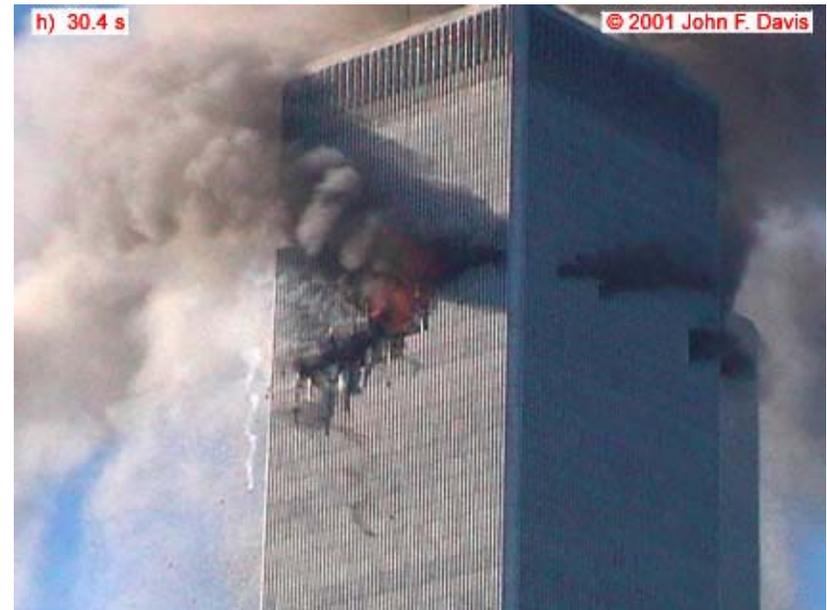
Figure 2-1. Series of frames from videos that show the aircraft striking WTC 1 and the immediate aftermath. The times relative to the plane strike are shown in the upper right-hand corner.

Figure 2-1. Series of frames from videos that show the aircraft striking WTC 1 and the immediate aftermath (cont.).

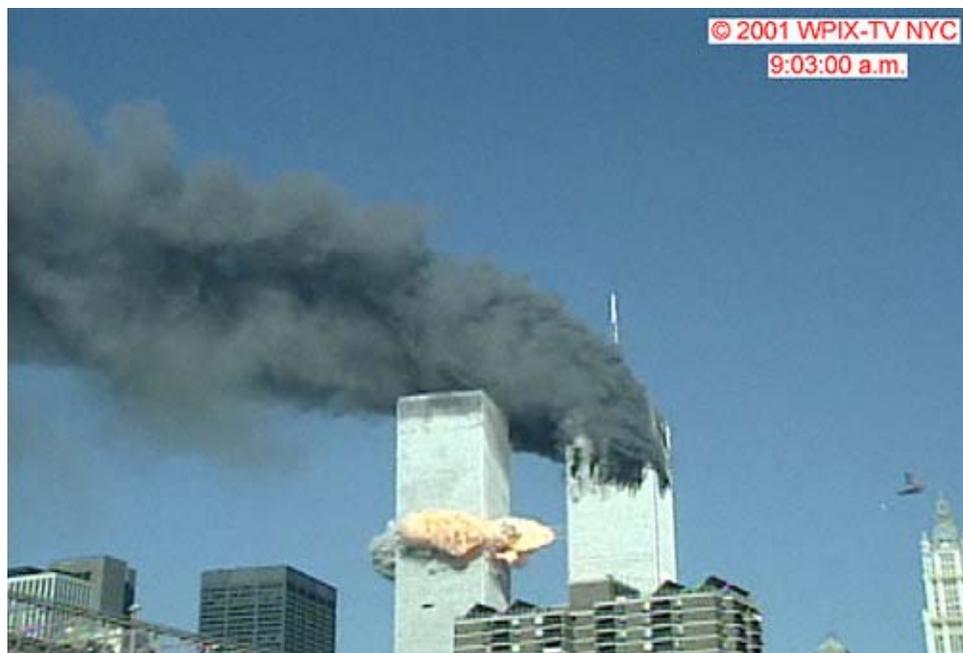
Figure 2–5. The nascent fireballs and dust clouds formed on WTC 2 1.2 s after the aircraft struck WTC 2.

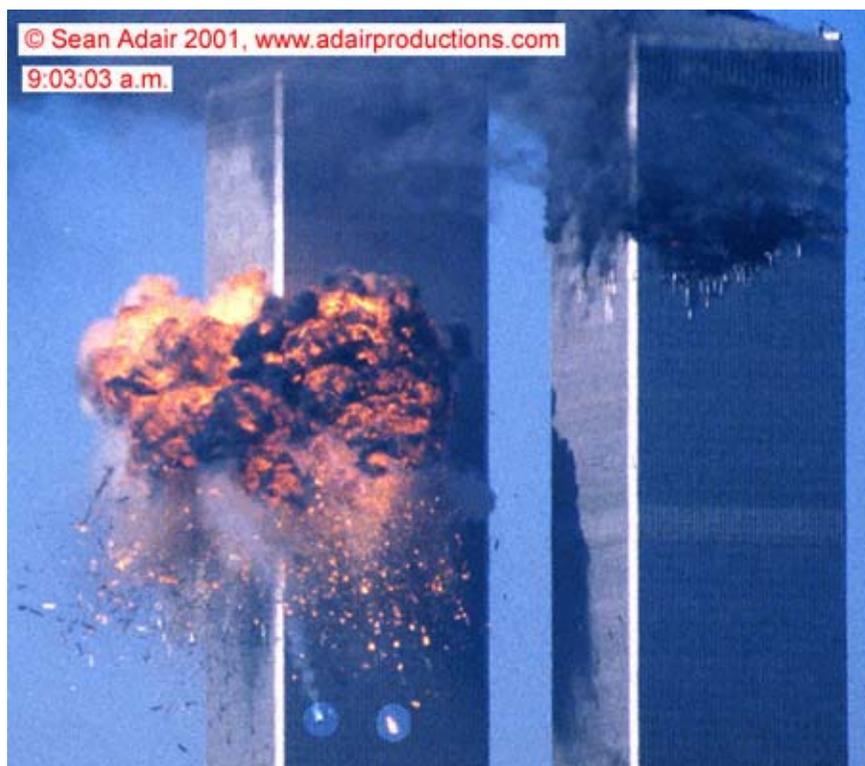
Figure 2–6. Photograph of the towers recorded from the north-northeast 4.3 s after the aircraft struck WTC 2.

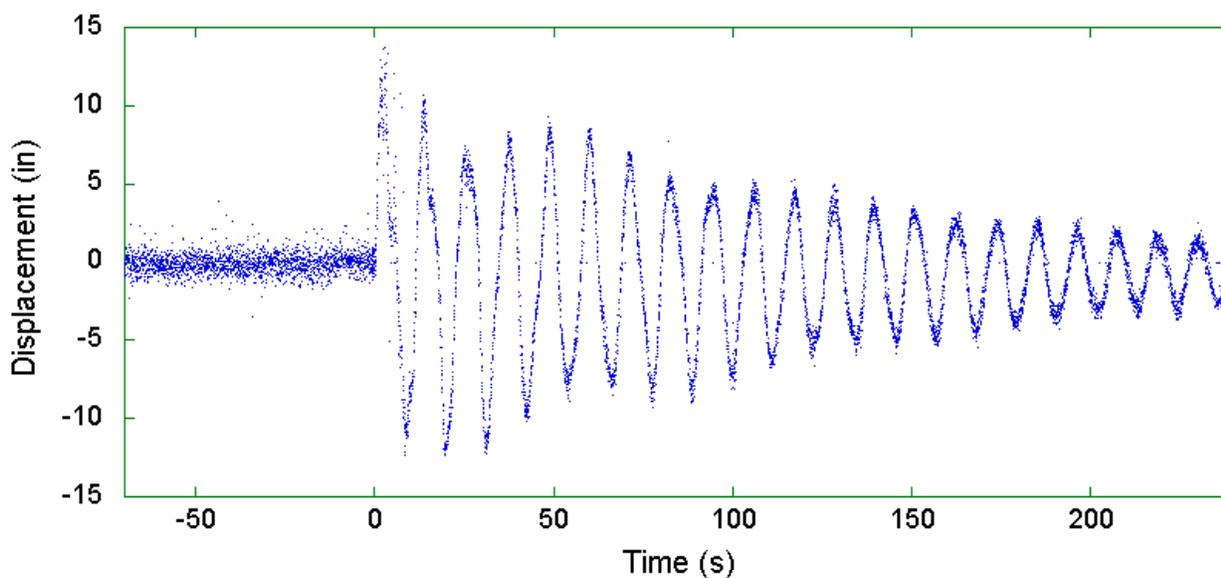
Close examination of the stable video revealed a perceptible movement of WTC 2 after it was struck by the aircraft. The building rocked back and forth, much like a pendulum, for many minutes. The stable nature of a video shot from the east allowed a detailed analysis of the north-south and torsional (twisting) motion of WTC 2 to be performed using image analysis of the Moiré patterns. Figure 2–9 shows the position of a location on the tower on the 70th floor as a function of time. A large increase in the motion of the tower followed the aircraft impact and slowly decreased after that. The peak amplitude of the movement in the north-south direction was determined to be 12 in. ± 1 in. at the 70th floor, which extrapolated to a value of 20 in. ± 3 in. at the roofline. Frequency analysis of the results revealed the fundamental north-south mode to have a period of 11.4 s, a torsional mode with a period of 5.3 s, and two higher frequency modes with periods of 3.9 s and 2.2 s. All periods were determined to an accuracy better than ± 0.1 s. The period of the fundamental mode was consistent with the expected range based on measurements of similar frequencies in WTC 1 (NIST NCSTAR 1-2). Similar measurements using a short video shot from the north yielded an amplitude of 12 in. ± 2 in. for the east-west motion, with a period of 5.3 s.

Figure 2-9. Displacement of the left-most window line on the 70th floor of WTC 2 as a function of time, determined using Moiré analysis.

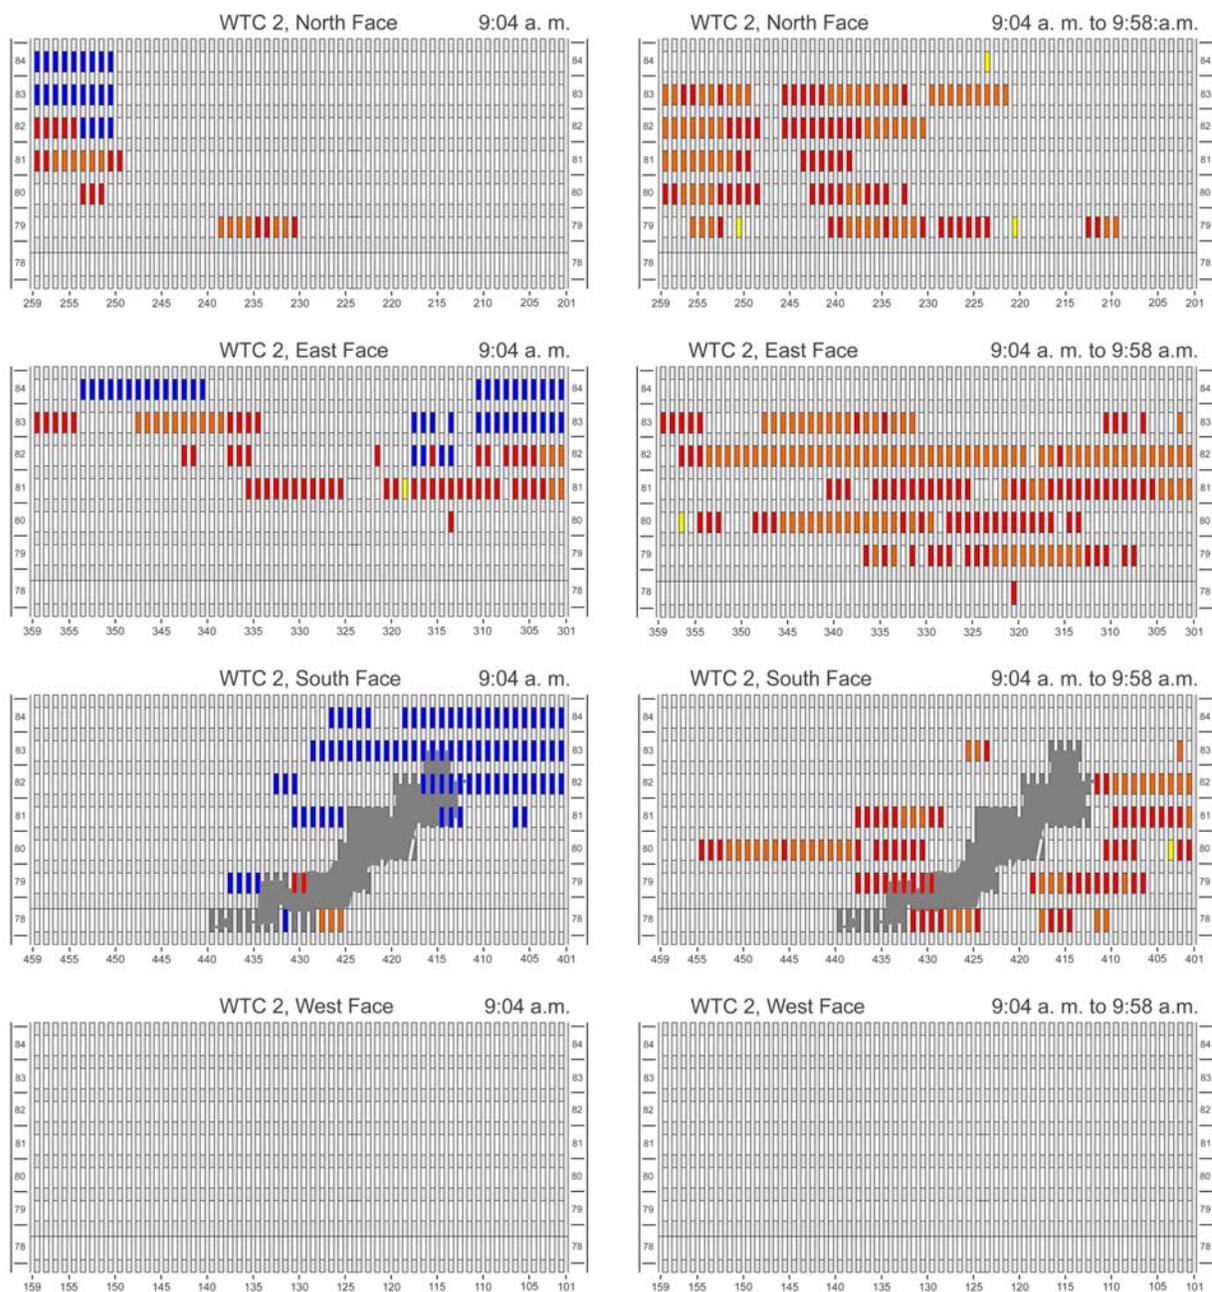
A curious aspect of the fire behavior in WTC 2 was the presence of the cold spot on the north face, which covered three floors over a length equal to one-sixth of the face width. The existence of the cold spot implies that little fuel was available in the immediate vicinity to support burning. A number of possible explanations were considered for the absence of fuel. One is that the area was vacant and that there was limited fuel present prior to the aircraft impact. NIST is unaware of any information that supports such a conclusion. A second possibility is that the fireballs that exited through the area were so intense that they pushed most available fuel in the area to the sides or out through the opened windows. A third possibility is that the floor slabs, particularly on the 81st and 82nd floors, in the immediate area collapsed during the aircraft impact and fireballs, in effect, creating a cavity behind the cold spot. The available visual evidence both supports and argues against all three possibilities. NIST has concluded that insufficient information is available to allow a likely formation mechanism for the cold spot to be postulated.

Figure 2–12. Maps of observed fire distributions on the four faces of WTC 2 shortly after the aircraft impact (near 9:04 a.m.) and corresponding integrated fire observations for the entire period between 9:03 a.m. and 9:59 a.m.

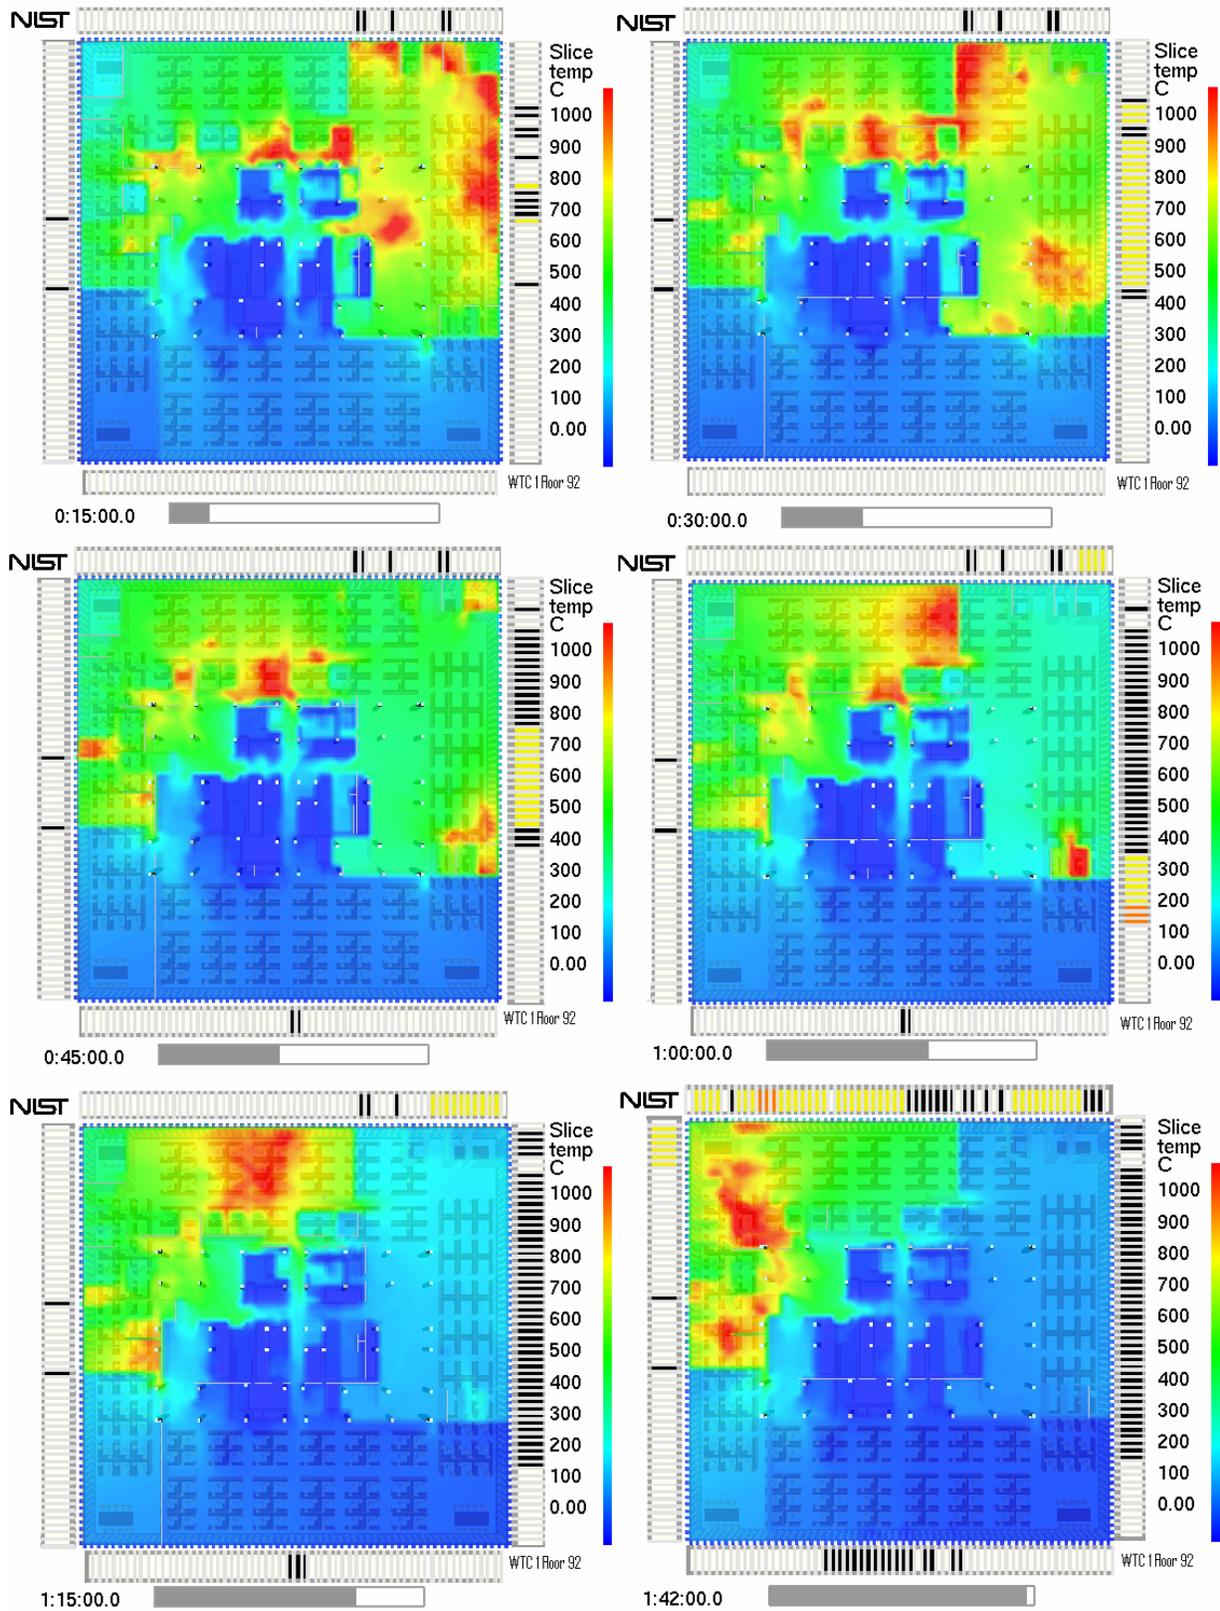
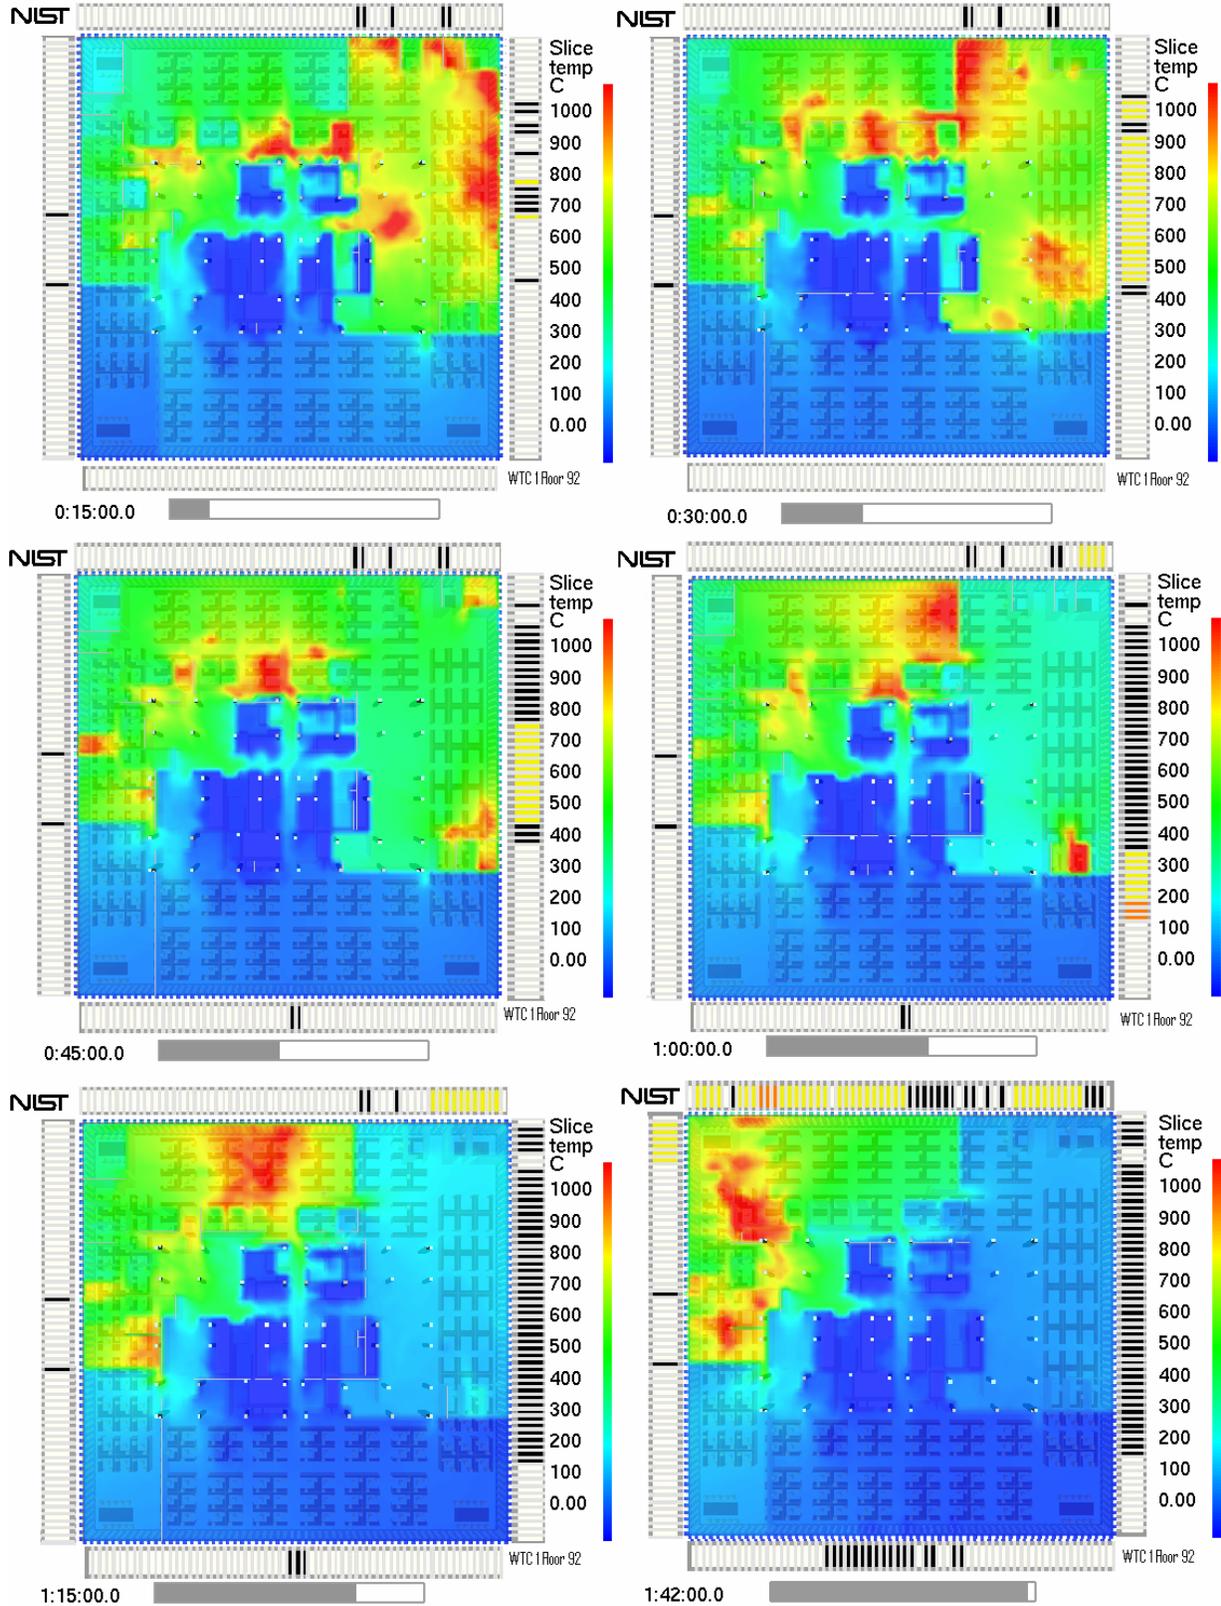
In the simulation, there was no damage on this floor other than window breakage. The ignition of jet fuel in the northeast corner and air from broken windows led to sustained burning of the contents in that corner. The combustibles were consumed about 45 min after the aircraft impact, and the fires moved south along the east face (where they were stopped by a partition) and west along the north side of the interior core. There was a wall that blocked the fires from spreading directly to the north face.

Eventually, the simulated fires arrived at the north face about 15 min sooner than was observed in the photographs and videos. The fires never reached the south section of the floor because of various walls that obstructed their spread.

The general pattern of the simulated fires was consistent with the photographic evidence. However, the burning rates were faster than observed: the simulated fire in the northeast corner burned out faster than actually observed, and the simulated fire on the west grew faster. The actual fire on the east face moved slightly further to the south than in the simulation, suggesting that the wall location was incorrect or that the wall had been penetrated. If the latter, it was not clear what caused the fire to stop where it did.

Figure 6–1. Simulated upper layer temperatures on floor 92 of WTC 1, Case A.

Figure 6–2. Simulated upper layer temperatures on floor 92 of WTC 1, Case B.

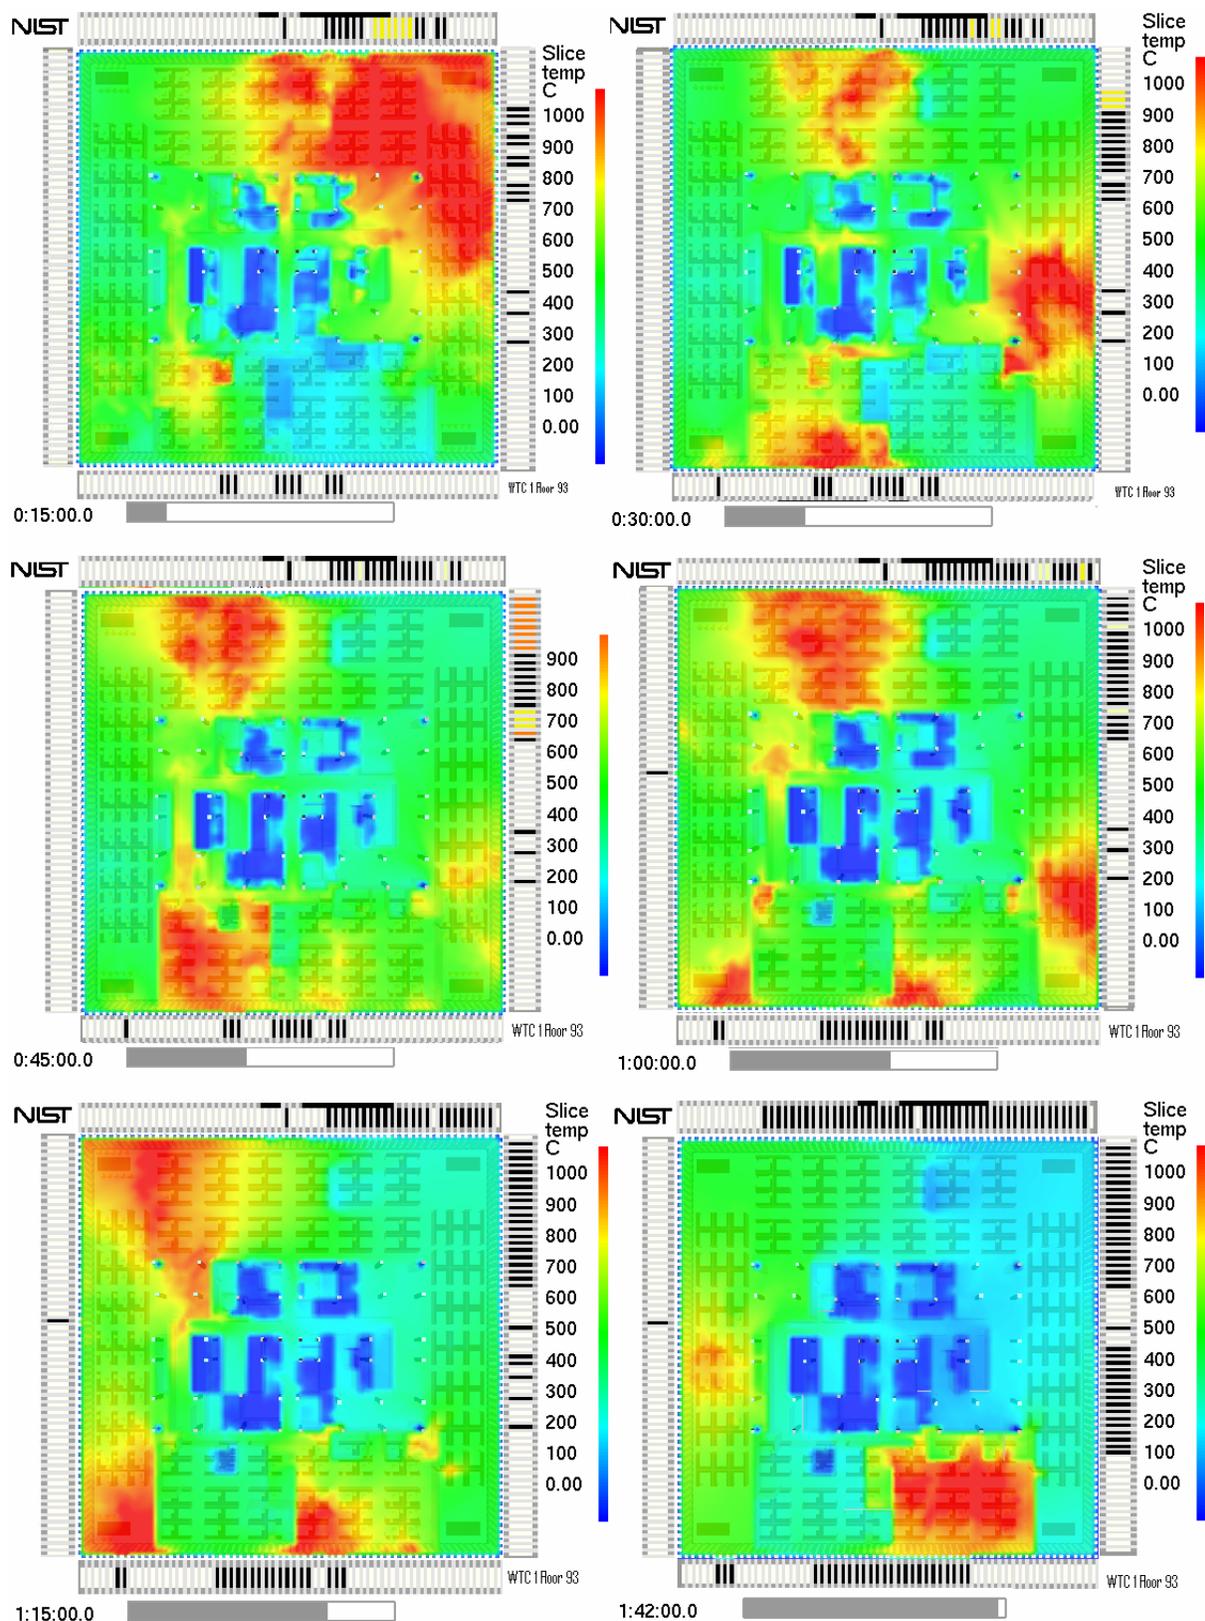
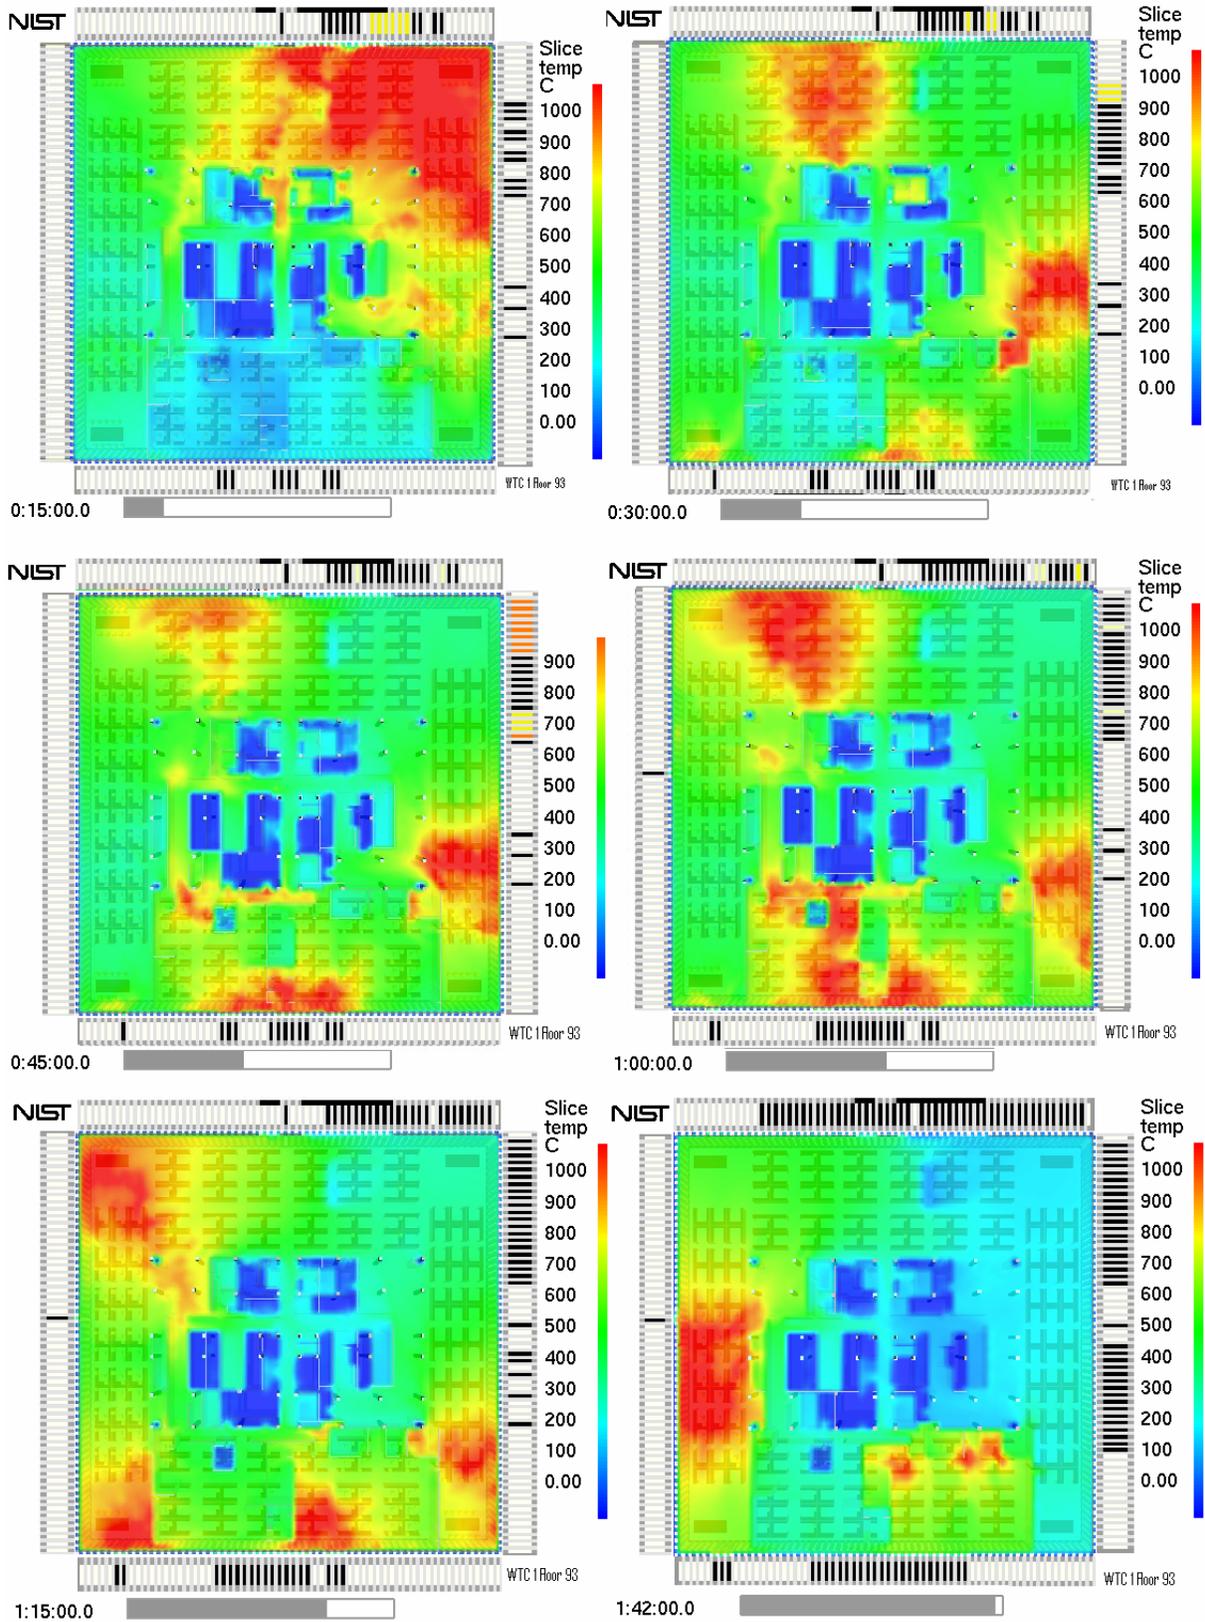
As on the 92nd floor, the simulated fires began in the northeast corner, just under where the left wing of the aircraft dripped jet fuel through the damaged floor slab from the 94th floor. Consuming the combustibles in the northeast in about 30 min, the fires moved west along the north face and south along the east face.

burning rate. The breaking of about 20 windows on the west side of the north face in the last 10 min indicated that there were interior fires or an overall build-up in the temperature of the gases. The observed window breakage along the south face in the last 10 min indicated the presence of a fire, but unlike the simulation, the fires had to have been away from the perimeter since they were not observed through the windows.

Figure 6–3. Simulated upper layer temperatures on floor 93 of WTC 1, Case A.

Figure 6-4. Simulated upper layer temperatures on floor 93 of WTC 1, Case B.

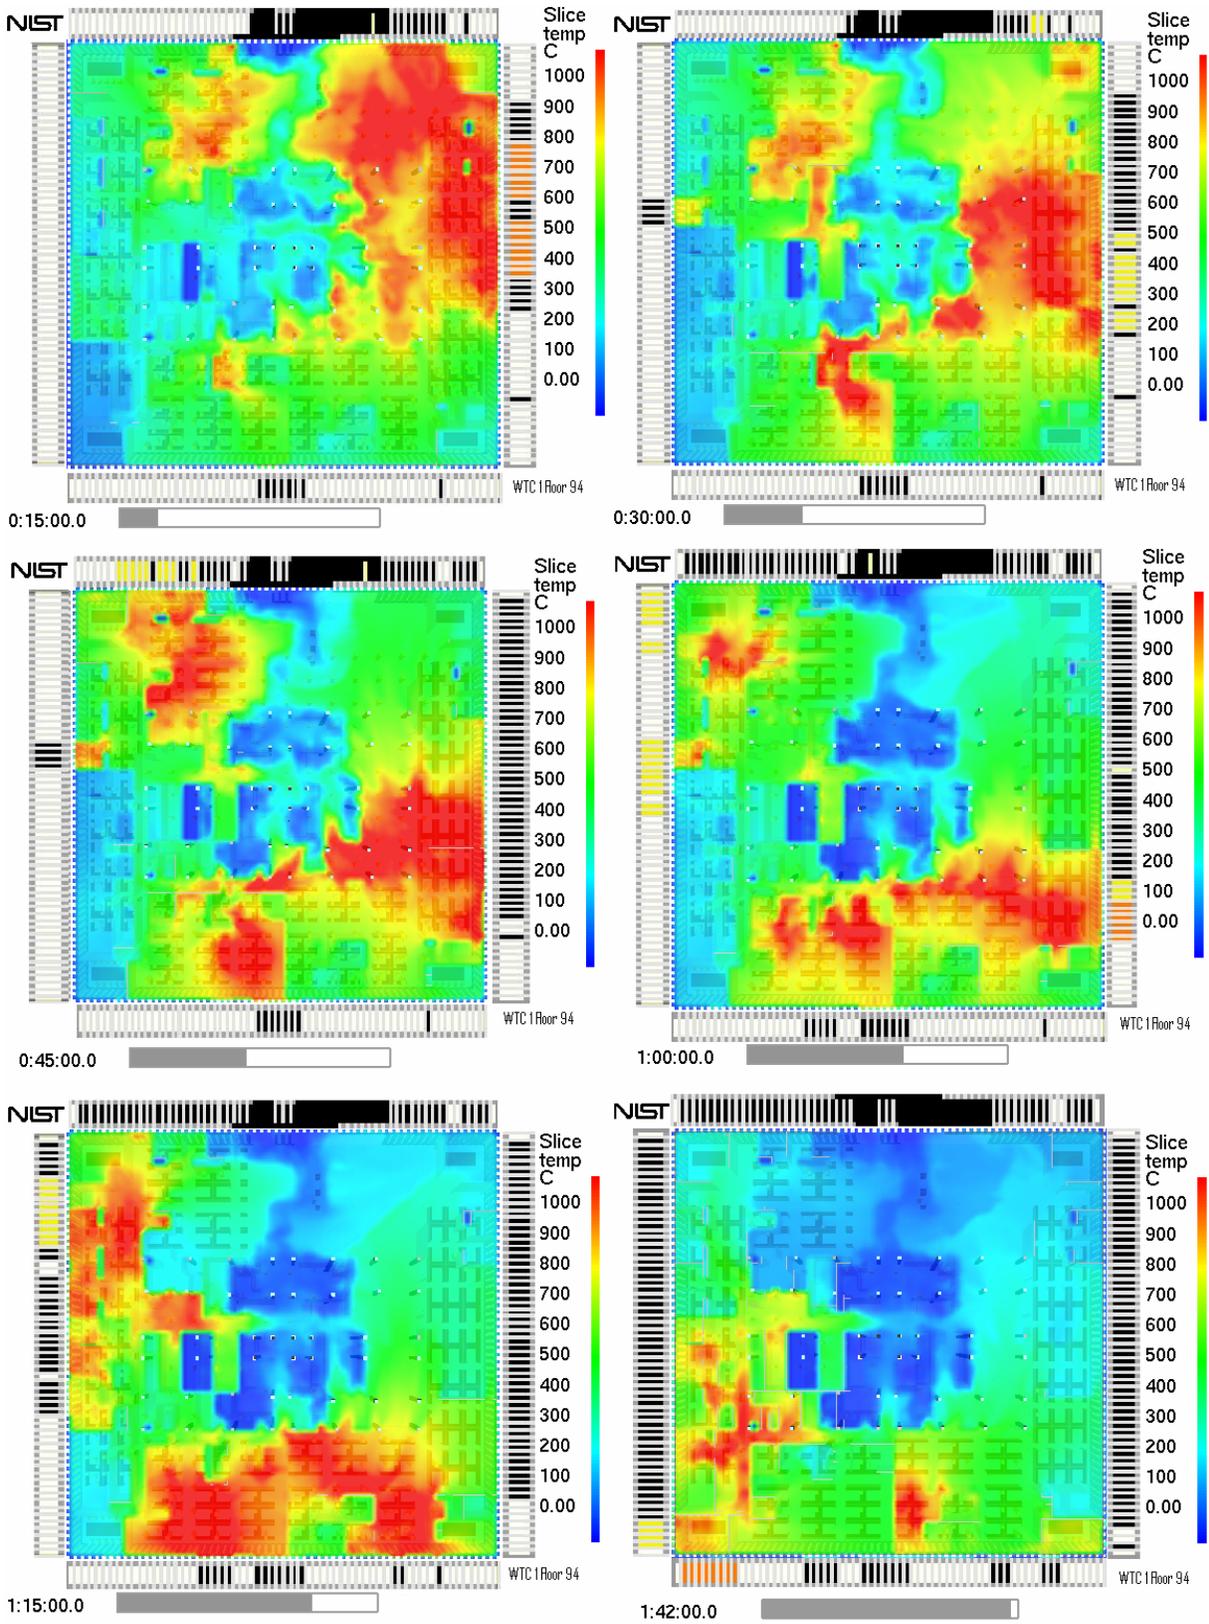
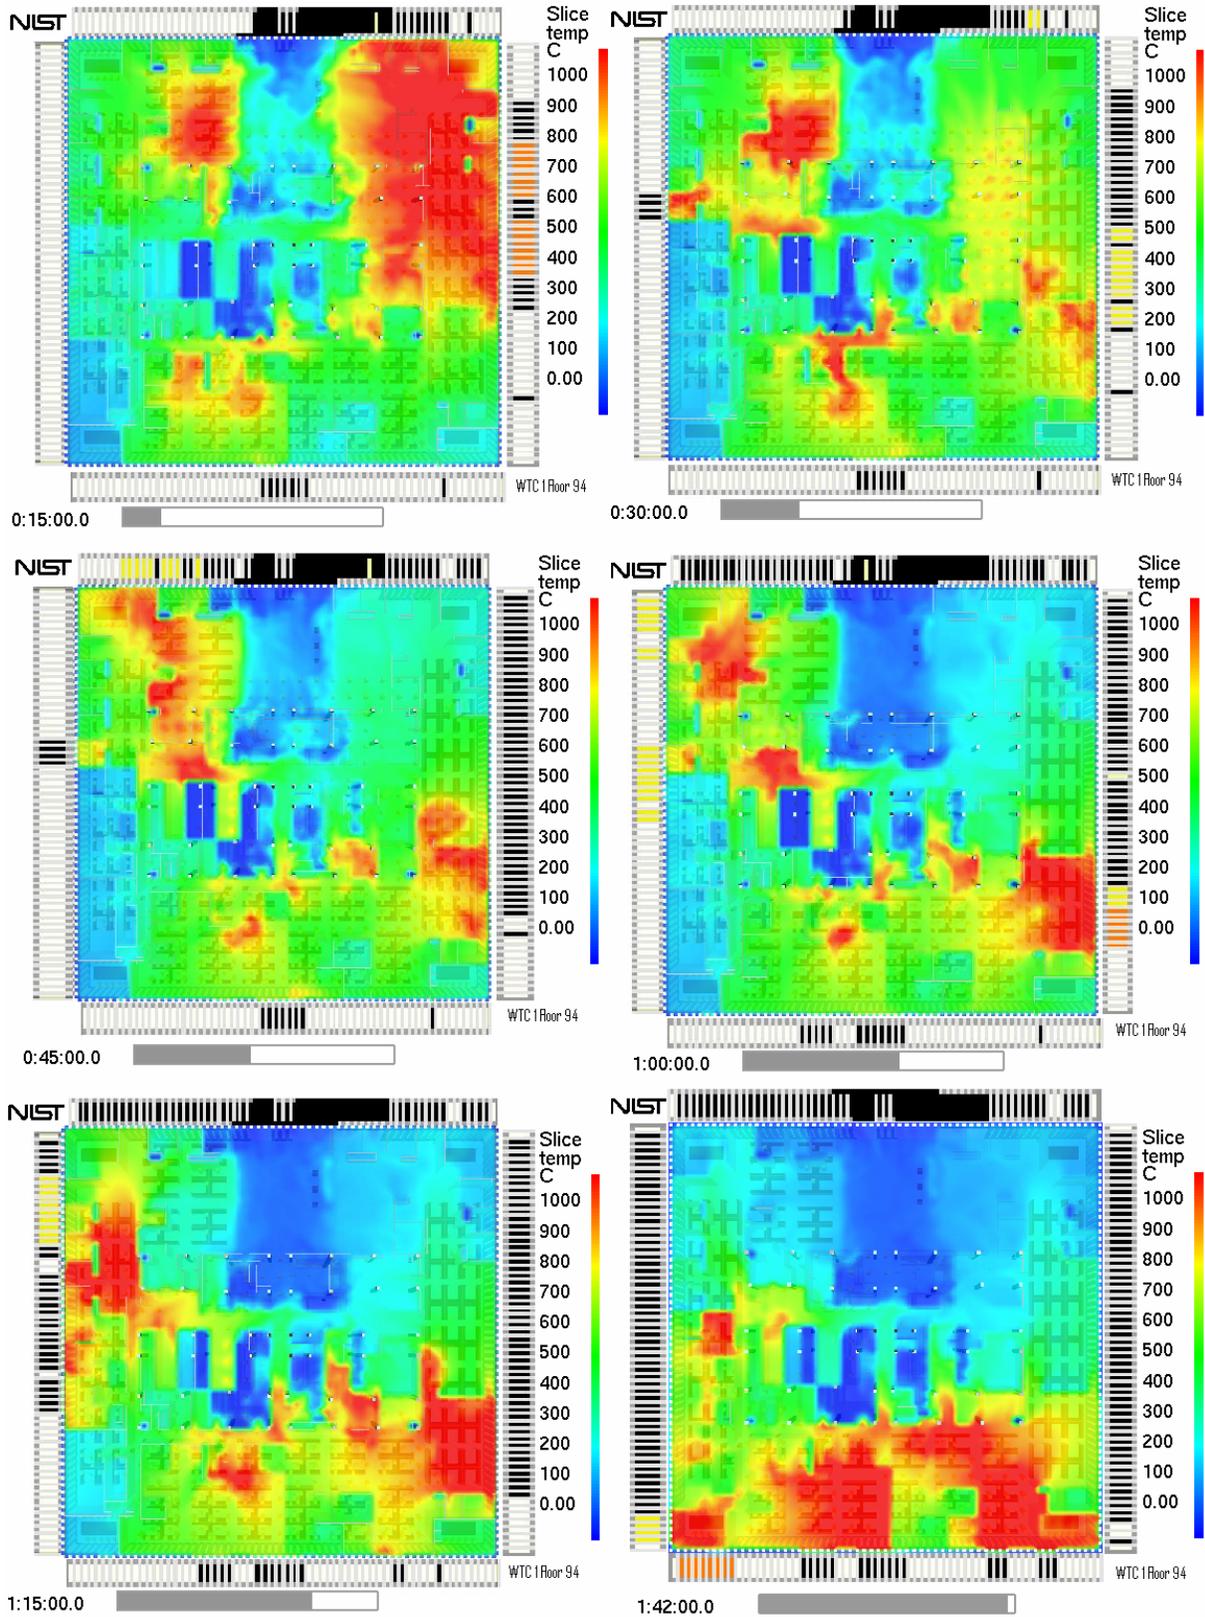
Floor 94 was directly impacted by the left wing of the aircraft, and a substantial amount of jet fuel was spread throughout the east side of the floor. Initially, severe fires were observed on the east face, and then steadily spread around the floor, with the heaviest activity in the end being in the southwest quadrant.

The simulation captured the movement of the fires reasonably well. The simulated fires burned vigorously in the northeast quadrant for the first 30 min. Then for the next hour, the fires moved at roughly the same rate as the real fires clockwise toward the southeast and counterclockwise toward the southeast. In some areas, the simulation shows the burning to be too close to the windows. The late fire on the south face was not seen in the photographs and videos.

Figure 6–5. Simulated upper layer temperatures on floor 94 of WTC 1, Case A.

Figure 6-6. Simulated upper layer temperatures on floor 94 of WTC 1, Case B.
