NIST NCSTAR 1-5

**Federal Building and Fire Safety Investigation of the
World Trade Center Disaster**

Reconstruction of the Fires in the World Trade Center Towers

September 2005

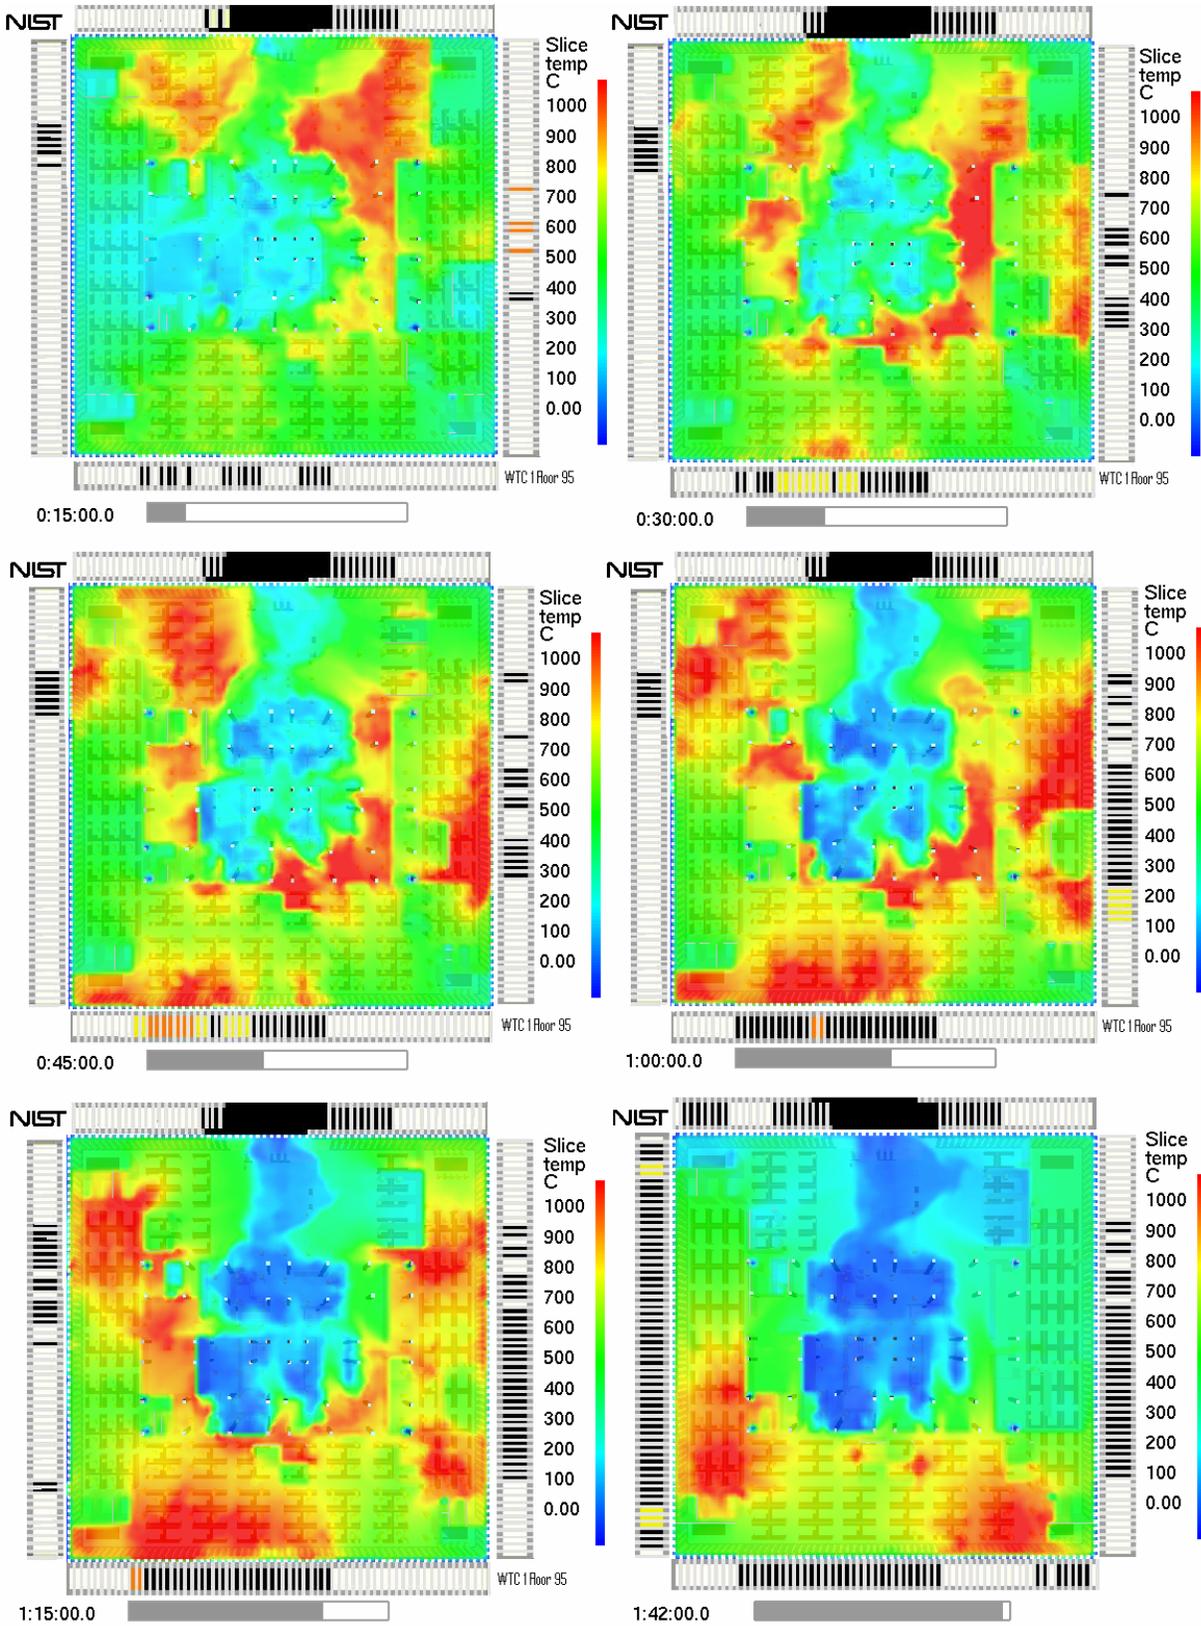
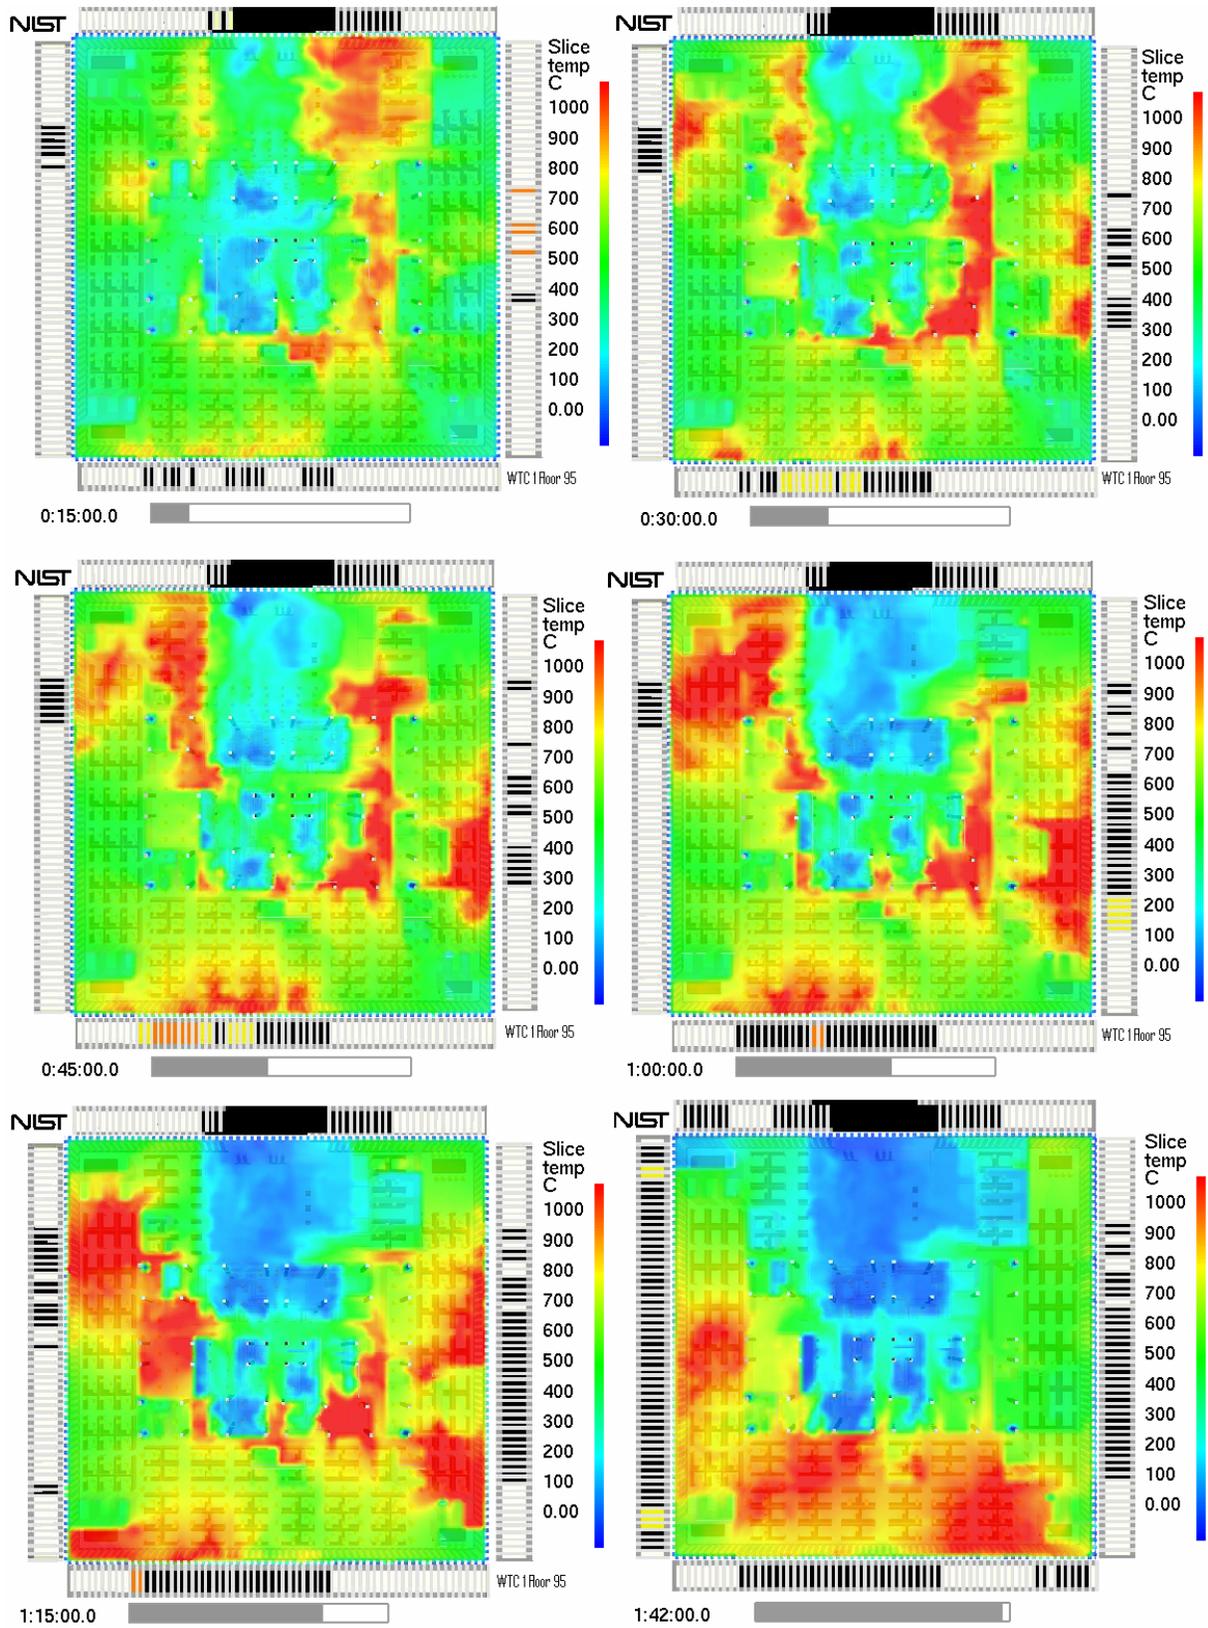
The simulated fires started around the center of the north face where the fuselage of the aircraft hit. The fires then followed the pattern of window breakage. There was substantial fire activity predicted in the building core due to the extensive wall damage (NIST NCSTAR 1-2). The simulations suggested that air rising through the core mixed with the oxygen-starved fuel gases that were accumulating on this floor because of the relatively light exterior damage away from the impact zone. However, there was no evidence to confirm or deny the existence of vigorous fire activity within the core.

Taking into account the tendency to simulate burning too close to the windows, the overall pattern of the fires is reasonably consistent with the observations. The fire on the north side of the building was growing just before additional windows break there. The same is true for the fire on the middle of the east side. The early fire simulated on the south side is consistent, but burns too long or too close to the broken windows.

Figure 6–7. Simulated upper layer temperatures on floor 95 of WTC 1, Case A.

Figure 6–8. Simulated upper layer temperatures on floor 95 of WTC 1, Case B.

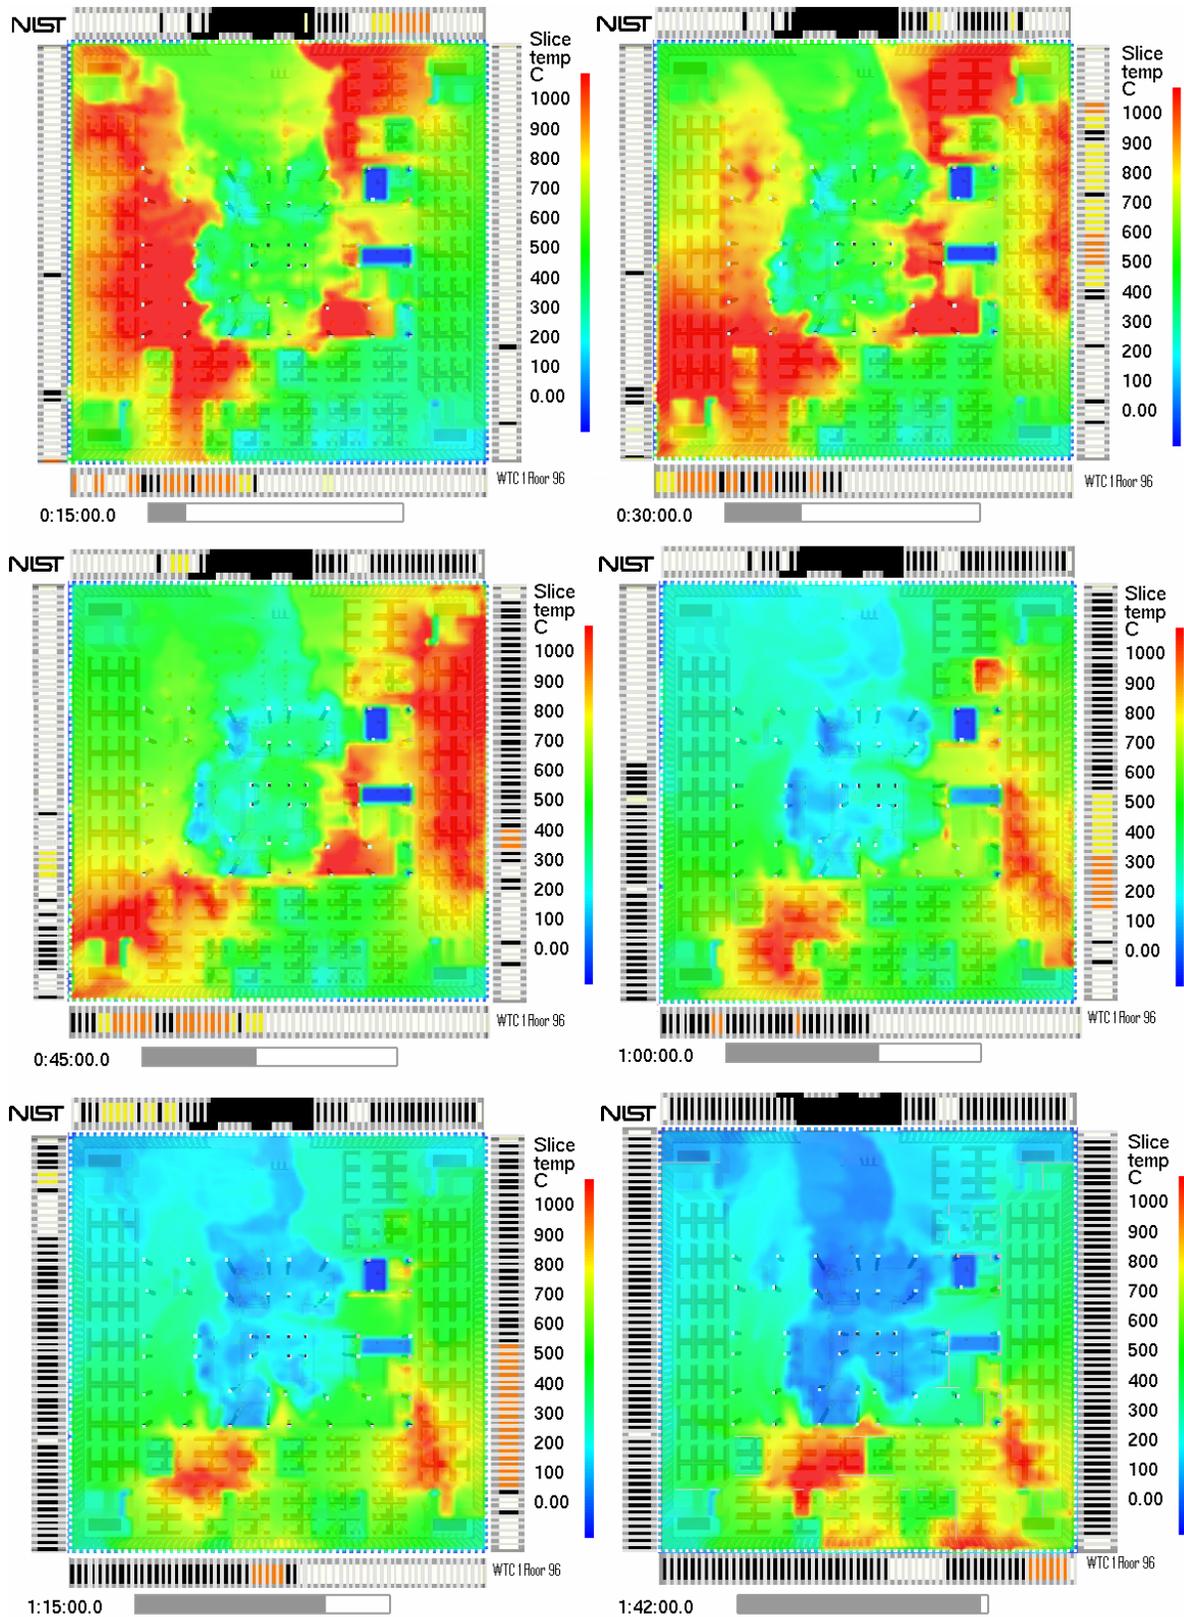
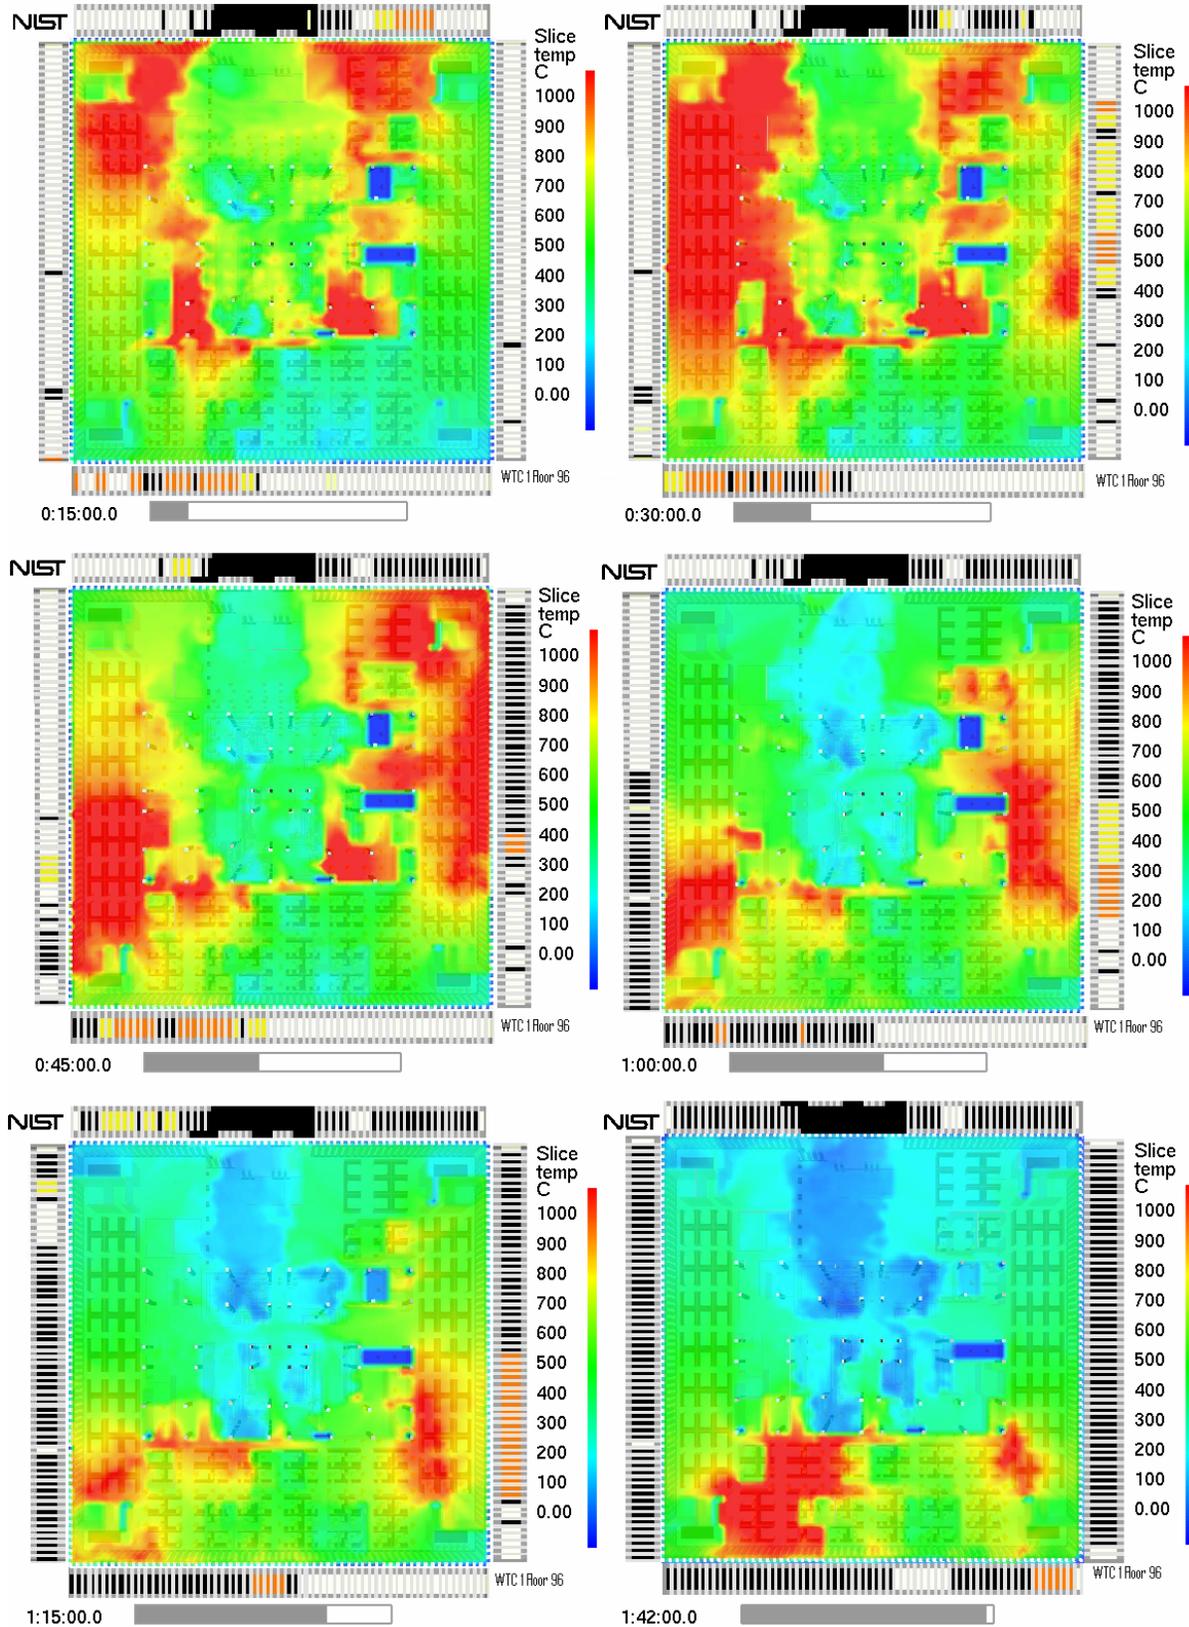
Floor 96 was directly impacted by the aircraft fuselage and inner wings. There was extensive damage to the core and internal walls. One simulated fire started to the east of the impact hole, spread southward along the east side of the building, and turned the corner to the south face. This behavior mimics closely the behavior of the actual fire. By contrast, the simulation overestimated the extent of the fire on the west face. The visual observations suggested that this fire originated in the south, not the impact area. The simulation is a fair rendition of the observations on the south side of the tower beginning about 15 min to 30 min after the aircraft impact. The model captured the delayed movement of the fires along the south face due to the presence of office walls.

Figure 6–9. Simulated upper layer temperatures on floor 96 of WTC 1, Case A.

Figure 6–10. Simulated upper layer temperatures on floor 96 of WTC 1, Case B.

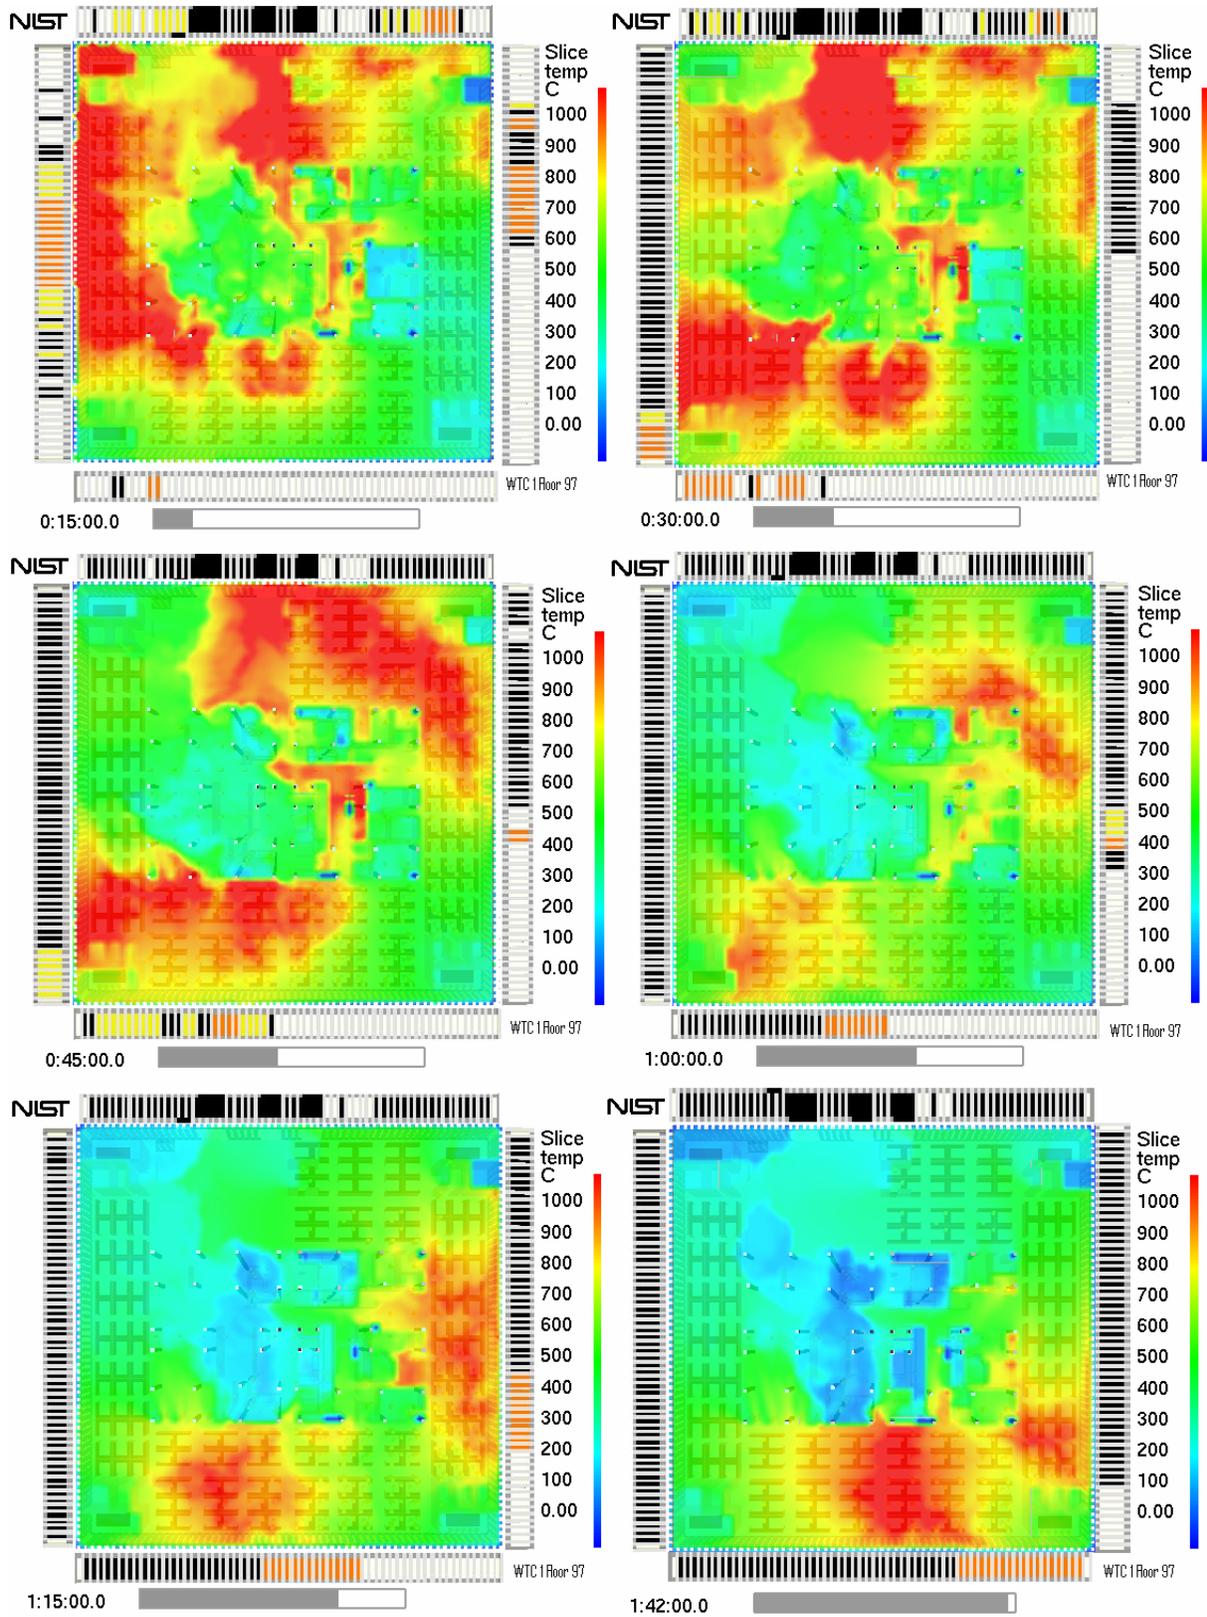
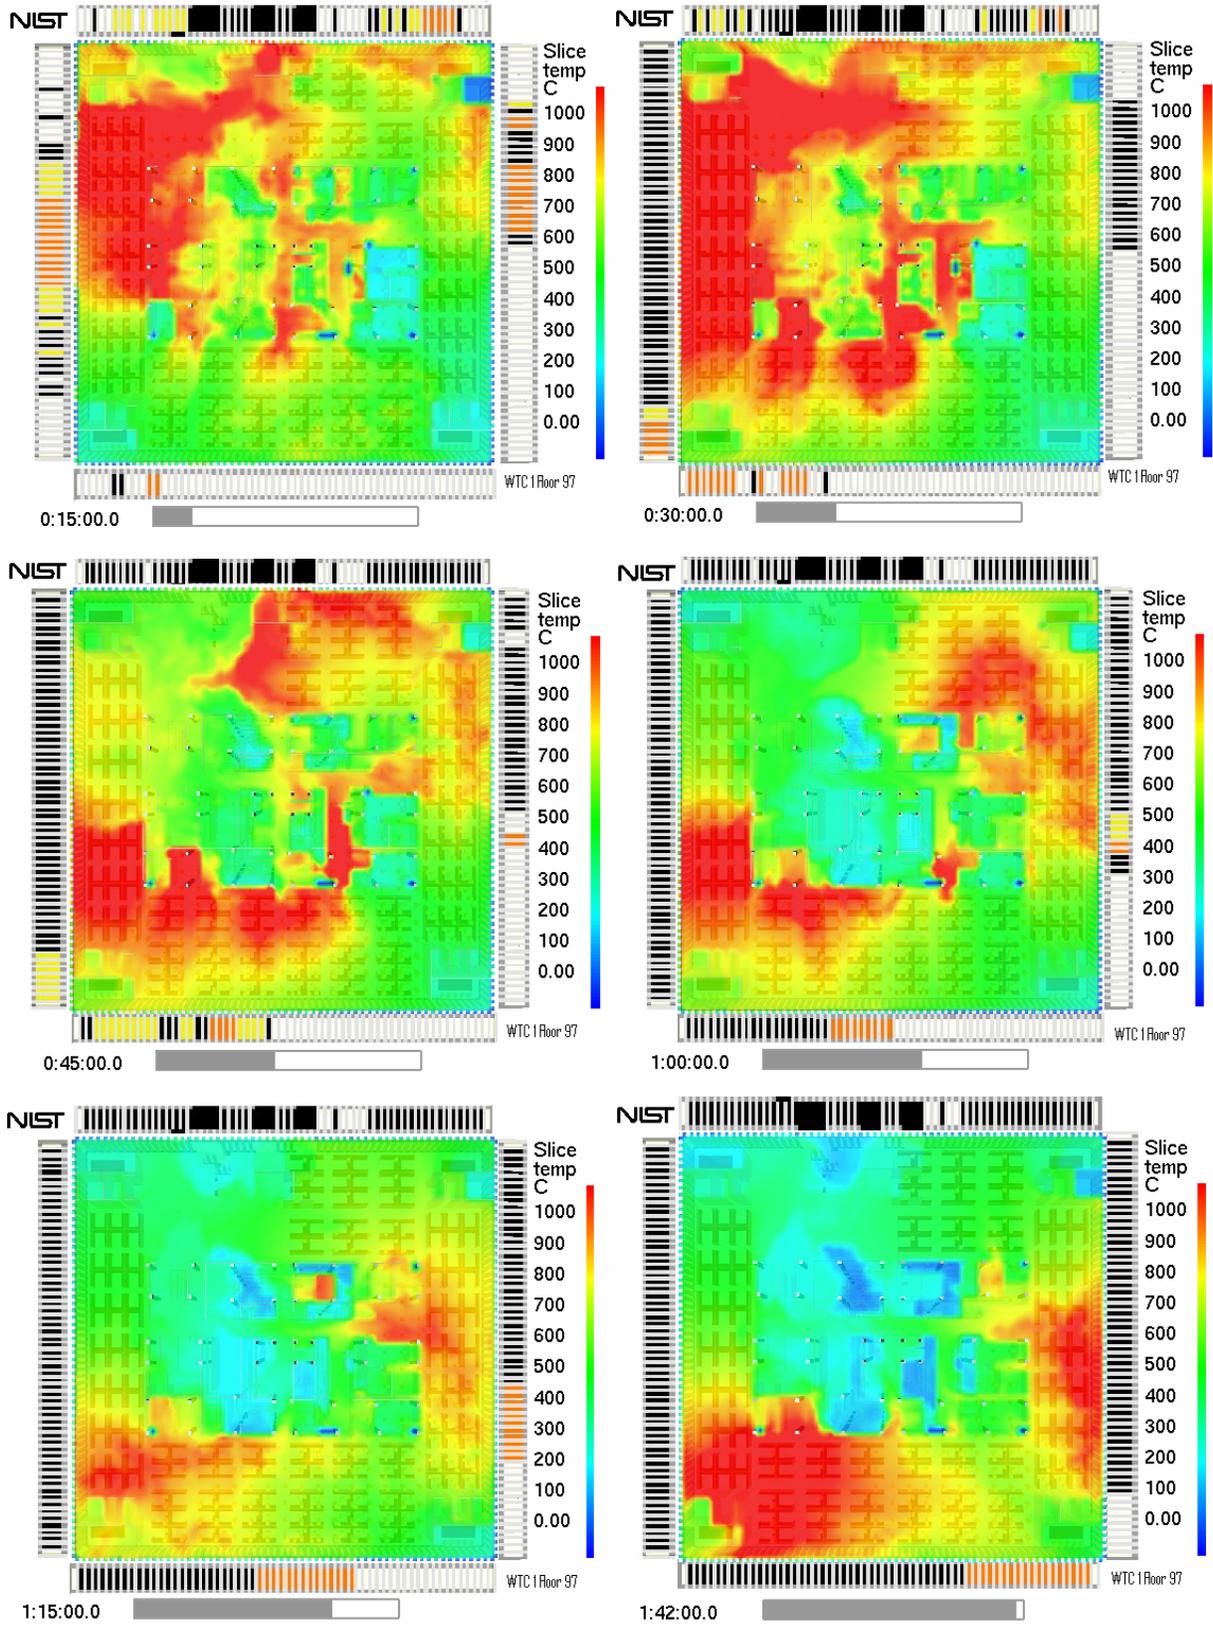
The fuel-laden section of the right wing of the aircraft impacted this floor, igniting extensive fires. The southward movement of the fire on the west side is well replicated. The fire on the east, while burning too close to the perimeter, arrived at the southeast corner at roughly the same time as the observed fire.

Figure 6–11. Simulated upper layer temperatures on floor 97 of WTC 1, Case A.

Figure 6–12. Simulated upper layer temperatures on floor 97 of WTC 1, Case B.

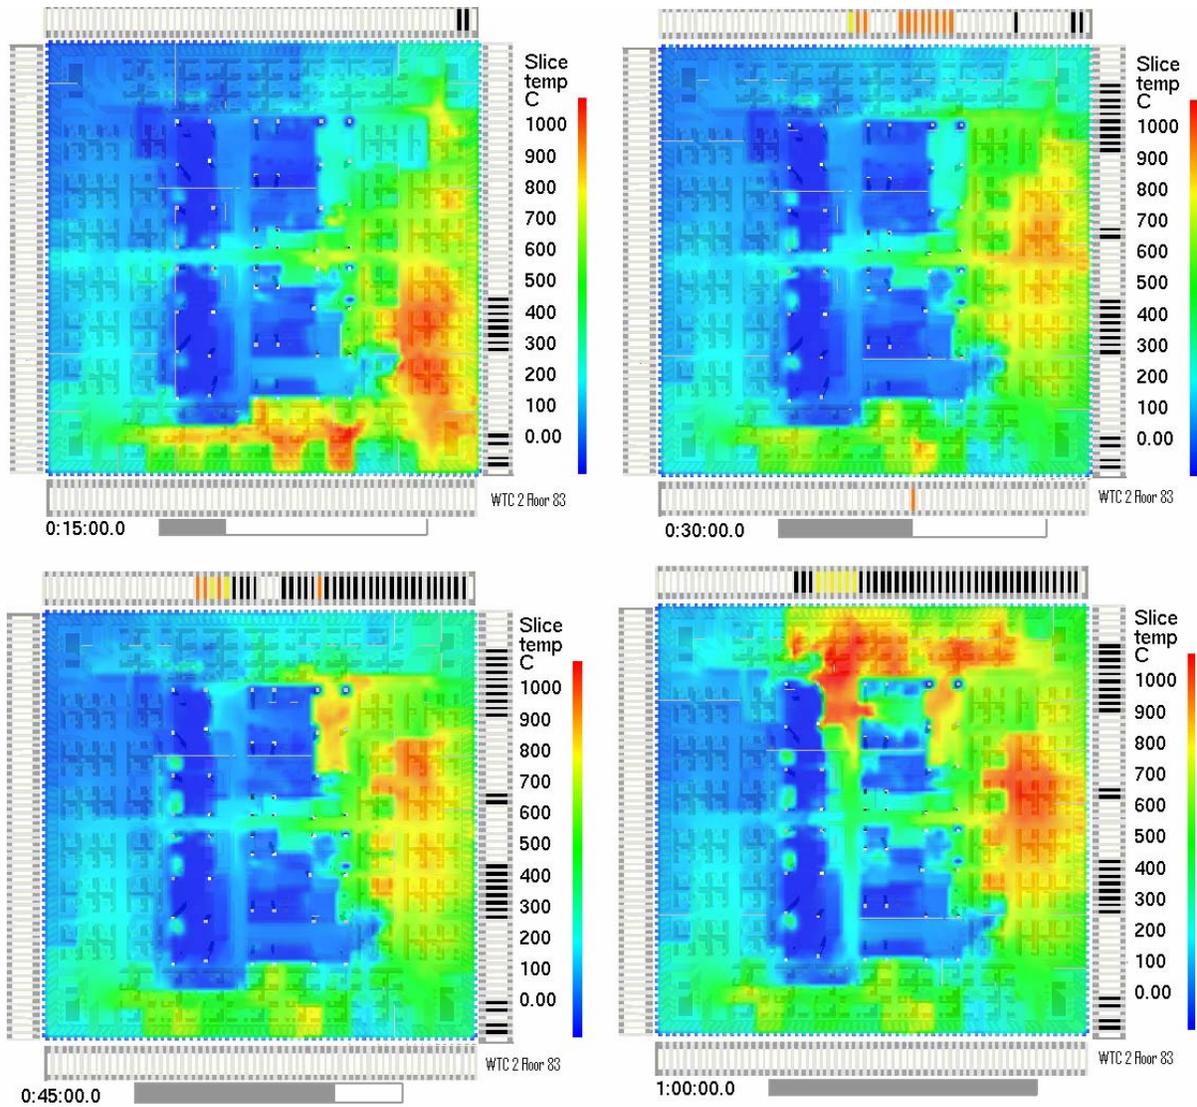
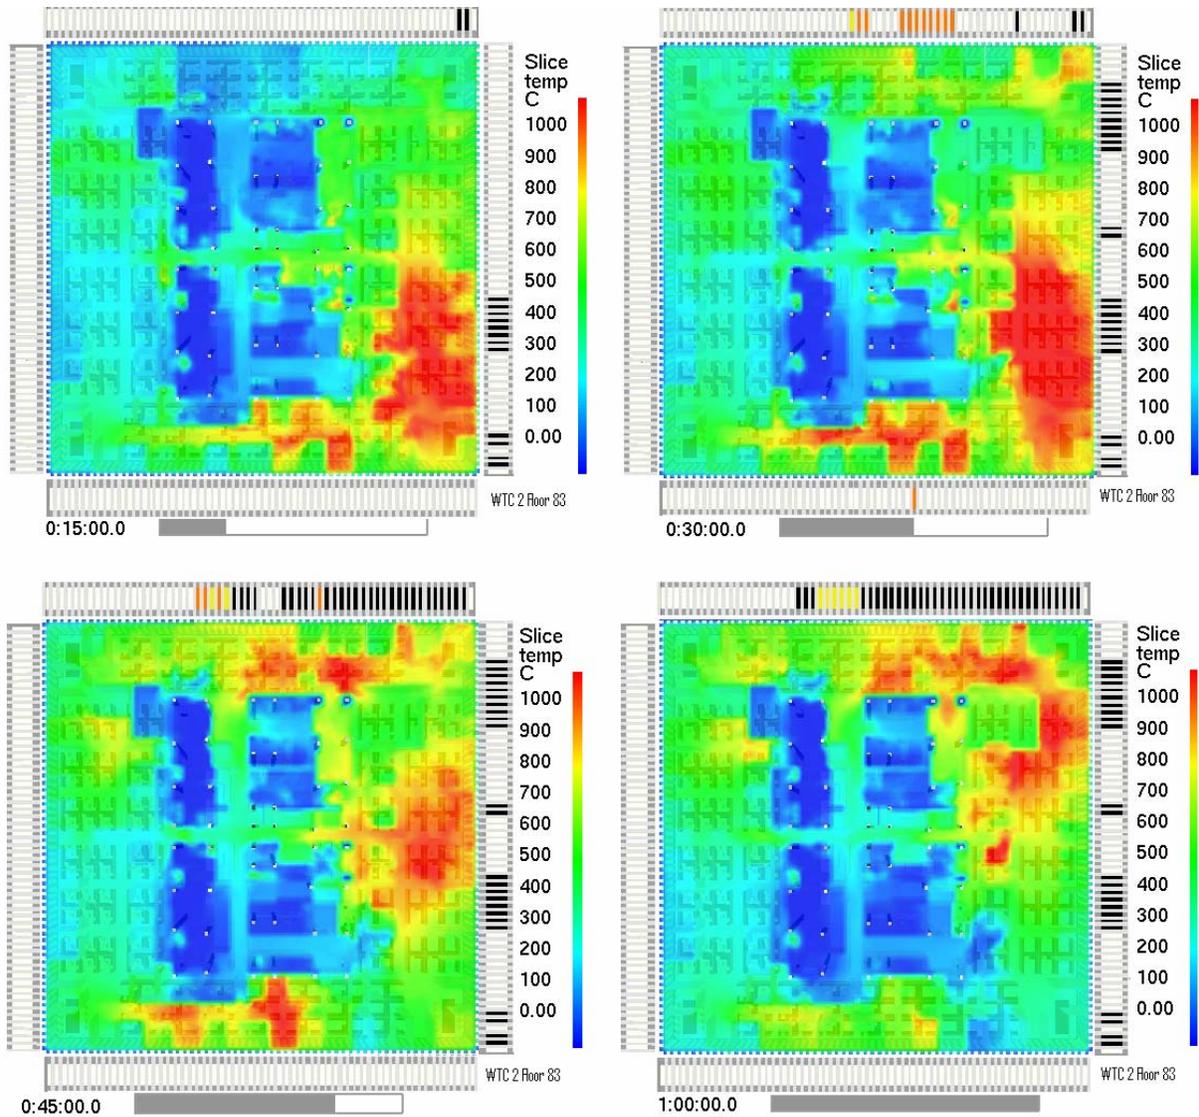
- The fire on the east side of the 83rd floor burned too intensely in the early stages, but reached the south face more realistically than Case C.

Figure 6–27. Simulated upper layer temperatures on floor 83 of WTC 2, Case C.

Figure 6–28. Simulated upper layer temperatures on floor 83 of WTC 2, Case D.

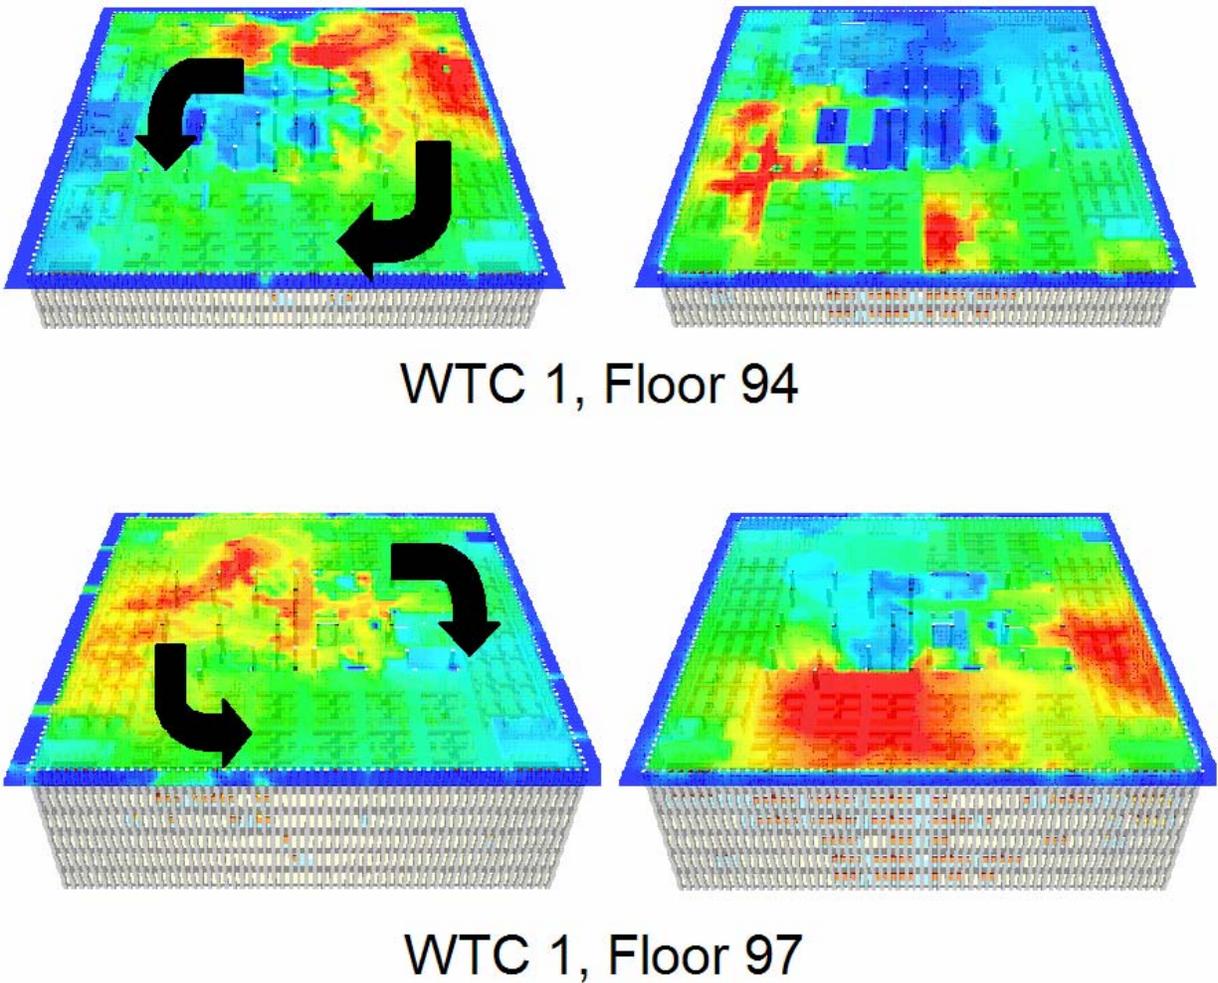
In WTC 1, much of the fire activity was initially in the vicinity of the impact area in the north part of the building, then it spread around the east and west faces, and was last observed to be concentrated in the south part of the building at the time of collapse, as depicted in Figure 6–29.

Figure 6–29. Direction of simulated fire movement on floors 94 and 97 of WTC 1.

The fact that the simulated fires encircled the building in roughly the same amount of time as the actual fires supported the estimate of the overall combustible load of 20 kg/m^2 (4 lb/ft^2). Simulations performed with higher loads required a proportionately longer amount of time to bring the fires around to the southeast because of the fact that the burn time was roughly proportional to the fuel mass in the oxygen-limited interior of the fire floors.
