NBS BUILDING SCIENCE SERIES 143

# Investigation of the Kansas City Hyatt Regency Walkways Collapse

R. D. Marshall  
E. O. Pfrang  
E. V. Leyendecker  
K. A. Woodward

Issued May 1982

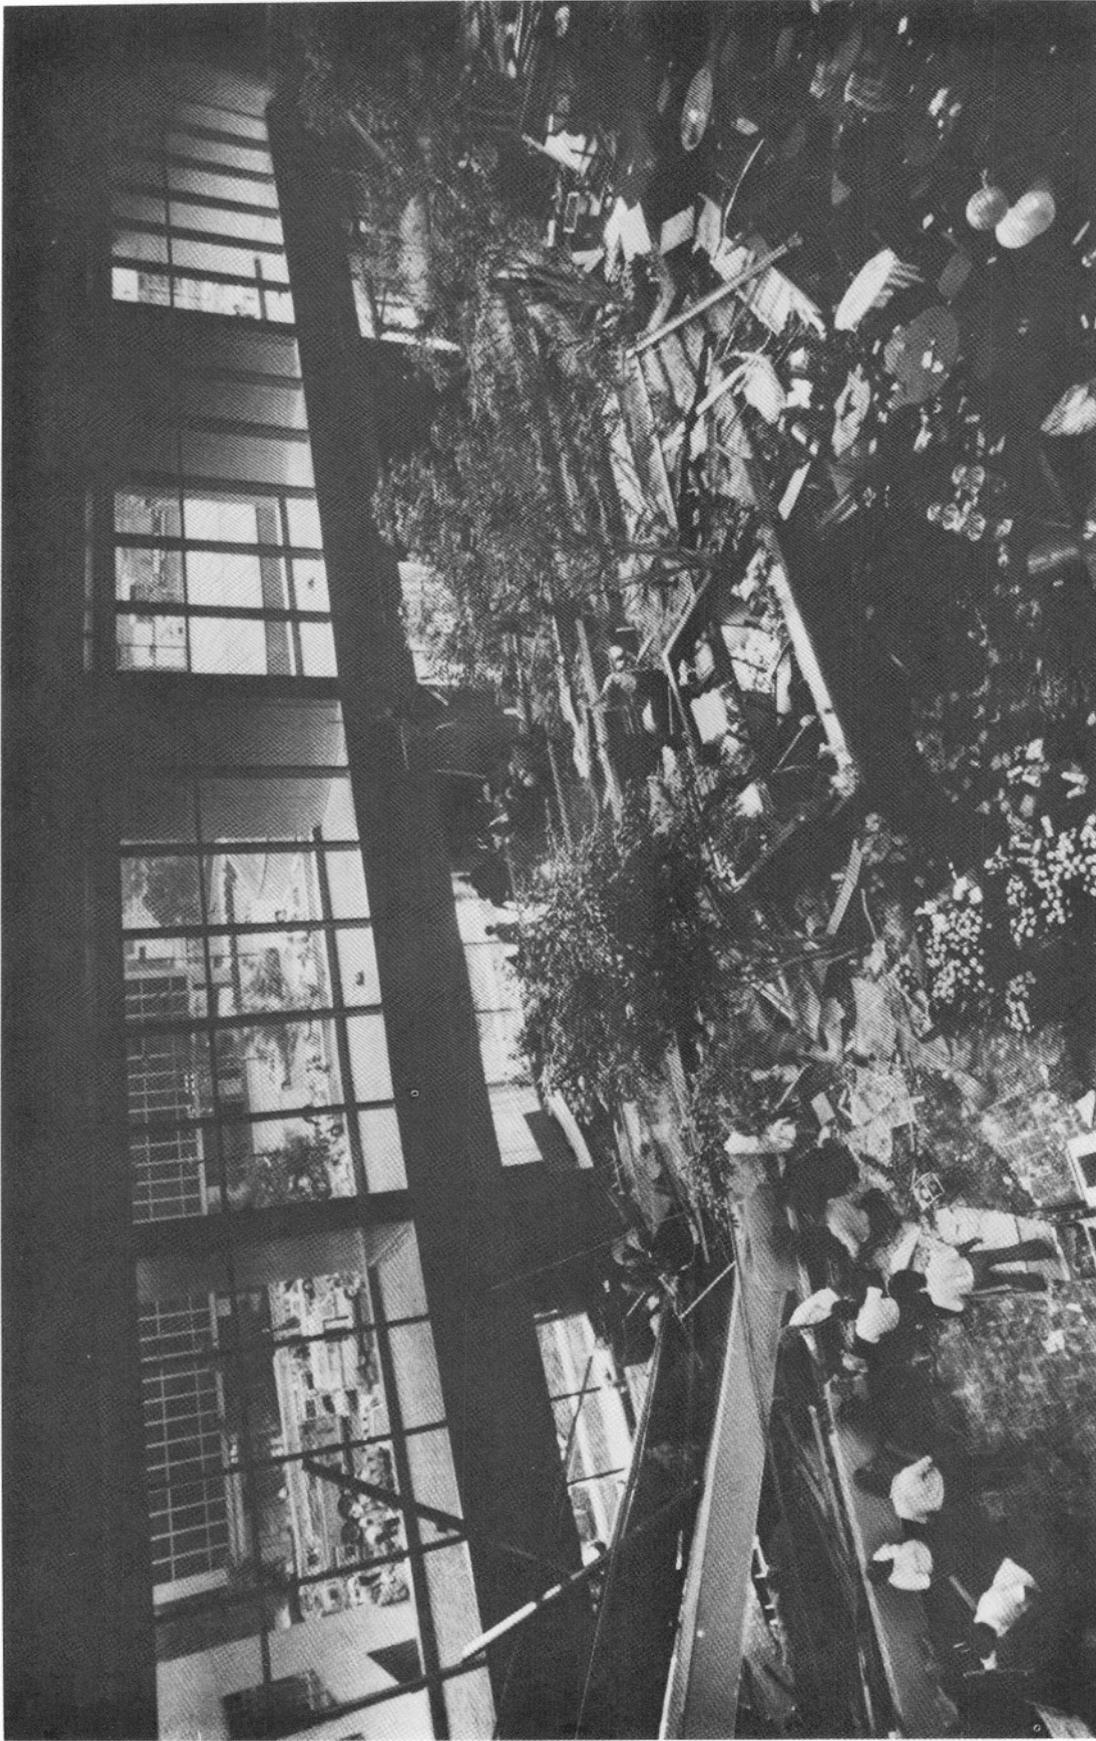
Figures 4.1 and 4.2 show the walkways shortly after the collapse, just as the rescue operation was getting under way. The photograph in figure 4.1 appears to have been taken from the stairway landing at the south side of the atrium between the second and third floors. The view is to the west-northwest and shows part of span U7-8 which lodged in the second-floor portal originally occupied by span L7-8. Spans U8-9 and U9-10 can be seen behind the trees in the middle of the picture. The photograph in figure 4.2 was taken from the third floor with the view directly to the north along the axis of the walkways. Span U7-8 is in the foreground and the third floor walkway can be seen to the upper right. Span U10-11 is visible at the far (north) side of the atrium. The north end of this span appears to have experienced an appreciable displacement to the west during the collapse. Water is coming from walkway sprinkler pipes severed when the north walkway spans were pulled off of their bearing seats.

Figure 4.1 Walkways shortly after the collapse. View is to the west-northwest with span U7-8 sloping down and to the right. Spans U8-9 and U9-10 are visible behind the trees. Photo by Greg Smith, reprinted by permission of The Kansas City Times, © 1981, The Kansas City Star Company.

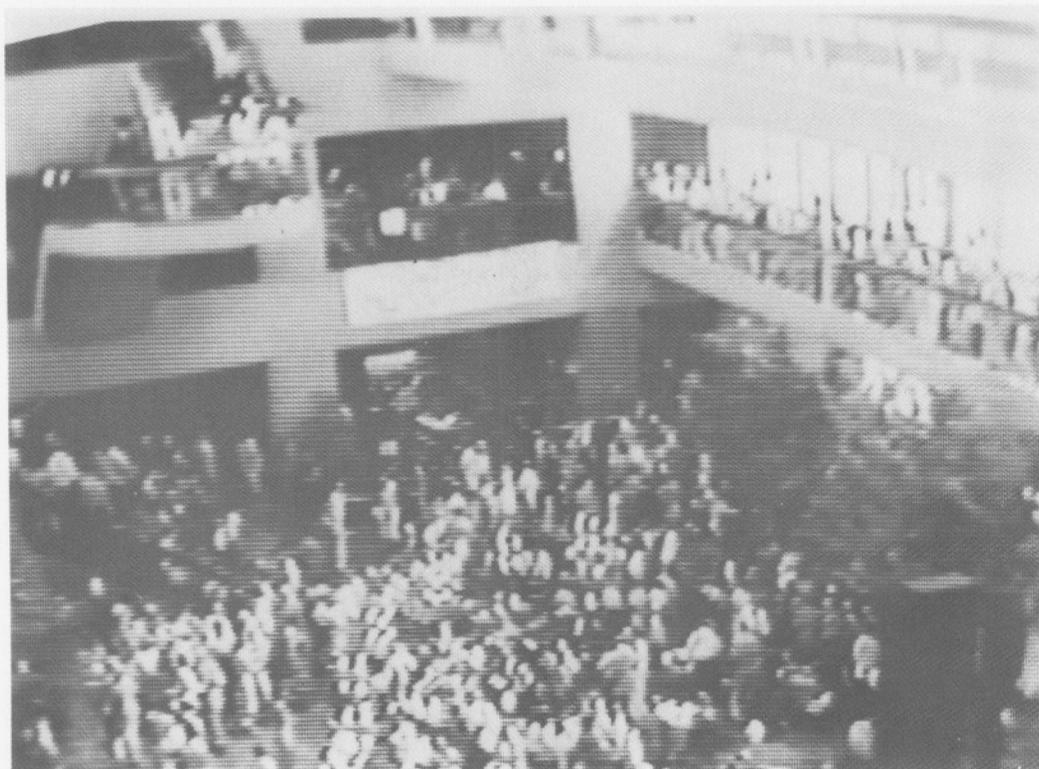
Three segments of the tape provided by KMBC TV were suitable for analysis. The scene in figure 4.4 is from the third floor balcony on the north side of the atrium with the view to the southwest. All of span L7-8 and most of span L8-9 of the second floor walkway are visible. A portion of the third floor walkway is visible at the upper right. The time bracket is believed to be 6:50 to 7:00 PM, based on the scheduled break of the band and their absence from the bandstand which is located directly below the banner on the south wall of the atrium. There appear to be 11 people on span L7-8 and 16 people on span L8-9. Of the 11 people on span L7-8, 10 appear to be standing at the handrail. Of the 16 people on span L8-9, 12 appear to be standing at the handrail.

Figure 4.4 Scene from third floor balcony on north side of atrium. View to the southwest showing spans L7-8 and L8-9 of second floor walkway. Videotape courtesy of KMBC TV.

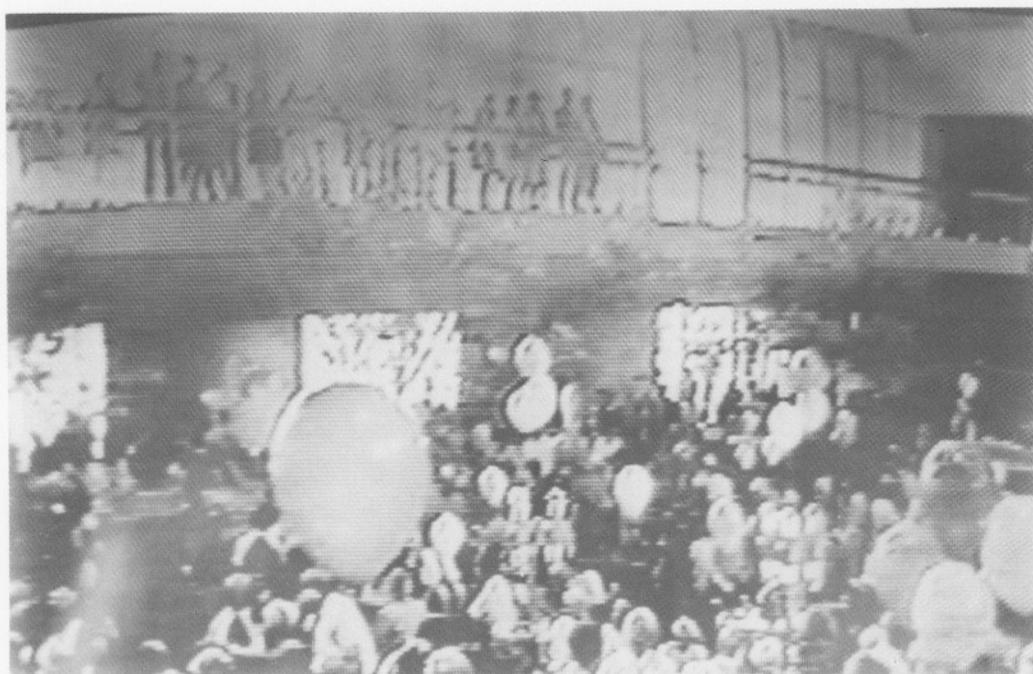
The scene in figure 4.5, believed to have been taken a few minutes after the frame shown in figure 4.4, appears to be from the landing of the main stairway in the southeast corner of the atrium, looking northwest. Part of span L8-9 and all of spans L9-10 and L10-11 of the second floor walkway are visible. Eight or nine people are occupying the south portion of span L9-10 along the handrail and span L10-11 is not occupied.

Figure 4.5 Scene from landing of main stairway in southeast corner of atrium. View to northwest shows part of span L8-9 and all of spans L9-10 and L10-11 of second floor walkway. Videotape courtesy of KMBC TV.

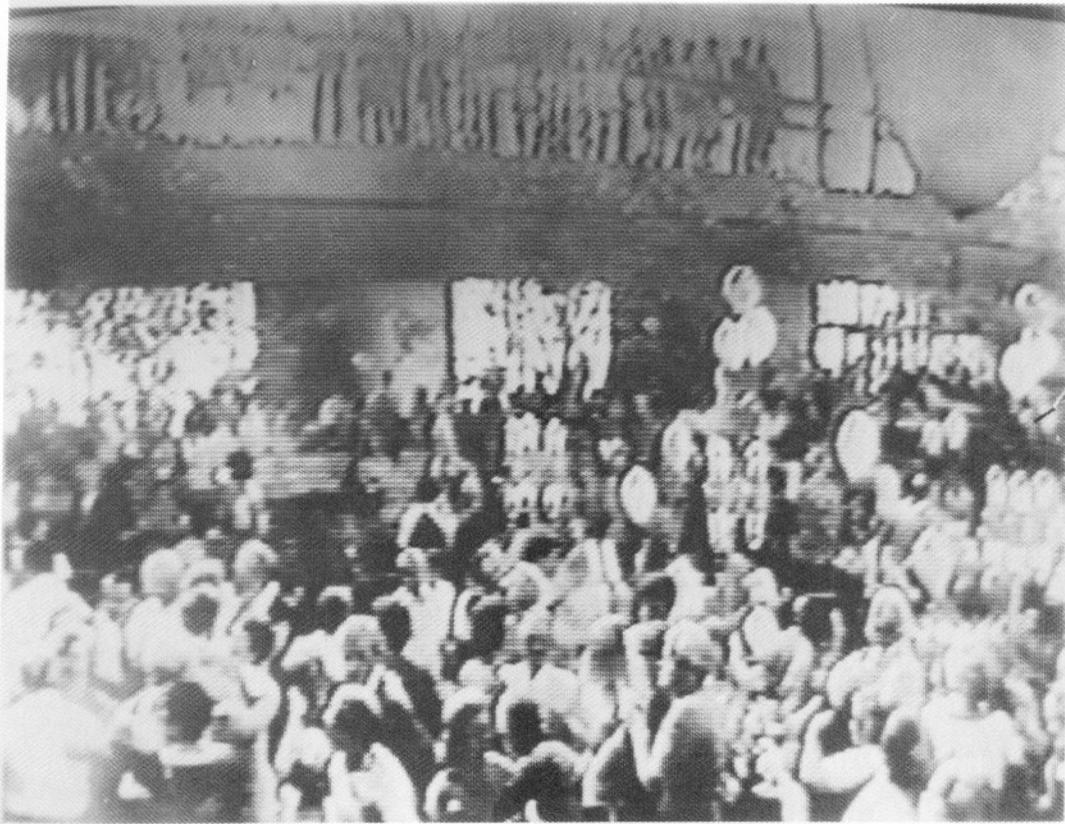
The scene in figure 4.6, taken a few frames later, appears to be from the same location as that in figure 4.5, but shows more of span L8-9. Judging from their relative heights, the people on span L9-10 have not moved from their positions shown in figure 4.5. It appears that the count on span L9-10 is now 11, but blurring makes an accurate count difficult.

Figure 4.6 Same view as figure 4.5, but a few frames later. Videotape courtesy of KMBC TV.

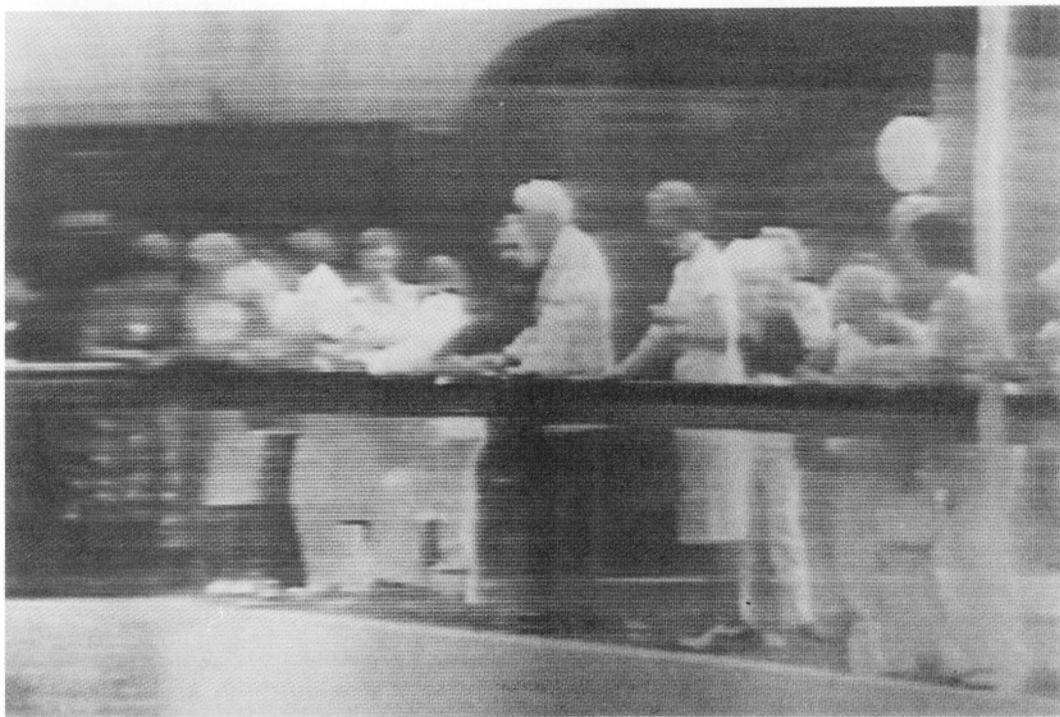
Figure 4.7 is a close-up of the southernmost span (span M7-8) in the third floor walkway. The view is from the same location as figure 4.4. Again, it is difficult to make an accurate count, but at least 11 persons can be observed.

Figure 4.7 View from third floor balcony on north side of atrium. View to southwest showing southernmost span (span M7-8) of third floor walkway. Videotape courtesy of KMBC TV.

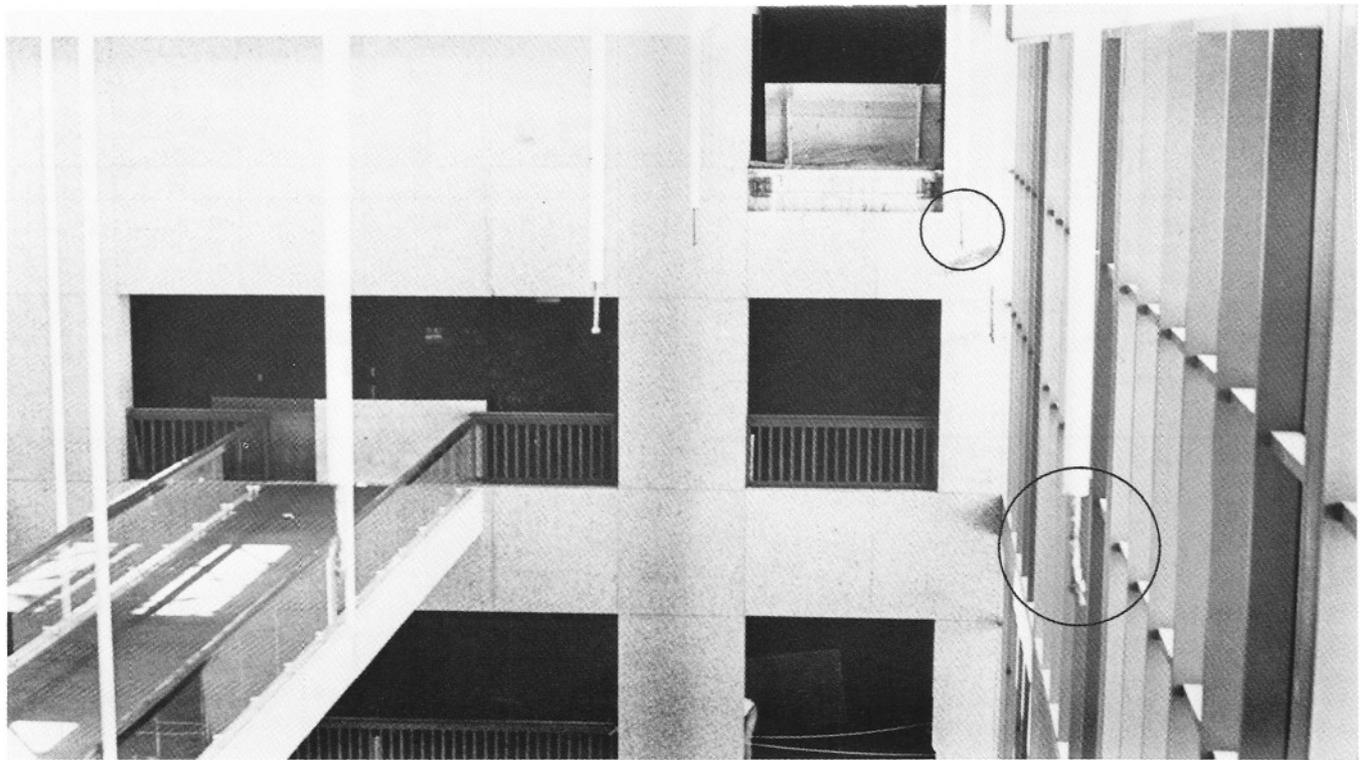
Figure 5.4 Fourth floor to ceiling hanger rods. View from fourth floor looking south.

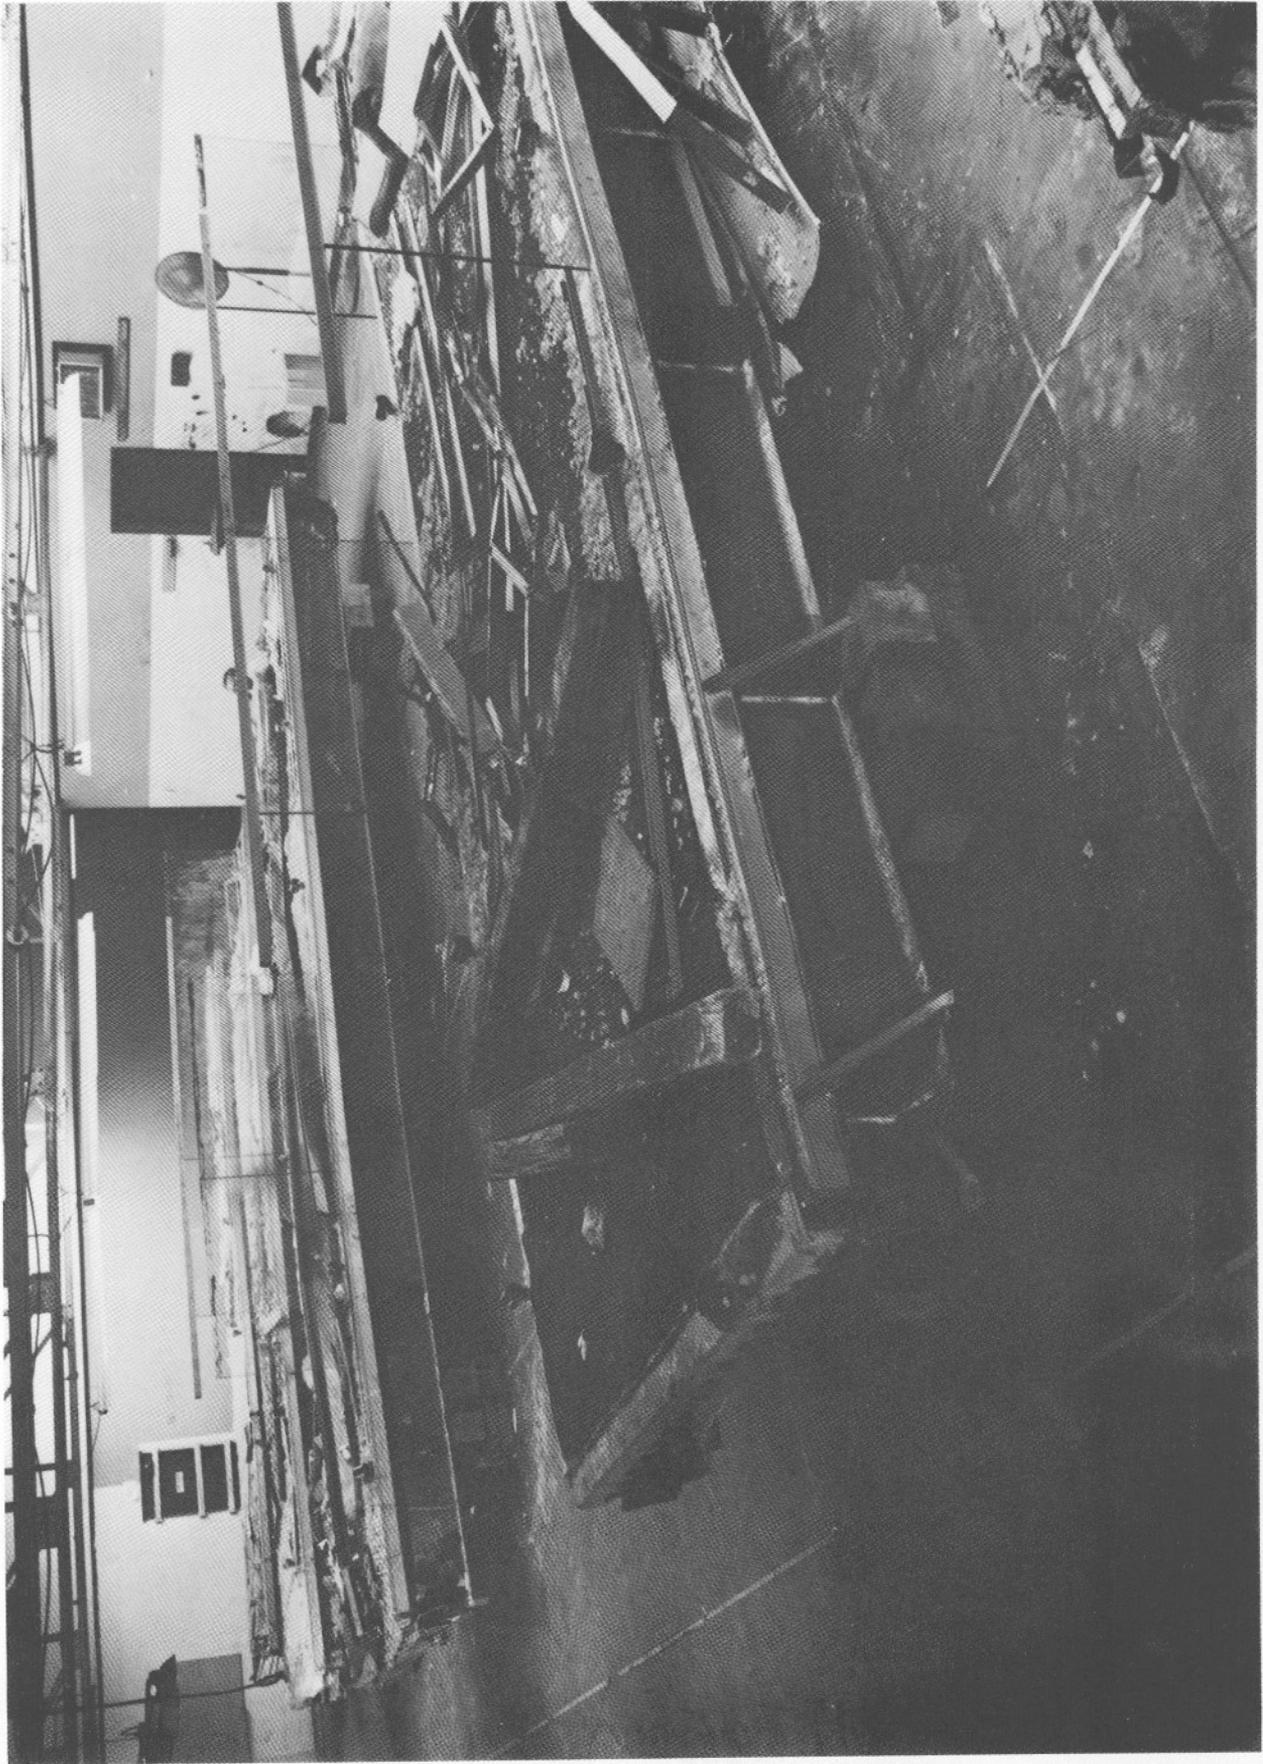
Figure 5.6 General view showing spans of fourth floor walkway.

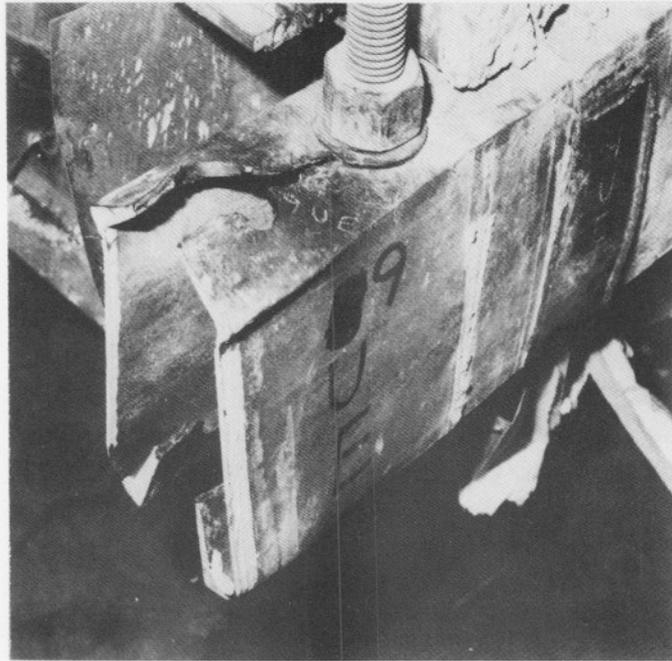
Based on the results of this investigation, it is concluded that the most probable cause of failure was insufficient load capacity of the box beam-hanger rod connections. Observed distortions of structural components strongly suggest that the failure of the walkway system initiated in the box beam-hanger rod connection on the east end of the fourth floor walkway's middle box beam.

Figure 5.7 Hanger rod pull-through at location 9UE.

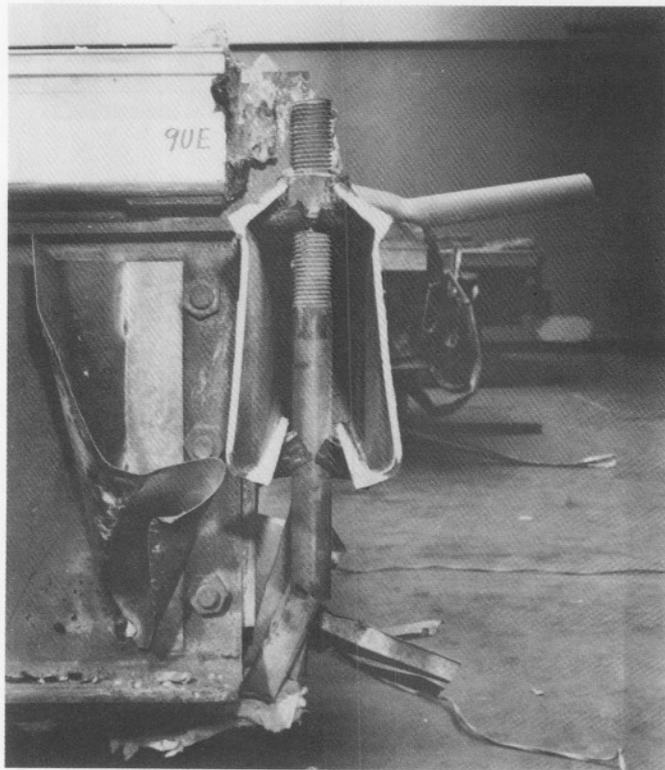
Figure 5.8 End view of box beam at location 9UE.

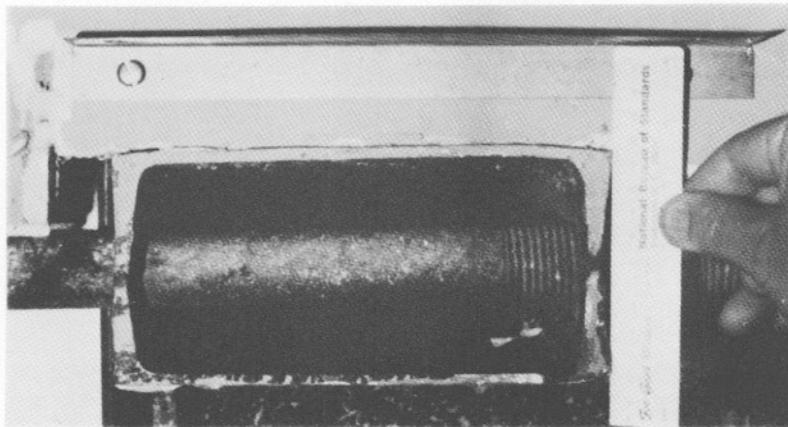
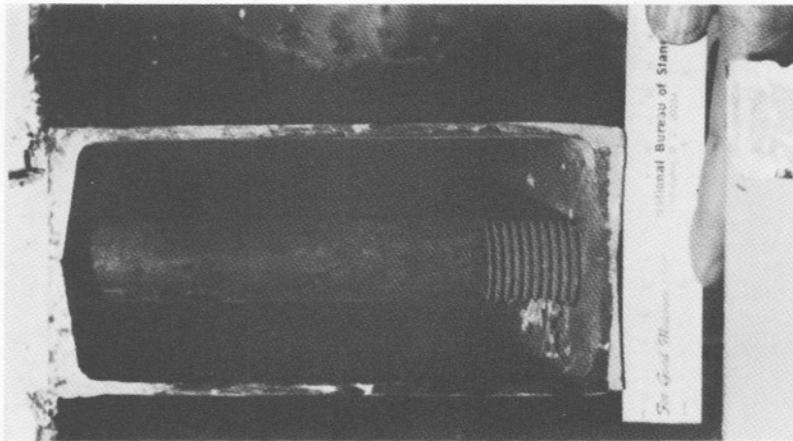
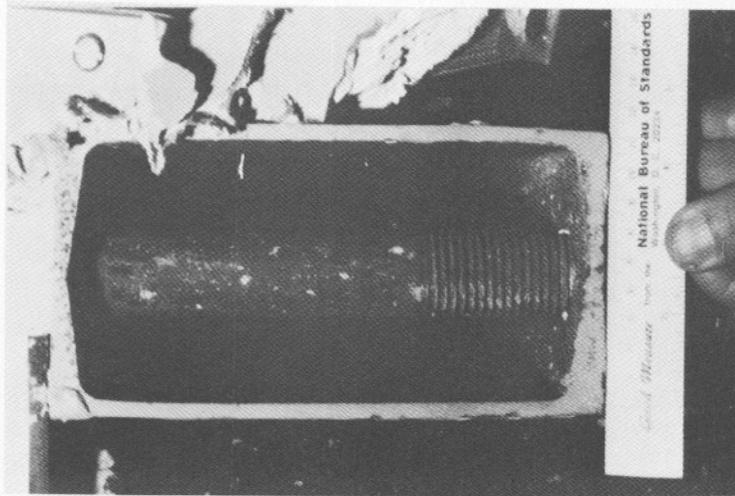
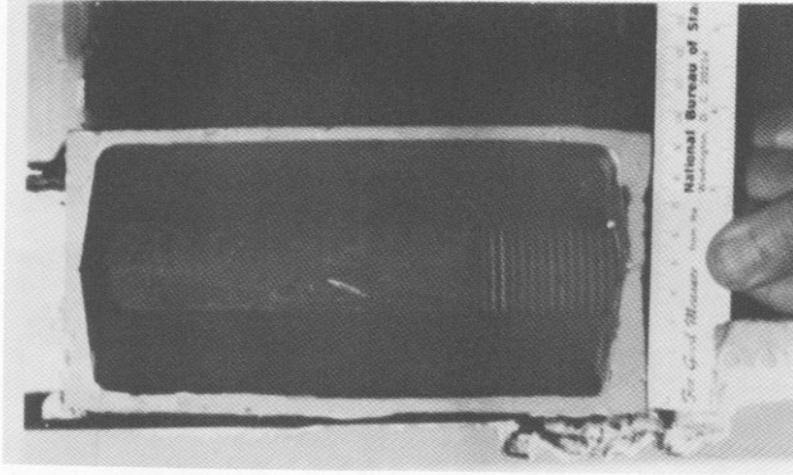
Figure 5.9 Evidence of permanent distortion in box beam ends of third floor walkway.

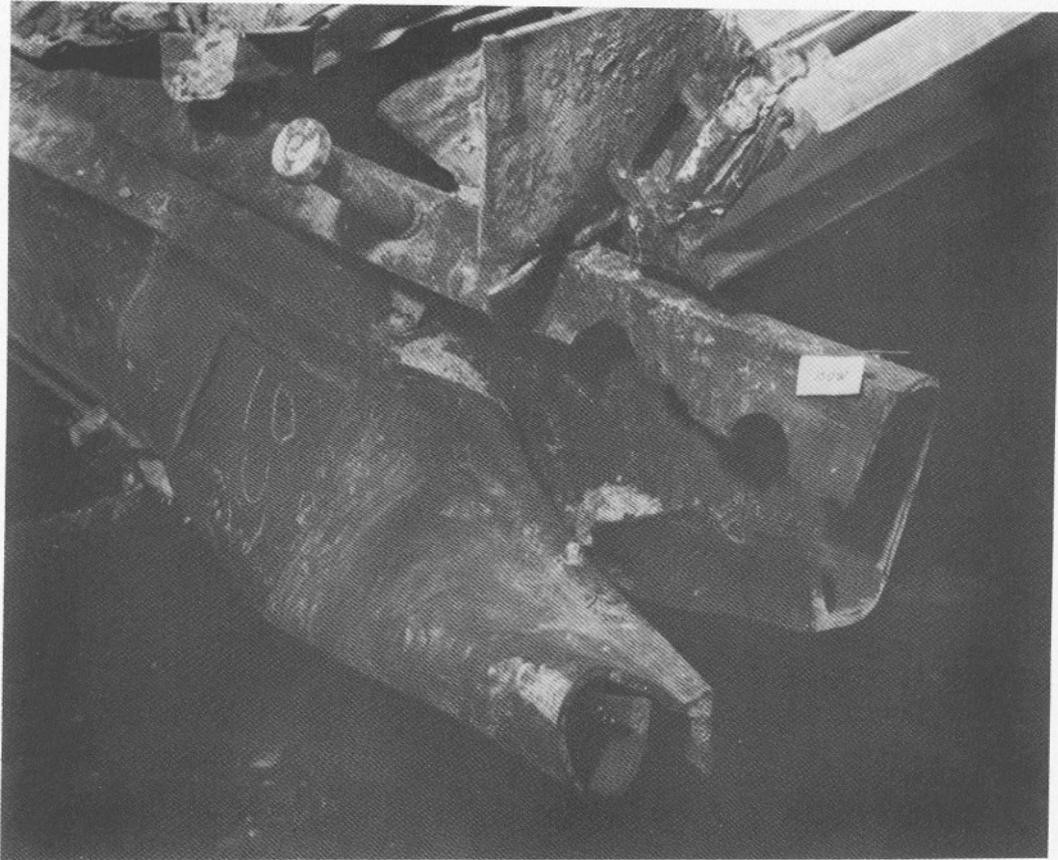
Figure 5.11 Box beam at location 10UW (Span U9-10).

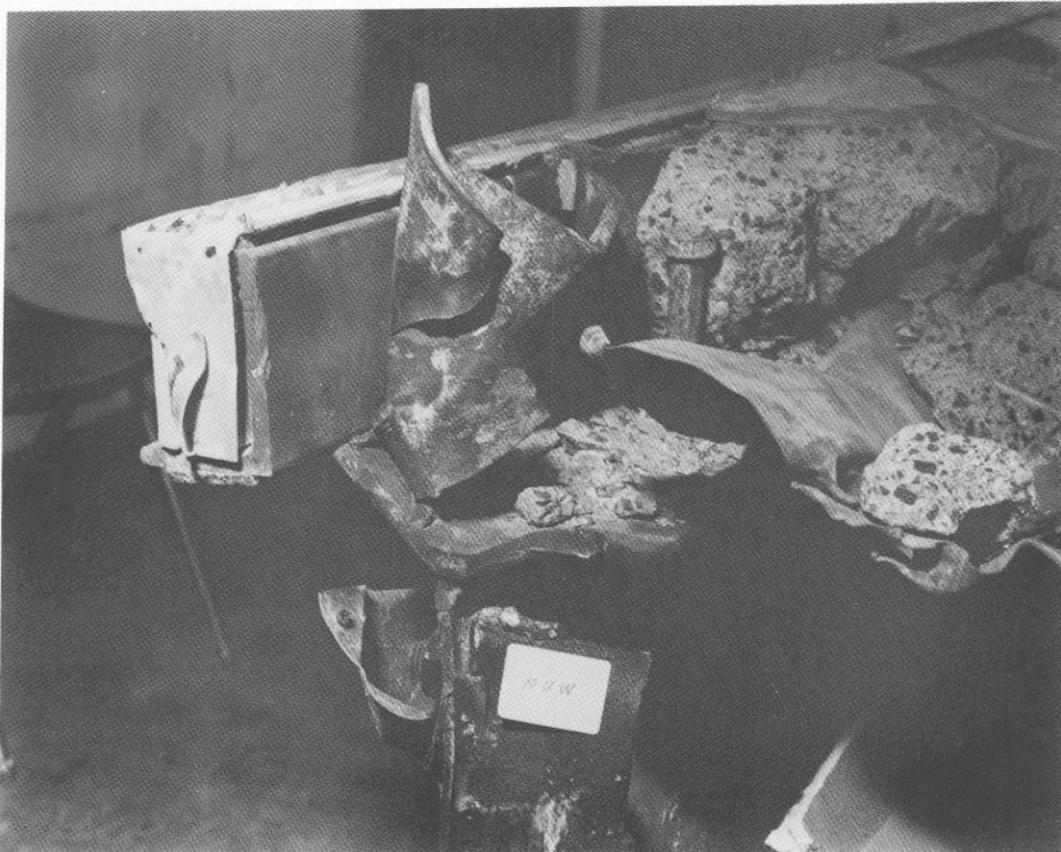
Figure 5.12 End view of 1/4" x 6" edging plate at location 10UW (Span U10-11).

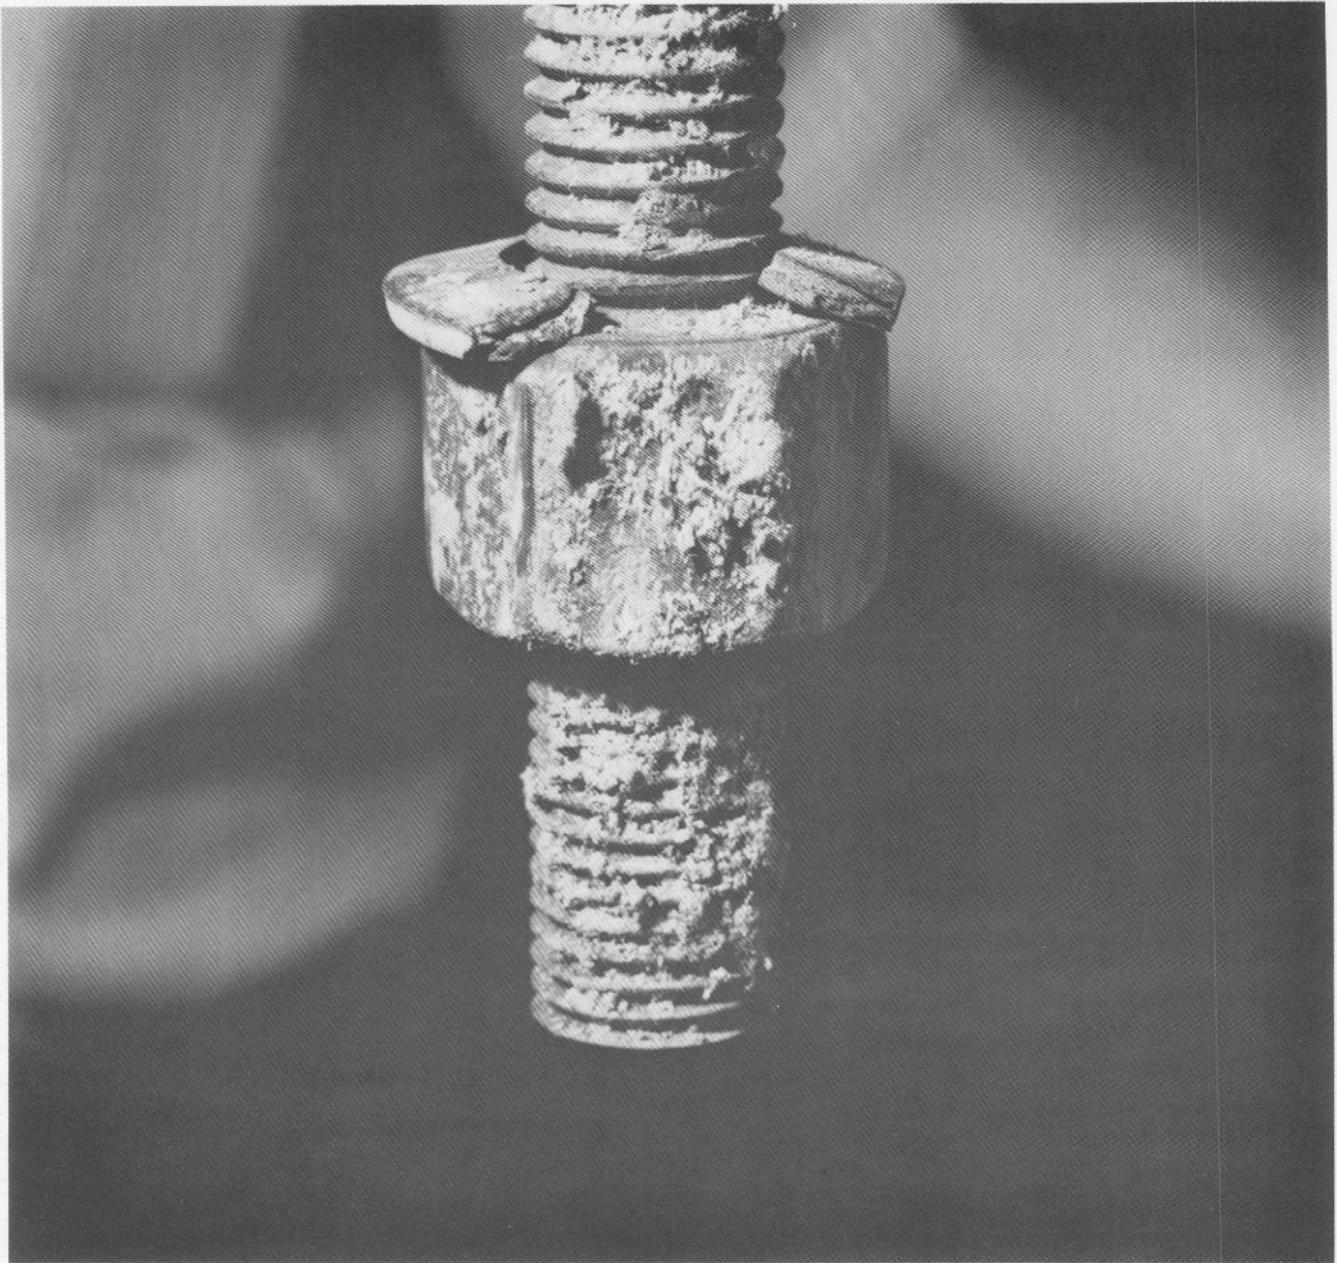
Figure 5.13 Washer at bottom end of fourth floor to ceiling hanger rod 9UW.

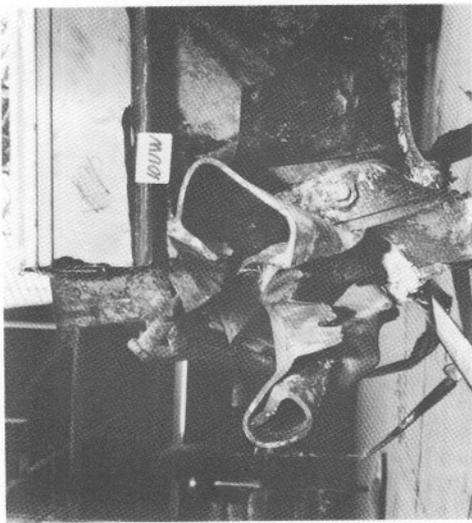
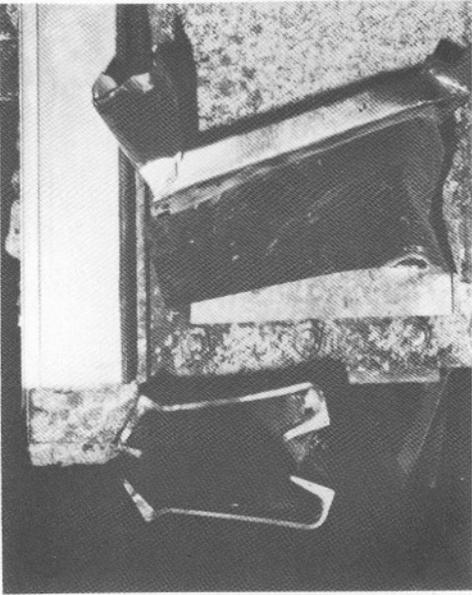
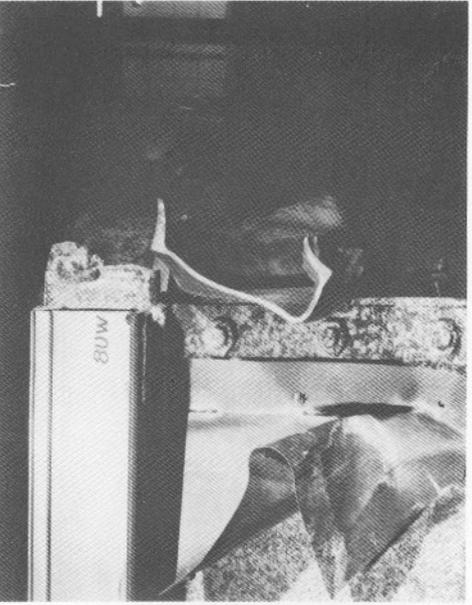
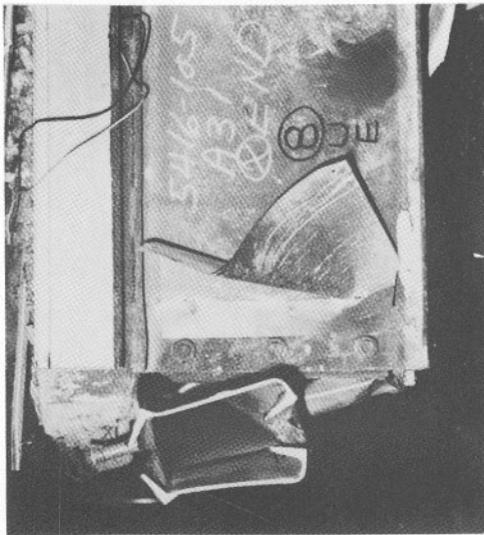
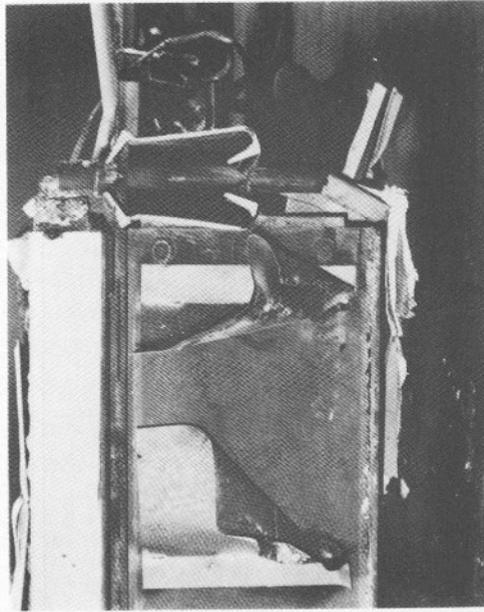
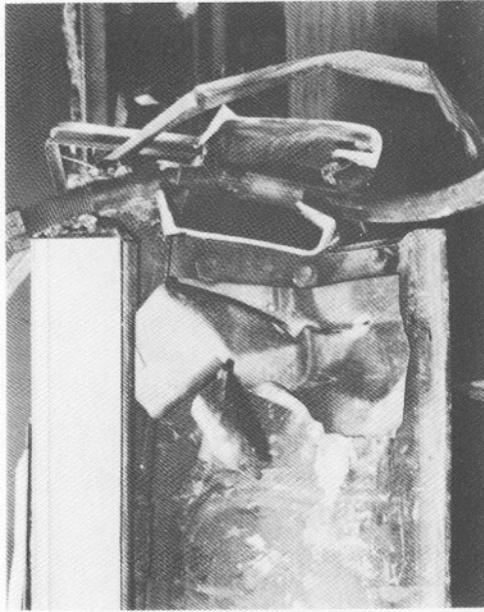
Figure 5.14 Observed symmetry of distortion of box beams at locations 8U and 10U relative to the box beam at location 9U.

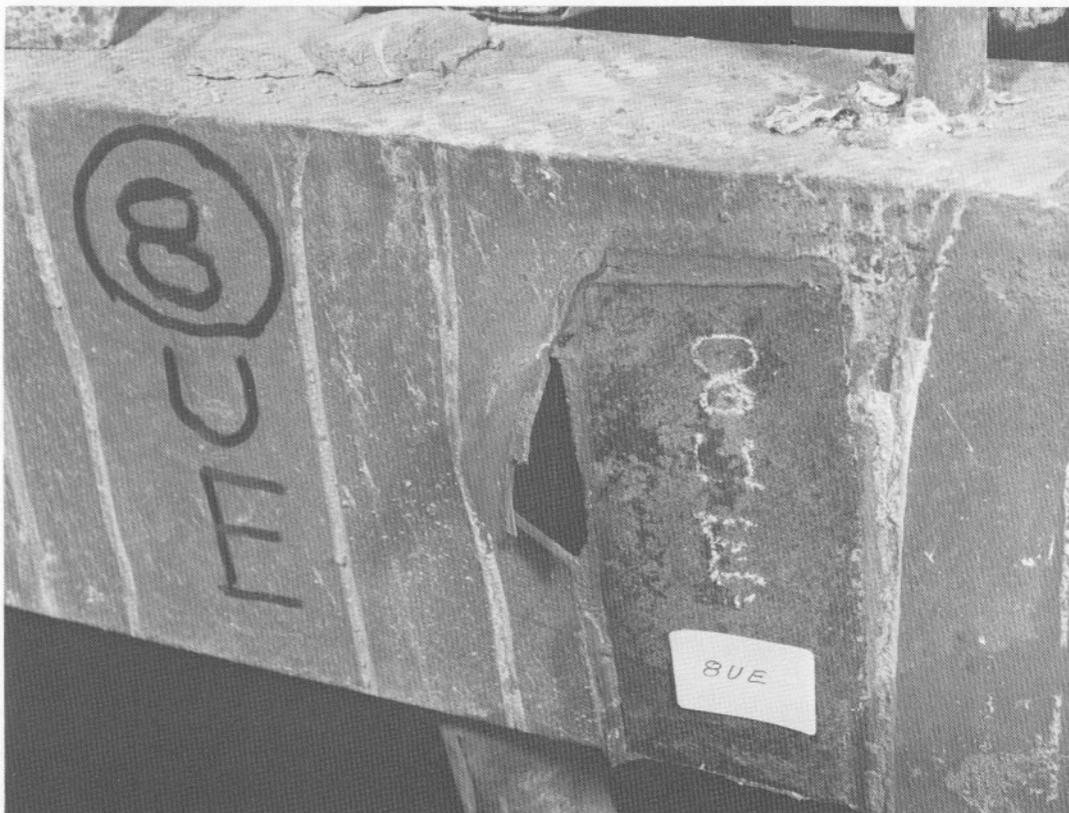
Figure 5.24 Tear in box beam web at location 8UE.

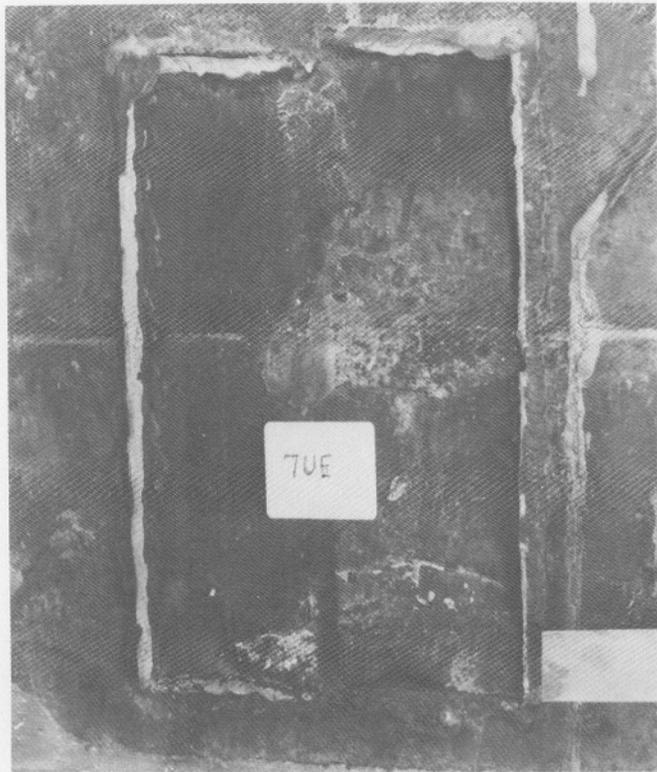
Figure 5.25 Embedded plate at connection 7UE.

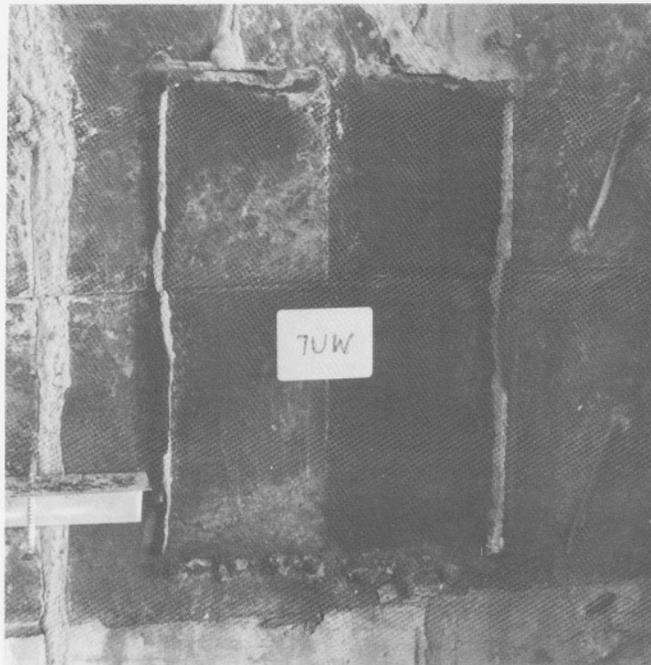
Figure 5.26 Embedded plate at connection 7UW.

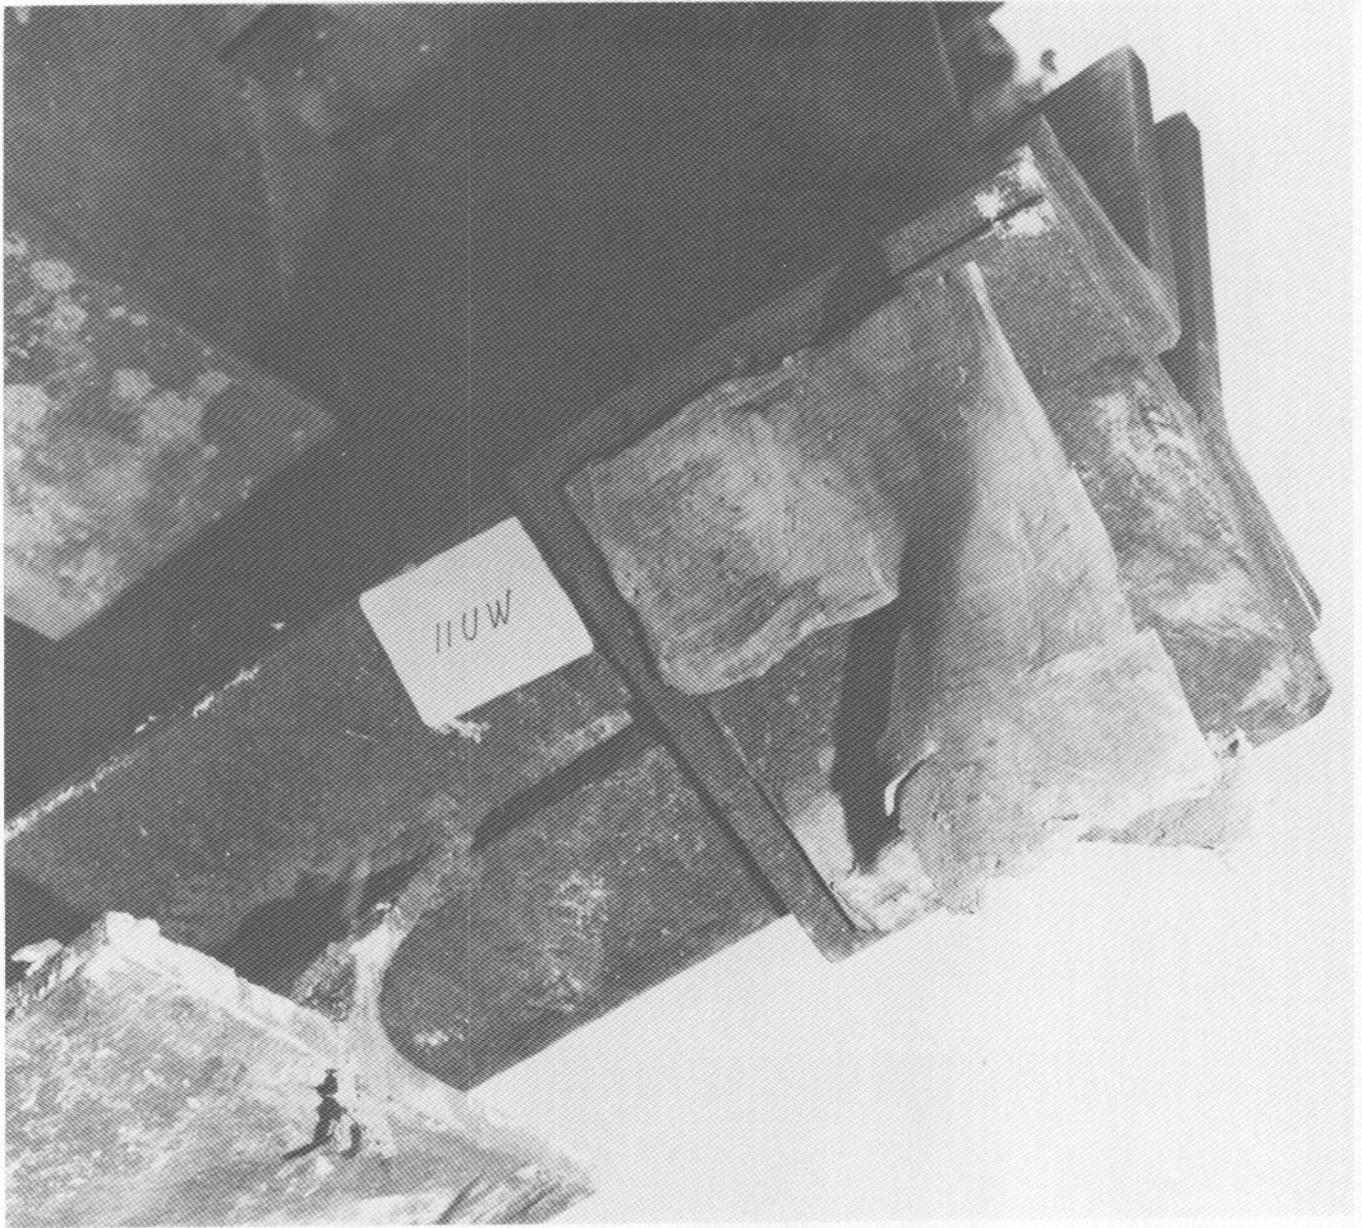
Figure 5.27 Modified bearing pad at location 11UW.

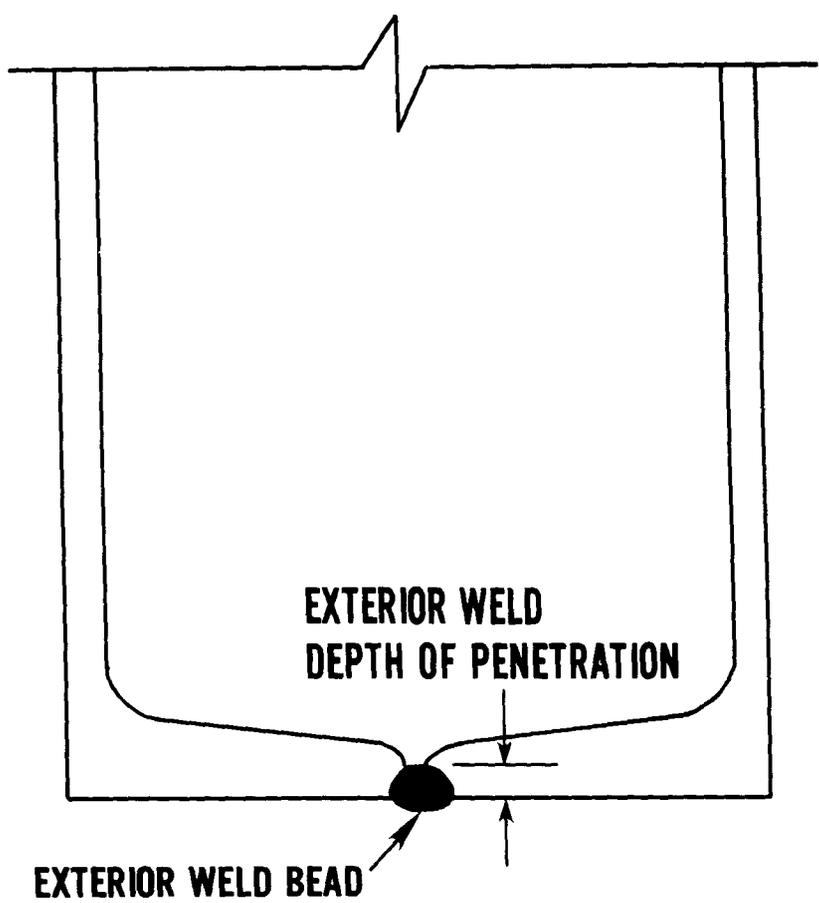
The walkway box beams had been fabricated by laying a weld bead along the channel flange tips from the outside of the box beam over the entire length of the beam. For purposes of describing the structural tests, such a weld is termed an exterior weld in this chapter. The depth of exterior weld penetration (figure 6.2) estimated from visual examination of the damaged walkway box beams was used as a guide in the fabrication of the short box beams. The welder fabricating the short box beams was able to produce welds having a fairly uniform penetration along the beam. However, to examine the significance of exterior weld penetration, specimens having penetration less than and greater than the estimated penetration were fabricated. The majority of short box beams were fabricated with a weld penetrating partially into the flange thickness and were termed "shallow penetration" welds. Several specimens were fabricated in which the welder was told to "fully penetrate" the flange thickness without using a backing strip. These welds were termed "deep penetration." Two specimens were fabricated with no weld bead laid along the outer 8 in (203 mm) of the short box beam except for a small tack weld at the free end of the specimen (figure 6.3). These two specimens were termed "no weld" specimens and were tested to determine a lower bound strength of the box beam-hanger rod connection.

Figure 6.2 Exterior weld penetration.

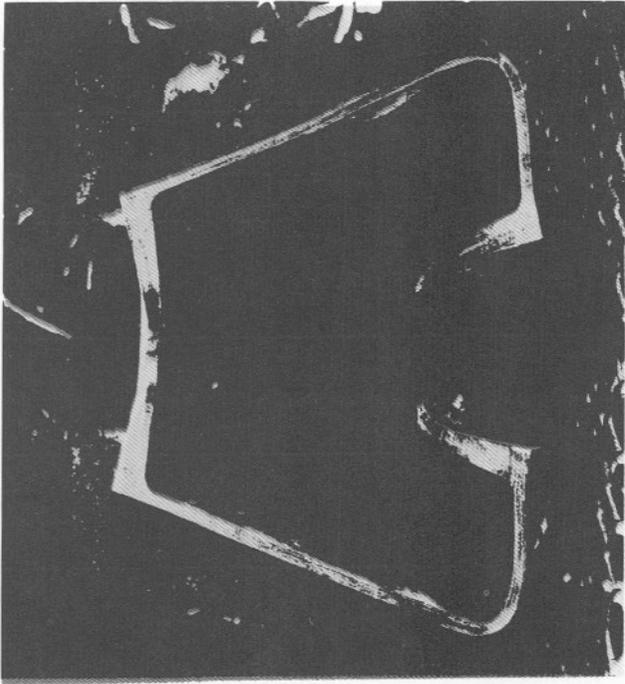
Figure 6.14 Deformed shapes.

Three different failure types, assigned the identifiers I, II, and III, were observed and are shown in figure 6.14. The bottom flanges of specimen K2, and others exhibiting type I behavior, fold back about a plastic hinge in the web and do not show any discernible bending. The flanges in type III behavior, illustrated by J1, fold back about the plastic hinge in the web but also show pronounced bending in the flange. Type II behavior exhibits slight bending in the flange tips as illustrated by specimen M1. None of the washers fractured in these tests.

Type III behavior is usually characterized by a load-deflection curve which has a relatively rounded shape (as compared to type I) at maximum load. Visual observation of a few specimens indicates that the exterior weld between the lower flange hanger rod holes also cracks between 6 to 8 kips (27 to 36 kN) of upper rod load. Cracking of the interior weld begins adjacent to the outer hanger rod hole at between 10 to 12 kips (44 to 53 kN) and progresses to the end of the beam by about 15 kips (67 kN). Shortly after this stage of cracking the deformations become visible. At the maximum load the interior weld has not yet fractured between the exterior hole and the beam end. The resistance to load decreases with increased deflection, but at a constant rate. The rate is quite similar to the load loss rate following the peak load in the type I behavior. The gradual loss in resistance to load continues with progressive cracking until the interior weld between the outer hole and the beam end fractures, at which point there is a sharp drop in load resistance. The bottom flanges exhibit pronounced bending as illustrated by specimen J1 in figure 6.14.

Type II behavior is between the two extremes (figure 6.15). Initially it exhibits the characteristics of type III behavior. However, the interior weld between the exterior hanger rod hole and beam end fractures at or just after the peak load, unlike the type III beams. The bottom flanges appear more like type I but show a small amount of bending as for specimen T3 in figure 6.14.

Type I Specimen K2

Type II Specimen M1

Type III Specimen J1
