NBS BUILDING SCIENCE SERIES 143

# Investigation of the Kansas City Hyatt Regency Walkways Collapse

R. D. Marshall  
E. O. Pfrang  
E. V. Leyendecker  
K. A. Woodward

Issued May 1982

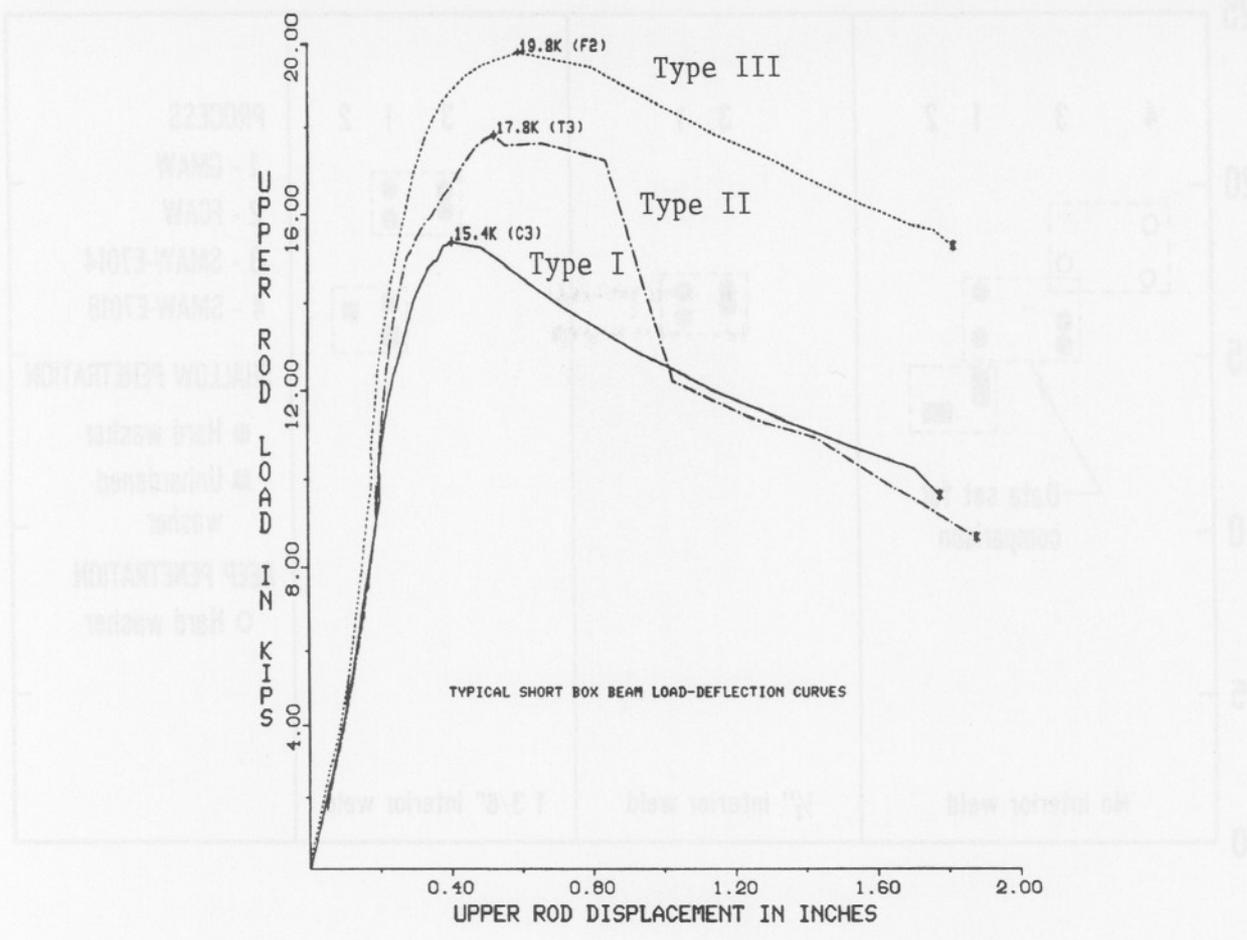
Figure 6.15 In-plane load deflection curves for specimens C-3, F-2, and T-3.

Three typical in-plane load-deflection curves for the short box beam specimens are shown in figure 6.15. (A complete set of load-deflection curves is presented in appendix A.6.10.) Each curve is a plot of the load measured by the upper rod load transducer versus the displacement of the rod measured by the LVDT at the box beam terminus of the upper loading rod (LVDT no. 2 in figure 6.13). The peak load achieved by each of the specimens is shown on their respective curves. The asterisk on each curve indicates the end of reliable measurement by the displacement device and does not necessarily denote final rod pull-through.

The in-plane load-deflection curves in figure 6.15 illustrate specimen behavior usually associated with failure types I, II, III and are again illustrated by specimen C3, specimen T3, and specimen F2, respectively.

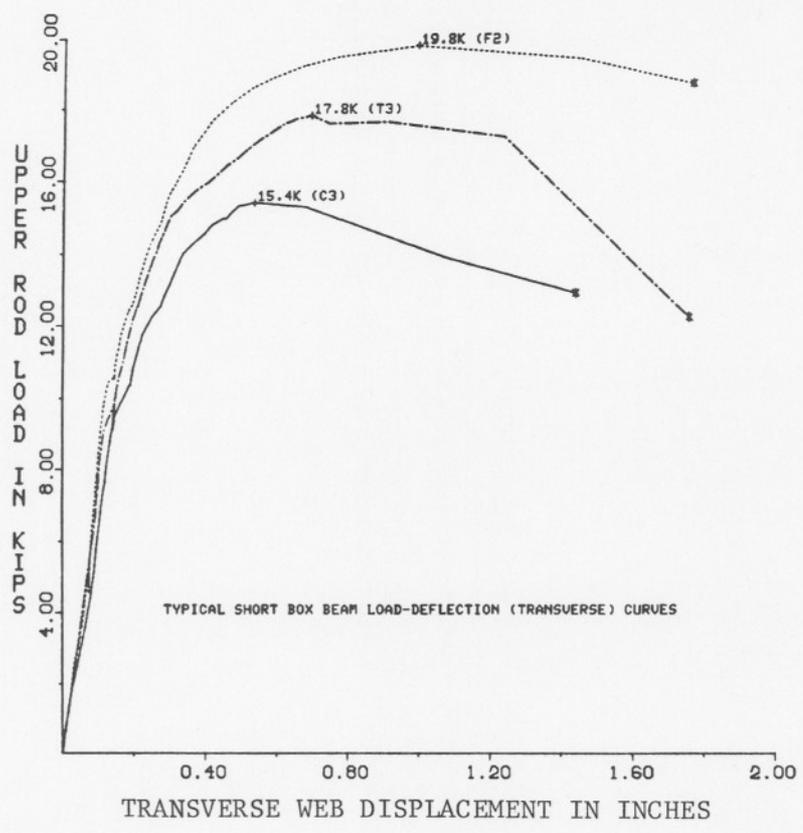
Figure 6.16 Out-of-plane web load displacement curves for specimens C-3, F-2, and T-3.

The out-of-plane load-deflection curves show the same trends as exhibited by the in-plane load-deflection curves. The out-of-plane load-deflection curves for the above described specimens are shown in figure 6.16. Each curve is a plot of the same load described for figure 6.15 versus the displacement measured by the middle transverse LVDT (figure 6.13). These data show that the web is beginning to deform outward shortly after the application of dead load from the second floor is started.

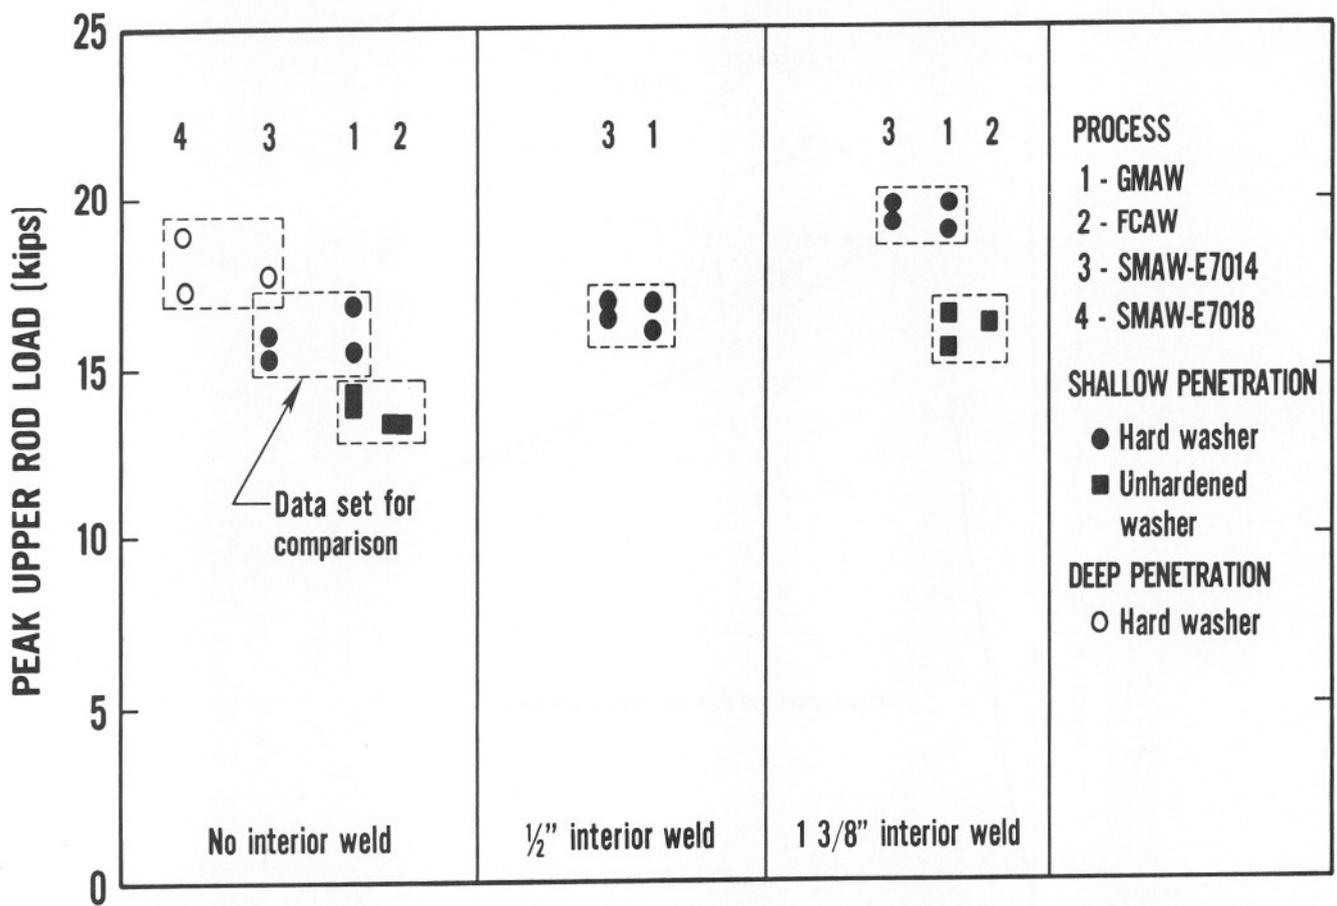
Figure 6.17 Effect of weld process.

Comparisons between specimens in which the only intentional difference is the welding process appear in figure 6.17. Six sets of data, each consisting of comparable specimens, are shown enclosed in the figure. Hardened washer data are used where possible since it was found (section 6.10.5) that hardened washers were used in the actual walkway construction. The specimens compared for a particular process were fabricated at the same time. This selection of data was done to maintain as much similarity as possible since there was variation in the amount of weld material deposited and, as discussed in

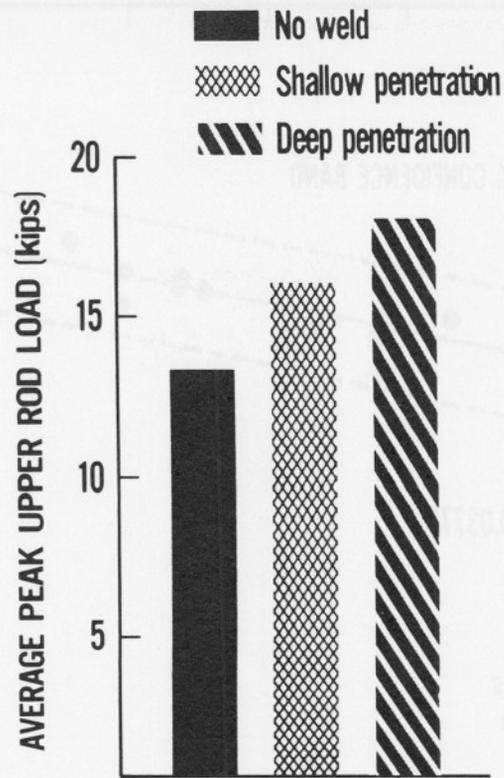
Figure 6.18 Effect of exterior weld penetration.

Exterior Weld Penetration. The exterior weld penetration depth for specimens without an interior weld has a significant effect on the peak upper rod load of the short box beams, as shown in figure 6.18. The average peak loads for specimens E1 and E2 having no weld (no penetration), C1 and C3 having a shallow penetration weld, and A1 and A2 having a deep penetration weld are shown in the figure to illustrate that there is significant difference in load resistance between the case of shallow penetration and deep penetration. The difference is about 2.5 kips (11.1 kN).

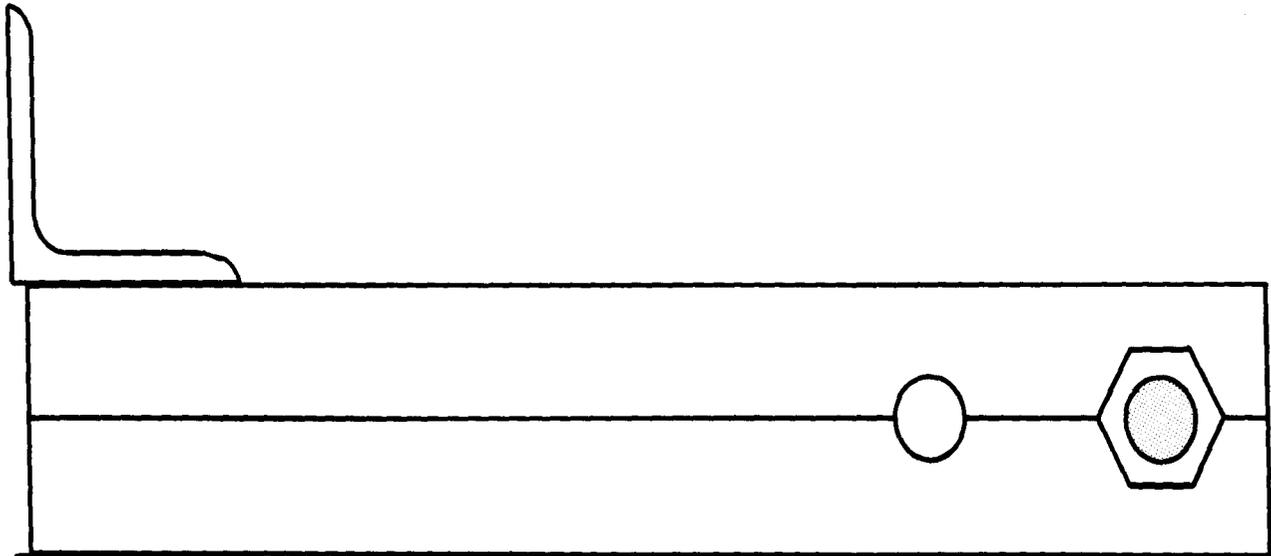
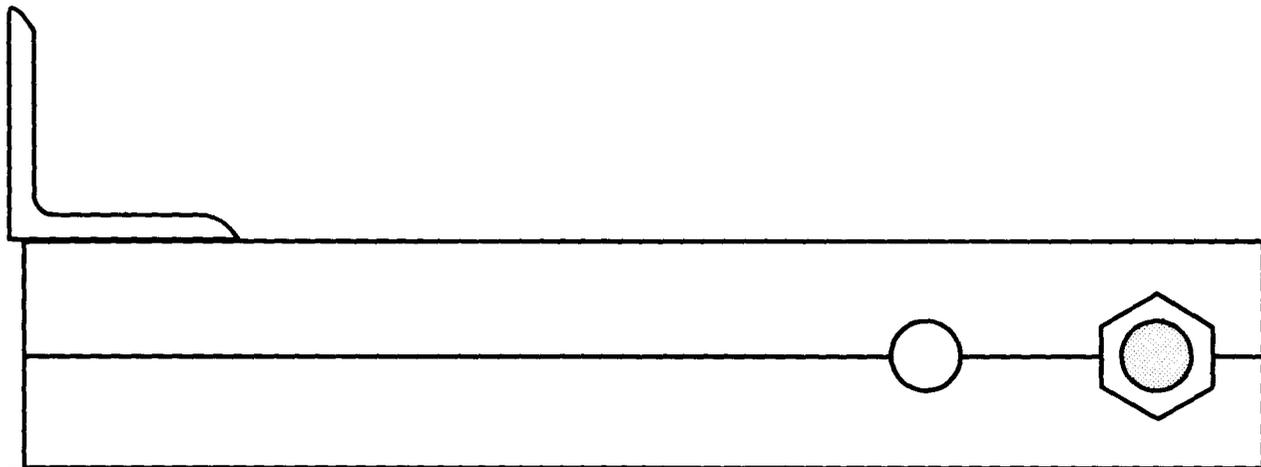
Figure 6.28 Nut orientation.

The data points for nut orientation are shown in figure 6.27. Based on these data nut orientation is not considered a significant parameter.

**NUT FACE PARALLEL TO BEAM  
LONGITUDINAL AXIS**

**NUT FACE PERPENDICULAR TO BEAM  
LONGITUDINAL AXIS**

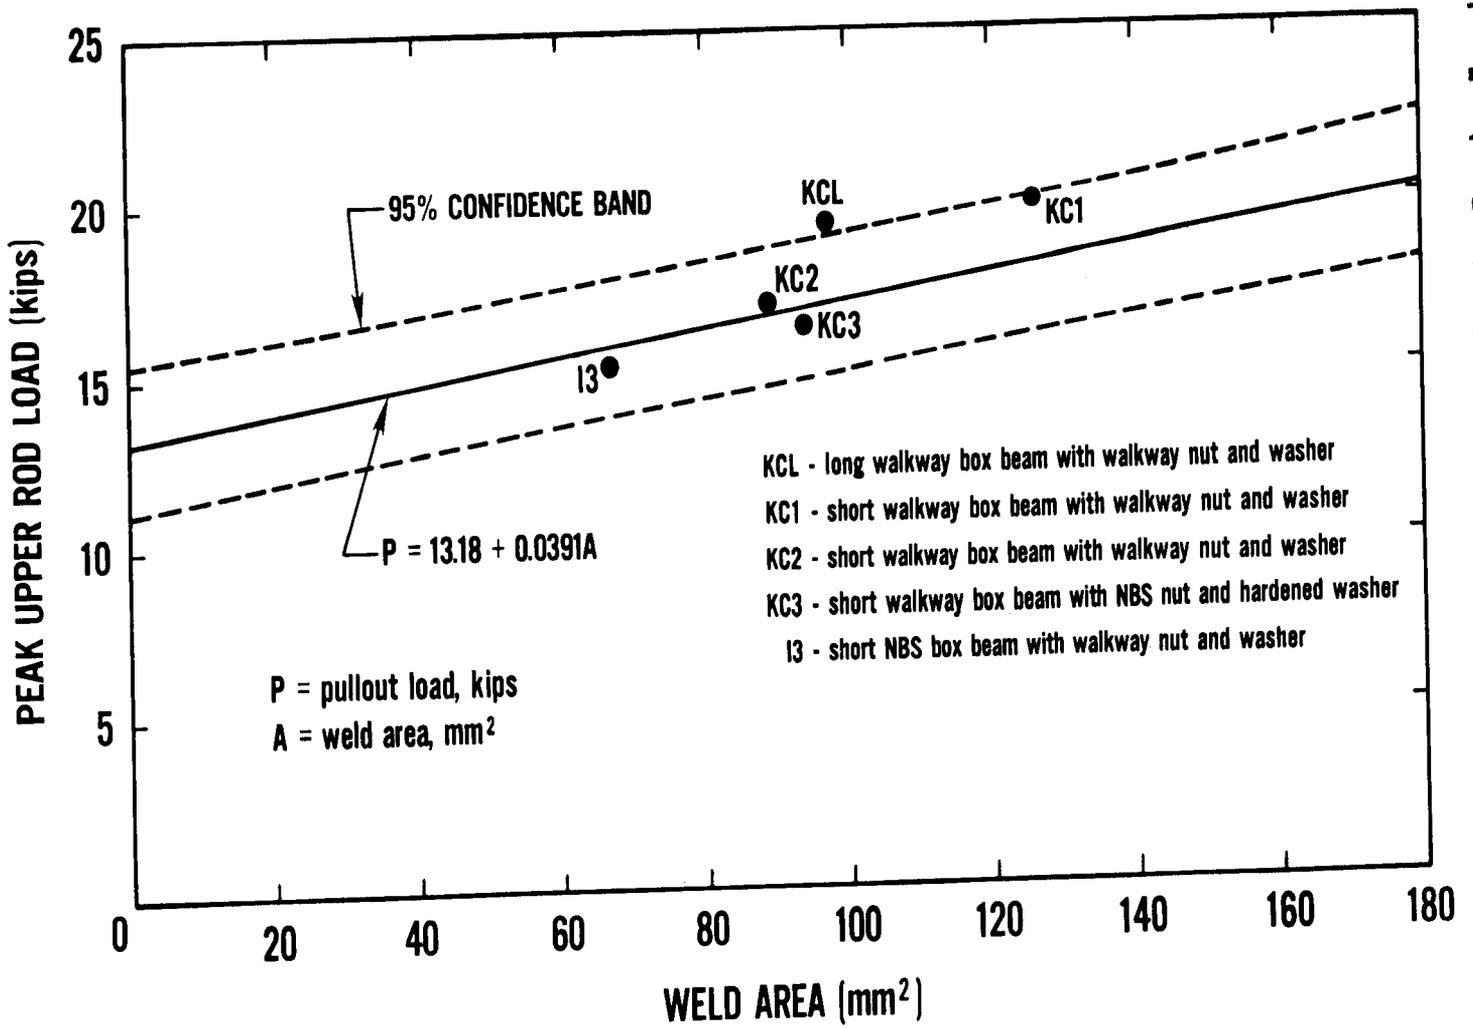
Figure 6.37 Comparison of walkway test series with NBS test results.

The remainder of the box beam test results involving walkway materials are shown in figure 6.37. Since the weld of specimen KCl never fully fractured the weld area recorded for this specimen is an estimate based on the area of

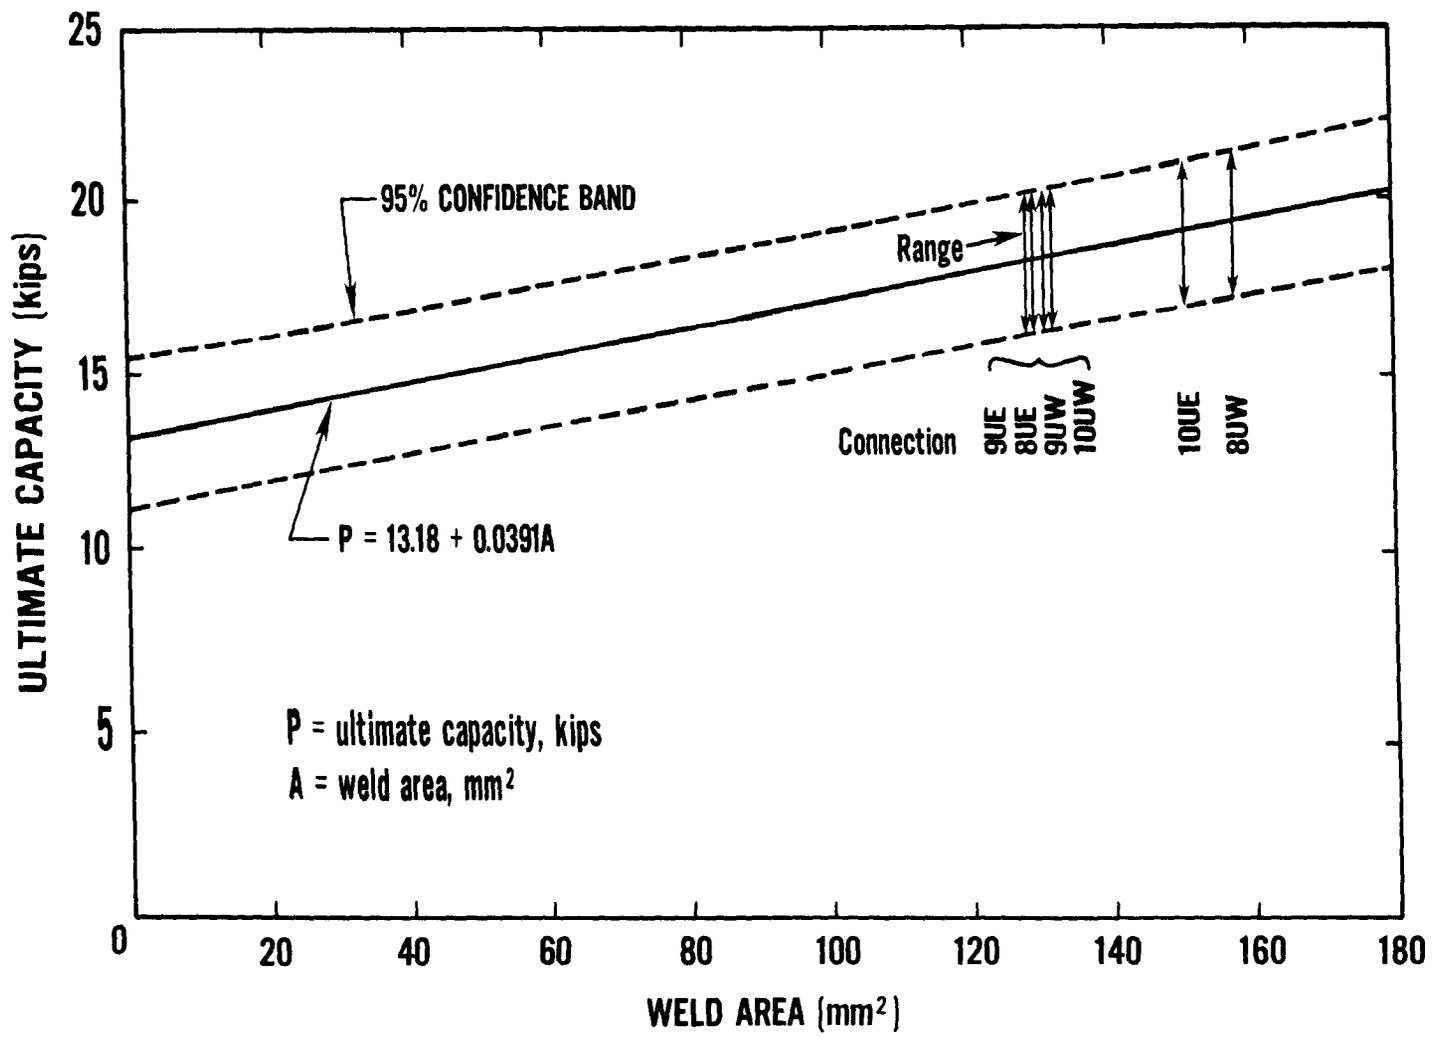
Figure 6.38 Estimated ultimate capacity for walkway box beam-hanger rod connections.

The meaning of figure 6.38 is amplified by discussing box beam-hanger rod connection 9UE as an example. Simply described, if many specimens like 9UE were tested, their average should fall close to the regression line. However, for a single test one can be 95 percent confident that the test result would fall within the 95 percent confidence band. Thus each connection should be thought of in terms of the range of ultimate strength as well as the average.

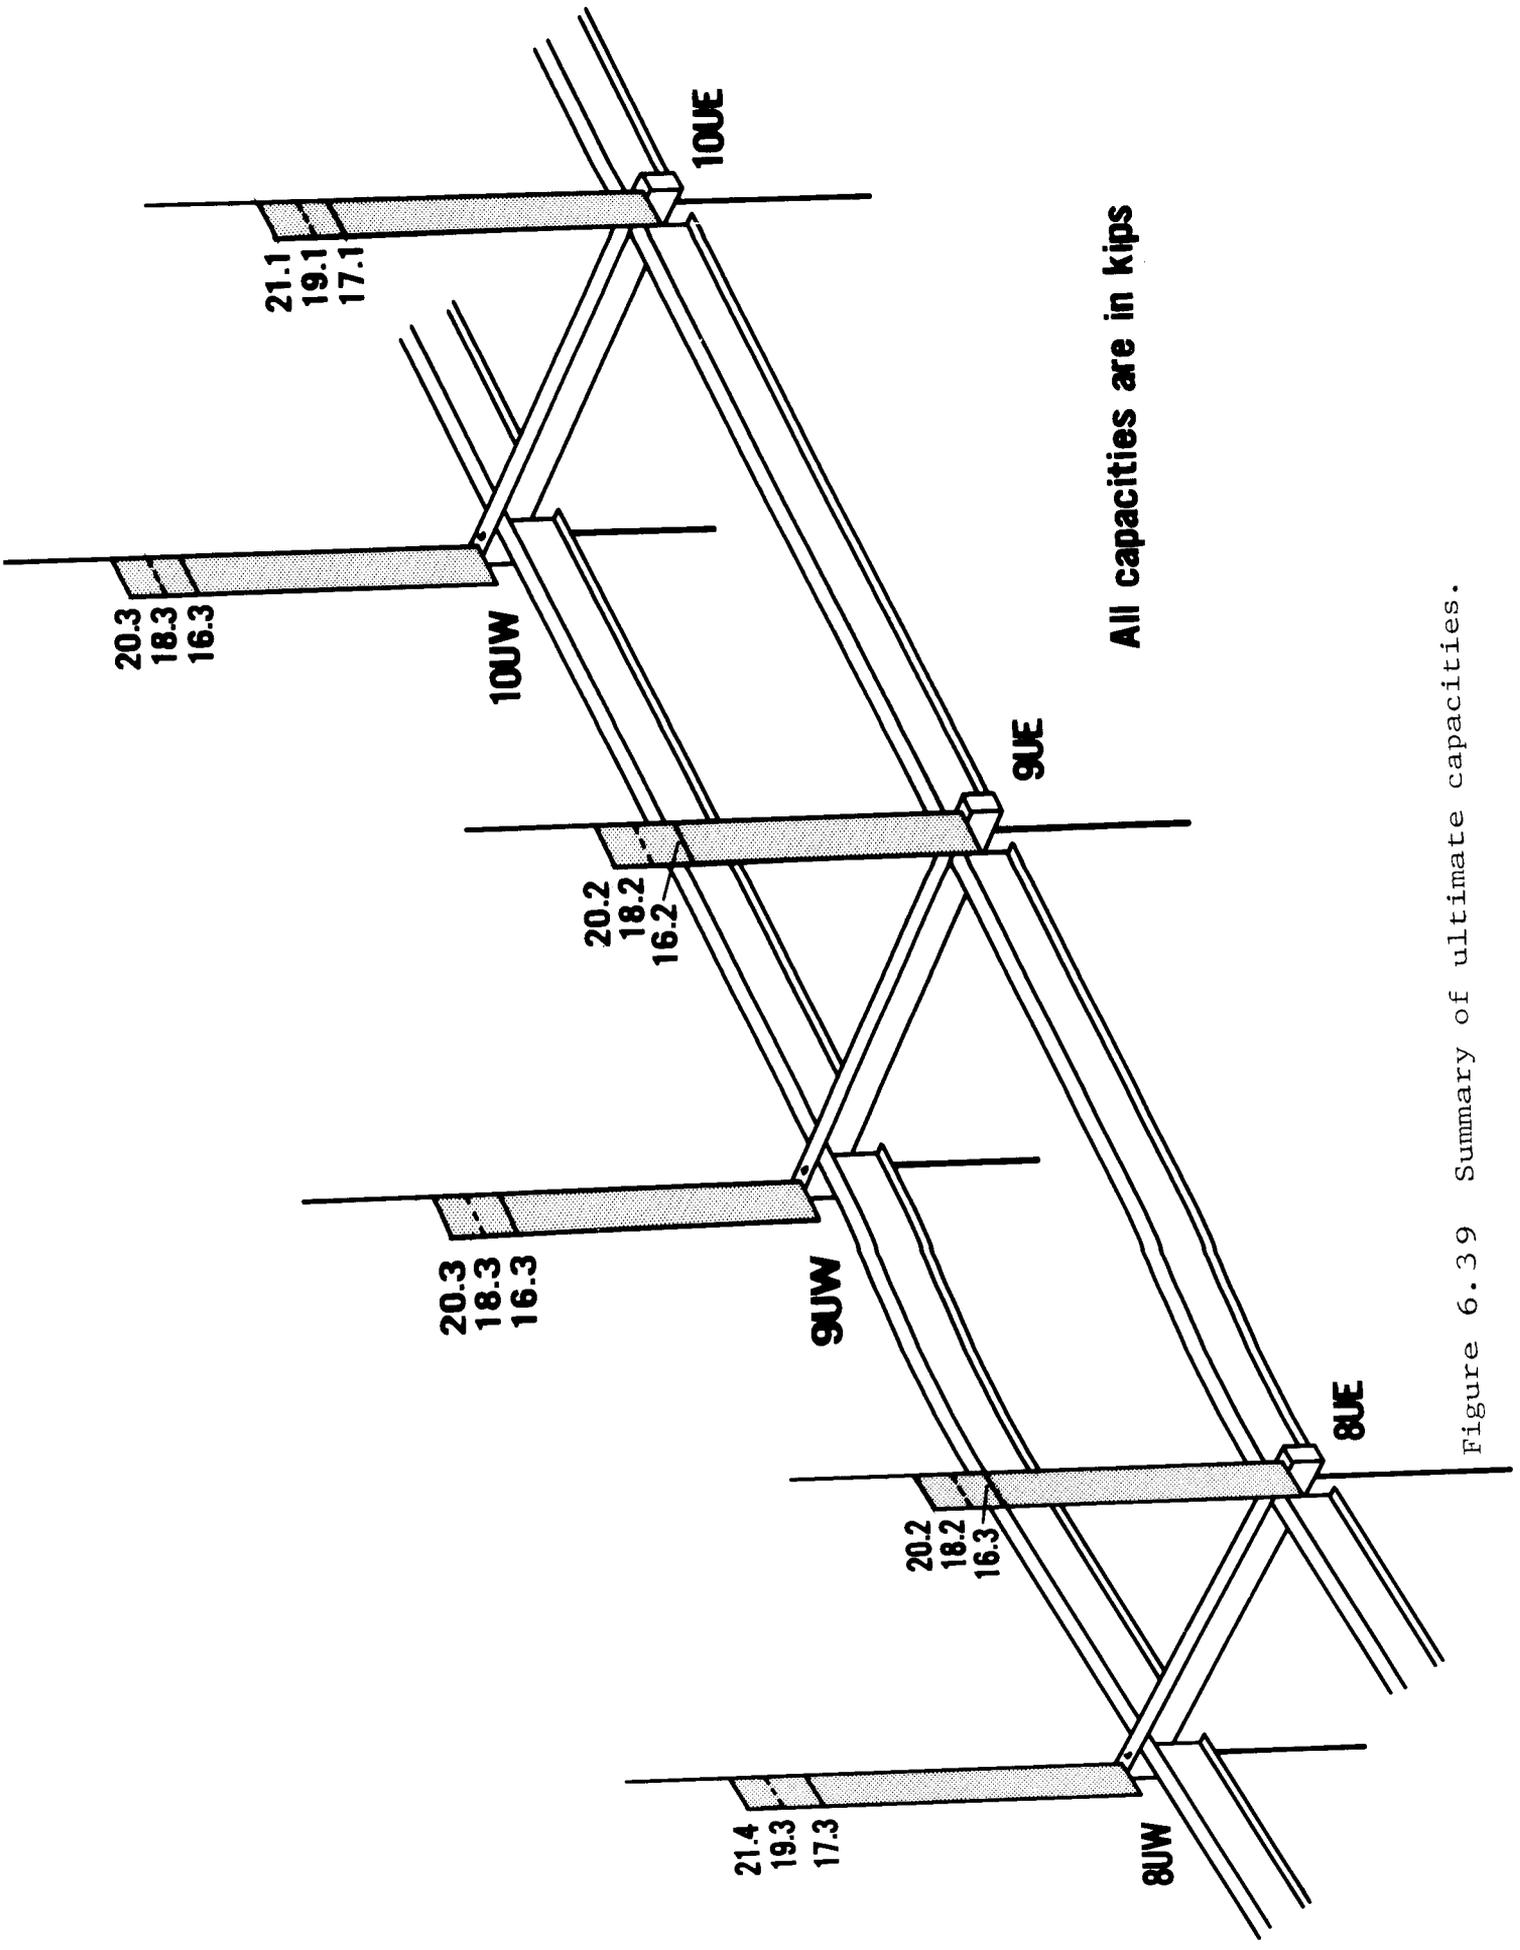
Figure 6.39 Summary of ultimate capacities.

These ultimate capacities are summarized in figure 6.39 on a layout of the six box beam-hanger rod connections. A bar diagram is shown adjacent to each hanger rod. Location 8UE is described to denote the meaning. The range from 16.3 to 20.2 kips (73 to 90 kN) is the 95 percent confidence interval estimate for this particular box beam-hanger rod connection. The mean ultimate capacity of 18.2 kips (81 kN) is also shown. The mean capacity for all connections is 18.6 kips (83 kN).

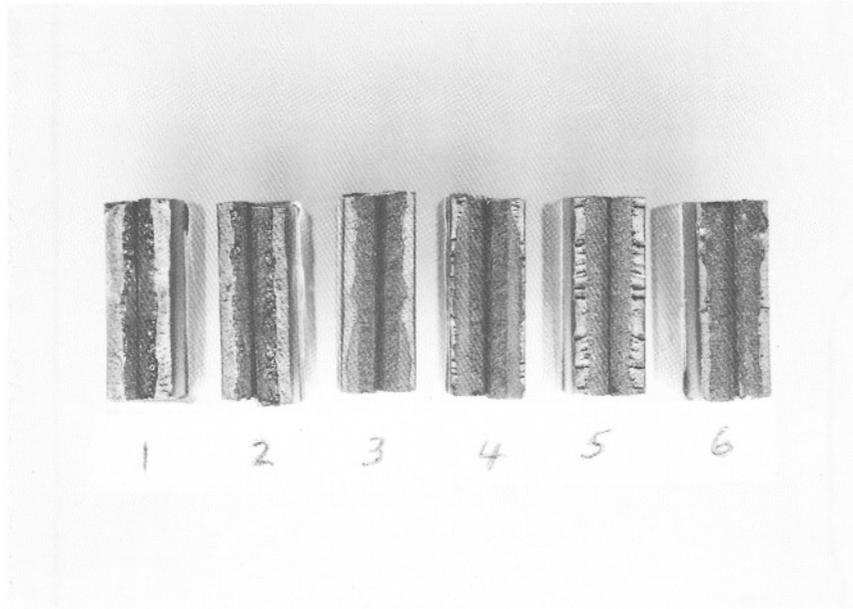
Variation in the transverse strength of the walkway box beam longitudinal welds was determined by testing 1.0 in (25.4 mm) wide tensile coupons to failure. Weld caps were machined flush to simulate conditions near the beam ends. The results, summarized in table 7.5, show a substantial variation in breaking load among specimens taken from the same beam. The observed variability is not unusual for the type of weldment tested considering the small weldment area sampled by each specimen. Figure 7.9 shows the variability in the amount of weld metal from specimen to specimen at the fracture. This variability correlates reasonably well with the specimen breaking loads (table 7.5). Differences in the amount of porosity found on the fracture surfaces of the specimens also contribute to the ultimate strength variation.

Figure 7.9 Fracture surfaces of walkway weldment tensile specimens. Both halves of each fracture are shown. The bright regions represent fracture and indicate the depth of weld penetration. Specimen key is as follows. X1

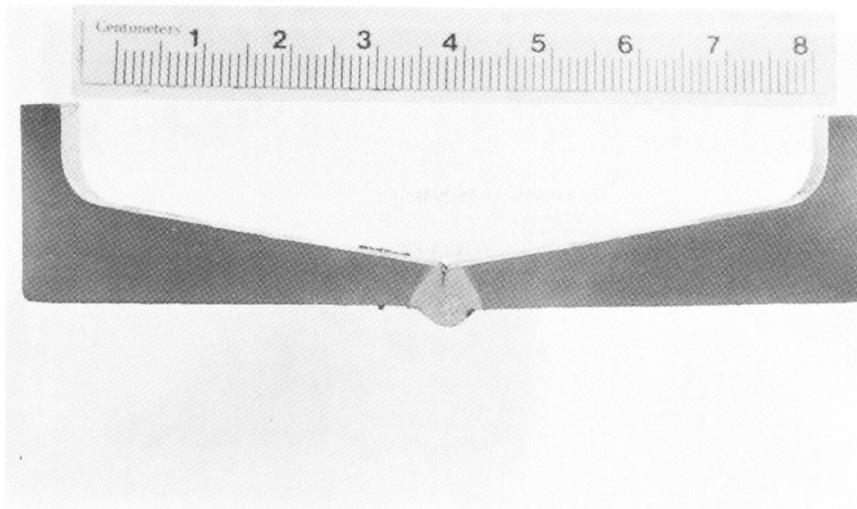
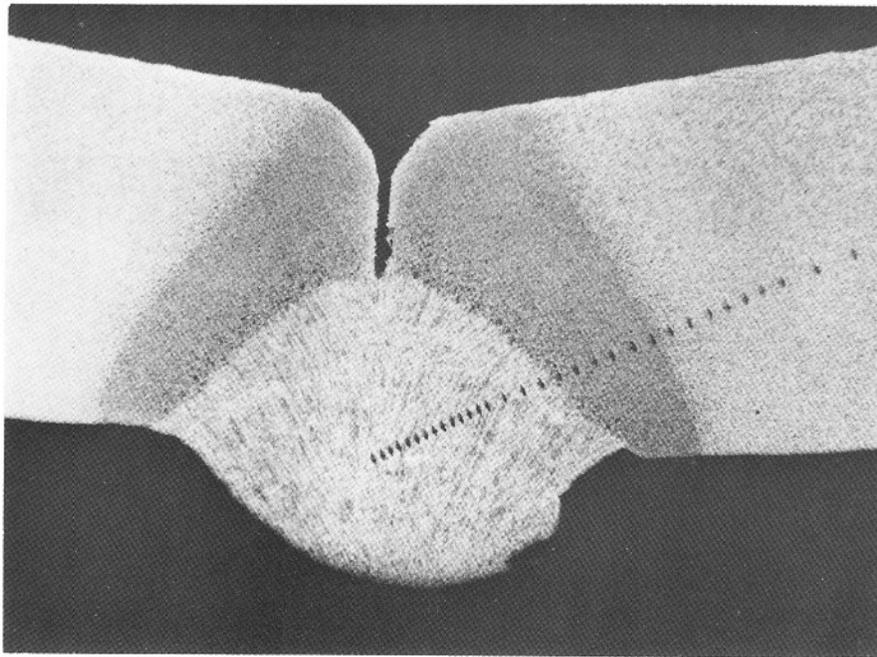
Figure 7.10 illustrates the appearance of an NBS weldment made by the GMAW process, while figures 7.11-7.13 illustrate the appearance of weld regions in box beams 9U, 8L and 9M, respectively. Basic walkway weldment hardnesses were normal. Maximum hardnesses were 92-95 Rockwell B (HRB) for the weld regions, 85-93 HRB for the heat-affected zones and 70-79 HRB for the unaffected parent metal. Small zones of increased hardness (28-33 HRC) were noted in the heat-affected zones of one section taken from location 9U and one section taken from location 8L. The structure of the hard zones appeared to be tempered martensite.

Figures 7.10 to 7.13 illustrate a substantial variability in the contour of the mating flange ends forming the faying surfaces for welding. The effect, coupled with differences in weld penetration, creates regions of varying notch acuity in the weld region. However, no cracks were observed to have initiated from such notches in any of the sections studied.

Figure 7.10 Transverse section through NBS weldment IC welded by the GMAW process. Dark regions separating weld metal from flange base metal are heat-affected portions of base metal. Aligned indentations are microhardness measurements. a, X1; b, X8 1/2

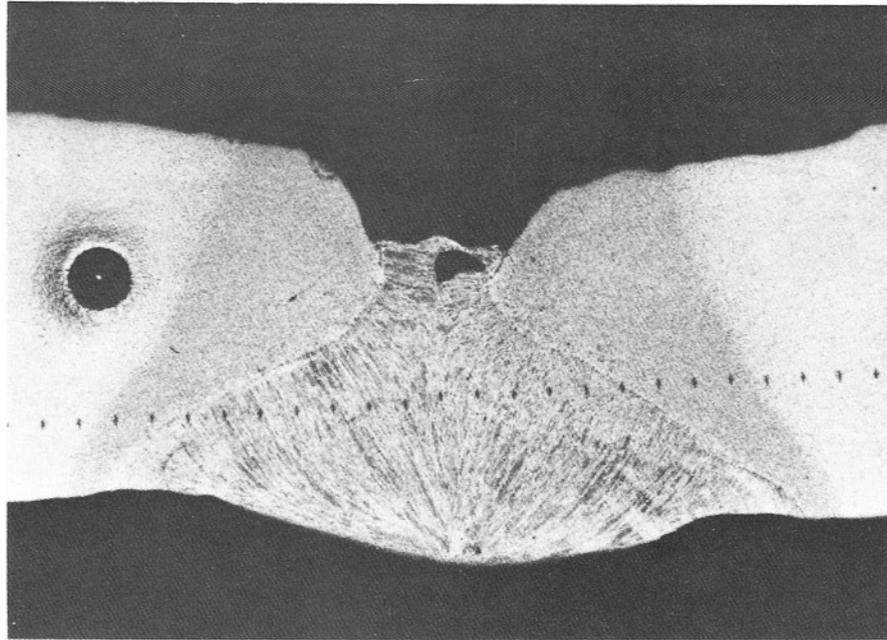
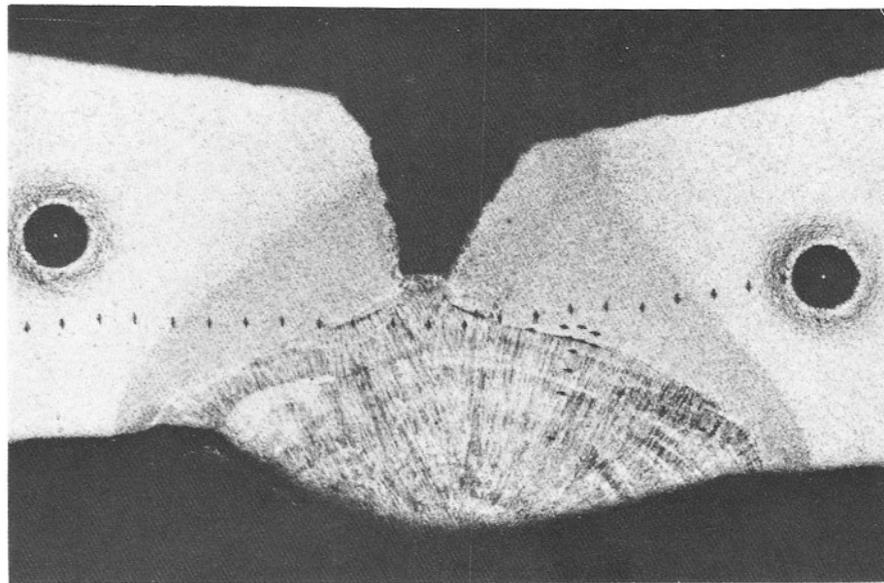
Figure 7.11 Cross sections through weld regions of box beam 9U (NBS 1). Sections were separated about 7 in (180 mm) along the beam length. Microhardness indentations traverse the surfaces. X 8 1/2

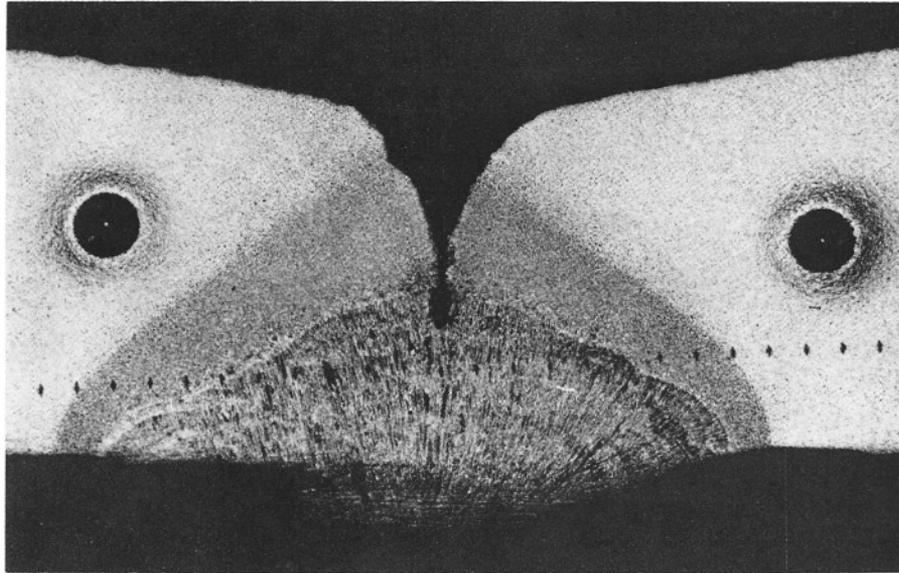
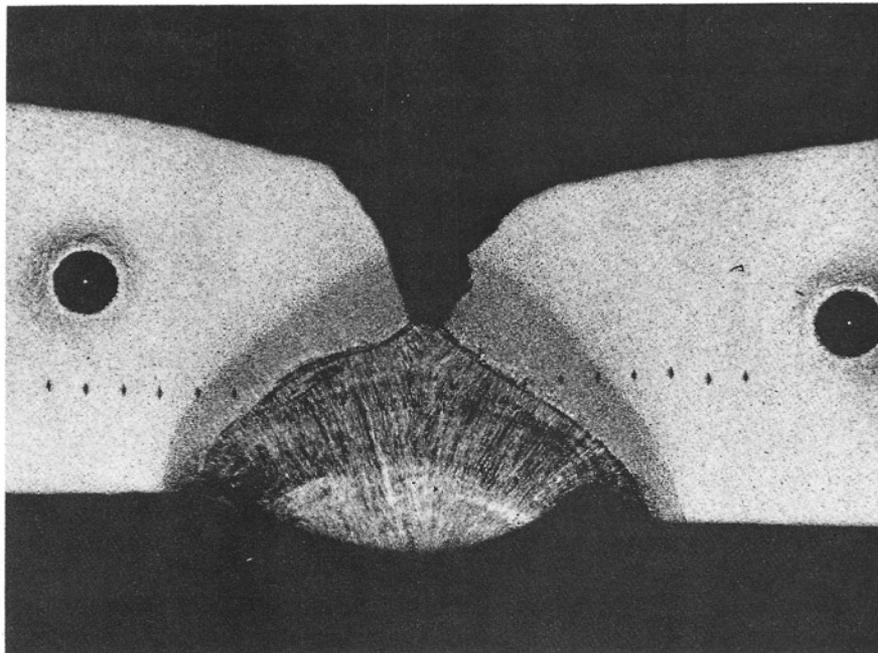
Figure 7.12 Cross sections through weld regions of box beam 8L. Sections were separated about 7.5 in (190 mm) along the beam length. Microhardness indentations traverse the surfaces. X8 1/2

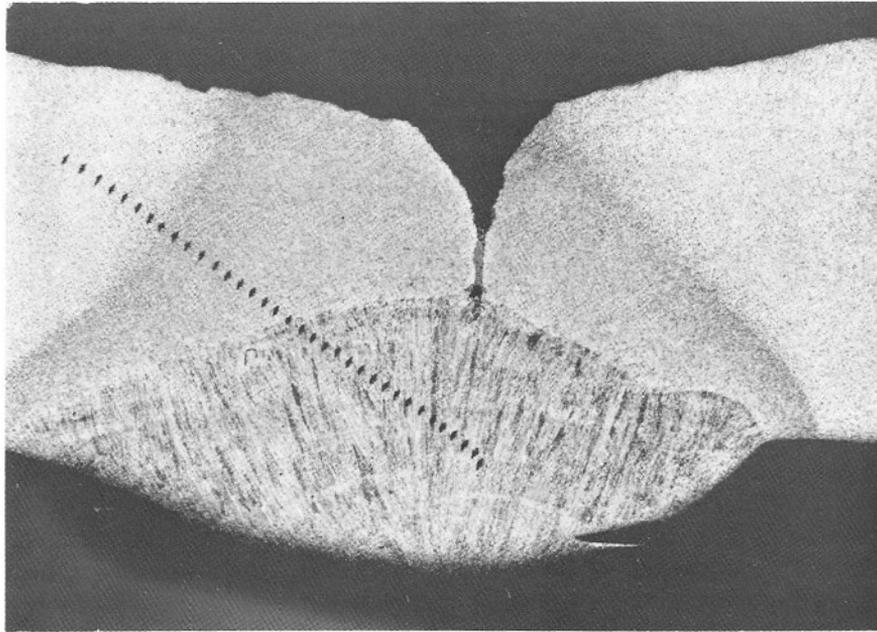
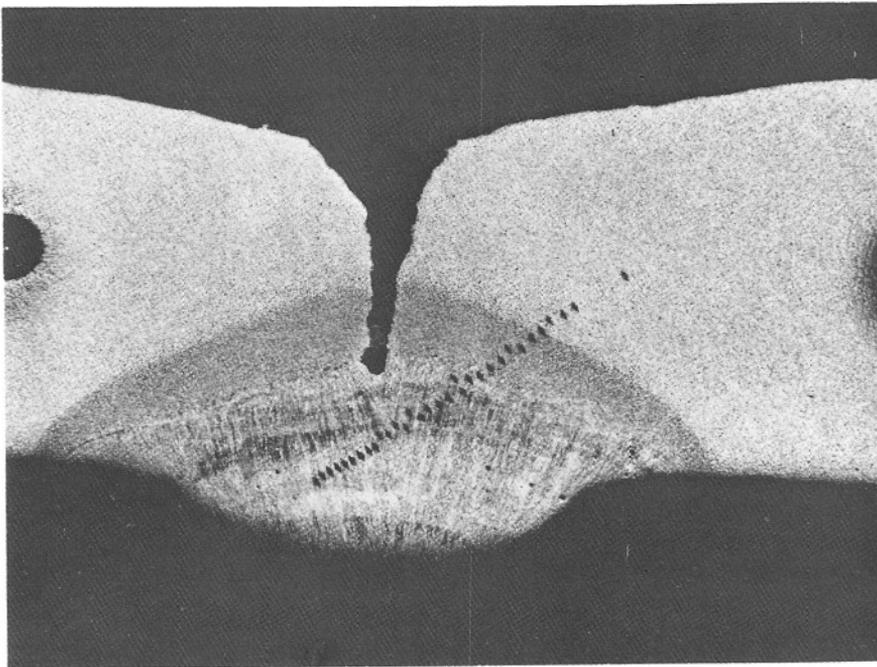
Figure 7.13 Cross sections through weld regions of box beam 9M. Sections were separated about 7.5 in (190 mm) along the beam length. Microhardness indentations traverse the surfaces. X8 1/2

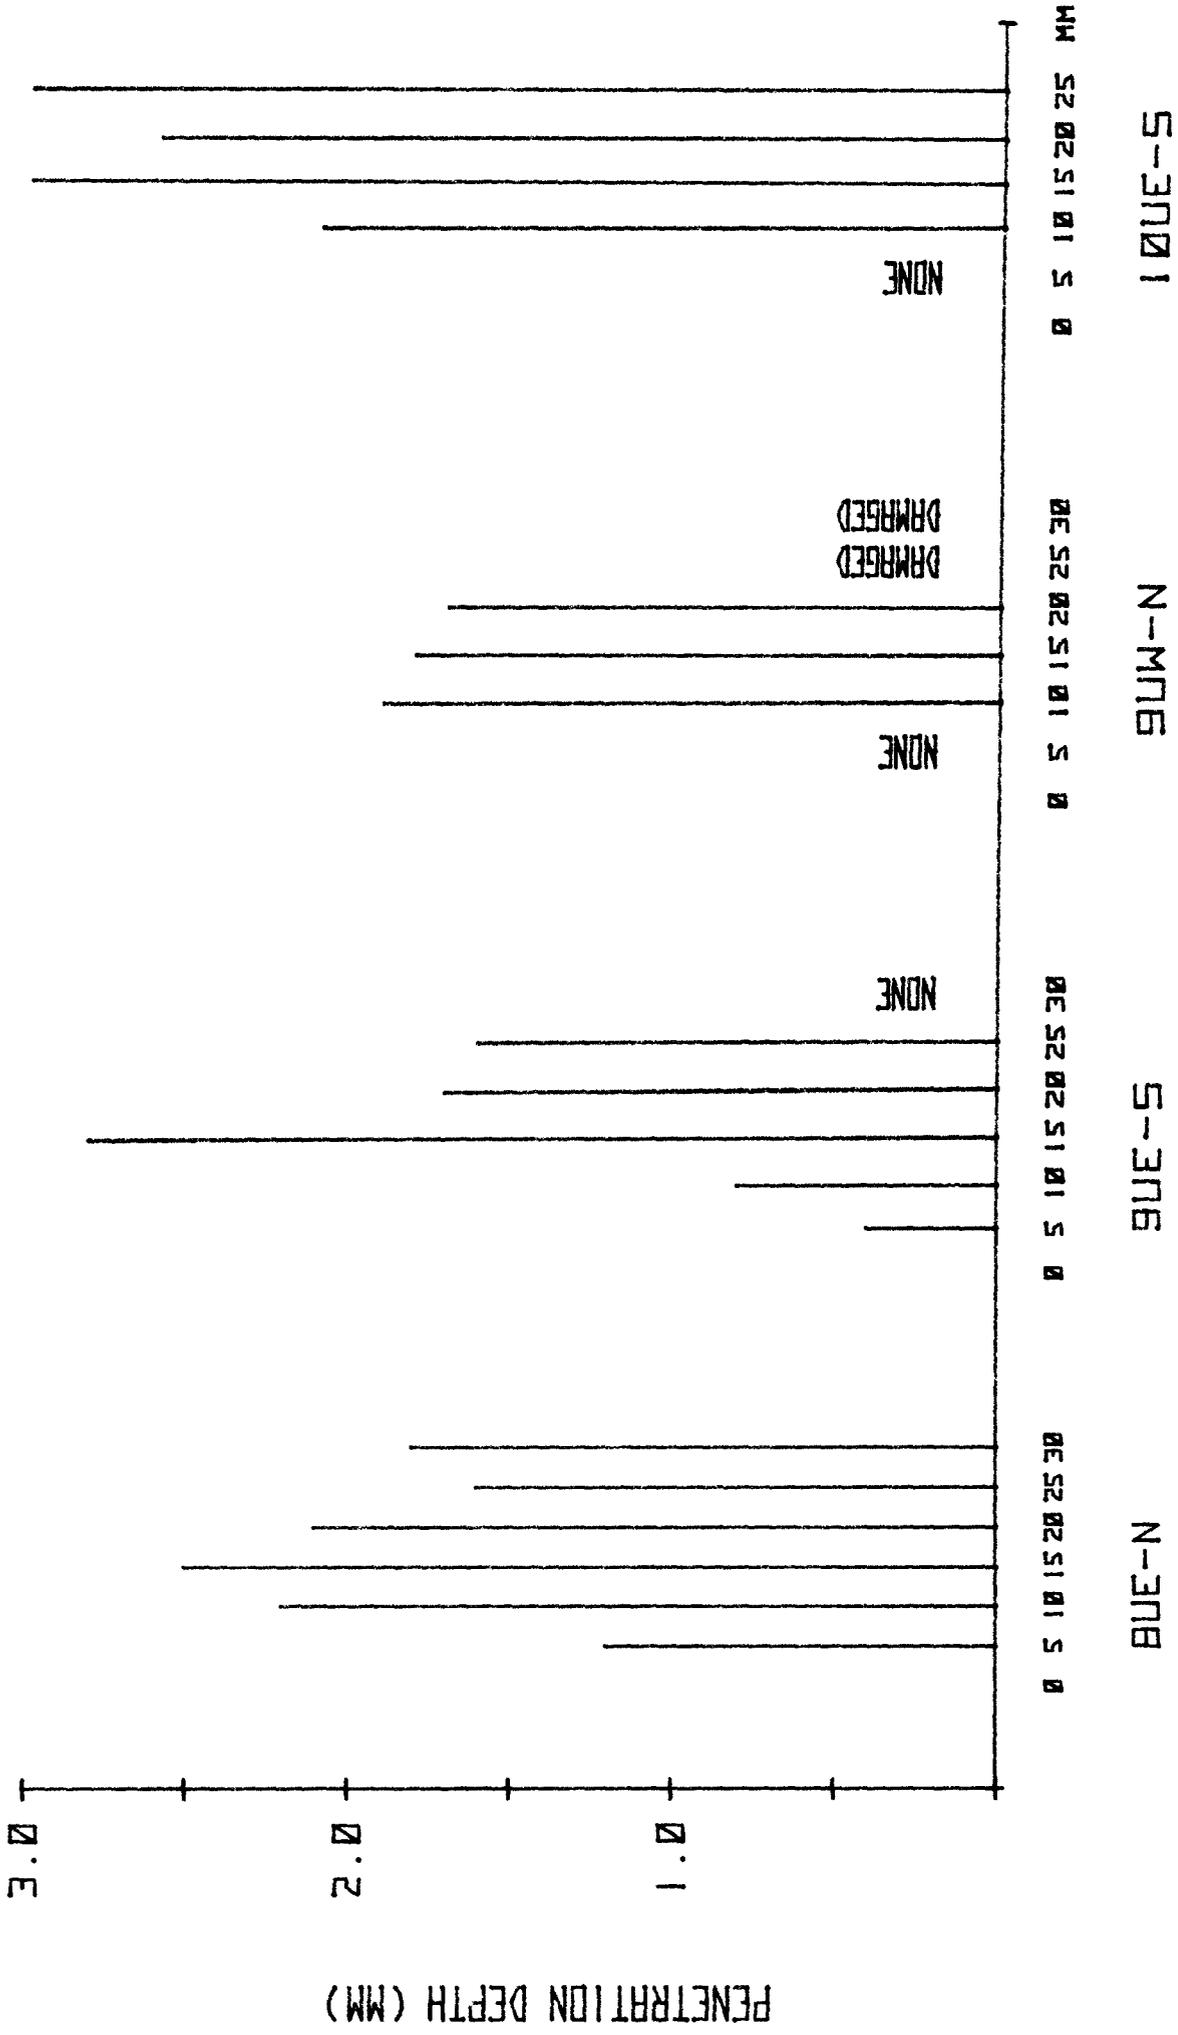
Figure 7.15 Overall depth of interior tack welds measured from fractures with data points reflecting equally spaced measurements from beam end (left) to hanger rod hole (right). NONE indicates no tack weld at that location.

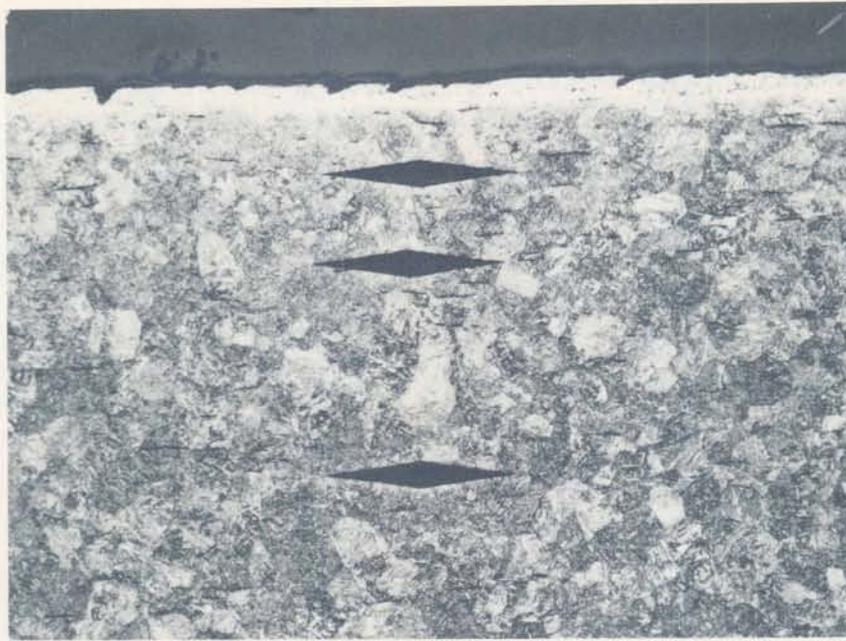
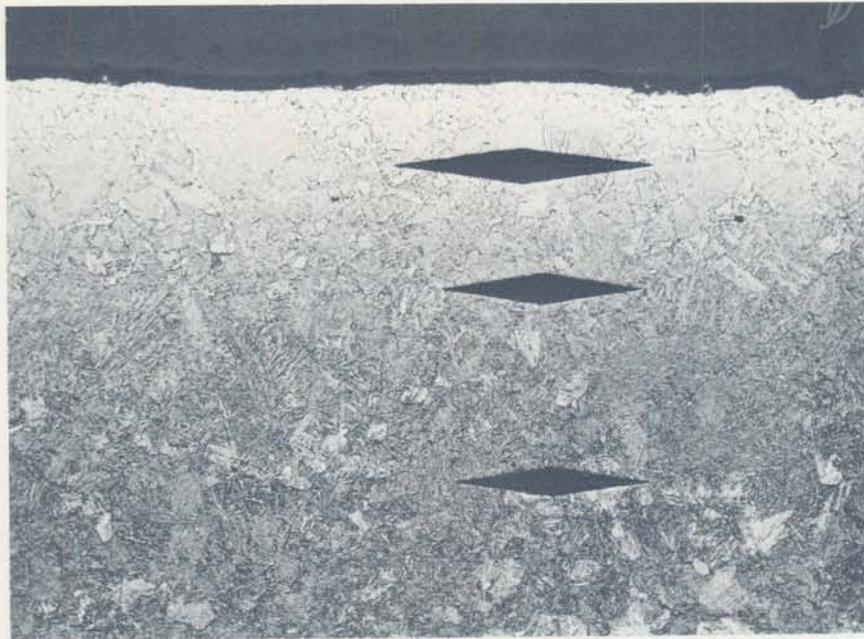
Photomicrographs of the fractured washer (9MW) and of the NBS hardened washer in figure 7.16 show a tempered martensite interior and a thin decarburized layer on the surface. This is typical for hardened washers.

Figure 7.16 Microstructures of washers from 9MW (NBS specimen 3), (a), and of hardened washer used in NBS tests, (b). Whiter layer near surface (top of illustrations) is decarburized layer. Interior structure is tempered martensite. Etchant: Picral. X200

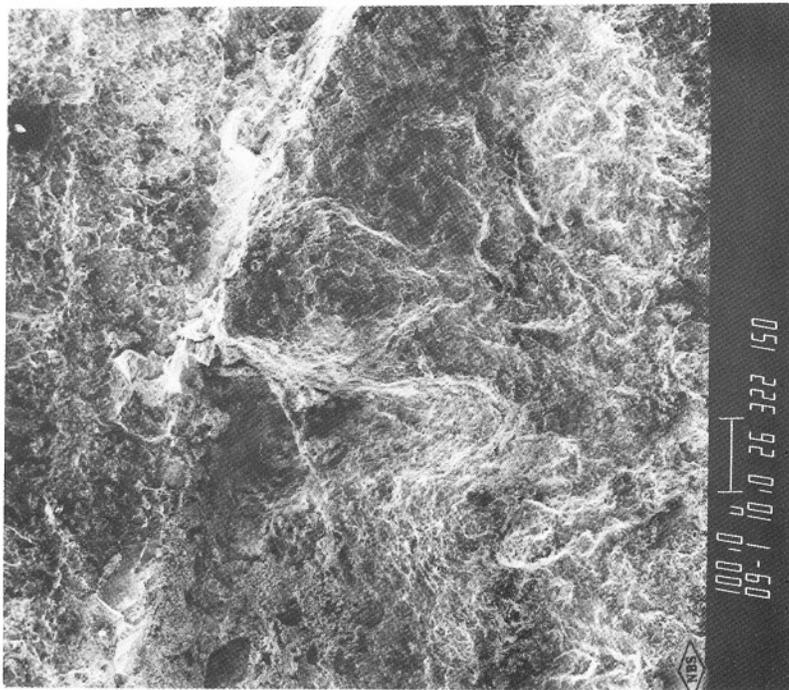
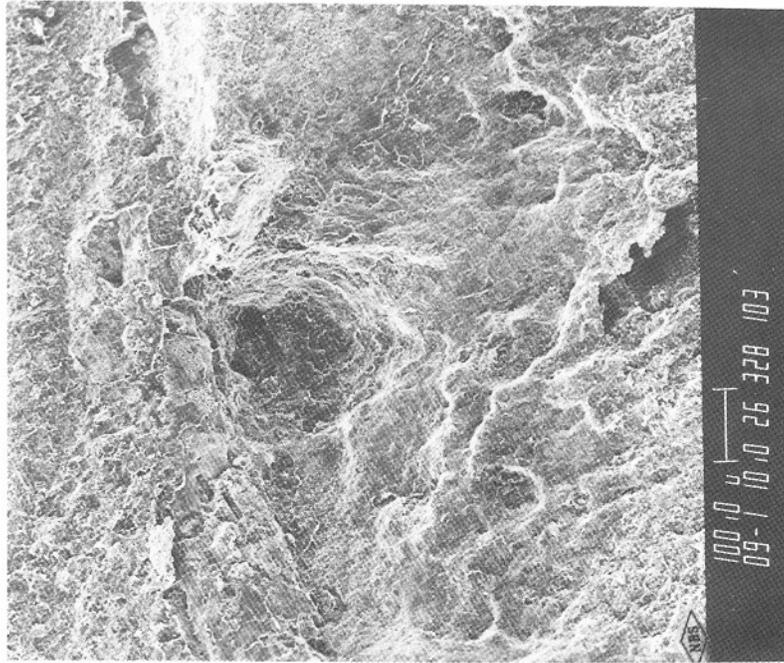
Procedures used to replicate the fracture surfaces have been described in section 5.5. The replication technique is capable of reproducing details of the fracture surface with reasonable fidelity, provided that intimate contact is achieved between the replication media and the surface (figure 8.1). Failure to achieve contact produces artifacts in the replica that must be discounted in the analysis. The replica is a mirror image of the original surface and may have a different sense of image contrast--in one case the image contrast is due to both topography and composition variation (8.1a) and in the other the image contrast is due to topography alone (8.1b). Selection of a specific replica from each surface for study was based on visual evaluation of the

Figure 8.1 Comparison of quality of image by direct SEM (a) and by replication (b) where replica contact is ideal. Fracture surface is located at root of upper exterior longitudinal weld of walkway box beam at location 8UW (north). Magnification X100.
