NBS BUILDING SCIENCE SERIES 143

# Investigation of the Kansas City Hyatt Regency Walkways Collapse

R. D. Marshall  
E. O. Pfrang  
E. V. Leyendecker  
K. A. Woodward

Issued May 1982

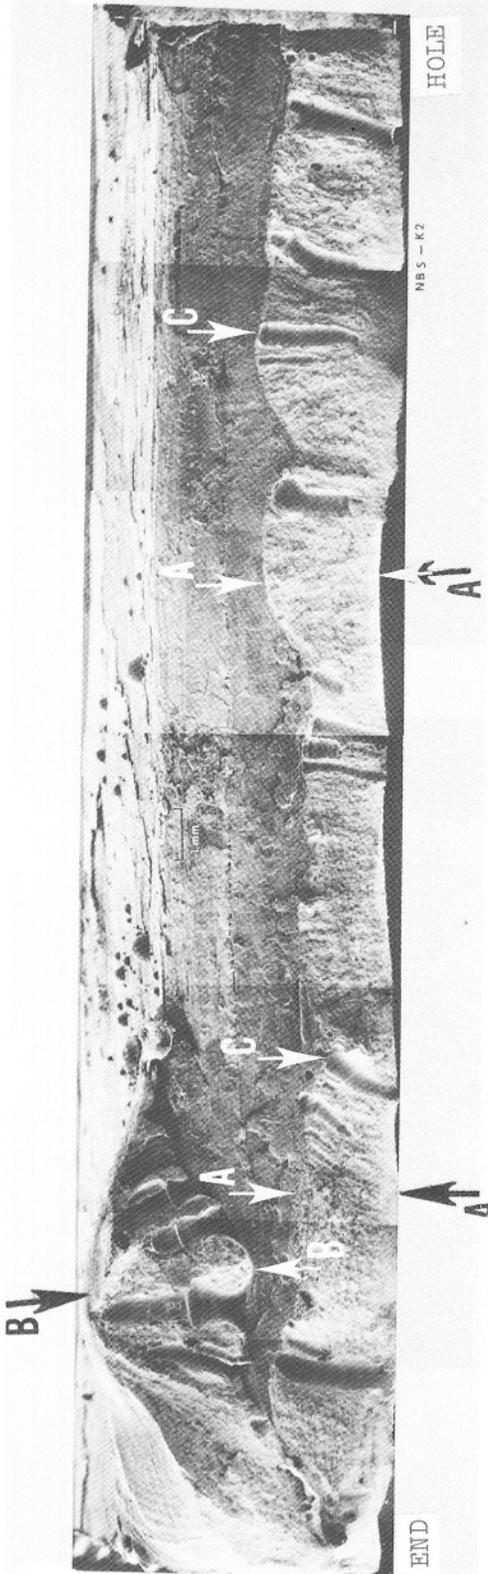
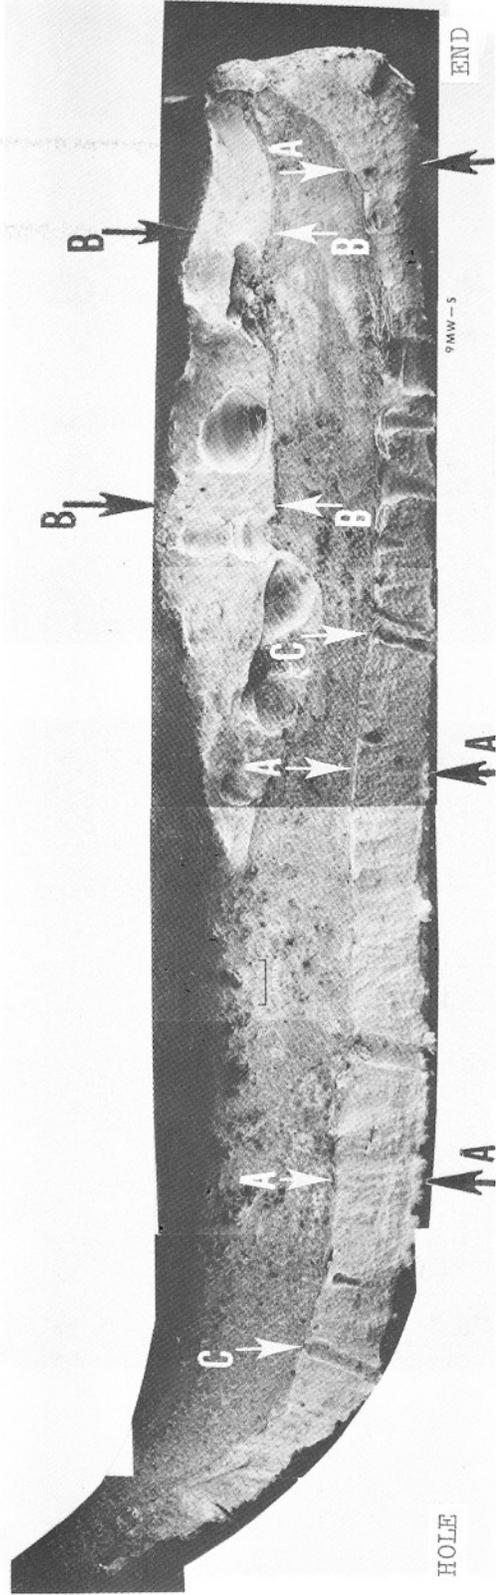
Figure 8.2 illustrates that the gross features of the fracture in the lower longitudinal weld between the outer hanger rod hole and beam end of box beams tested to failure were similar, regardless of whether the beam had been fabricated at NBS or had been obtained from the walkway debris. Rounded and piping porosity are evident in both fractures. The sharply delineated weld region in these figures indicates the absence of rust on the freshly fractured surfaces.

Rounded gas porosity (both large and fine) and piping (elongated) porosity similar to that illustrated in figure 8.2 were evident in the fracture areas of the interior tack and exterior longitudinal welds at locations 8UE, 9UE, 9UW, and 10UE. Fractographic examination indicated that these flaws did not serve preferentially as crack initiation sites. It appears that, in the case of the lower exterior welds, cracks initiated at the root of the weld and propagated

Figure 8.2 One half of box beam fracture surface between beam end and outer hanger rod hole for NBS fabricated box beam K2 (a) and for walkway box beam 9M tested at NBS (b). Exterior longitudinal weld indicated by arrows A, interior tack weld indicated by arrows B, examples of piping porosity indicated by arrows C. Magnification X6.

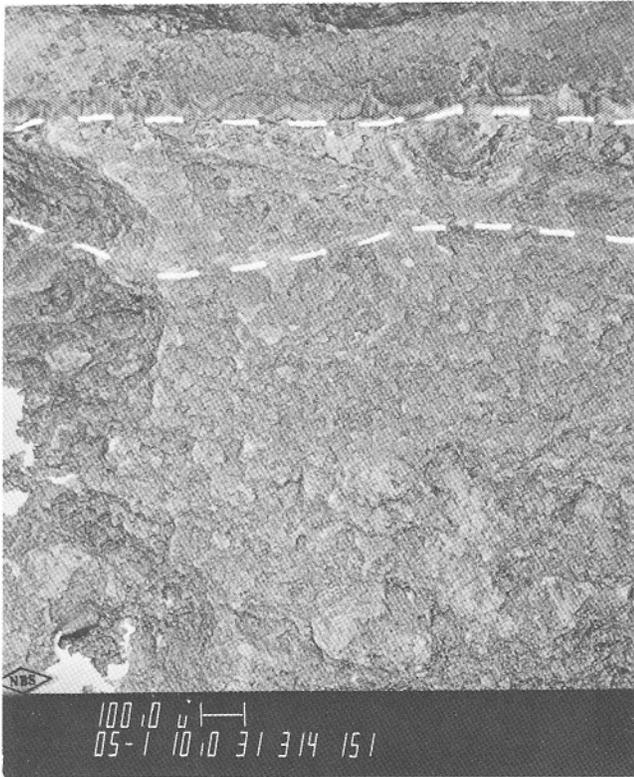
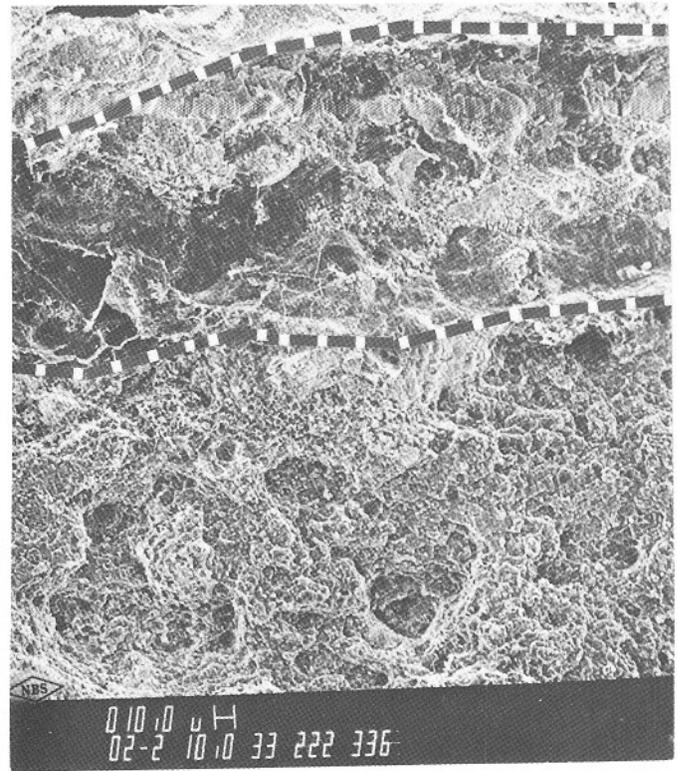
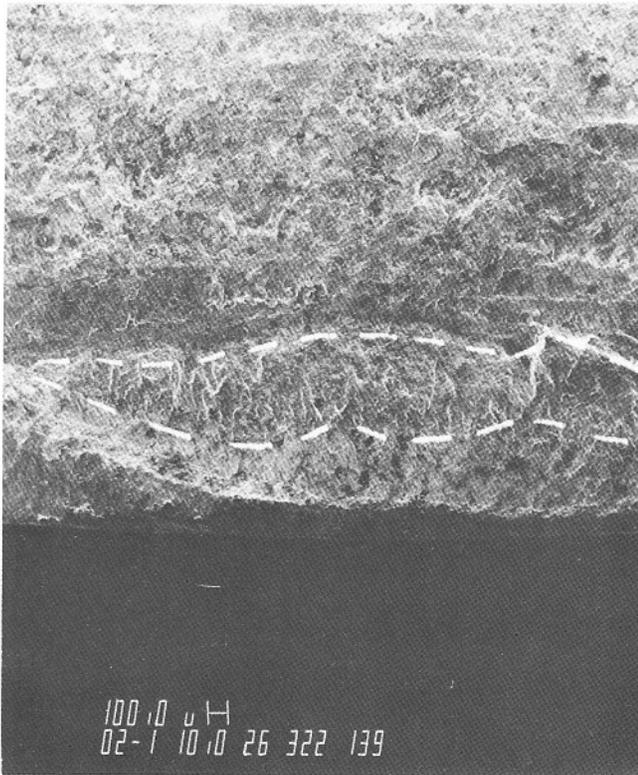
Different textures in the fracture topography provided evidence that cracks had existed in the weld roots in the regions between the hanger rod holes and in the regions between the outer hanger rod holes and beam ends prior to gross weld failure at the time of collapse. Figures 8.5 (a-c) illustrate the appearance of several such regions in the exterior longitudinal welds at locations 9UW, 9UE and 8UW.

Figure 8.5 Fractographic evidence of pre-existing cracks in walkway box beam exterior longitudinal welds at locations (a) 9UW, (b) 9UE, (c) 8UW. Regions interpreted as cracks outlined by dashed lines. Magnifications X55, X250, and X25, respectively.

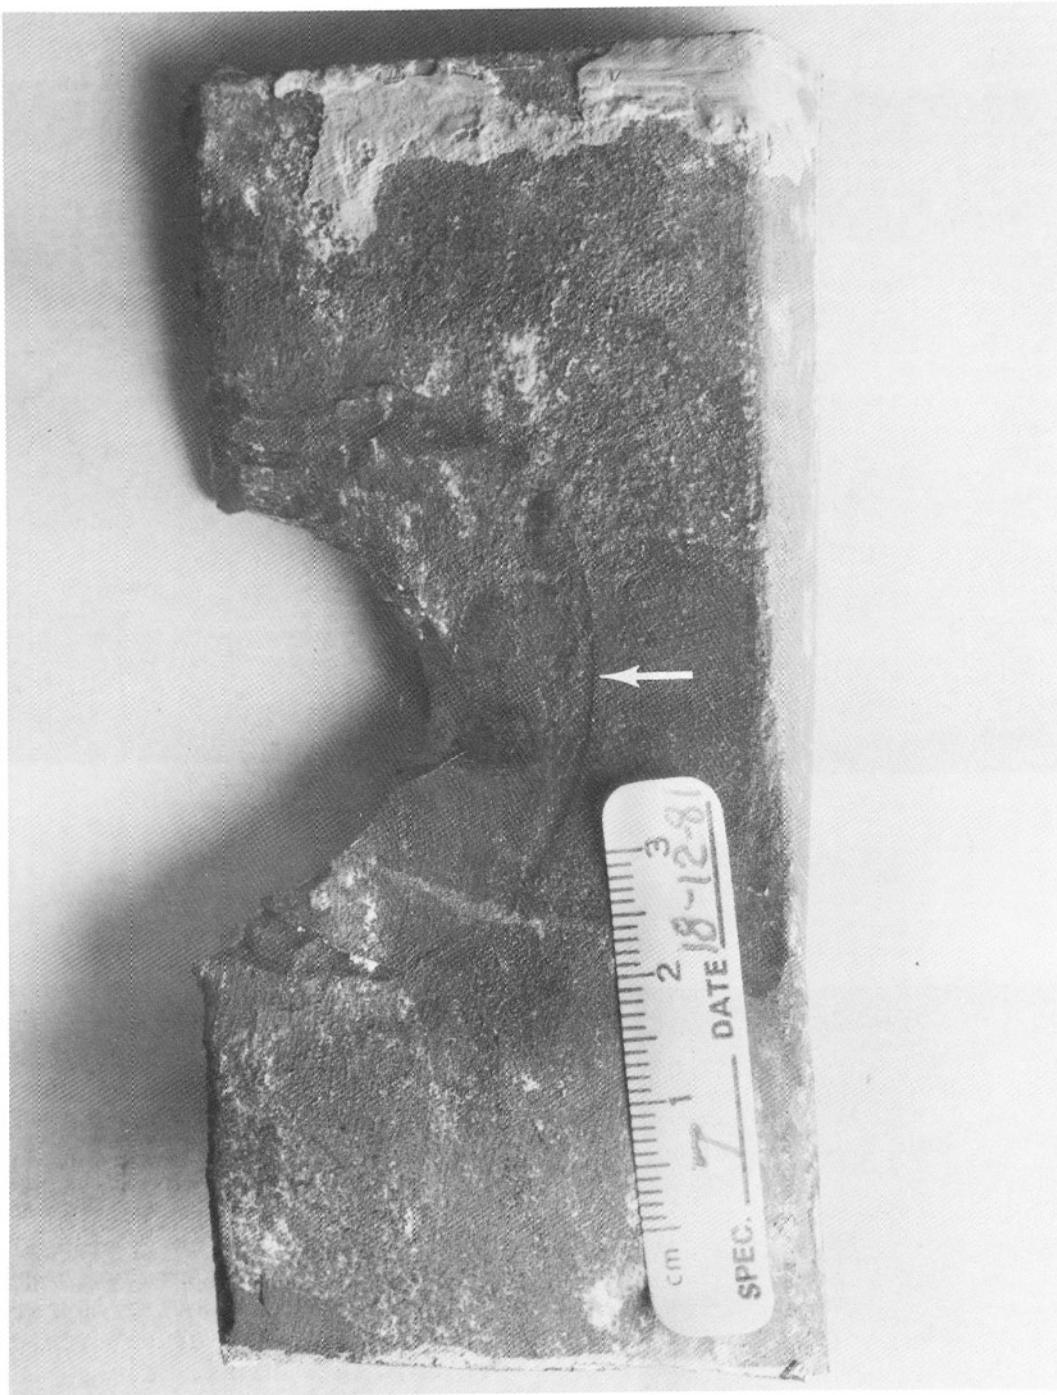
Washers at locations 9UE and 8UE were missing after the collapse. However, figures 8.8 and 8.10 provide clear evidence that washers had been installed at both locations.

Figure 8.10 Washer contact region on bottom flange at location 8UE (north).  
Arrow denotes initial washer position. Magnification X1.5.

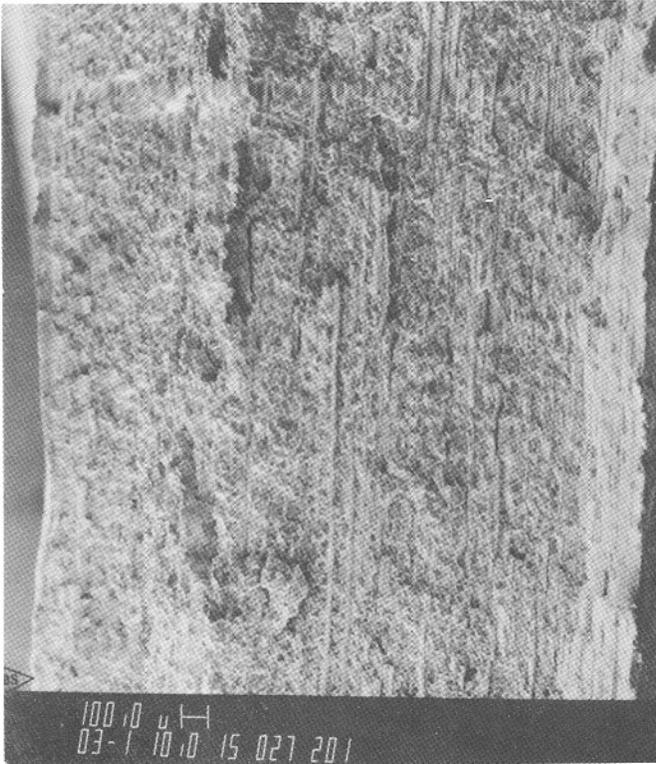
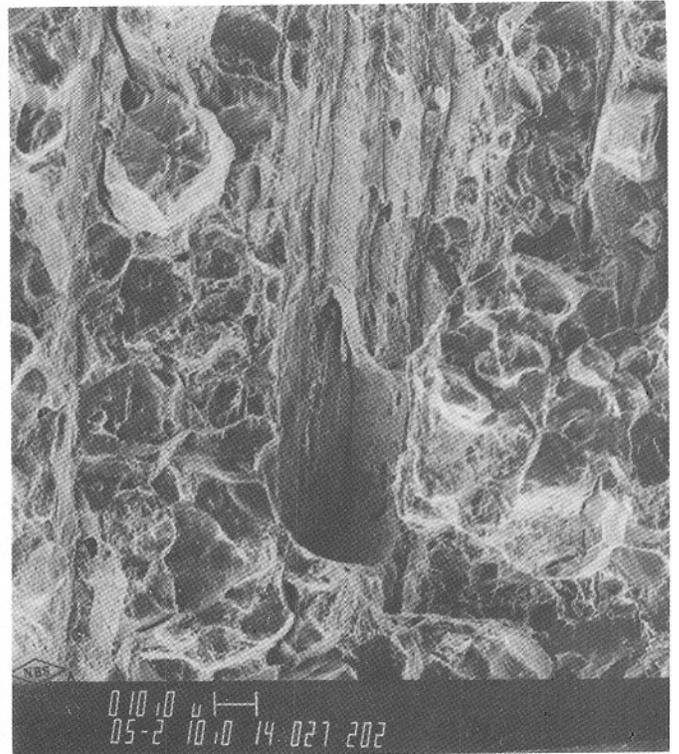
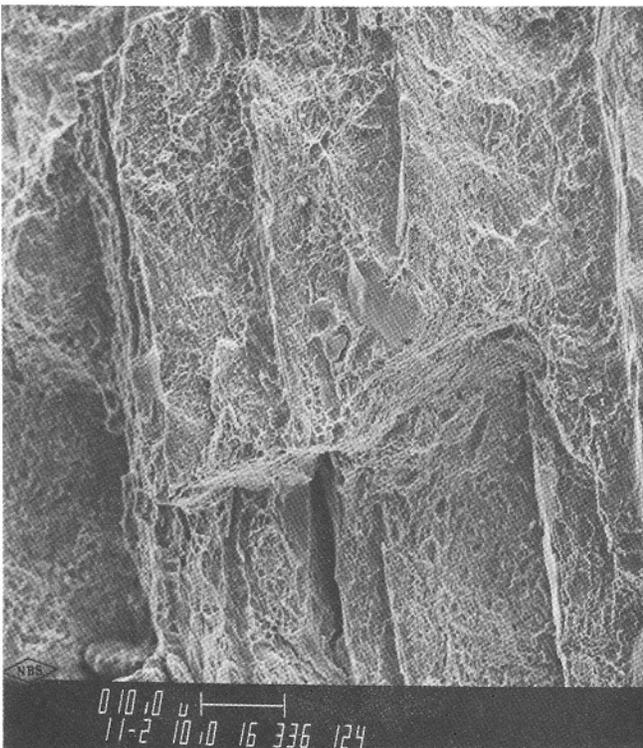
As noted in chapter 6, some washers obtained from the walkway debris fractured in the course of NBS beam tests while hardened washers purchased by NBS did not fracture under similar test conditions. Examination of the fracture surface of a walkway washer at location 9MW that failed during an NBS test conducted on walkway box beam 9M revealed that the washer had failed in a predominantly brittle manner. This is evidenced by the dominant intergranular and cleavage modes of failure illustrated in figure 8.11b. This is a magnified photomicrograph of the central region of the fracture surface shown in figure 8.11a. By contrast, figure 8.11c shows predominantly ductile failure at the surface decarburized layer of the washer.

Prominent elongated MnS inclusions can be observed on the fracture surfaces in figures 8.11a and 8.11c. Hardened washers bent around a direction parallel to such inclusions could be expected to display low ductility.

Figure 8.11 Fractographic appearance of hardened washer fractured in NBS test of walkway box beam 9M, washer installed at location 9MW (a). Center portion, area (b), reveals a mixture of brittle (intergranular and cleavage) and ductile fracture. Area (c) reveals ductile rupture through a decarburized surface layer. Elongated features are indicative of MnS stringers. Magnifications (a) X35, (b) X550, (c) X1050.

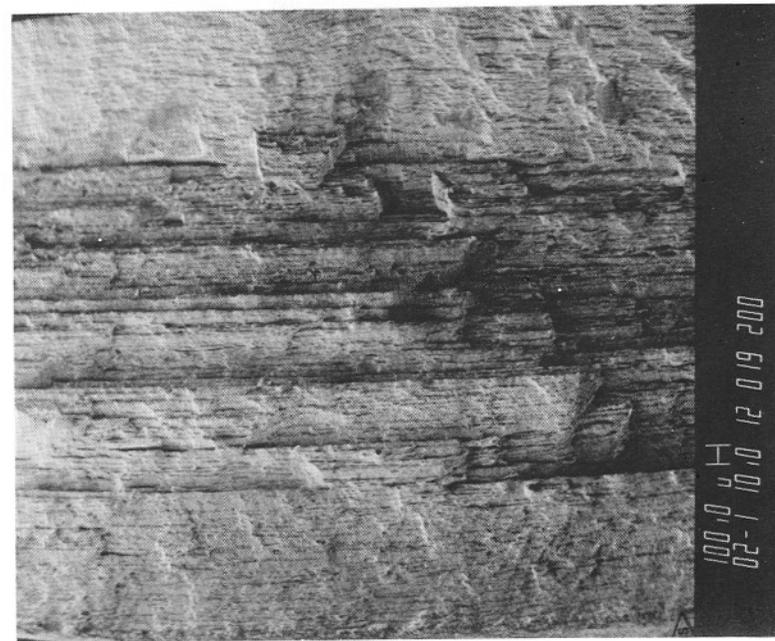
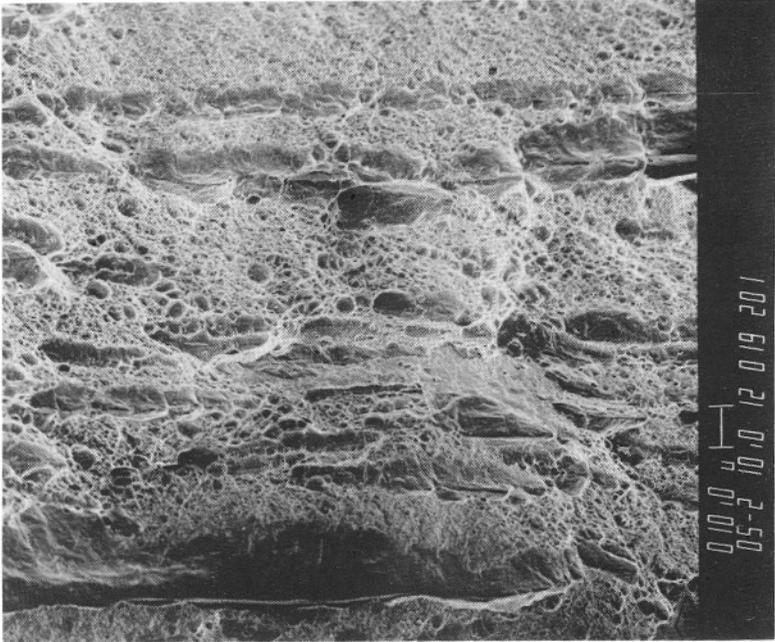
These figures show that the fracture characteristics of the walkway and NBS washers were basically similar. Both contained elongated stringers of MnS (figures 8.12a and 8.14a). Fracture characteristics of the walkway and NBS washers varied from predominantly ductile (figures 8.12 and 8.14) to predominantly intergranular (figures 8.13 and 8.15). However, the walkway washers displayed a higher percentage of intergranular fracture.

Figure 8.12 Fractographic appearance of walkway washer fractured in NBS test of box beam 9M (specimen KCl). Lower magnification view (a) shows high density of MnS stringers oriented parallel to the bend axis. Higher magnification view of center portion (b) shows mostly ductile rupture. Magnification (a) X25, (b) X550.

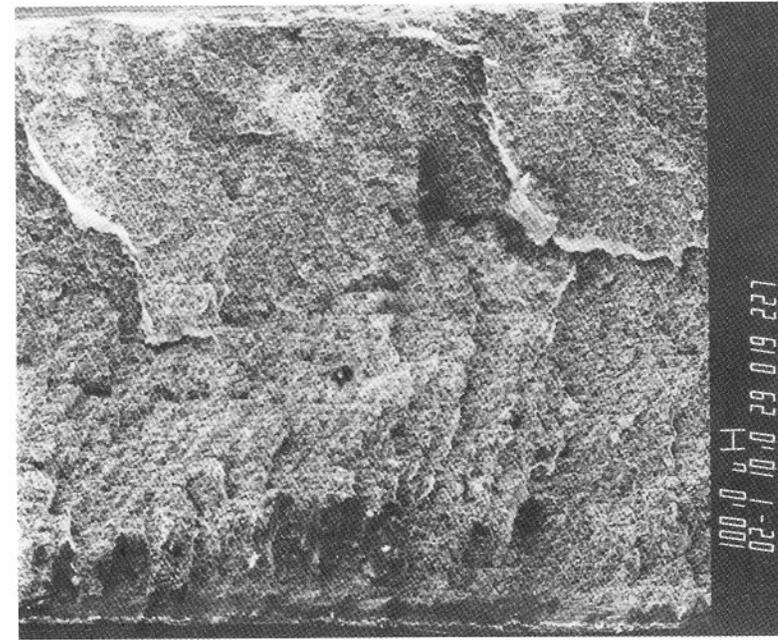
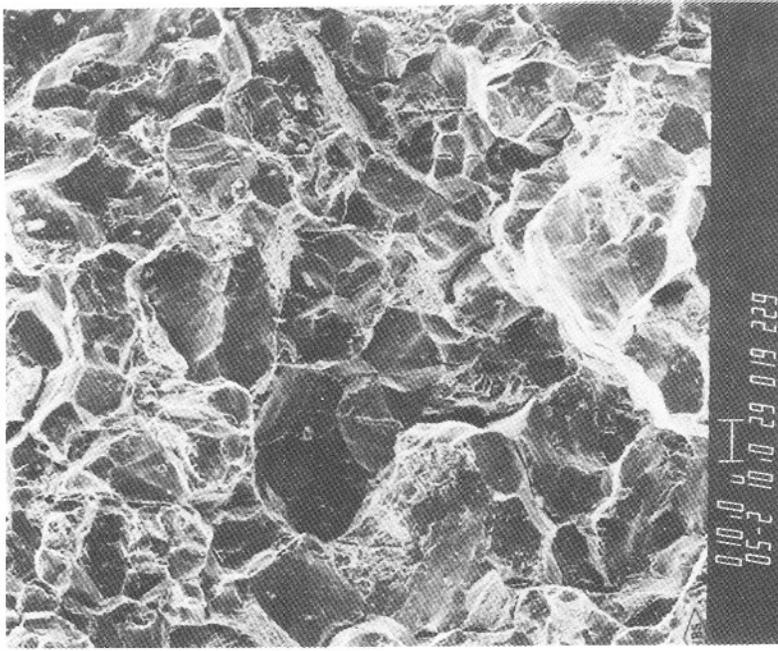
Figure 8.13 Fractographic appearance of walkway washer from upper end of hanger rod at location 9UE (NBS 11B) broken at NBS. Lower magnification view (a) shows no prominent MnS inclusions. Higher magnification view of center portion (b) shows essentially brittle intergranular fracture with a small amount of ductile rupture. Magnification (a) X25, (b) X550.

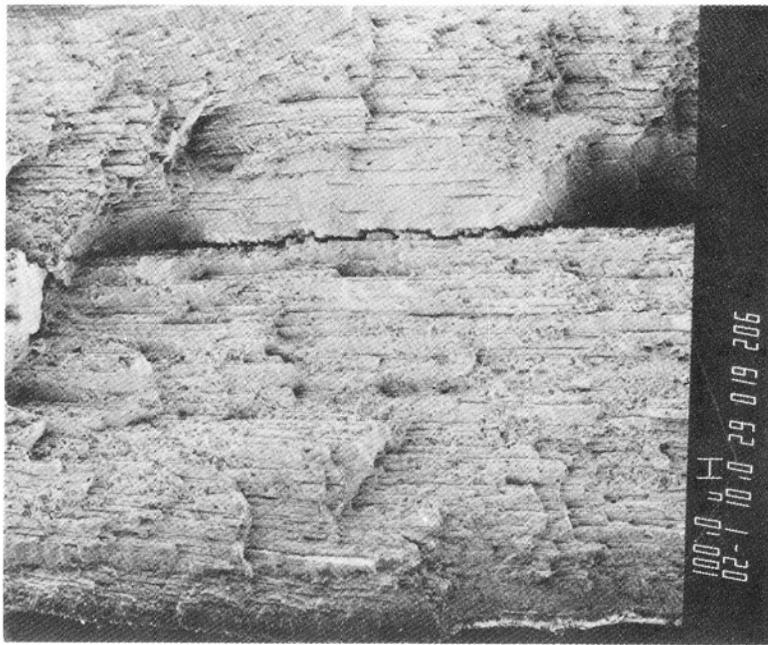
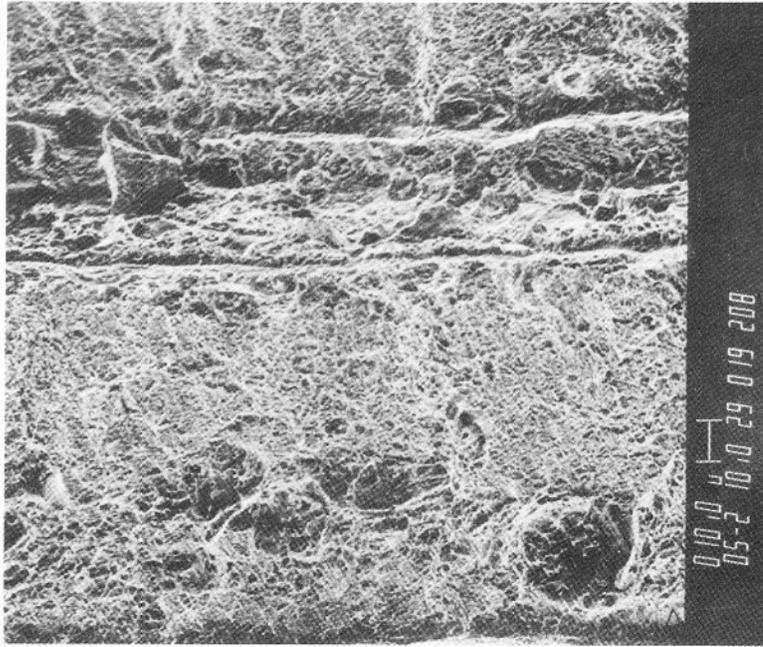
Figure 8.14 Fractographic appearance of NBS washer No. 3 broken at NBS. Low magnification view (a) shows elongated MnS inclusions. Higher magnification view of center portion (b) shows essentially ductile rupture. Magnification (a) X25, (b) X550.

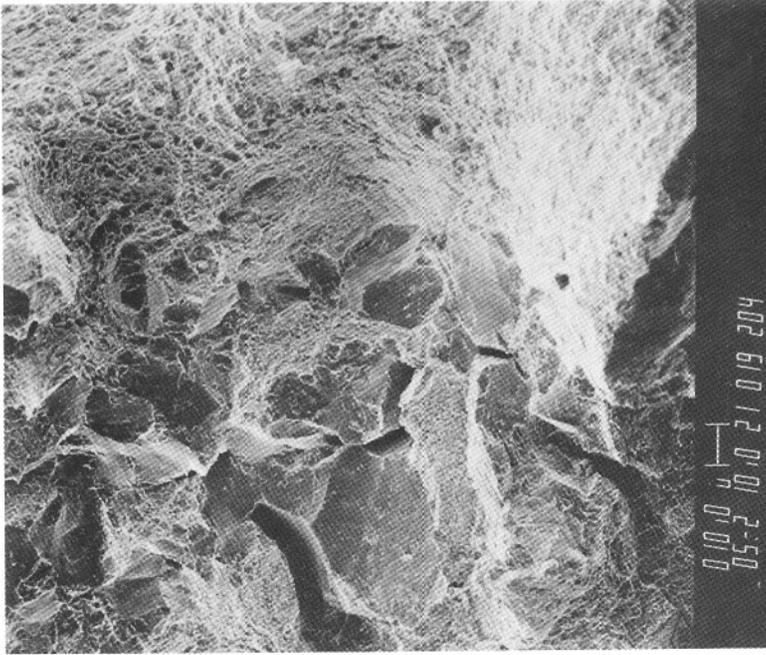
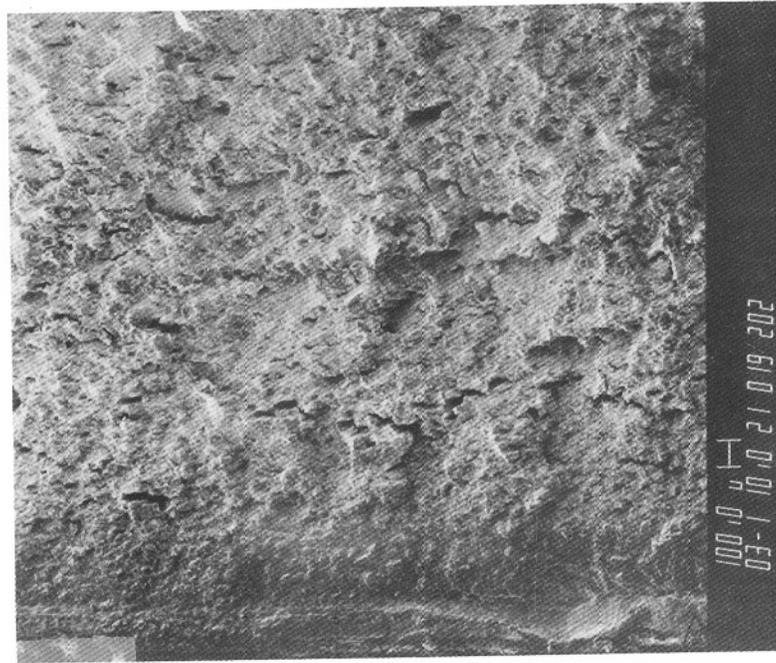
Figure 8.15 Fractographic appearance of NBS washer No. 2 broken at NBS. Low magnification view (a) shows no prominent MnS inclusions. Higher magnification view of center portion (b) shows 15-20 percent brittle intergranular fracture along with ductile rupture. Magnification (a) X35, (b) X550.

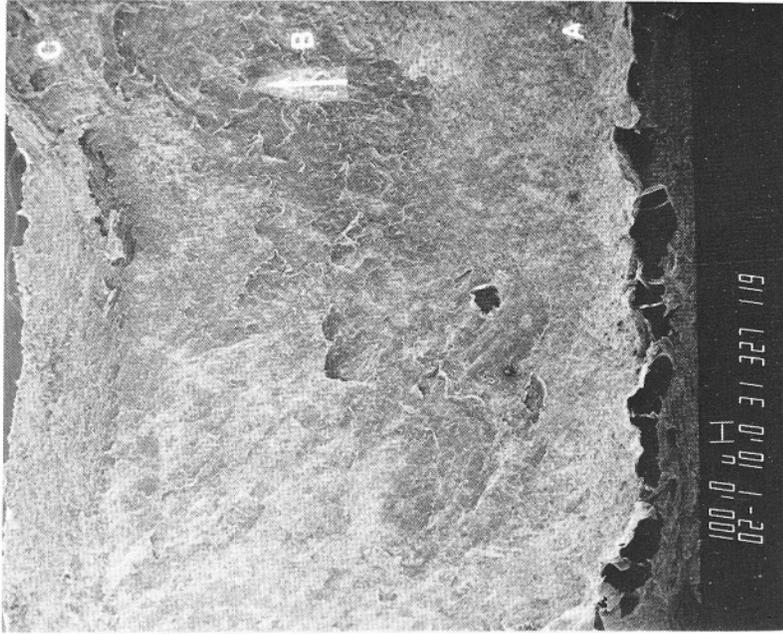
Figure 8.16 Fracture at top fillet weld at clip angle attachment, location 9UE (north). Initiation at A, propagation in direction B to shear lip at C. Magnification X25.

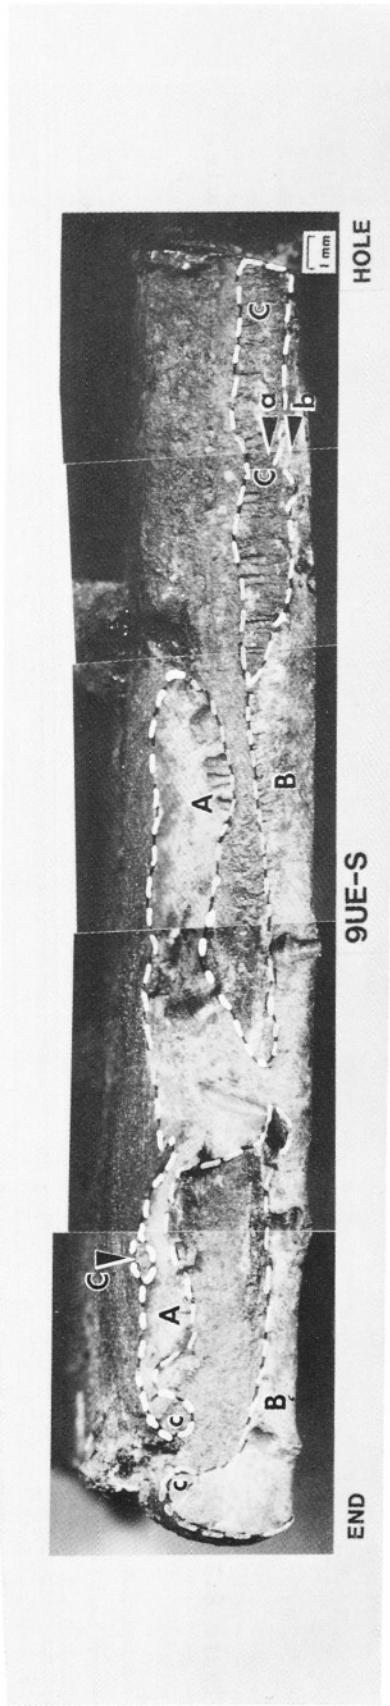
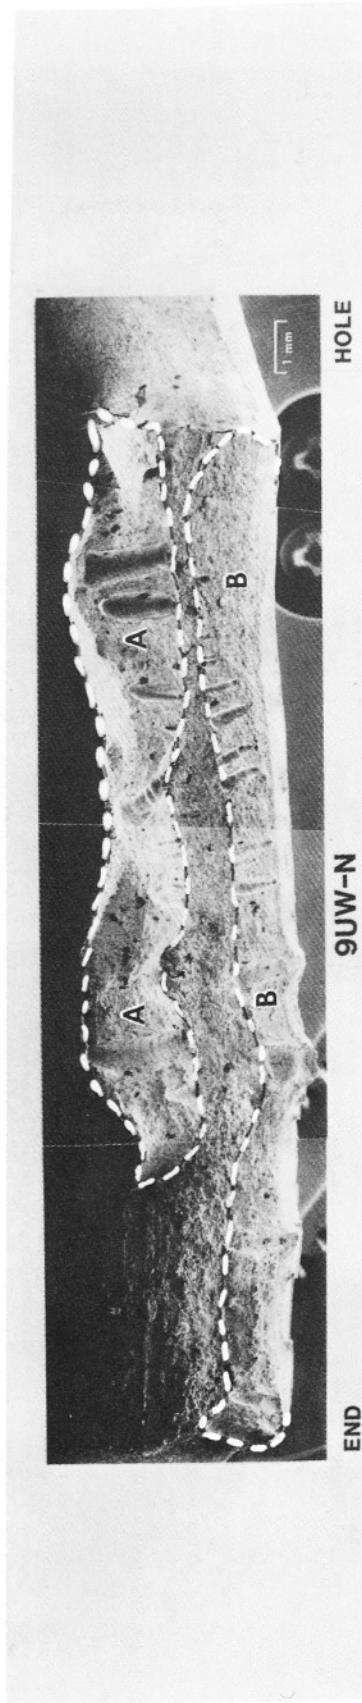
Figure 8.18 One half of box beam lower fracture surface between beam end and outer hanger rod hole.

(A) fracture area of the interior tack weld, (B) exterior longitudinal weld, (C) preexisting crack regions. This designation also is applicable to figures 8.19, 8.20, and 8.21. (a) and (b) noted by arrows on 9UE, indicate locations of figures 8.22 (a) and (b), respectively.

(a) location 9UE - S (optical, magnification X4.5)

(b) location 9UW - N (SEM, magnification X6.5)

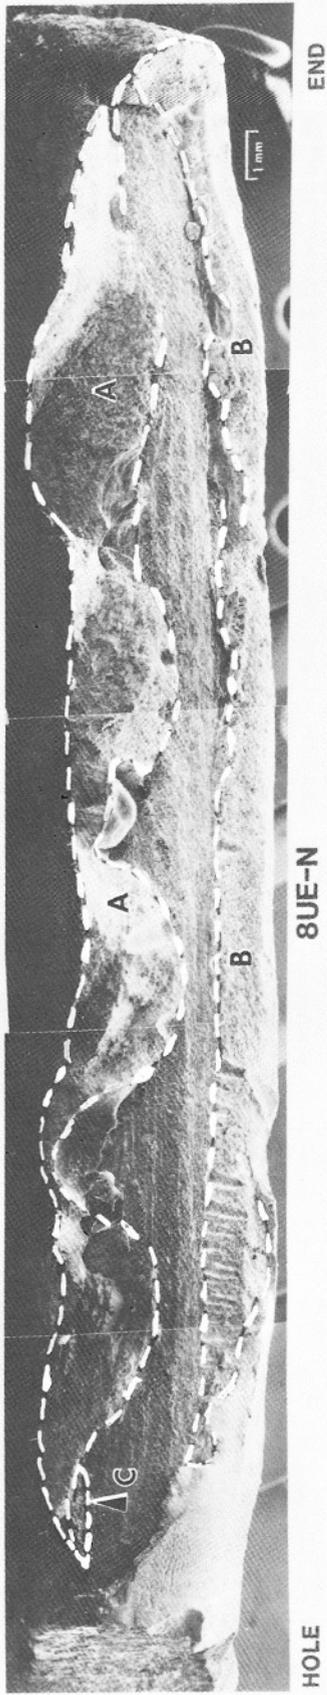
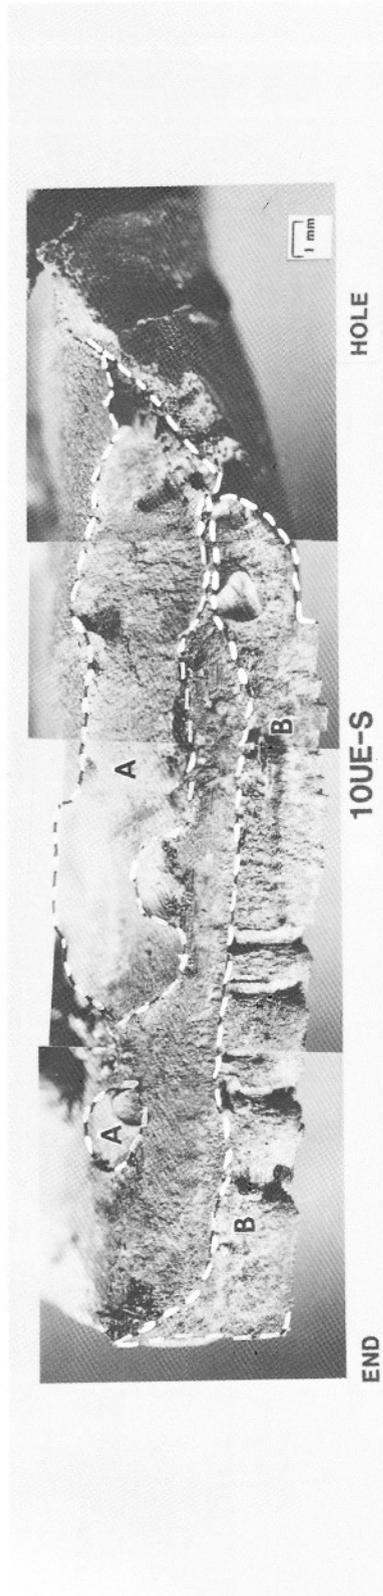
Figure 8.19 One half of box beam lower fracture surface between beam end and outer hanger rod hole.

(a) Location 8UE - N (SEM, magnification X6.5)

(b) Location 10UE - S (optical, magnification X4.5)

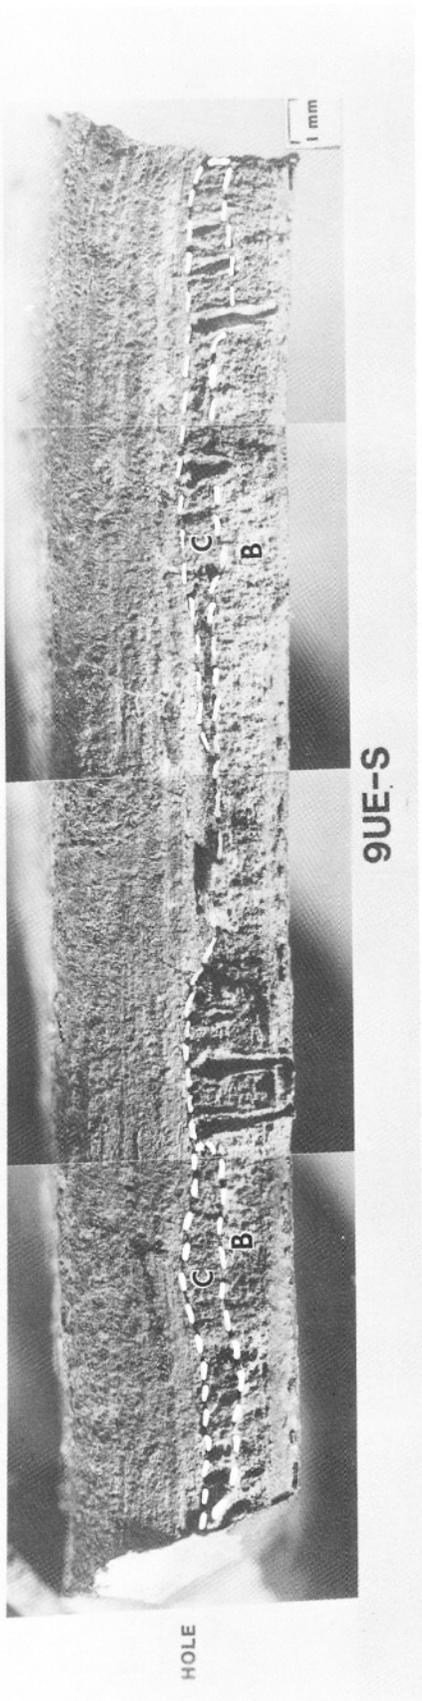
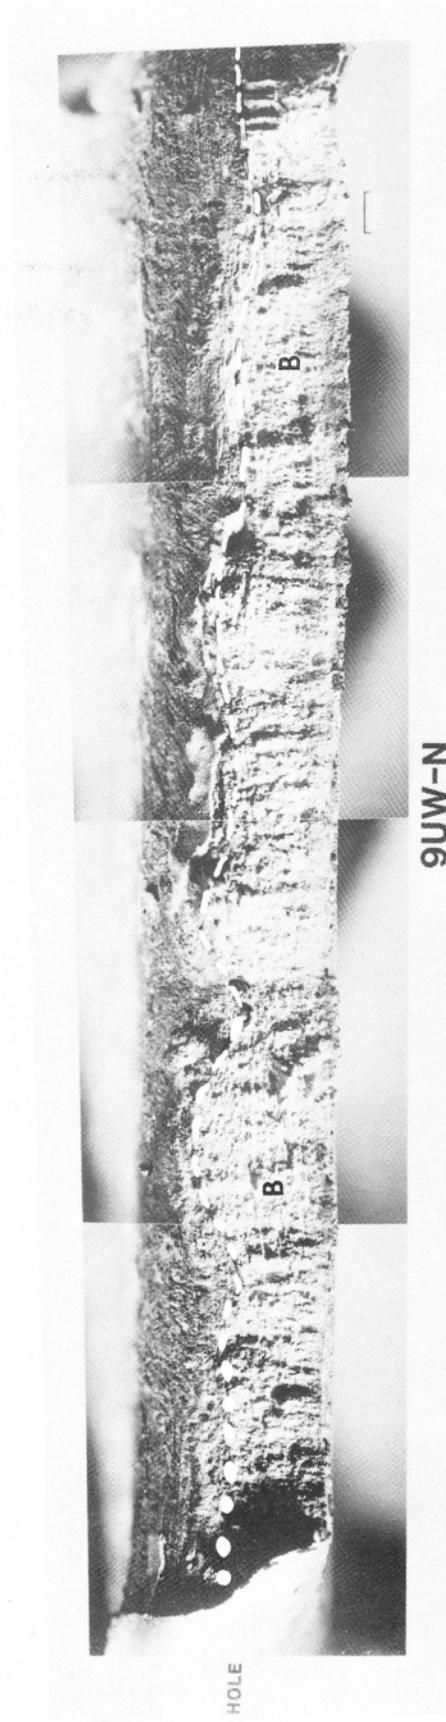
Figure 8.20 One half of box beam lower fracture surface between outer and inner hanger rod holes.

(a) location 9UE - S (optical, magnification X5.5)

(b) location 9UW - N (optical, magnification X5.5)

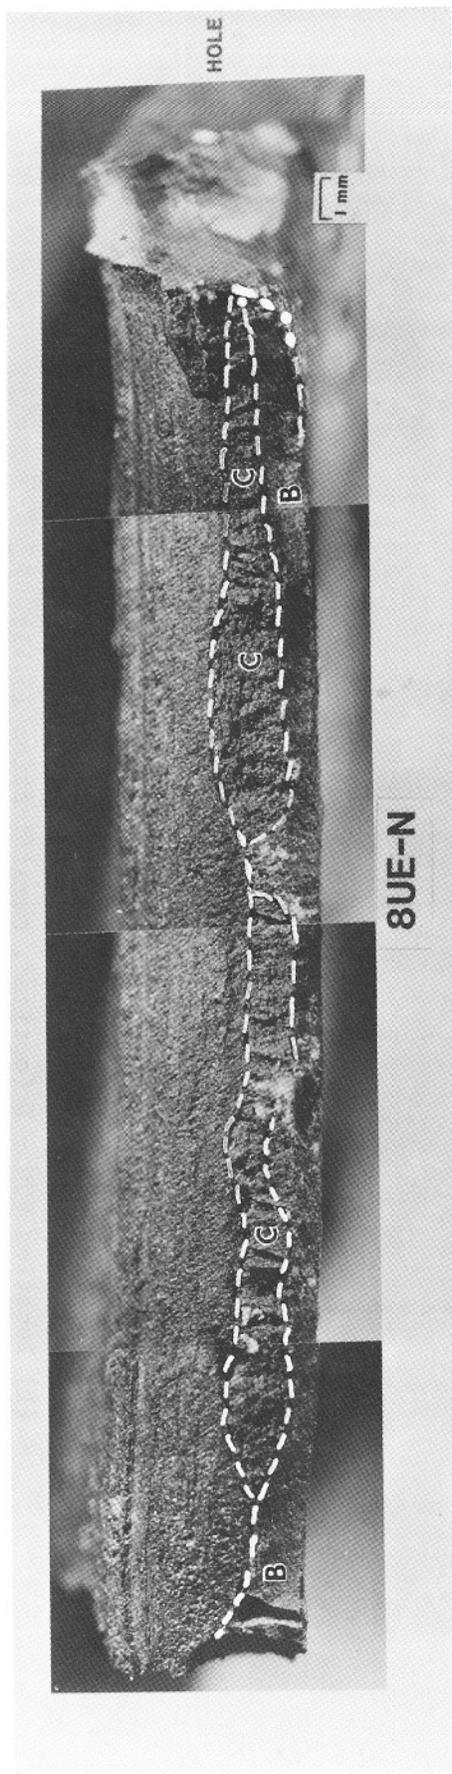
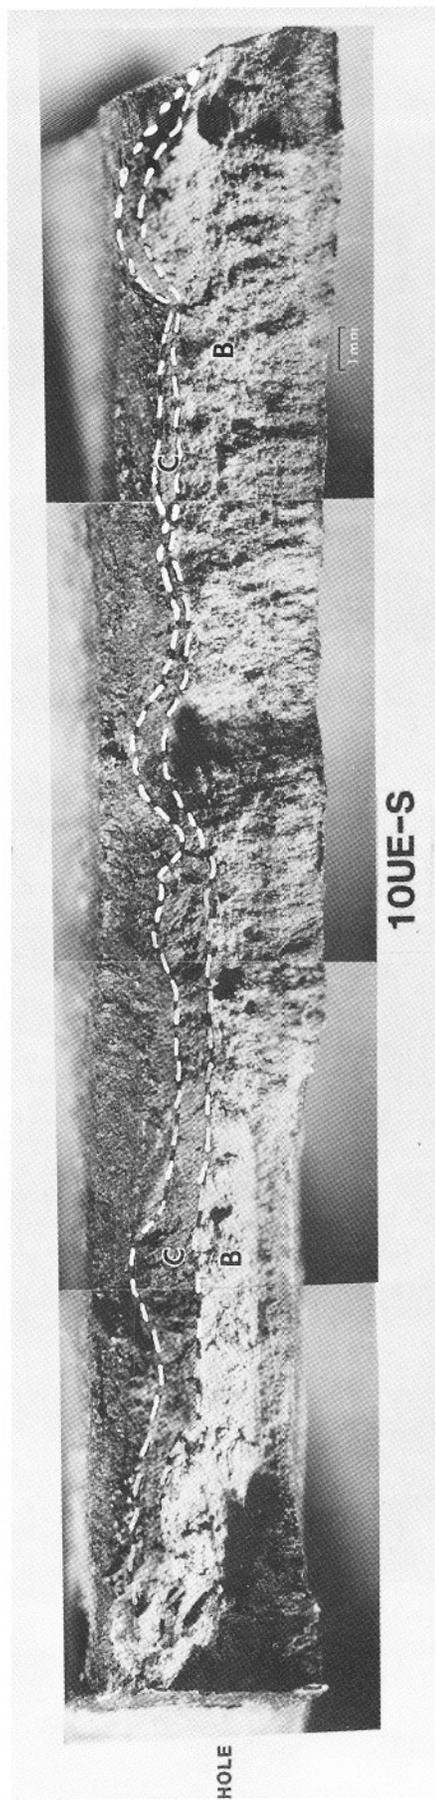
Figure 8.21 One half of box beam lower fracture surface between outer and inner hanger rod holes.

(a) location 8UE - N (optical, magnification X5.5)

(b) location 10UE - S (optical, magnification X5.5)

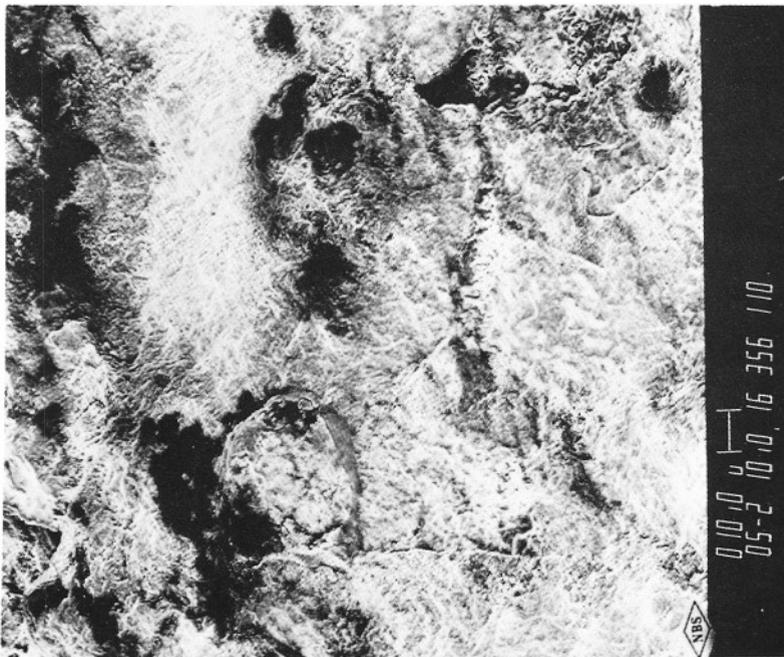
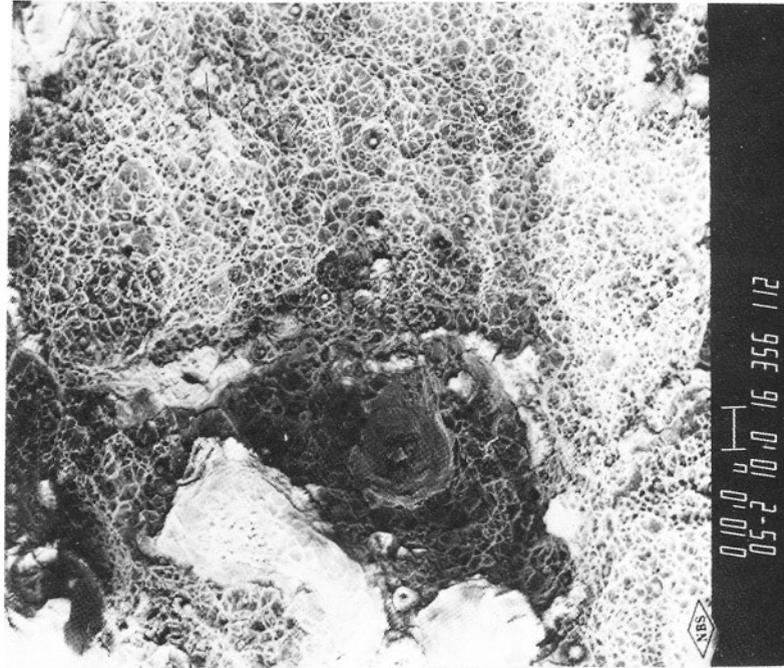
Figure 8.22 Fracture appearance in the preexisting crack region (a) and in the region of final crack propagation (b) at location 9UE adjacent to the outer hanger rod hole. Magnification X550.

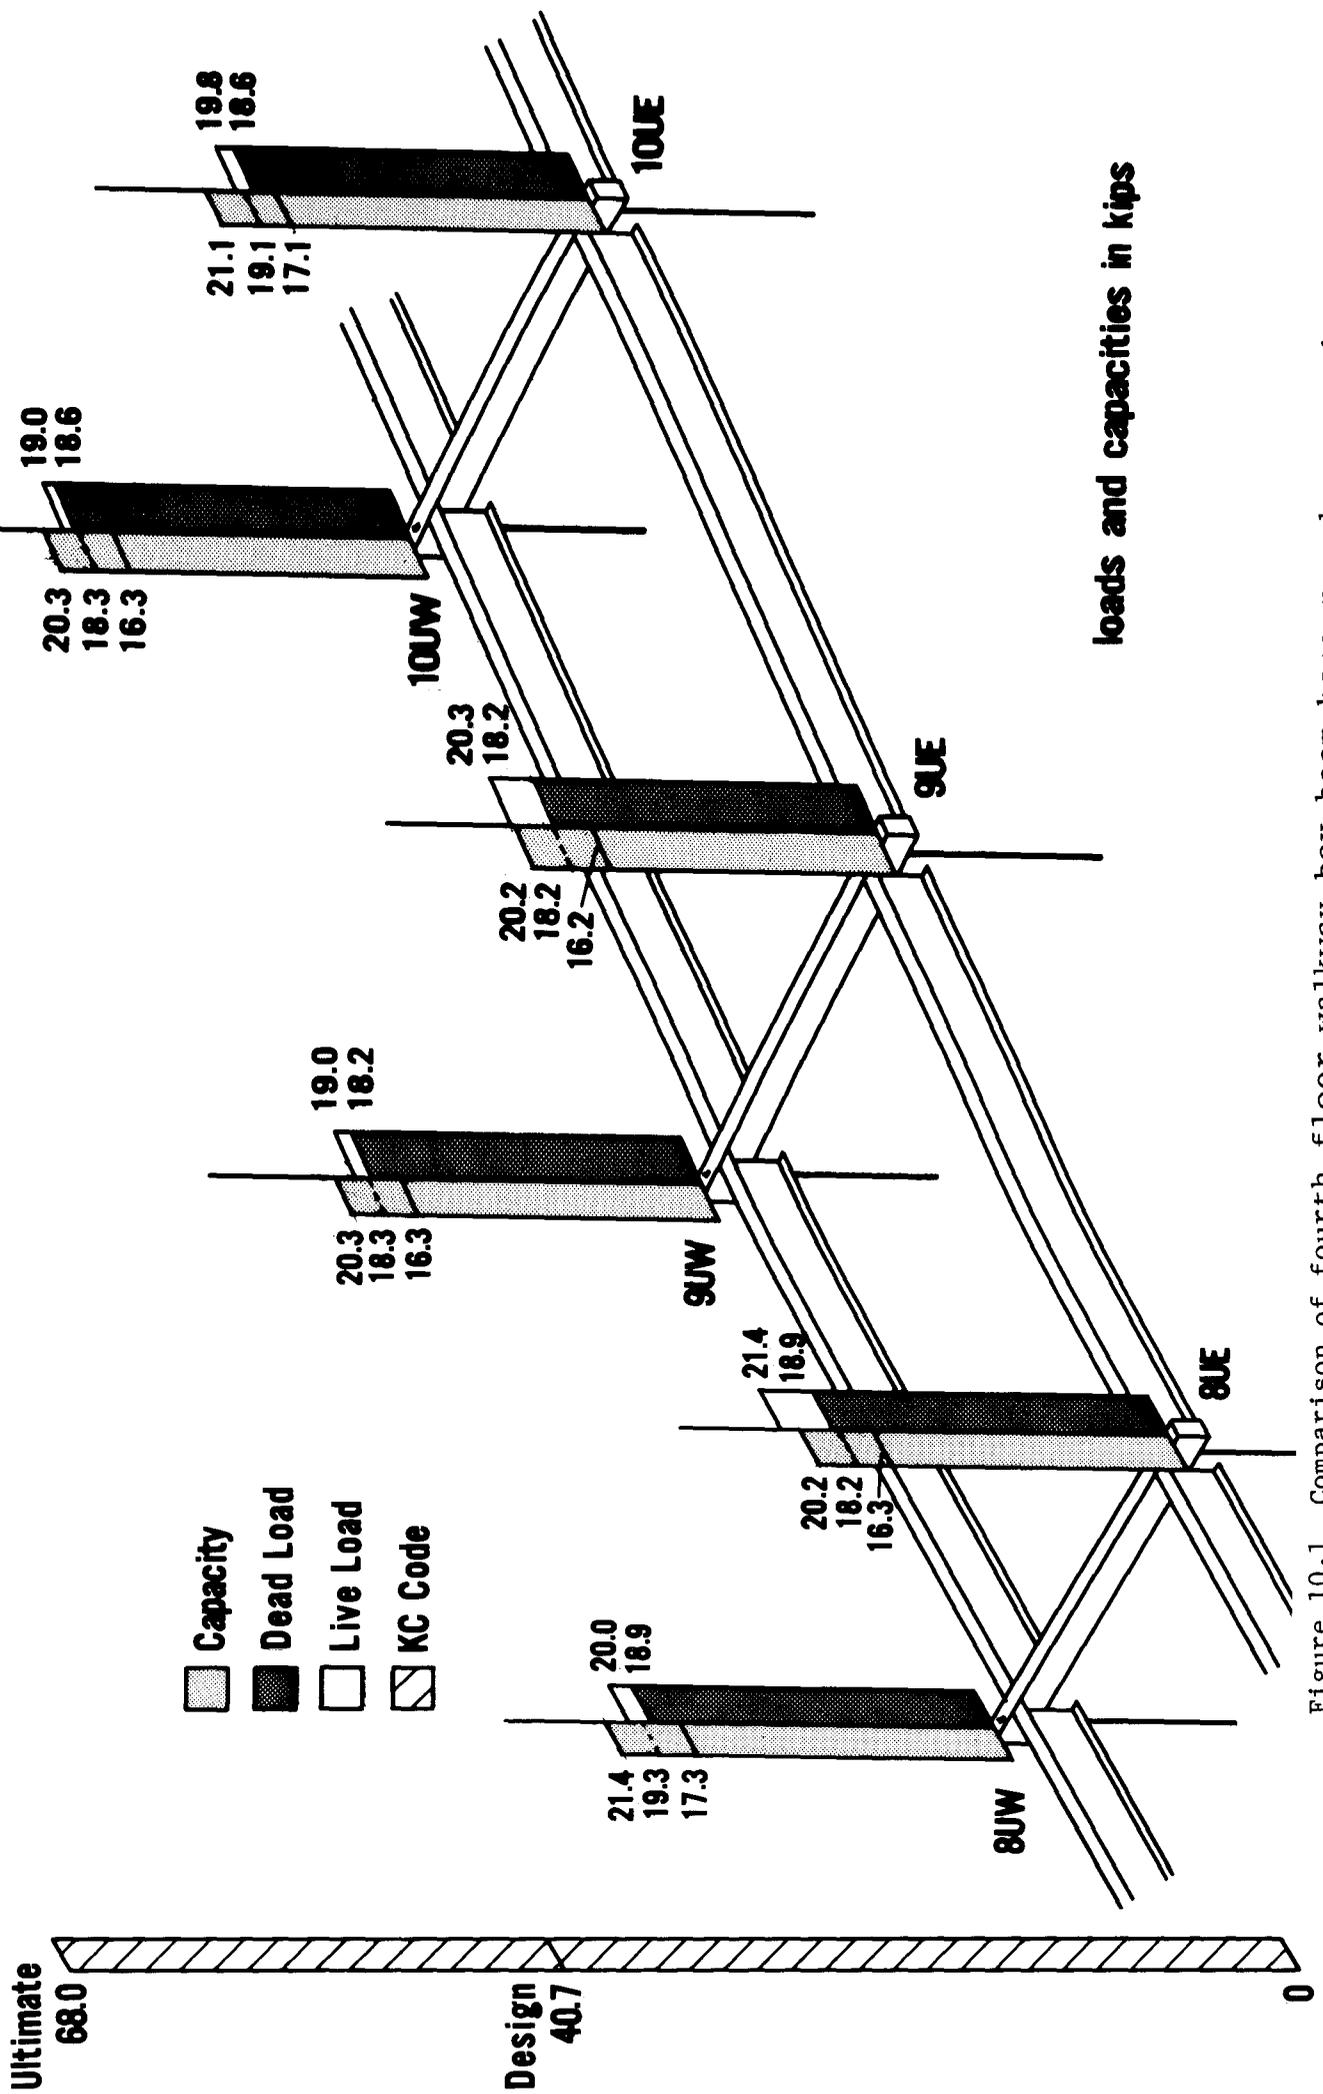
A layout of the 6 fourth floor box beam-hanger rod connections is shown in figure 10.1. Two bar diagrams, one for load capacity of the connection and one for imposed load, are shown adjacent to each hanger rod. The bar diagram on the left side of the figure will be discussed in section 10.3.

Figure 10.1 presents similar information for the other fourth floor box beam-hanger rod connections. This figure shows that, with the exception of locations 8UE and 10UW, the estimated mean ultimate capacity of each fourth floor box beam-hanger rod connection either equals or slightly exceeds the estimated dead load effect. However, the estimated mean ultimate capacity is exceeded by the sum of the estimated dead load and upper-bound live load in every case.

It is important to point out that the load capacities described in figure 10.1 are ultimate values. As noted in section 9.3.3, the design load (estimated nominal dead load plus code-specified design live load) for a fourth floor to

Because of the safety factor, the resulting connection would be expected to have an ultimate load capacity substantially higher than the working stress value of 40.7 kips (181 kN). Using a factor of safety of 1.67, which is the lowest value that would govern any part of the design of the box beam-hanger rod connections under the applicable provisions of the AISC Specification, it would be expected that the ultimate load capacity of the resulting connection would be at least 1.67 times 40.7, or 68 kips (302 kN). Thus any given box beam-hanger rod connection in the fourth floor walkway should have been able to support an ultimate load of at least 68 kips (302 kN) instead of the average ultimate capacity of 18.6 kips (83 kN) estimated for the 6 fourth floor walkway connections. Since the AISC Specification is the basis for the steel design provisions of the Kansas City Building Code, this same ultimate load capacity would be expected of a connection designed under the Kansas City Building Code. The hanger rod load to be applied in working stress design under the Kansas City Building Code and the expected ultimate load capacity are shown in the bar diagram on the left in figure 10.1.

Figure 10.1 Comparison of fourth floor walkway box beam-hanger rod connection capacities with loads believed to have been acting at time of collapse.
