NBS BUILDING SCIENCE SERIES 143

# Investigation of the Kansas City Hyatt Regency Walkways Collapse

R. D. Marshall  
E. O. Pfrang  
E. V. Leyendecker  
K. A. Woodward

Issued May 1982

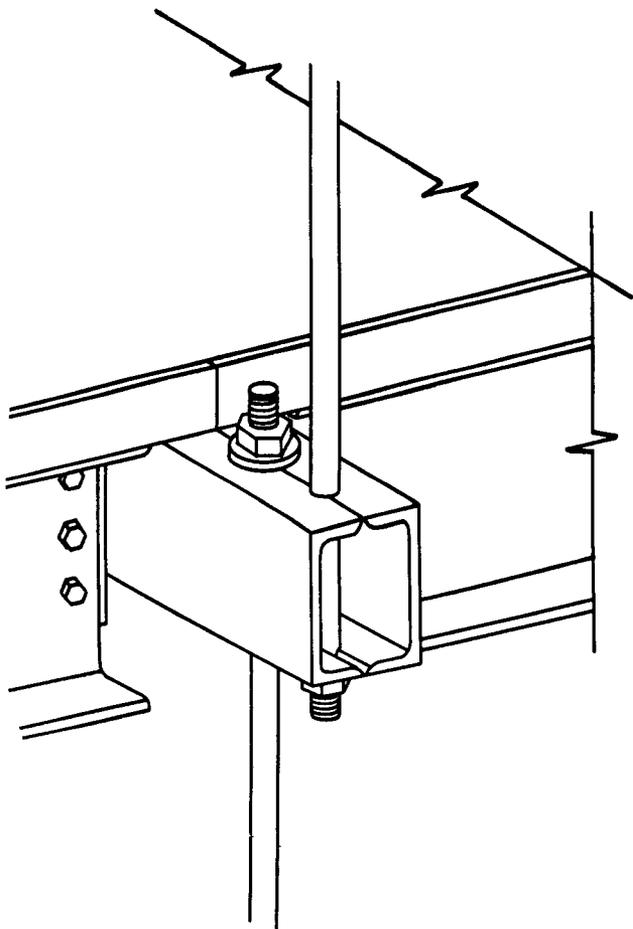
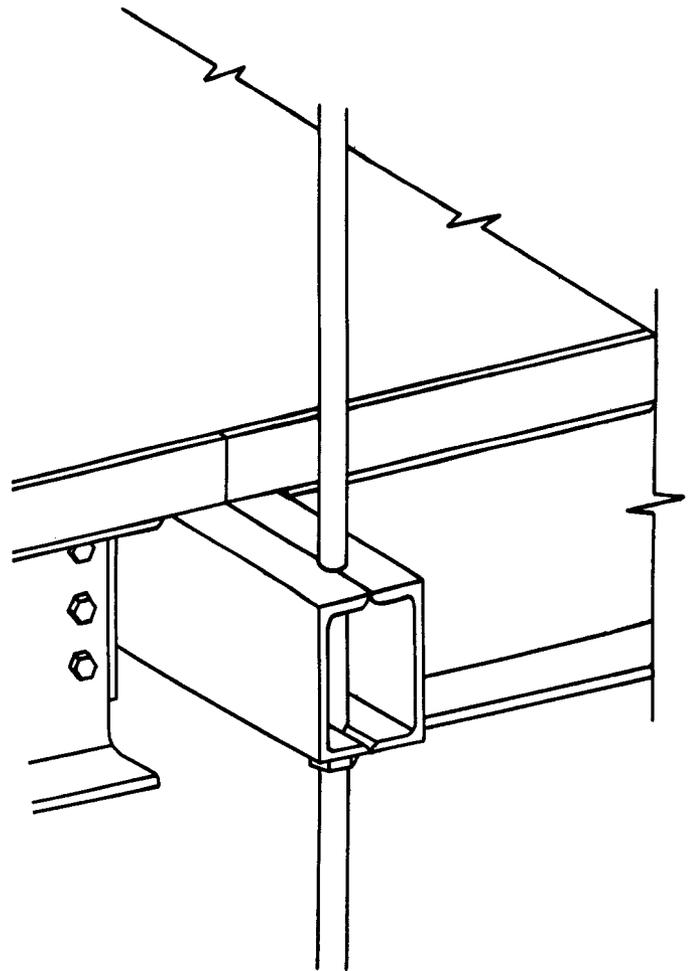
As has been described in chapter 3, the hanger rod configuration actually used consisted of two hanger rods: the fourth floor to ceiling hanger rod segment as originally detailed and the second to fourth floor segment offset 4 in (102 mm) inward along the axis of the box beam (see figure 10.2). The washer and nut arrangement called for in the original connection detail as shown on Dwg. S405.1 was retained in the actual construction. With this modification the design load to be transferred by each second floor box beam-hanger rod connection was unchanged, as were the loads in the upper and lower hanger rod segments. However, the load to be transferred from the fourth floor box beam to the upper hanger rod under this arrangement was essentially doubled, thus compounding an already critical condition. The design load for the fourth floor box beam-hanger rod connection would be 40.7 kips (181 kN) for this configuration.

Figure 10.2 Comparison of interrupted and continuous hanger rod details.

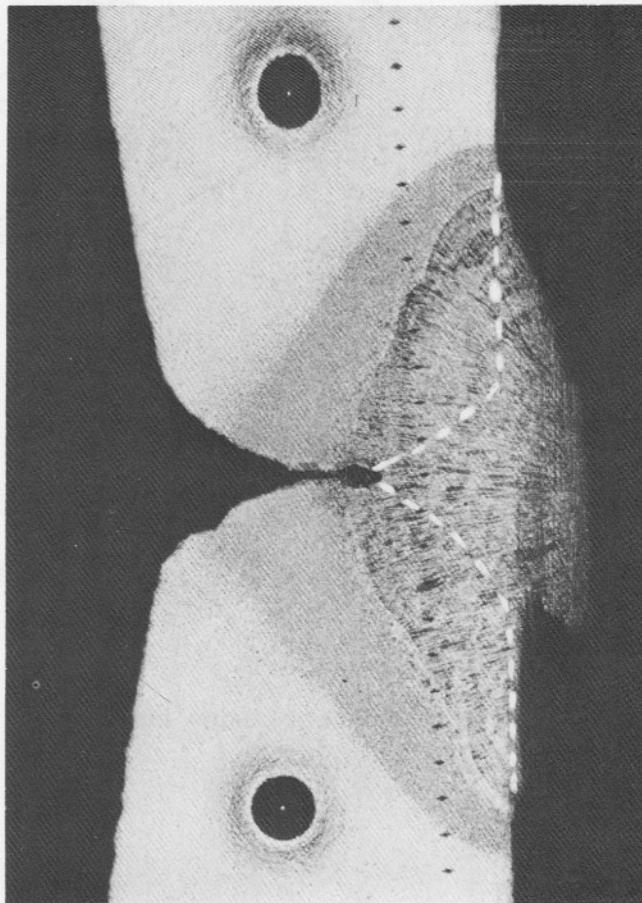
The welding symbol and field observations relevant to the box beam longitudinal welds have been discussed in sections 3.3 and 5.3.3, respectively. As noted in section 3.3, the welding symbol used on the shop drawings is interpreted to require a prequalified partial joint penetration groove weld. However, the geometry of the mating surfaces as discussed in section 5.3.3 and as illustrated in figure 10.3 does not satisfy the dimensional tolerances for a prequalified partial joint penetration groove weld as stated in section 2.10 of AWS D1.1-79; the root face is less than 3 mm (Item 2.10.2.4), and the required minimum root opening was not provided.

Figure 10.3 Cross section through weld region of walkway box beam 8L showing the exterior longitudinal weld joint at the bottom flange. Dotted lines indicate approximate original geometry of the flange toes. X8 1/2

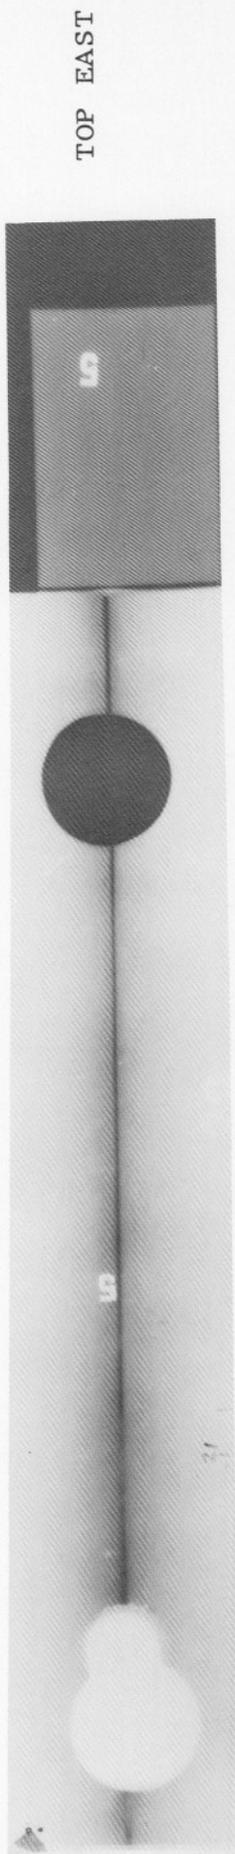
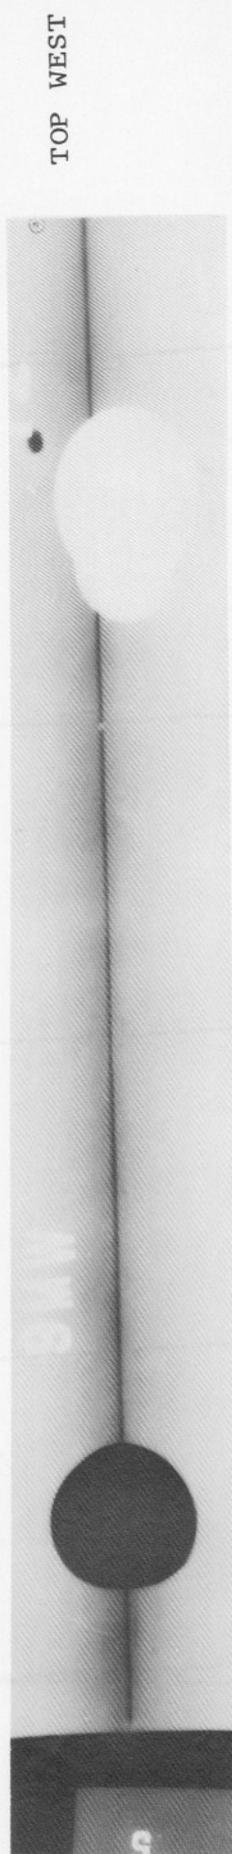
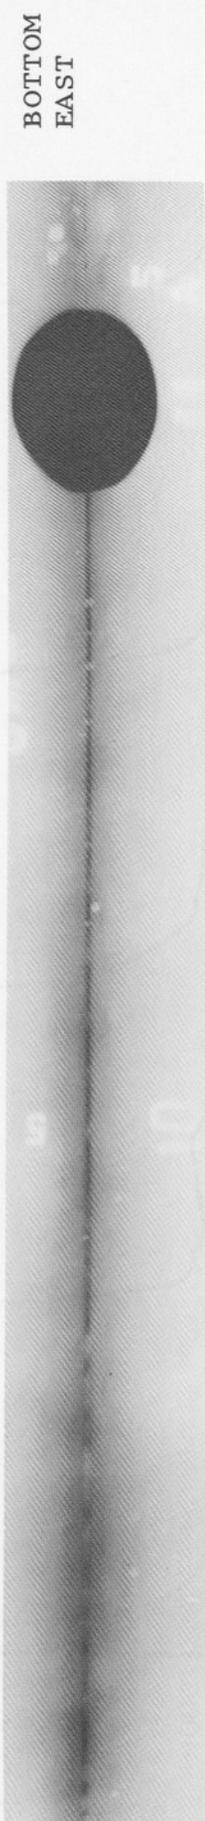
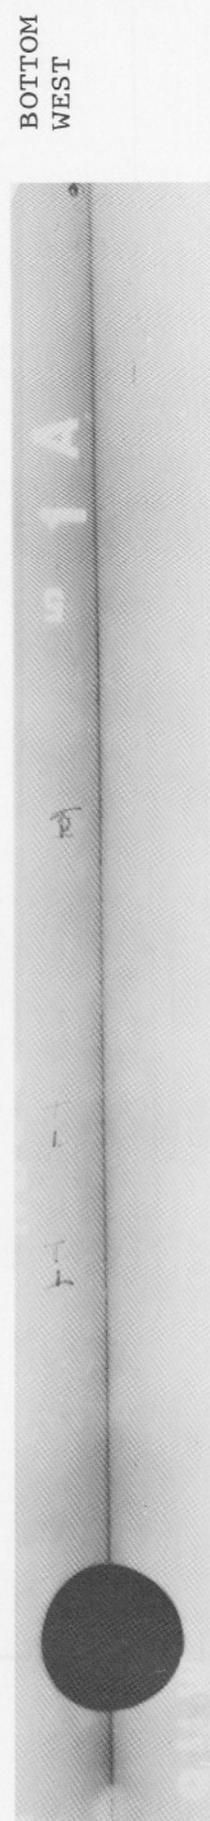
Figure A7.2.2-1 Radiographs of portions of box beam 9M used in the analysis described in section 7.2 of the report.

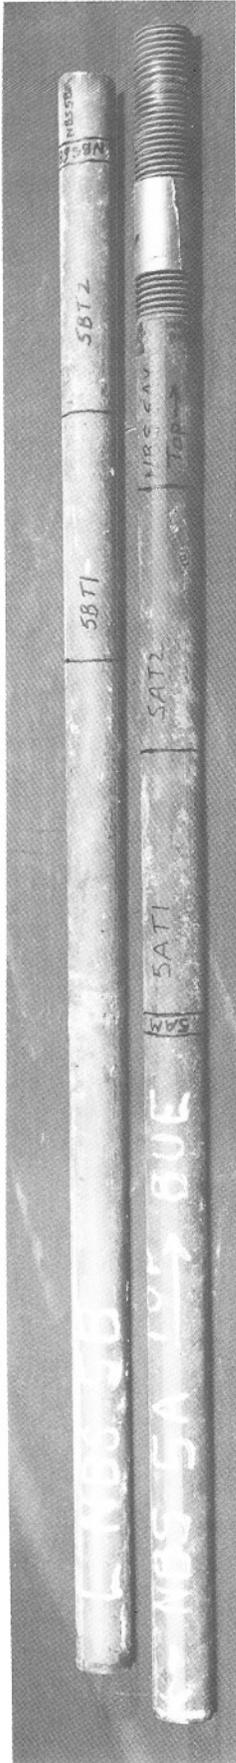
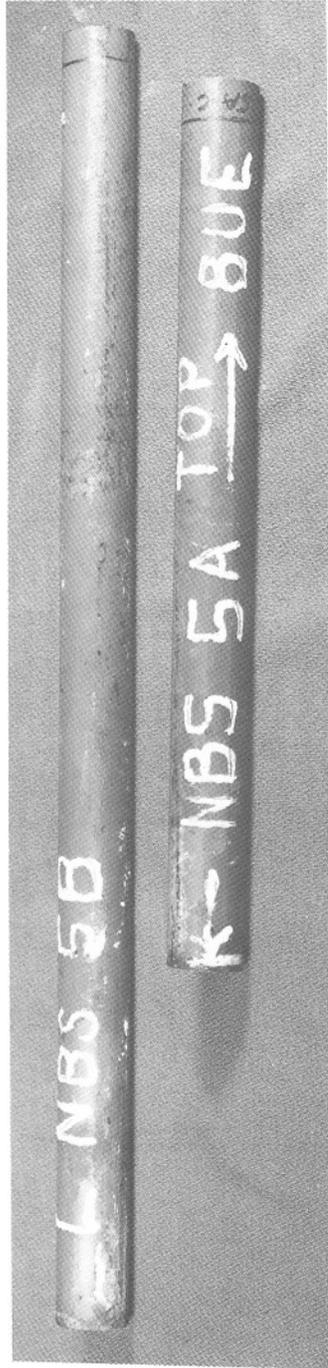
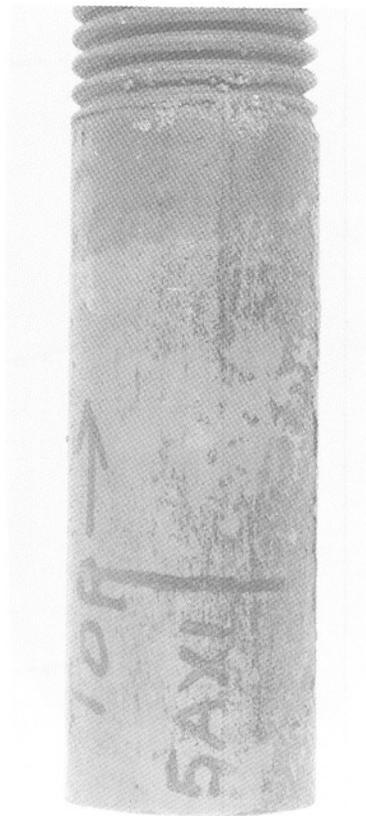
Figure A7.3.3-1. Location of test specimens from hanger rod segments NBS 5A and NBS 5B obtained from the walkway debris.

Transverse and longitudinal sections from each of the walkway hanger rod segments obtained from the debris (NBS 5A and 5B) were examined metallographically. The locations of these sections in the hanger rods are shown in figure A7.3.3-1. A representative region showing the etched microstructure of the transverse section from hanger rod NBS 5A is shown in figure A7.4.2-1. The

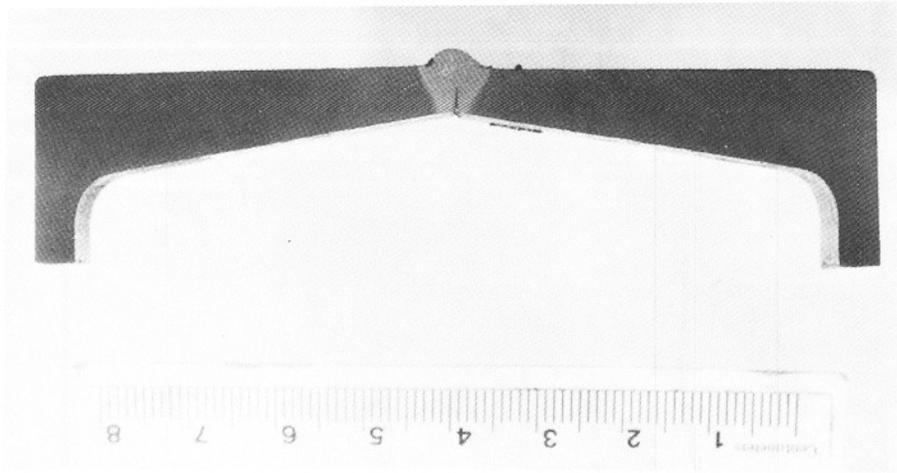
Figure A7.4.1-1 Transverse section through NBS weldment IC welded by the GMAW process using mild steel welding rod. The weld is in the center connecting flange parts of the two channel segments, Parts of the web regions of each channel are also included in the section. Etchant: two percent nital ~X1

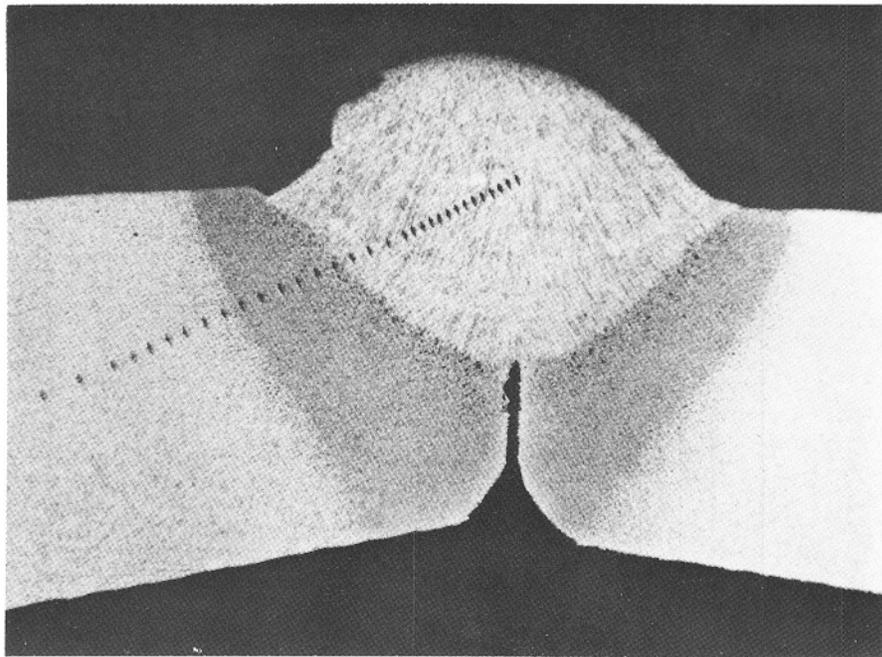
Figure A7.4.1-2. Part of the transverse section shown above, but a higher magnification. The light region in the center is weld metal. The dark regions adjacent to the weld metal are the heat affected zones. The light regions to the left and right in the photograph represent base flange regions of the channel segments. The line of small dark, elongated marks is the result of microhardness measurements. Etchant: two percent nital. X8.5

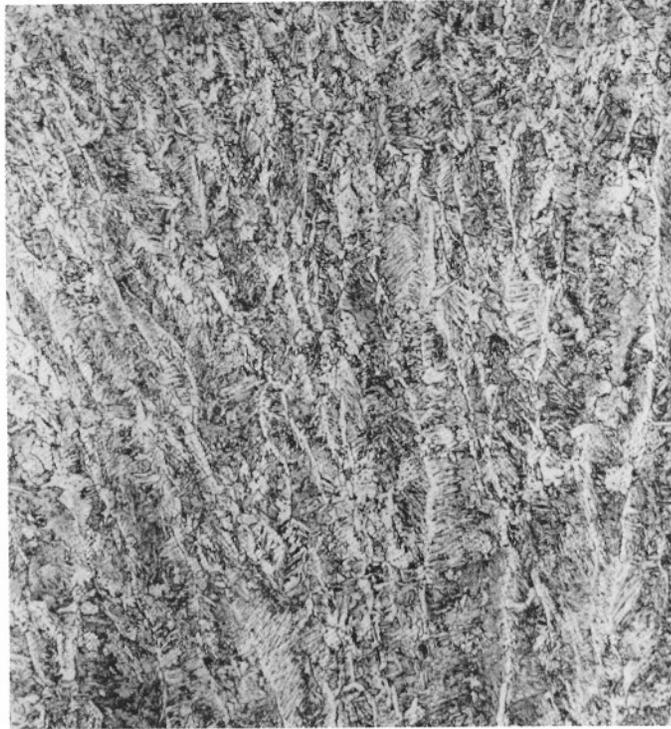
Figure A7.4.1-3 Microstructure representative of the weld metal in transverse section through NBS weldment IC. The microstructure appears to consist primarily of bainite. Etchant: two percent nital. X200

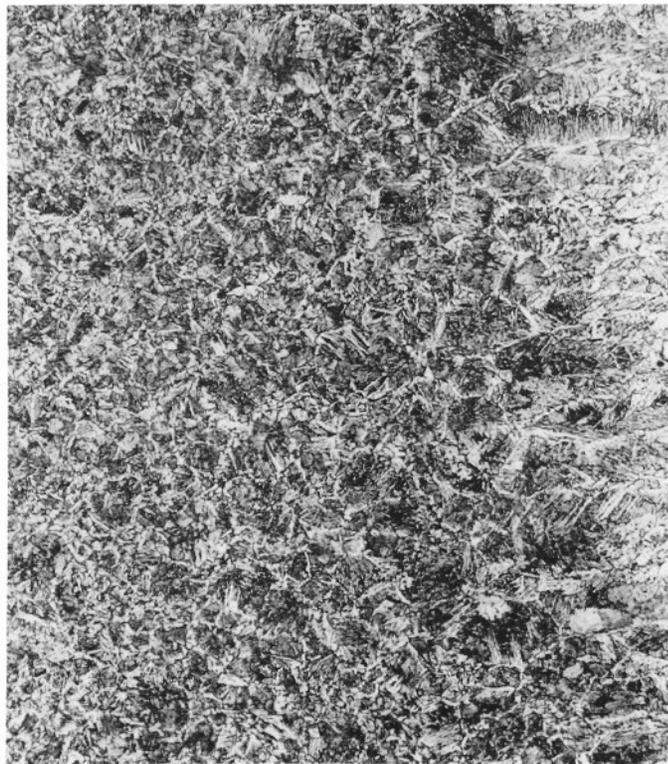
Figure A7.4.1-4 Transition region from weld metal (right) to heat affected zone (left) in transverse section through NBS weldment IC. Etchant: two percent nital. X200

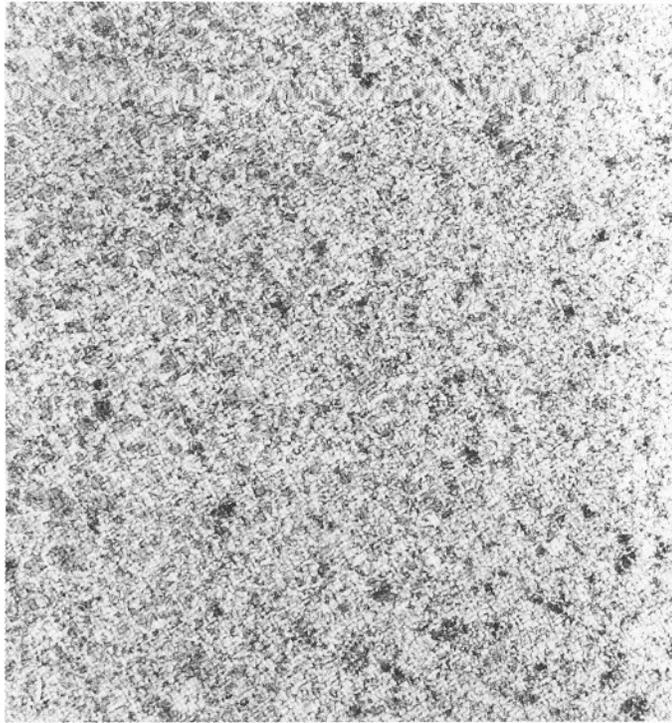
Figure A7.4.1-5 Representative microstructure of the heat affected zone in transverse section through NBS weldment IC. The microstructure consists of ferrite, primarily as a network in prior austenite grain boundaries, bainite, partially spheroidized carbides, and tempered martensite. Etchant: two percent nital. X200

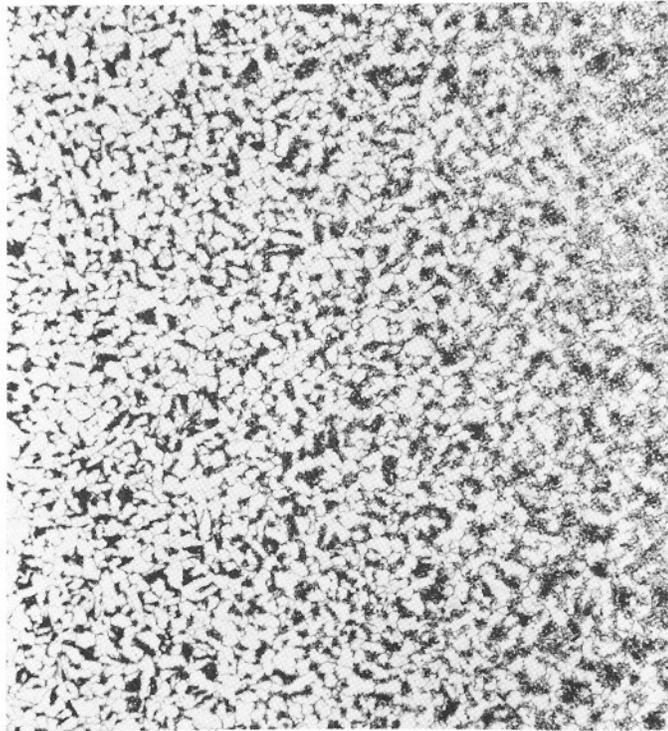
Figure A7.4.1-6 Microstructure representative of the transition region from the heat affected zone (right) to base channel material (left) in NBS weldment IC. Etchant: two percent nital. X200

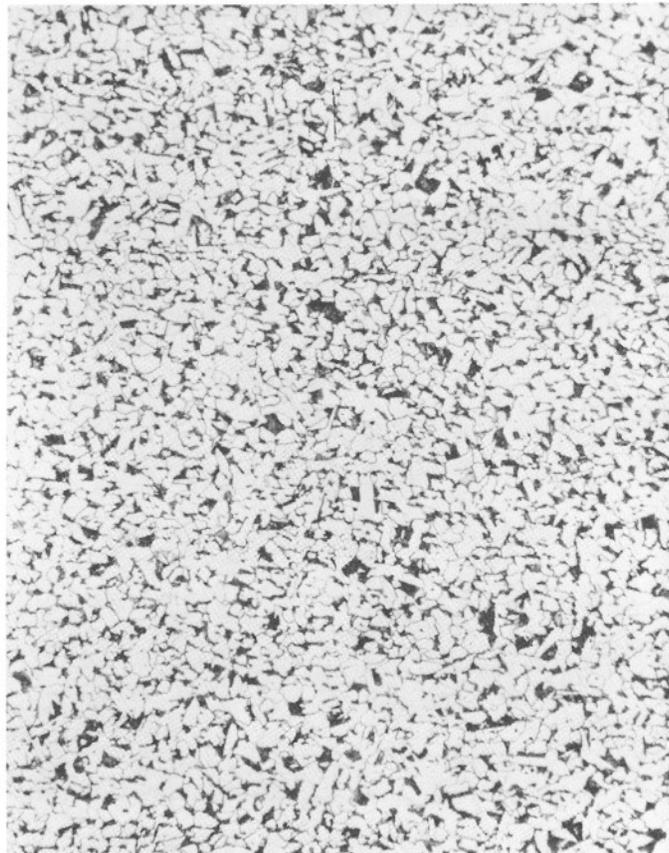
Figure A7.4.1-7 Microstructure representative of the base channel material from NBS weldment IC. The microstructure consists of relatively fine grained ferrite (light) and pearlite (dark) in a normalized condition. Etchant: two percent nital. X200

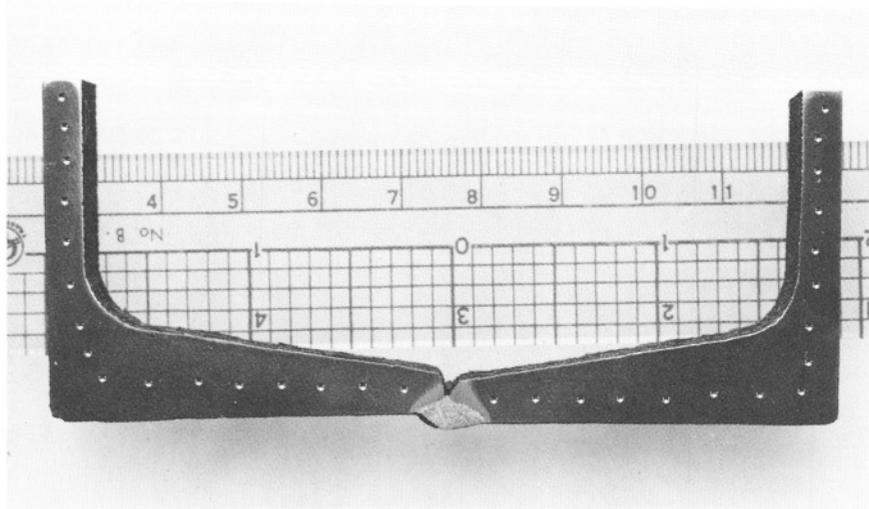
Figure A7.4.1-8 Transverse section 1B1 through the bottom of walkway box beam 9U (NBS 1). The north channel of the box beam is to the left and the south channel is to the right. The weld connecting the flanges of the two channels used to fabricate the box beam is in the center. Parts of the web regions of each channel had been removed before this photograph was taken. The indentations appearing on the surface of the section are the result of hardness measurements. Etchant: two percent nital. ~X1

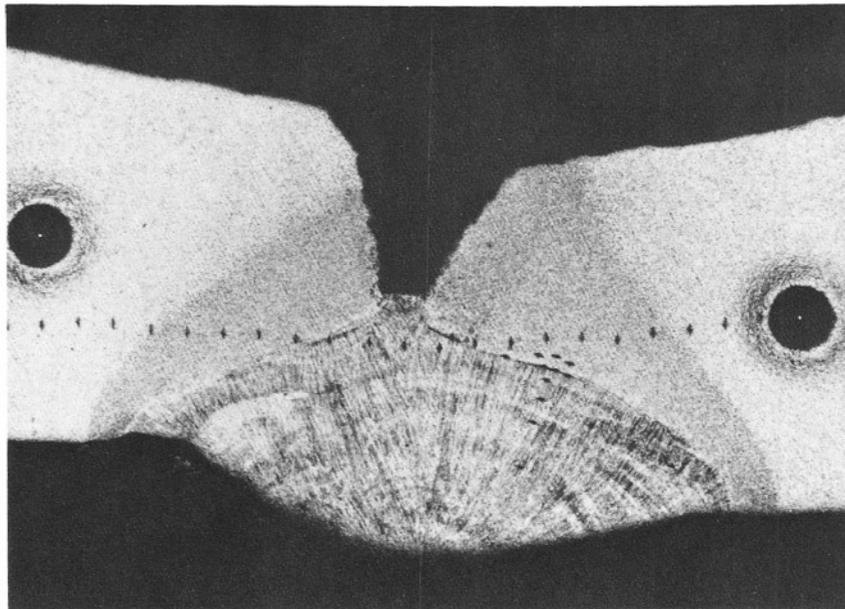
Figure A7.4.1-9 Part of the transverse section shown in figure A7.4.1-8, but at higher magnification. The region at the bottom center is weld metal. The dark gray regions on either side of the weld metal are the heat affected zones associated with the weld. The lighter regions at either side of the figure beyond the heat affected zone are base channel material. Etchant: two percent nital. X8.5

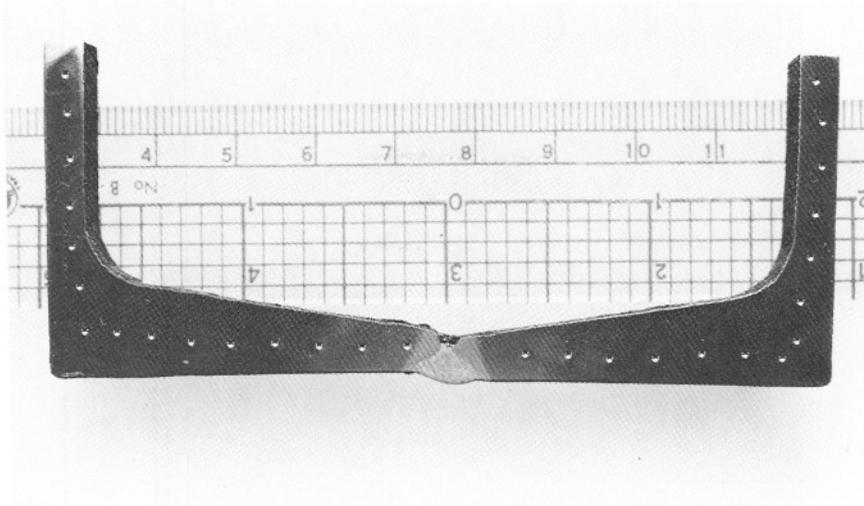
Figure A7.4.1-10 Transverse section 1BM2 through the bottom of walkway box beam 9U (NBS 1). The north channel of the box beam is to the left and the south channel is to the right. The weld connecting the flanges of the two channels used to fabricate the box beam is in the center. Parts of the web regions of each channel had been removed before this photograph was taken. The indentations appearing on the surface of the section are the result of hardness measurements. Etchant: two percent nital. ~X1

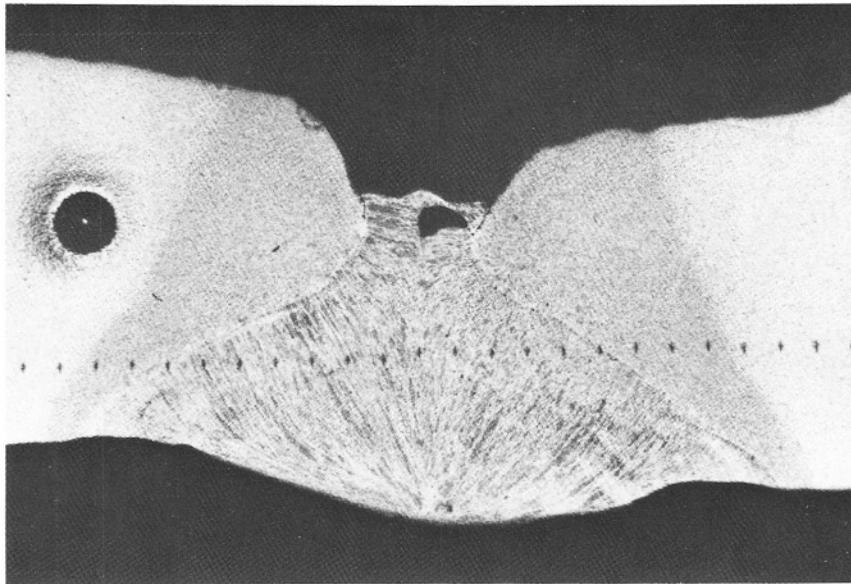
Figure A7.4.1-11 Part of the transverse section shown in figure A7.4.1-10, but at higher magnification. The region at the bottom center is weld metal. The dark gray regions on either side of the weld metal are the heat affected zones associated with the weld. The lighter regions on either side of the photomicrograph are base channel material. Etchant: two percent nital. X8.5

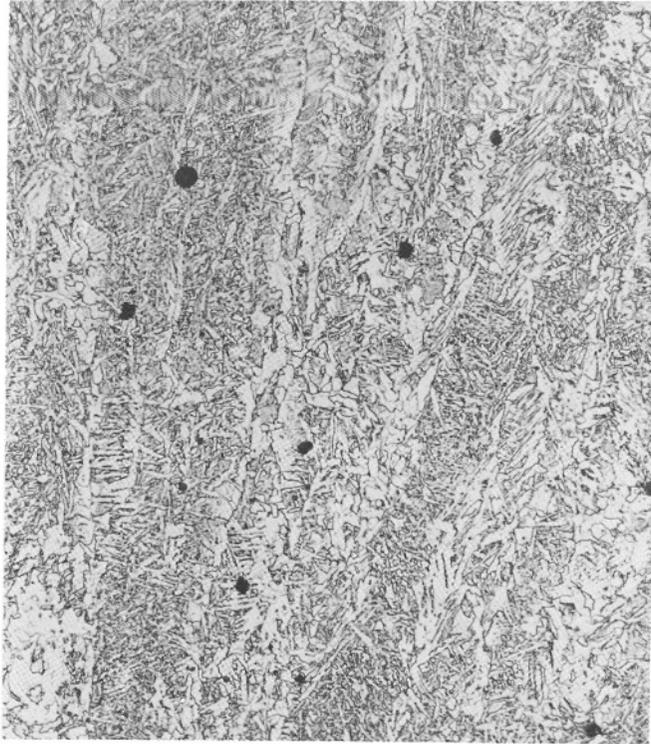
Figure A7.4.1-12 Representative microstructure of the weld metal in transverse section 1BM1 through box beam 9U (NBS 1). The microstructure consists primarily of bainite. Some inclusions are evident. Etchant: two percent nital. X200

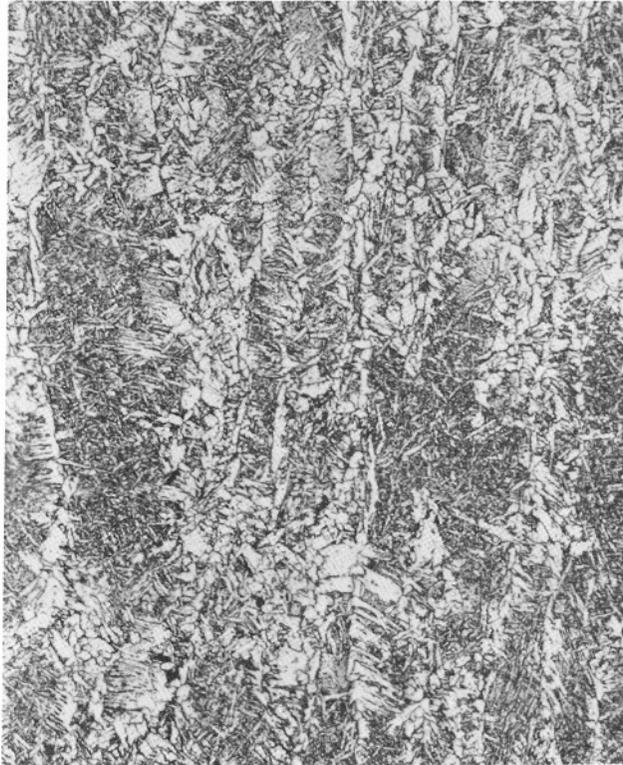
Figure A7.4.1-13 Representative microstructure of the weld metal in transverse section 1BM2 through box beam 9U (NBS 1). The microstructure consists primarily of bainite. Etchant: two percent nital. X200

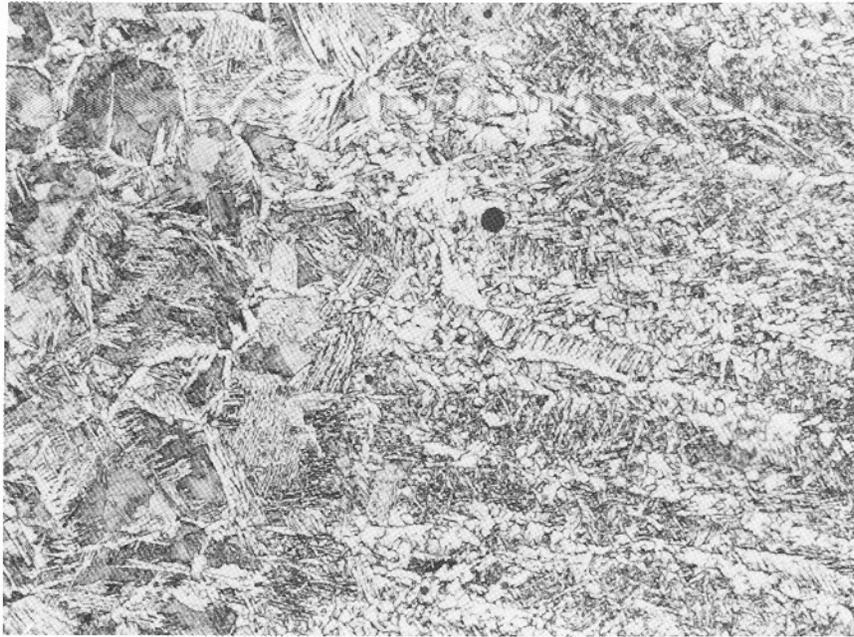
Hard patches were not observed in the transition region from weld to heat affected zone in section 1BM2. An area representative of this region in section 1BM2 is shown in figure A7.4.1-16.

Figure 7.4.1-16 Transition zone from weld metal (right) to heat affected zone (left) in section 1BM2. Some inclusions can be seen. Etchant: two percent nital. X200

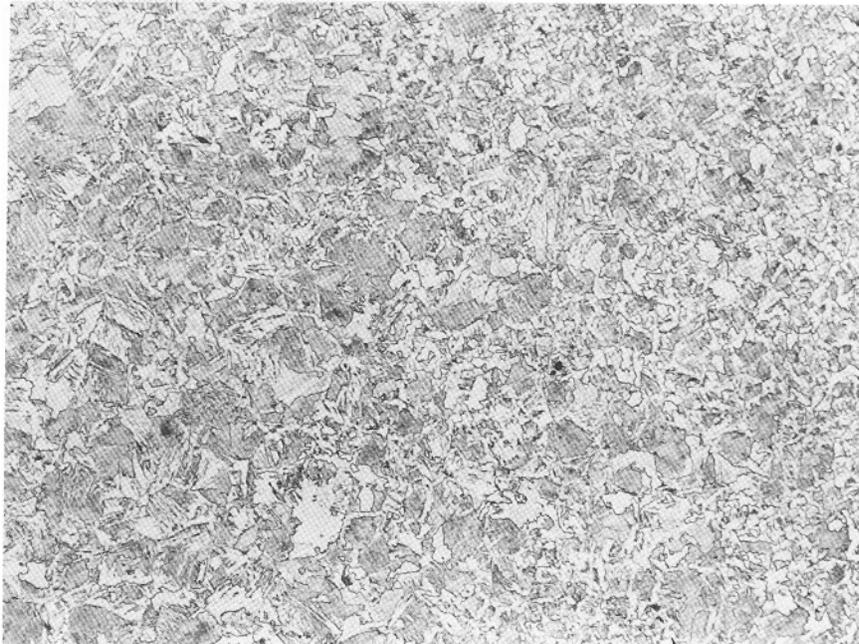
Regions representative of the heat affected zones (HAZ) of sections 1BM1 and 1BM2 are shown in figures A7.4.1-17 and A7.4.1-18, respectively. In both cases, the microstructure appears to consist of ferrite, both as a network in prior austenite grain boundaries and as needles, bainite, partially spheroidized carbides, and tempered martensite. Hardness of the heat affected zones in section 1BM1 is somewhat greater at the south channel than at the north. At both heat affected zones, hardness decreased with distance from the weld. Hardness values in the heat affected zones of section 1BM2 were similar for both zones.

Figure A7.4.1-17 Region representative of the heat affected zone in section 1BM1. The microstructure appears to consist of ferrite, both as a network in prior austenite grains and as needles, bainite, partially spheroidized carbides, and tempered martensite. Etchant: two percent nital. X200

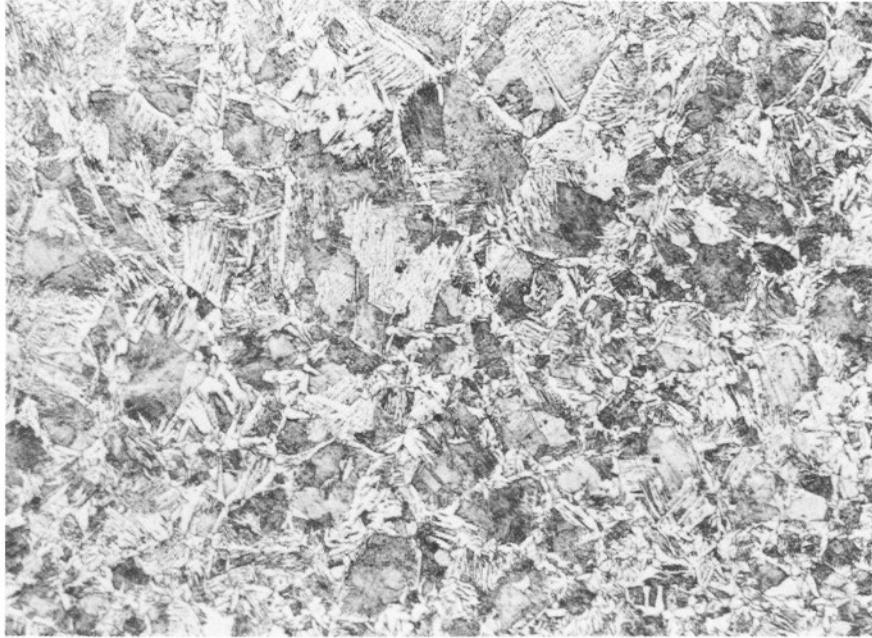
Figure 7.4.1-18 Region representative of the heat affected zone in section 1BM2. The microstructure appears to consist of ferrite, both as a network in prior austenite grains and as needles, bainite, partially spheroidized carbides, and tempered martensite. Etchant: two percent nital. X200

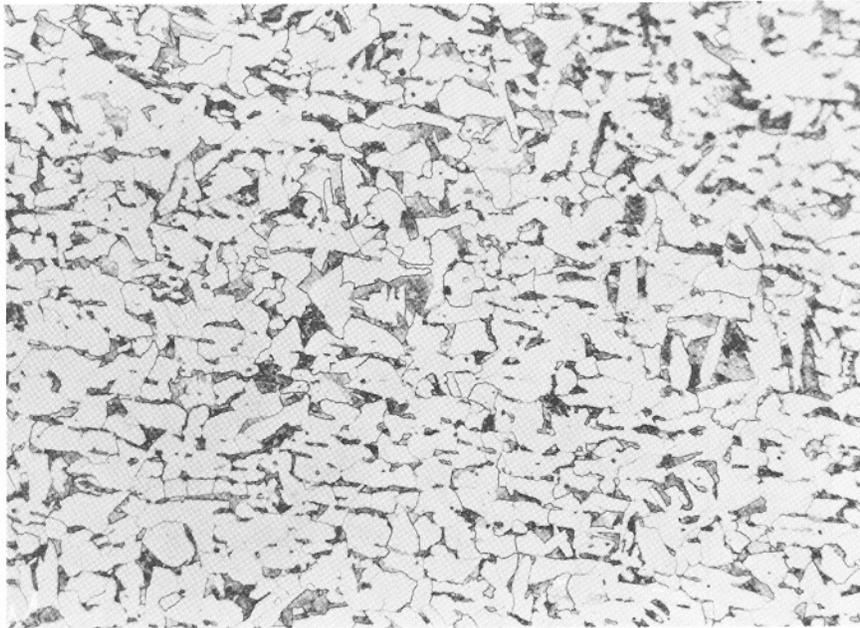
Base material from both channel pieces appeared similar. A region representative of section 1BM1 is shown in figure A7.4.1-20. The microstructure consists primarily of ferrite (light) and pearlite (dark) in a normalized condition. Rockwell B hardness measurements made on both sections indicated no significant differences in hardness between the two channel pieces used to fabricate the box beam. Regions of the channel adjacent to the heat affected zones and in the web region about 0.6 to 1 in (15 to 25 mm) from the bottom of the beam were harder than elsewhere with HRB hardness averaging 81.5. The hardness of the

Figure A7.4.1-20 Region representative of base channel material in section 1BM1. The microstructure consists primarily of ferrite (light) and pearlite (dark) in the normalized condition. Etchant: two percent nital. X200

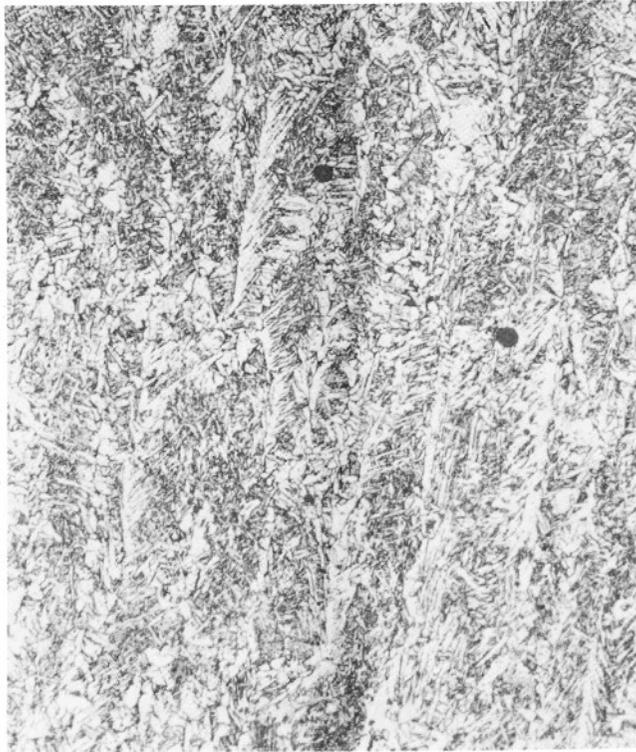
Regions representative of the weld metal in sections 2BM1 and 2BM2 are shown in figures A7.4.1-25 and A7.4.1-26, respectively. Overall, the microstructure in both cases appeared similar and consisted primarily of bainite. Inclusions are evident in both sections. The average hardness values for weld metal in the two sections do not differ significantly.

Figure A7.4.1-25 Representative microstructure of the weld metal in transverse section 2BM1 through box beam 8L (NBS 2). The microstructure appears to consist primarily of bainite. Some inclusions are evident. Etchant: two percent nital. X200

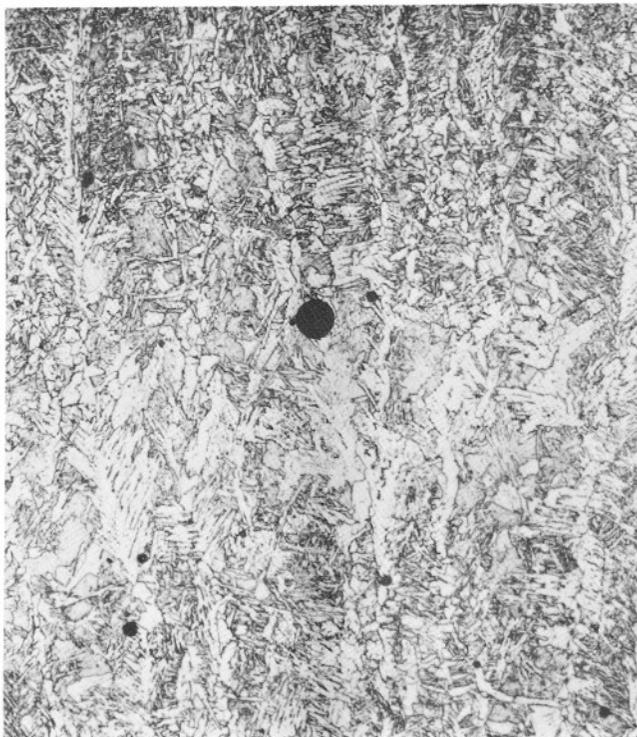
Figure A7.4.1-26 Representative microstructure of the weld metal in transverse section 2BM2 through box beam 8L (NBS 2). The microstructure appears to consist primarily of bainite. Some inclusions are evident. Etchant: two percent nital. X200

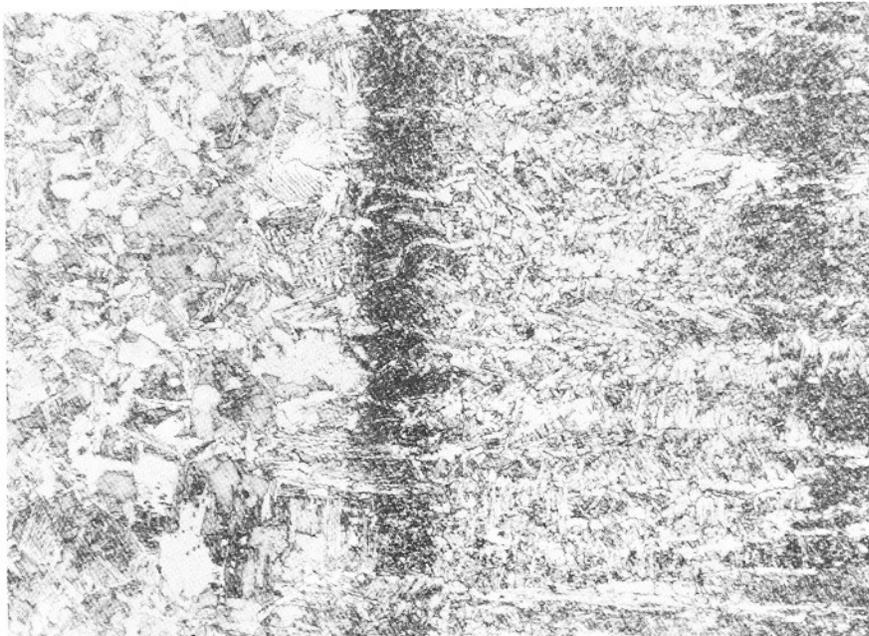
As was the case in section 1BM1 from box beam 9U, there were some hard spots at the transition from weld to the heat affected zone in section 2BM2 on the south side. The transition in section 2BM2 is shown in figure A7.4.1-28 at 200 magnifications. One of the hard regions is shown at much higher magnification (X1200) in figure A7.4.1-29. The microstructure of this region appears to be tempered martensite. The highest hardness value obtained in this region was 298 HK<sub>500</sub> which is approximately equivalent to 28 Rockwell C. Away from the hard regions, hardness averaged 247 HK<sub>500</sub> (99 HRB).

Figure A7.4.1-28 Transition zone from weld metal (right) to heat affected zone (left) in section 2BM2. Etchant: two percent nital. X200

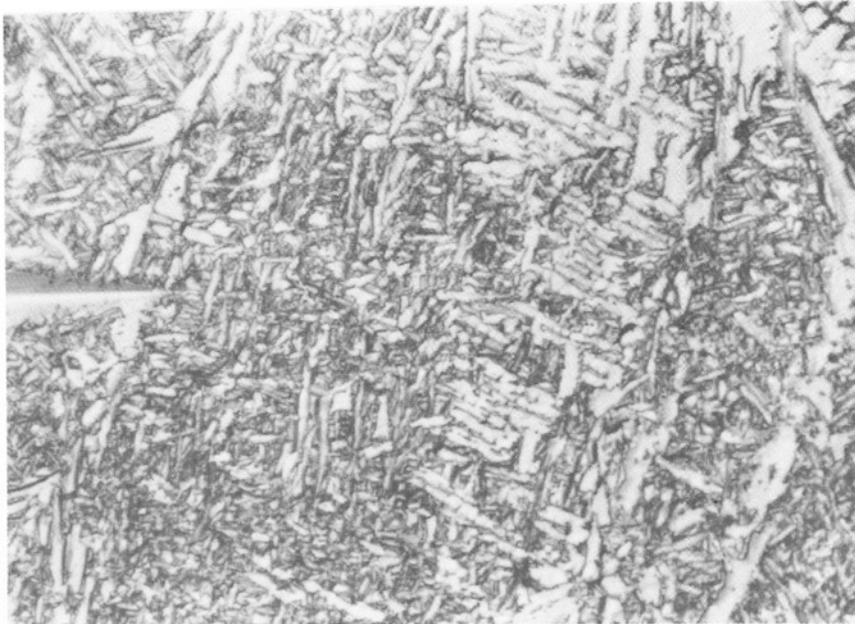
Figure A7.4.1-29 Region of the transition zone from weld metal to the heat affected zone in section 2BM2. This region is one of the hard areas. The microstructure appears to consist of tempered martensite. Part of a hardness test impression can be seen at the left center. Etchant: two percent nital. X1200

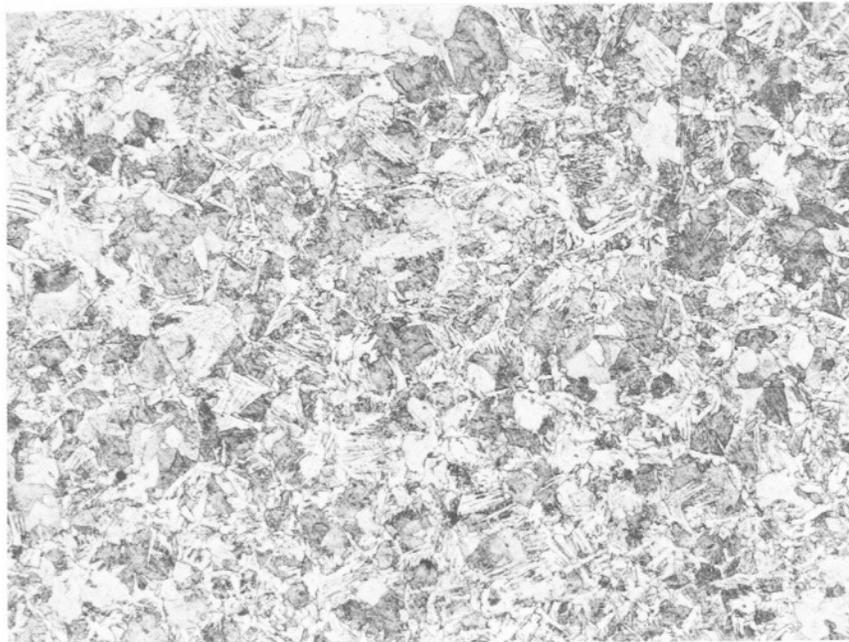
In the heat affected zones, the microstructure was similar in both sections 2BM1 and 2BM2. A representative region from section 2BM1 is shown in figure A7.4.1-30. The microstructure appears to consist of ferrite, both as a network in prior austenite grain boundaries and as needles, bainite, partially spheroidized carbides and tempered martensite. Hardness was 5 to 6 HRB points lower for the heat affected zones in section 2BM2 than in the weld metal. In section 2BM1, hardness was similar for both weld metal and the heat affected zone.

Figure A7.4.1-30 Representative microstructure of the heat affected zone in section 2BM1. The microstructure appears to consist of ferrite, both as a network in prior austenite grain boundaries and as needles, bainite, partially spheroidized carbides, and tempered martensite. Etchant: two percent nital. X200

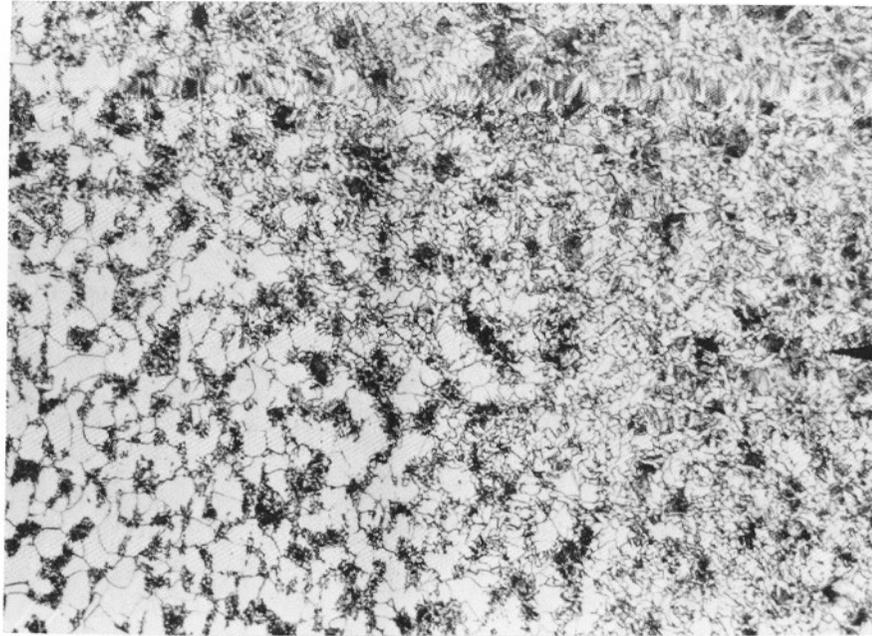
The transition regions from the heat affected zones to base channel material appeared similar for both sections. A region representative of this transition in section 2BM1 is shown in figure A7.4.1-31. A region representative of the base channel material in both sections is shown for section 2BM1 in figure A7.4.1-32. The microstructure of the channel material consists primarily of ferrite and pearlite in a normalized condition.

Figure A7.4.1-31 Transition region from heat affected zone (right) to base channel material (left) in section 2BM1. Etchant: two percent nital. X200

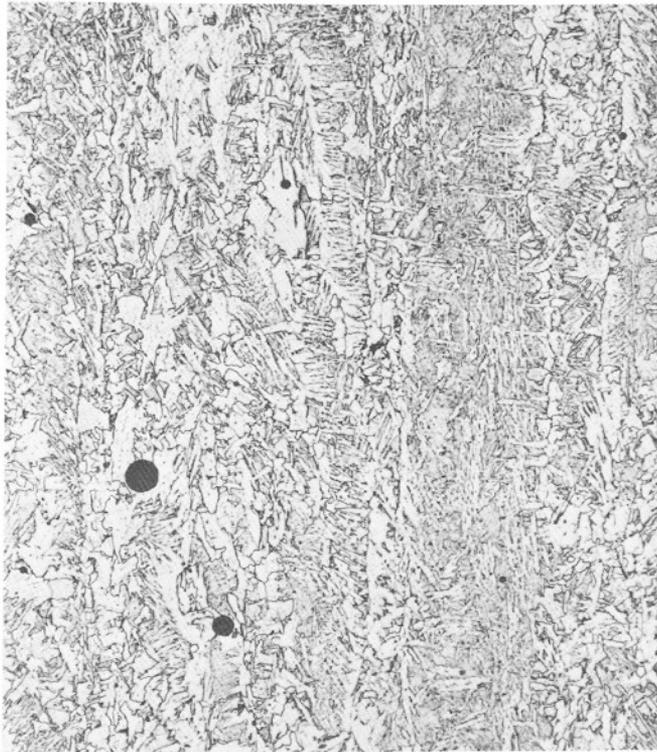
Representative regions of the weld from sections 3BM1 and 3BM2 are shown in figures A7.4.1-37 and A7.4.1-38, respectively. In both cases, the microstructure appears to consist primarily of bainite. More inclusions are evident in section 3BM1 than in section 3BM2. The average hardness of the weld was essentially the same for both sections, being somewhat lower than that of the welds at the sections from the other two walkway box beams.

Figure A7.4.1-37 Representative microstructure of the weld metal in transverse section 3BM1 through box beam 9M (NBS 3). The microstructure consists primarily of bainite. Several inclusions are evident. Etchant: two percent nital. X200

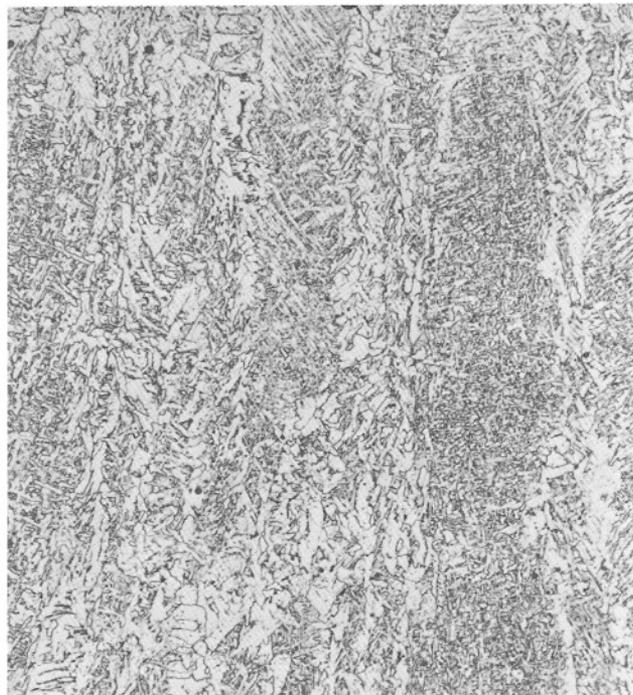
Figure A7.4.1-38 Representative microstructure of the weld metal in transverse section 3BM2 through box beam 9M (NBS 3). The microstructure consists primarily of bainite. Etchant: two percent nital. X200

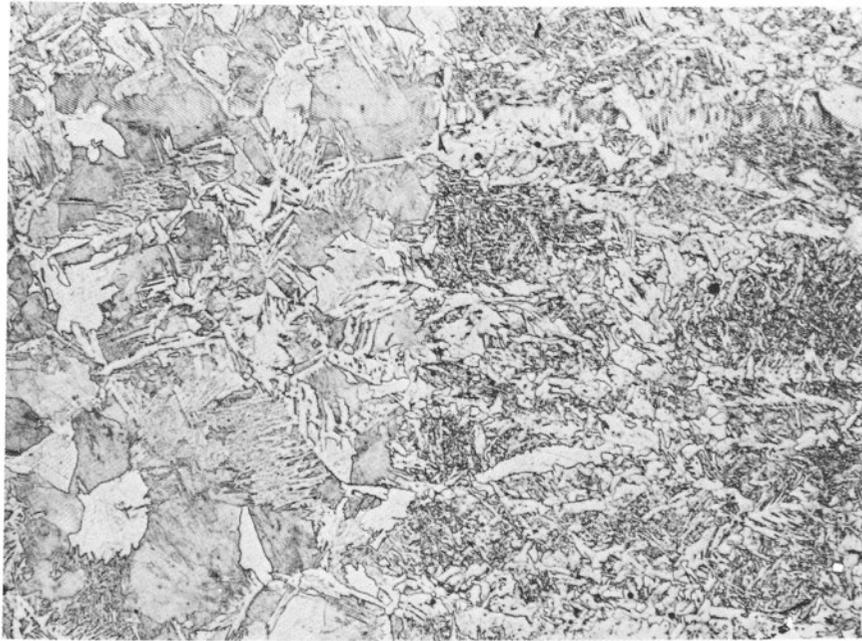
Nothing unusual was observed at the transition from the weld to the heat affected zones in either section. None of the harder regions found in the transition regions of sections 1BM1 and 2BM2 were in evidence. A region representative of these transition regions in section 3BM2 is shown in figure A7.4.1-39.

Figure A7.4.1-39 Transition zone from weld metal (right) to heat affected zone (left) in section 3BM2. Some inclusions can be seen primarily in the weld metal. Etchant: two percent nital. X200

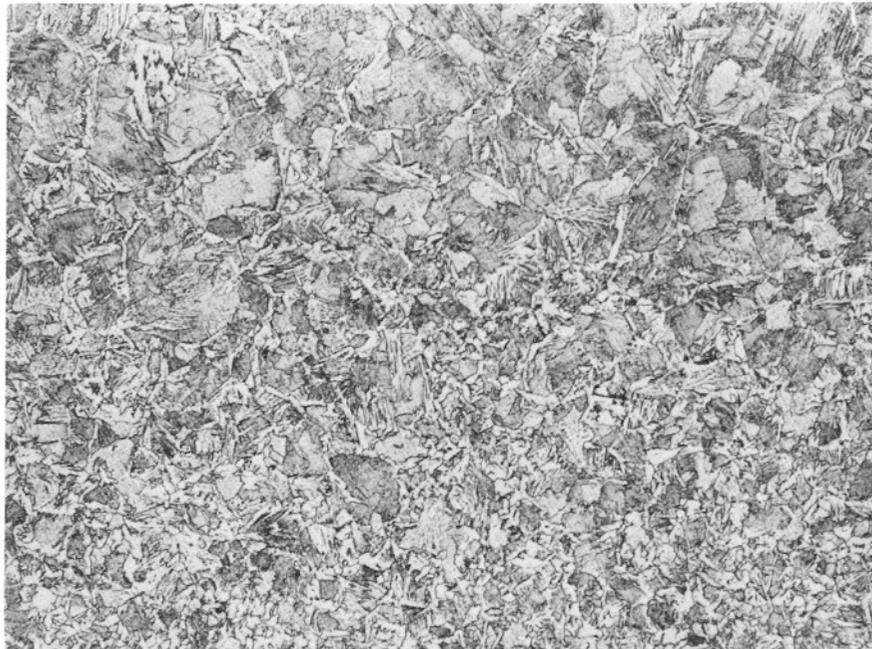
The microstructure and hardness of the heat affected zones in both section 3BM1 and 3BM2 were similar. In both cases, the microstructure consists of ferrite both as a network in prior austenite grain boundaries and as needles, bainite, partially spheroidized carbides and some tempered martensite. Hardness in the heat affected zones was similar to that of the weld. A region representative of the heat affected zone in section 3BM1 is shown in figure A7.4.1-40.

Figure A7.4.1-40 Region representative of the heat affected zone in section 3BM1. The microstructure appears to consist of ferrite both as a network in prior austenite grain boundaries and as needles, bainite, partially spheroidized carbides, and tempered martensite. Etchant: two percent nital. X200
