NBS BUILDING SCIENCE SERIES 143

# Investigation of the Kansas City Hyatt Regency Walkways Collapse

R. D. Marshall  
E. O. Pfrang  
E. V. Leyendecker  
K. A. Woodward

Issued May 1982

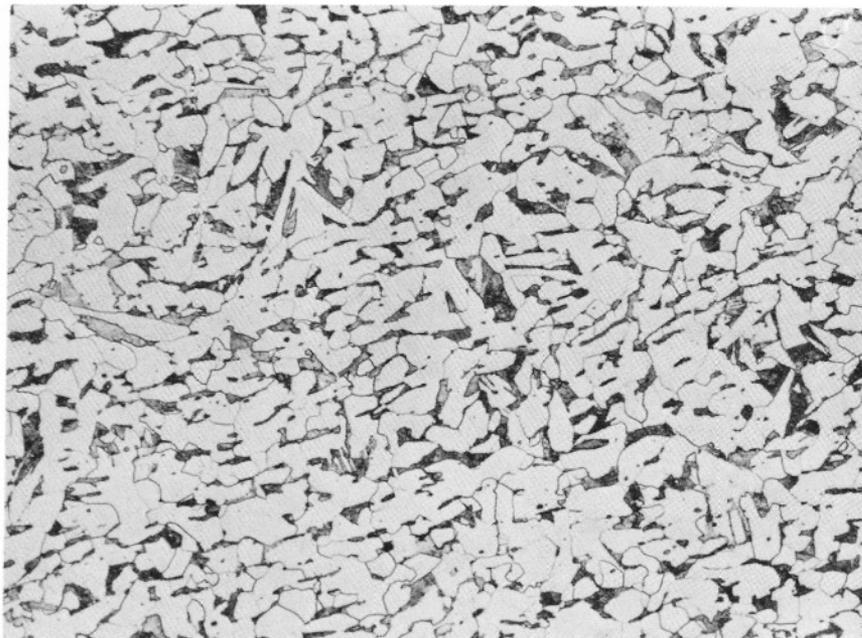
The base material of both channel pieces of the box beam appeared similar in microstructure in both sections 3BM1 and 3BM2. In both cases, the microstructure consists of ferrite and pearlite in a normalized condition. A region representative of the channel material is shown in figure A7.4.1-42. Hardness of both channels was also similar.

Figure A7.4.1-42 Representative region of base channel material in section 3BM1. The microstructure consists of ferrite (light) and pearlite (dark) in the normalized condition. Etchant: two percent nital. X200

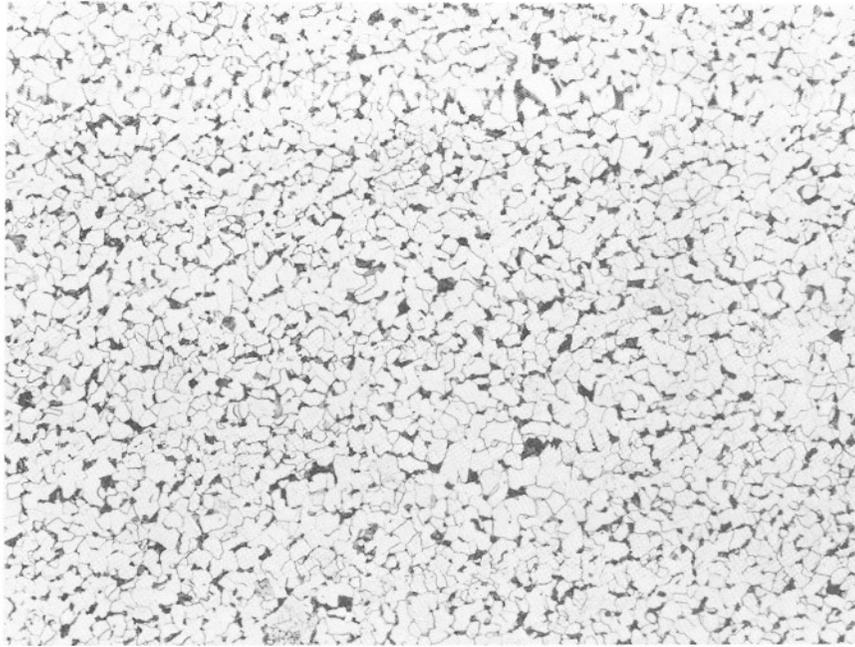
Transverse and longitudinal sections from each of the walkway hanger rod segments obtained from the debris (NBS 5A and 5B) were examined metallographically. The locations of these sections in the hanger rods are shown in figure A7.3.3-1. A representative region showing the etched microstructure of the transverse section from hanger rod NBS 5A is shown in figure A7.4.2-1. The

microstructure consists of ferrite (light) and pearlite (dark) in a reasonably fine grained (ASTM grain size 9) normalized structure.

Figure A7.4.2-1 Transverse section through hanger rod NBS 5A showing the representative microstructure. The microstructure consists of relatively fine grained ferrite (light) and pearlite (dark) in a normalized condition. Etchant: two percent nital. X100

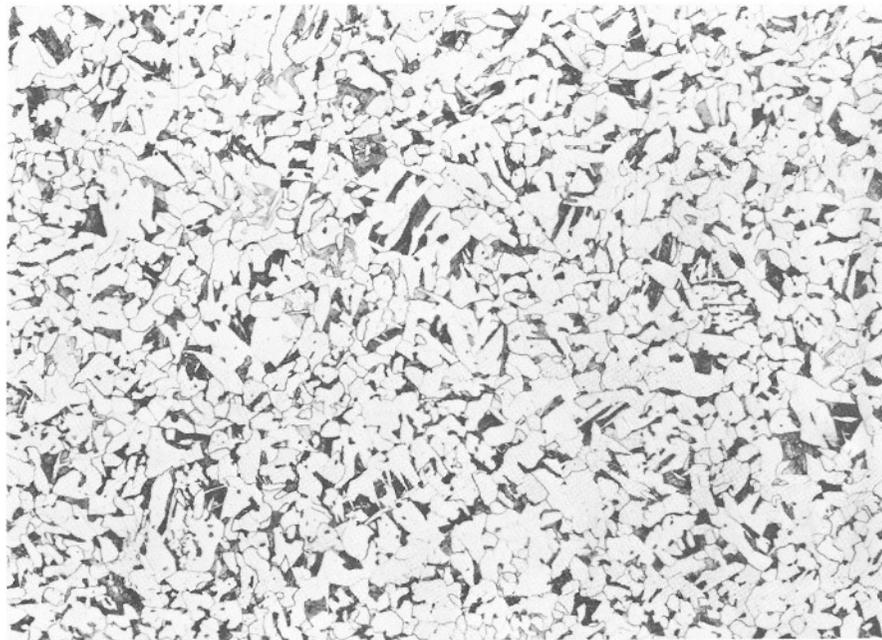
The representative microstructure of the transverse section from hanger rod NBS 5B is shown in figure A7.4.2-2. The microstructure again consists of ferrite (light) and pearlite (dark) in the normalized condition. This microstructure is coarser (ASTM grain size 7-1/2 to 8) than that of hanger rod NBS 5A, and there appears to be more pearlite present than in hanger rod NBS 5A.

Figure A7.4.2-2 Transverse section through hanger rod NBS 5B showing the representative microstructure. The microstructure consists of ferrite (light) and pearlite (dark) in a normalized condition. Etchant: two percent nital. X100

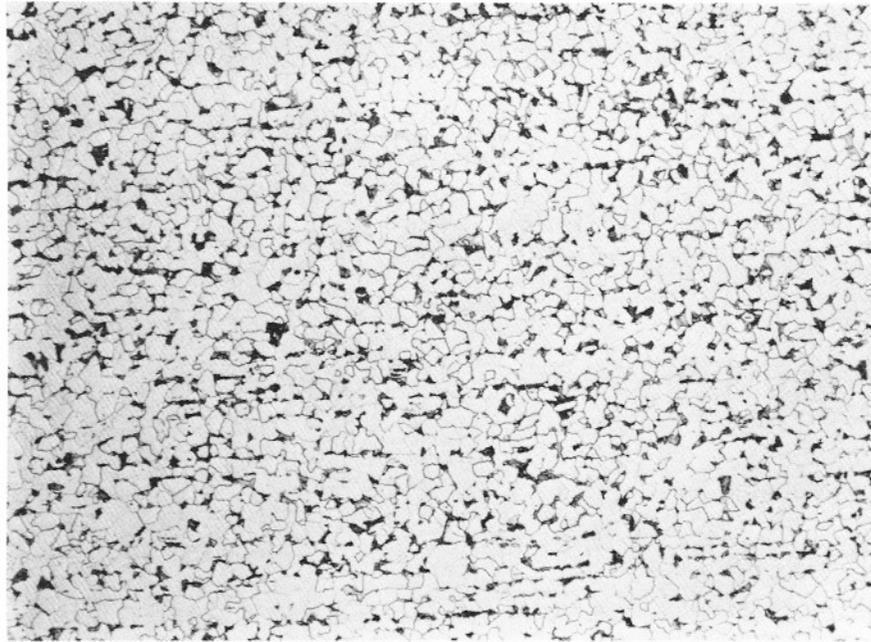
Longitudinal sections through each hanger rod segment revealed the material of both to be fully normalized with equiaxed grains. Regions representative of the longitudinal microstructures are shown in figure A7.4.2-3 for rod segment NBS 5A and in figure A7.4.2-4 for rod segment NBS 5B.

Figure A7.4.2-3 Longitudinal section through hanger rod NBS 5A showing the normalized microstructure consisting of ferrite and pearlite. Etchant: two percent nital. X100

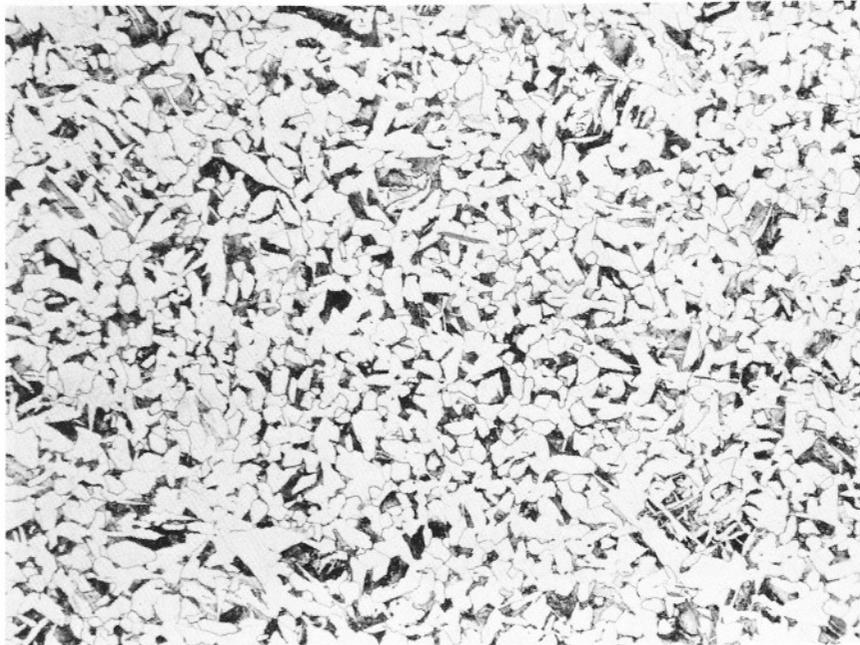
Figure A7.4.2-4 Longitudinal section through hanger rod NBS 5B showing the normalized microstructure consisting of ferrite and pearlite. Etchant: two percent nital. X100

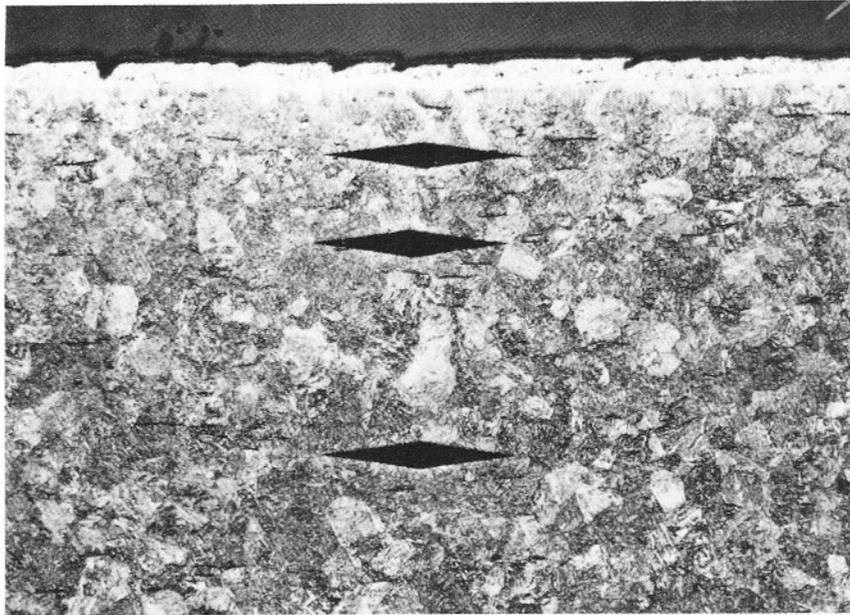
Knoop microhardness measurements at a load of 500 grams force (HK<sub>500</sub>) were made on a cross section through a washer from the walkway debris at location 9MW after it had been used in an NBS full length test on box beam 9M. During the test, the washer fractured into five pieces. A microhardness traverse was made through the thickness of the washer on the section examined. The washer thickness was approximately 0.075 in (1.80 mm). Average hardness from 16 measurements across the section was 459 HK<sub>500</sub> which is approximately equivalent to 44.3 HRC and the hardness range was 422 to 514 HK<sub>500</sub> (41.5 to 48.5 HRC). The highest values were near the center of the section and the lowest values were near the surface of the washer. The microstructure of the washer from location 9MW is shown in figure A7.4.3-1. There is a very small apparent decarburized

layer at the surface (light area at the top in the figure). Tempered martensite is the primary constituent of the microstructure.

Figure A7.4.3-1 Microstructure of washer from location 9MW in the walkway debris. The thin, light layer at the surface (horizontal near the top in the figure) is the decarburized layer at the washer surface. The microstructure consists primarily of tempered martensite. Etchant: Picral. X200

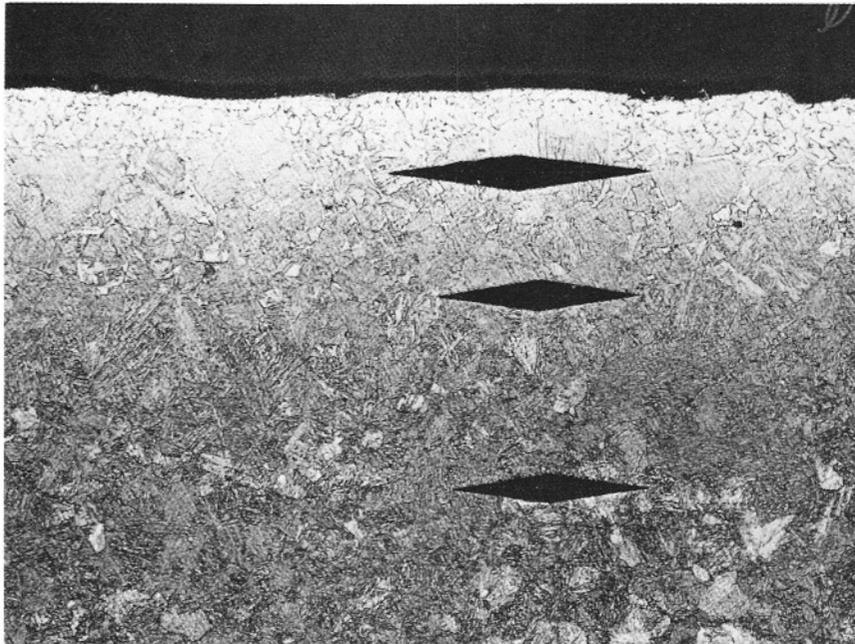
A similar microhardness traverse on a section through one of the NBS hard washers was made. Hardness values in this section, excluding the decarburized layer at the surface, averaged 431 HK<sub>500</sub> (42.5 HRC) and ranged from 401 to 422 HK<sub>500</sub> (40 to 43.5 HRC). Measured hardness in the decarburized layer was as low as 247 HK<sub>500</sub> (99 HRB). The microstructure of the NBS hard washer is shown in figure A7.4.3-2. The decarburized layer at the surface appears light in the figure. Tempered martensite is the primary constituent in the microstructure.

Figure A7.4.3-2 Microstructure of NBS hard washer. The light layer at the surface (horizontal near the top in the figure) is decarburized. The microstructure consists primarily of tempered martensite. Etchant: Picral. X200

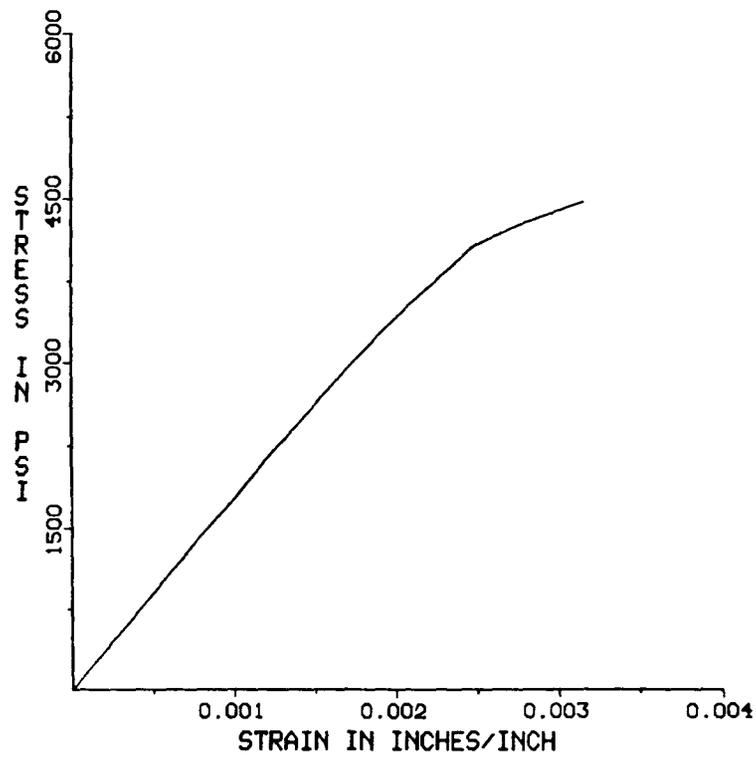
Figure A7.6-6. Stress-strain plot for concrete core 4-13.

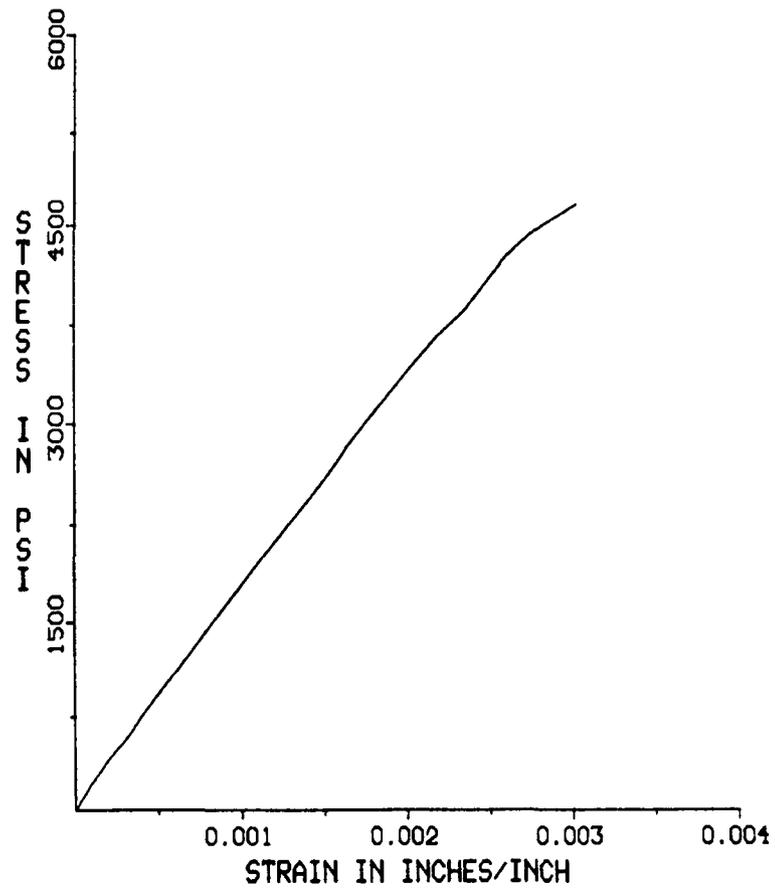
Figure A7.6-7. Stress-strain plot for concrete core 4-16.

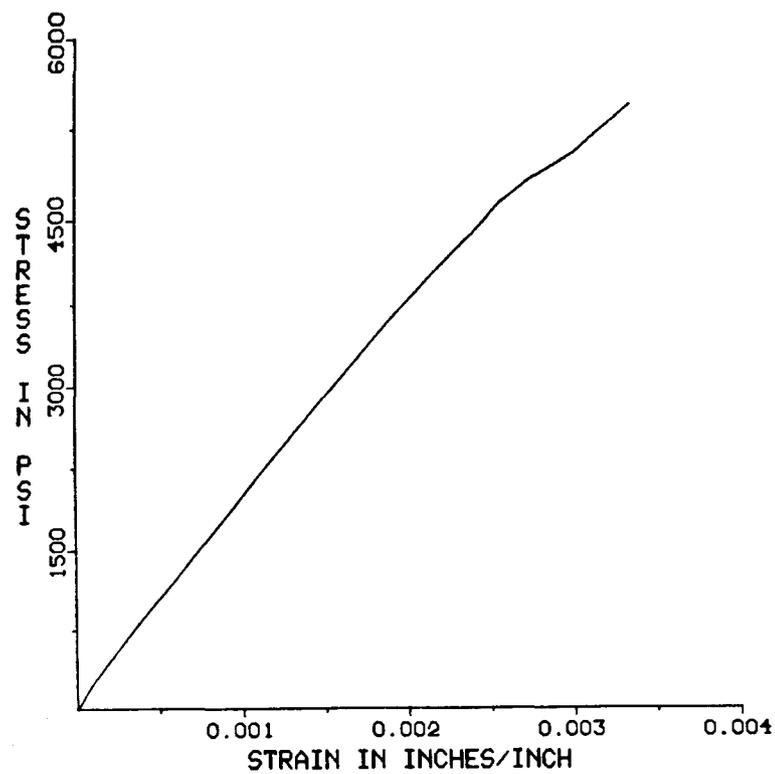
Figure A7.6-8. Stress-strain plot for concrete core 4-18.

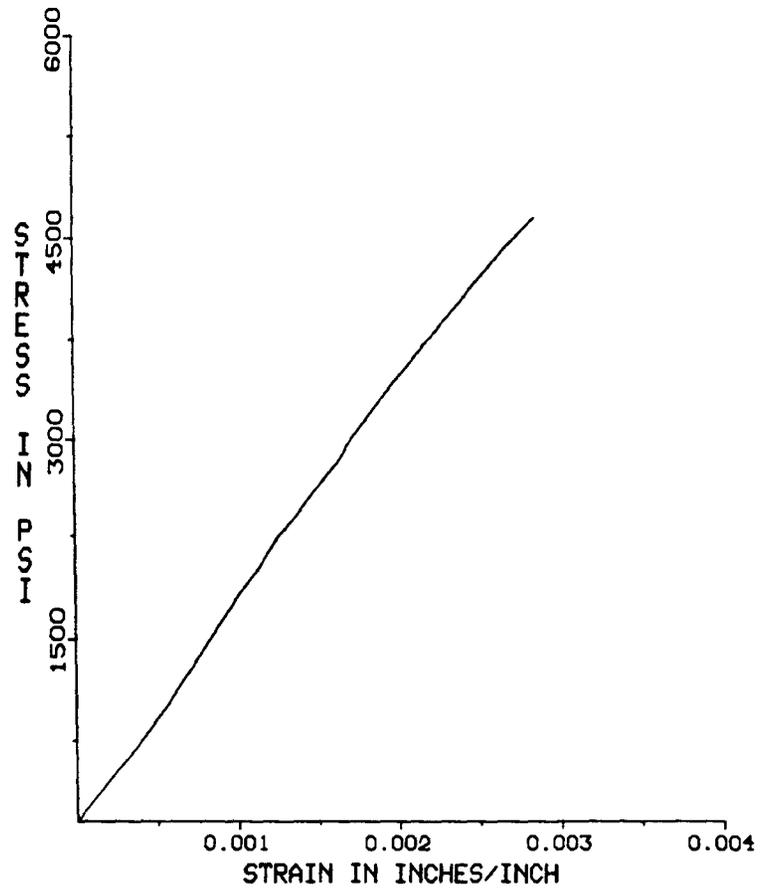
Figure A7.6-9. Stress-strain plot for concrete core 4-19.
