# Source of Phenol Emissions Affecting the Indoor Air of an Office Building

Jonathan W. Martin  
Franklin R. Guenther  
Tinh Nguyen  
Walter S. Liggett, Jr.  
Eric Byrd  
Lisa Oakley

February 1994  
Building and Fire Research Laboratory  
National Institute of Standards and Technology  
Gaithersburg, MD 20899

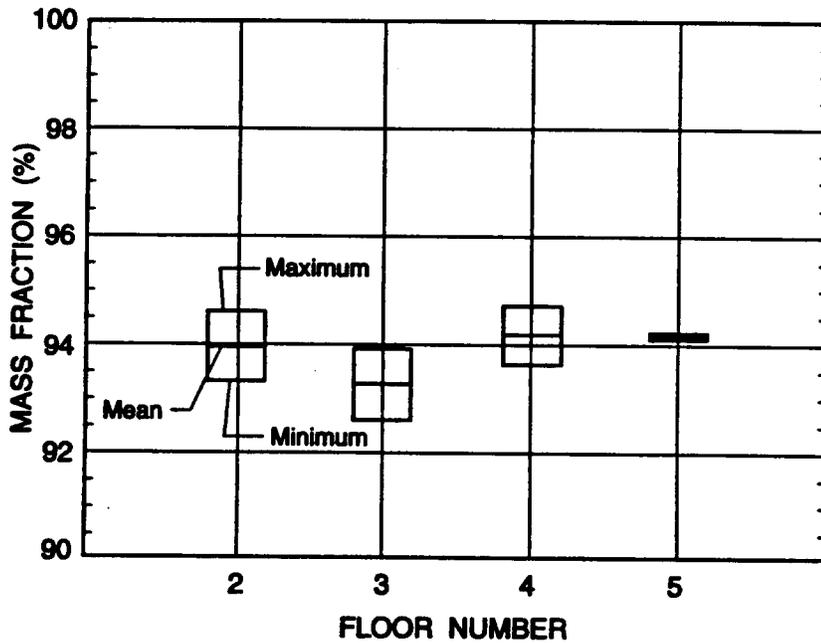
Figure A2. Box-and-whisker diagram for mass fraction of low volatile organic material volatilizing between 200 and 800 °C from the composite samples made from core samples taken from floors 2 through 5.

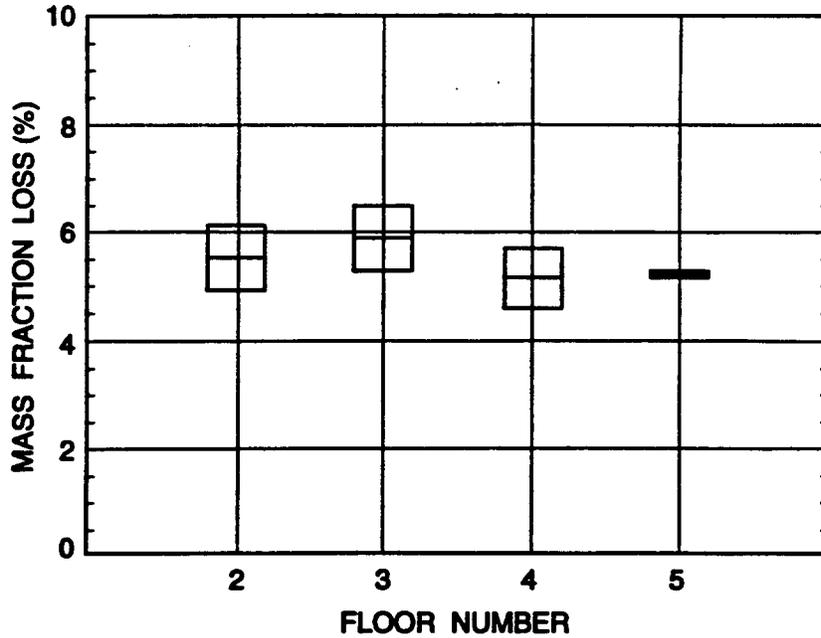
Figure A3. Box-and-whisker diagram for mass fraction of low volatile organic material volatilizing between 200 and 800 °C from composite sample made from cores taken from Floors 2 through 5.

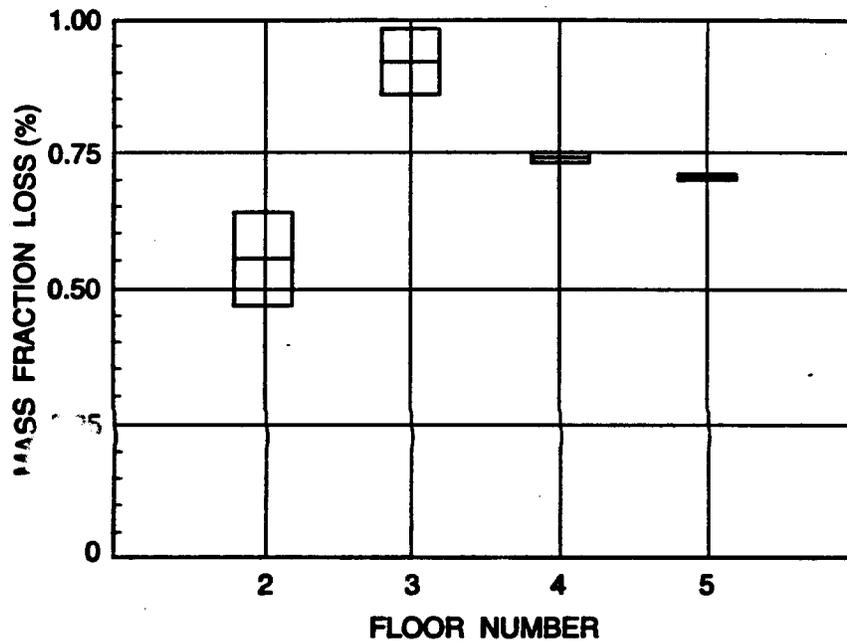
Figure A4. Box-and-whisker diagram for the mass fraction of volatile organic materials volatilizing between room temperature and 200 °C for composite samples made from core samples taken from Floors 2 through 5.

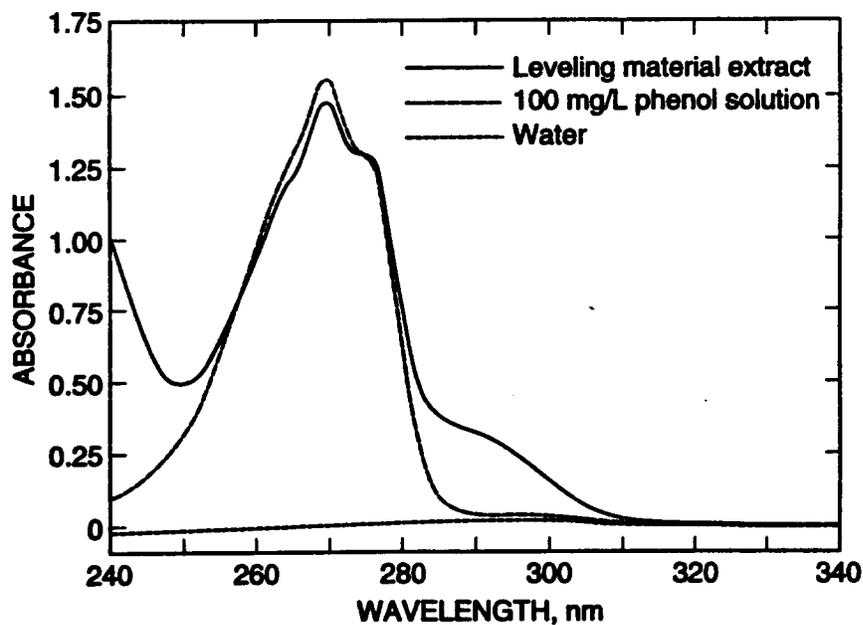
Figure D1. UV-spectra of water, a 100 mg/L aqueous phenol solution, and the Soxhlet water extract from the floor leveling material.
