An Experimental Determination of a Real Fire Performance of a Non-Load Bearing Glass Wall Assembly*

Abstract. A glass wall assembly was exposed to an intense real-scale compartment fire. The wall assembly consisted of four glass sections, two of which were fitted with tempered double-pane glass and the other two sections were fitted with tempered single-pane glass. At each glass section, temperatures were measured at the exposed face and the unexposed face. Total heat flux gauges were used to measure both the temporal variation of the energy incident on the glass wall and the transmitted energy rate detected through two of the glass sections. Visual and infrared cameras were used to image the unexposed face of each wall assembly during the fire exposure. Results of glass breakage and subsequent glass fall out were compared to studies in the literature for glass sections exposed to compartment fires. The behavior of the glass wall assembly under a fire load is presented.

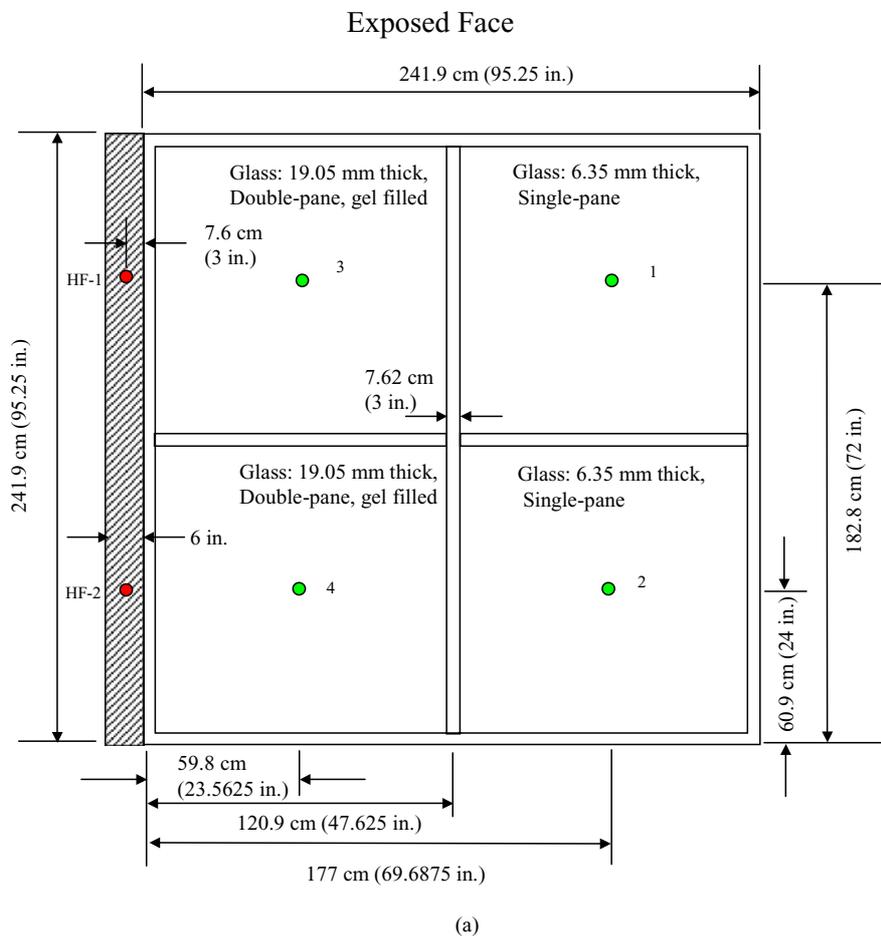
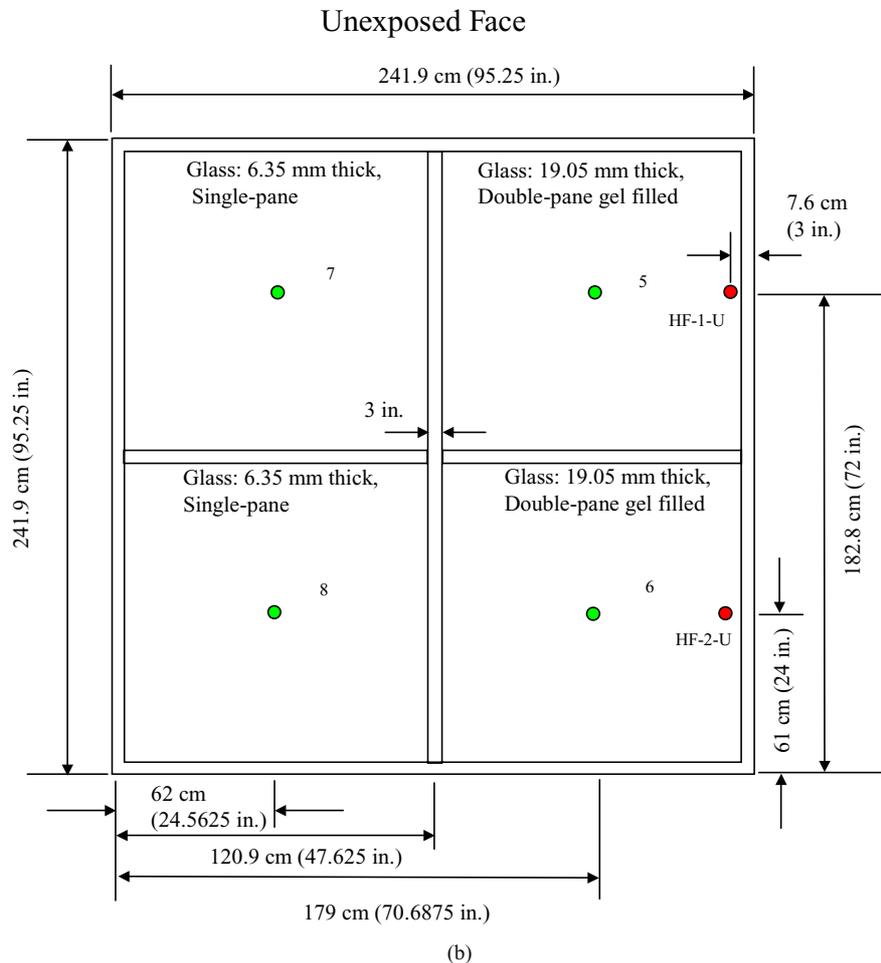
Figure 1. (a) Drawing of glass wall assembly showing the exposed face.(b) Drawing of the glass wall assembly showing the unexposed face.(c) Schematic of compartment used for the fire test. (Continued in next page.)

Figure 1(a) and 1(b) display schematics of the glass partition used for fire testing. The dimensions of the assembly were 2.42 m by 2.42 m. The frame was fitted with two different types of glass. Double-pane tempered glass (SAFTI Superlite II XL¹) was installed in the two sections on the left (see Figure 1(a)). The double-pane glass consisted of two tempered glass panes, each with a thickness of 6.35 mm. Sandwiched in between the glass panes was a 6.35 mm layer of gel insulation. As a consequence, the double-pane glass had a total thickness of 19.05 mm. On the right hand side, single-pane tempered glass (SAFTI Superlite I) with a thickness of 6.35 mm was installed (see Figure 1(a)).

Temperatures were obtained using type K bare thermocouples (22 gauge) taped to the glass sections. Temperatures were obtained at the exposed and unexposed face and the locations of these thermocouples is displayed Figure 1(a)–(b). The thermocouples were offset 25.4 mm on the unexposed face to avoid blockage of radiation due to placement of the exposed face thermocouples.

Two Schmidt-Boelter water cooled total heat flux gauges (15 mm diameter) were used to measure the heat flux incident on the glass wall. The location of these gauges is shown in Figure 1(a)–(b). Ideally, it is desirable to have the gauges mounted flush to the surface of the glass sections, that way the gauges would be as close to the measurement location as possible. Unfortunately, it is not possible to drill into the glass sections to mount the gauges. An additional strategy may be to mount the gauges directly in front of the glass sections. This, however, is not desirable since the gauges would be shielding the glass sections from the radiation of the fire. Therefore, the gauges were located off to the side of the double-pane sections and mounted flush to the column (see Figure 1(a)). This method has been used extensively to obtain heat flux data for glazed sections [8–9].

Additionally, two Schmidt-Boelter water cooled total heat flux gauges (15 mm diameter) were placed behind the two double-pane glass sections (on the unexposed side). The gauges were placed at the same height (near the column) as the gauges located at the exposed face (see Figure 1(b)) and were located 15 mm from the glass surface. Such measurements were performed behind the double-pane glass assembly since it was expected that these two sections would survive longer in the fire than the single-pane glass sections and thus offer the ability to collect meaningful data for a longer duration.

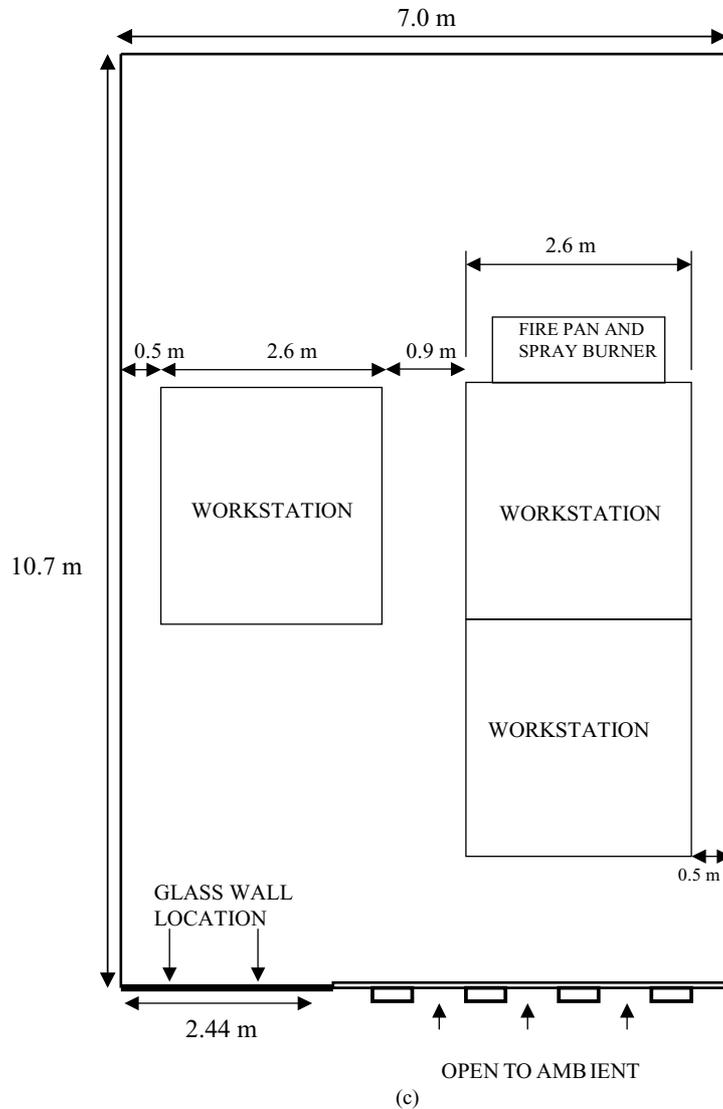
Figure 1. (Continued.)

The size of the compartment for the fire experiments was 10.7 m long by 7.0 m wide by 3.4 m high. A schematic of the compartment is displayed in Figure 1(c). A 2.44 m by 2.44 m

opening was constructed on the lower 7.0 m side of the compartment to mount the glass wall assembly. The entire assembly was mounted flush to the ceiling of the compartment and all instrumentation was installed while the partition assembly was mounted. The compartment was lined with calcium silicate board.

The compartment was constructed to simulate a typical office space that would be found in tall buildings. Accordingly, the combustibles within the compartment consisted of three workstations for each of the fire exposures reported here. The fires were ignited using a spray burner (see Figure 1(c)). Gas-phase temperature profiles were obtained using thermocouple

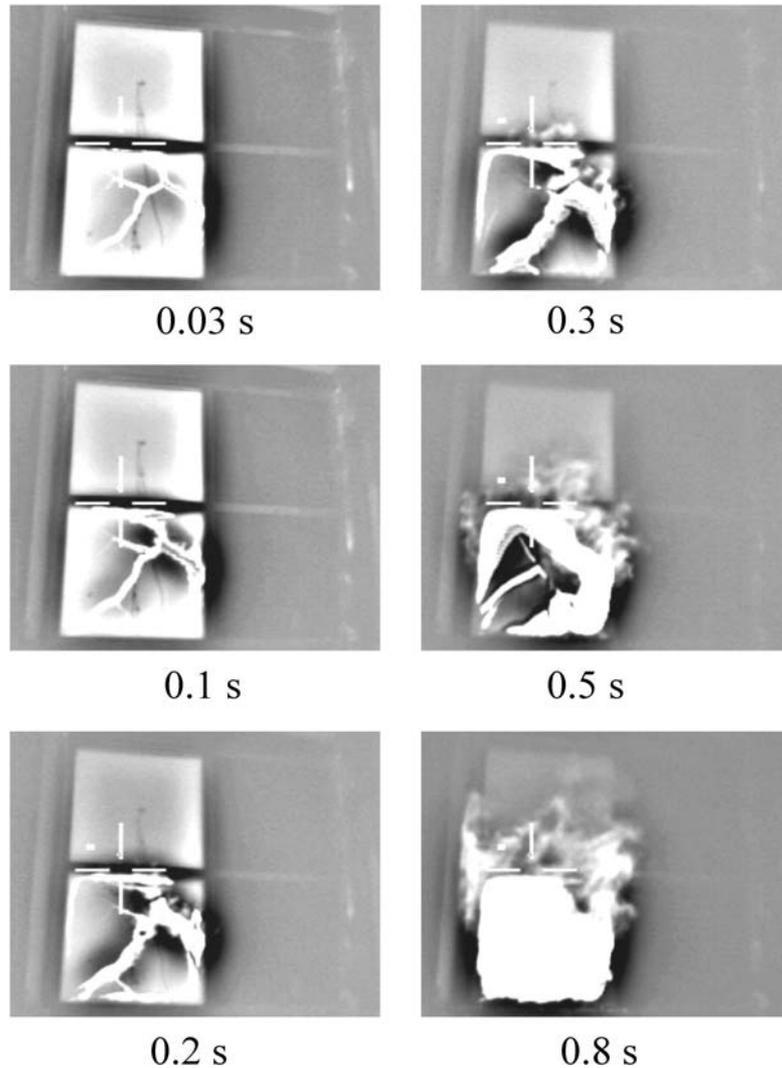
Figure 3. (a) Temporal evolution of the glass fall out as seen with the infra-red camera. The camera is focused on the unexposed face.

Both visual and infrared cameras were used to obtain information for the glass cracking and fall out process. The cameras were focused on the unexposed face of the glass wall. Figure 3 displays these processes for the bottom section of the single-pane glass section. From these images, the cracking and fall out process was rapid. Cracks developed across the glass and the panel fell out after 0.8 seconds of initial crack formation. The time scale of the fall out process was similar for the both single-pane sections.

Comparing these results with the present measurements, the exposed glass surface temperature for fall out of the bottom single-pane glass panel was 400°C. The total heat flux incident at this section of the glass wall was 50 kW/m². These values are similar to literature values [8, 9]. Shields et al. [8, 9] stressed that vent formation due to glass fall out occurs at much higher glass temperatures than previously accepted values in the literature. Present measurements further support this position. Similar to literature values, the single-pane glass sections were observed to break before the time of the peak heat release rate of the fire. It must be noted, however, that in the present experiments glass breakage and glass fallout for the single-pane sections occurred at essentially the same time after ignition (see Figure 3).

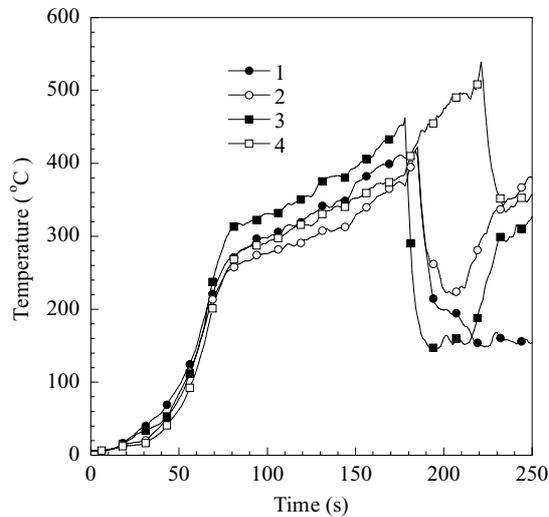
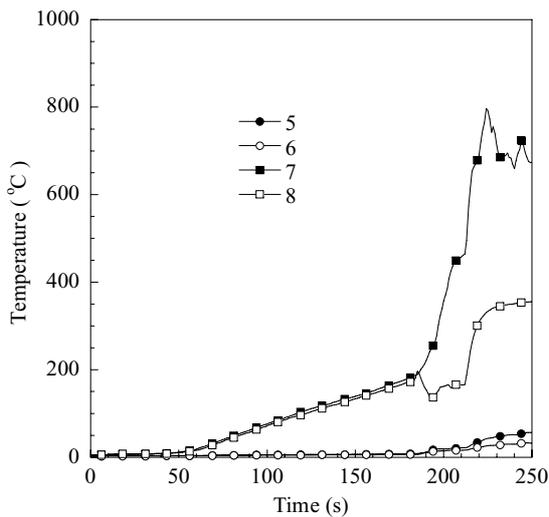
Figure 4. (a) Temporal evolution of temperatures measured on the exposed glass face as a function of location, and (b) Temporal evolution of temperatures measured on the unexposed glass face as a function of location.

The temperatures were measured at the exposed and unexposed face for the four glass sections and these distributions are displayed in Figures 4(a)–(b). Of all the reported results, the exposed face temperature measurements have the largest uncertainty due to the inherent difficulty of measuring surface temperatures within the fire environment. It has been shown that differences of greater than 100°C for exposed surfaces may be realized [12]. Accordingly, the relative combined uncertainty in these temperature increases at the exposed surface was $\pm 30\%$. For the unexposed surface temperatures, the relative combined uncertainty is estimated to be $\pm 10^{\circ}\text{C}$, as these measurements are taken on surfaces not directly exposed to the large heat fluxes. For the exposed face temperature locations (see Figure 4(a)), thermocouple location 3 indicated that this glass section was the first to fall out. This was in agreement with the direct visual observations from the video records. At thermocouple locations 1 and 2, the temperature traces suggested that both panels fell out at the same time. However, the glass section with thermocouple location 2 fell out 27 seconds before the panel where thermocouple 1 was mounted. When the bottom single-pane glass section fell out, a vent was created. The flow induced by this event resulted in the thermocouple 1 becoming disengaged from the glass surface. As a result, the fall out time indicated by the thermocouple trace is incorrect for thermocouple location 1. The trace

The unexposed face temperature measurements are displayed in Figure 4(b). Thermocouple location 8 corresponds to the backside temperature for thermocouple location 2. Since this section fell out, the time of fall out matched thermocouple location 2. Thermocouple location 7 resulted in a large increase in temperature when fall out was observed for thermocouple location 8. As mentioned, the upper single pane section remained in place

obtained for thermocouple location 4 shows that the inside panel of the double-pane glass section on the bottom fell out last. This agreed with the fall out time measured from the video records.

after the bottom single pane section fell out. As soon as the bottom single pane section was gone, hot gases rushed out of the compartment and upwards due to buoyancy over thermocouple 7. Therefore, the temperature measured at thermocouple location 7 is merely the prevailing gas temperature after the lower single-pane glass section fell out. The exposed face temperature at fall out was 400°C–500°C for all glass sections. For unexposed

temperature measurements on the double-pane glass sections (thermocouple locations 5 and 6) the temperatures never climbed above 80°C and 120°C for thermocouple location 6 and 5, respectively.

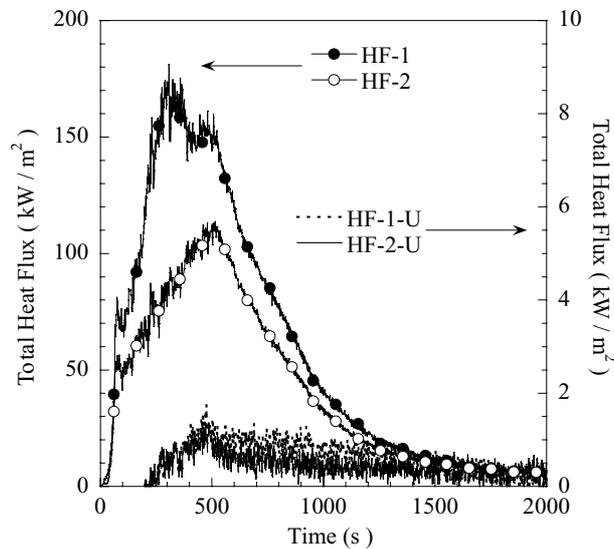
Figure 5. Temporal evolution of the total heat flux measurements, both at the exposed and unexposed face.

Figure 5 displays the measured total heat flux measurements. The combined uncertainty in the total heat flux measurements was $\pm 10\%$ [10]. Measurements obtained at the exposed and unexposed face are shown. During the time of glass fall out, the total heat flux at the exposed face was between $50\text{--}70\text{ kW/m}^2$ at locations HF-1 and HF-2, respectively. At the unexposed face of the double-pane gel filled glass sections, the measured total heat flux was only on the order of 1 kW/m^2 to 2 kW/m^2 .

diffusivity = 0.46×10^{-6} m²/s, glass absorption length = 0.1×10^{-2} m, glass breaking stress = 0.12×10^9 Pa, glass Young's Modulus = 0.7×10^{11} Pa, glass thermal coefficient of linear expansion = $0.85 \times 10^{-5}/^{\circ}\text{C}$, glass thickness = 0.0063 m, shaded thickness = 0.0508 m, and half-width of glass section = 0.58 m. In addition, BREAK1 [21] required the following additional input parameters: the heat transfer coefficient, unexposed side = 5.0 W/m²K, ambient temperature of glass, unexposed side = 300 K, emissivity of the glass = 0.85, emissivity of ambient = 0.8, and heat transfer coefficient on hot layer side = 20 W/m²K. Finally, the heat flux data (see Figure 5) was used as boundary conditions for the model.

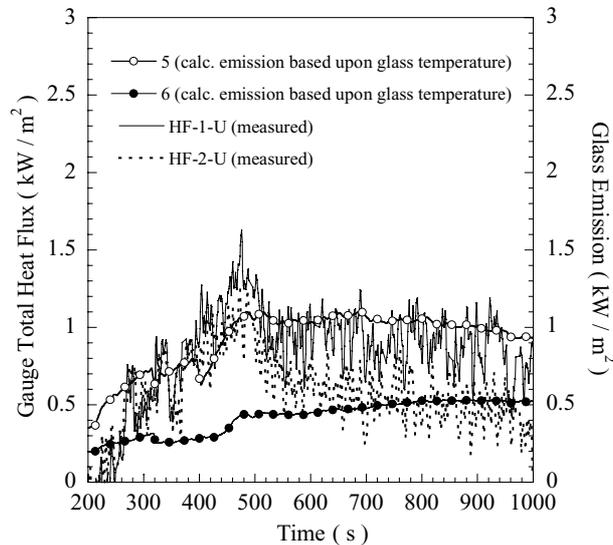
Figure 6. Temporal evolution of the calculated emission based upon glass temperature. The temporal evolution of the measured total heat flux at the unexposed glass surface is shown as well.

In terms of fire safety, it is important to understand how much energy is transmitted through the glass as a consequence of the fire exposure [13, 15]. As mentioned, two total heat flux gauges were placed behind the double-pane glass. The measured unexposed glass temperatures were used to calculate glass emission (due to surface re-emission by the glass) [15]. The hemispherical emissivity used in these calculations was 0.85, a value typically assigned to window glass [15]. The results of these calculations are shown in Figure 6 and are plotted along side the heat flux measurements. The calculations suggest that the majority of the heat flux measured was due to emission from the glass. Consequently, the amount of radiation transmitted through the two gel filled double-pane glass sections was minimal.
