STRUCTURAL COLLAPSE RESEARCH AT NIST

D. W. Stroup and N. P. Bryner
Building and Fire Research Laboratory
National Institute of Standards and Technology
Gaithersburg, MD, USA 20899-8661

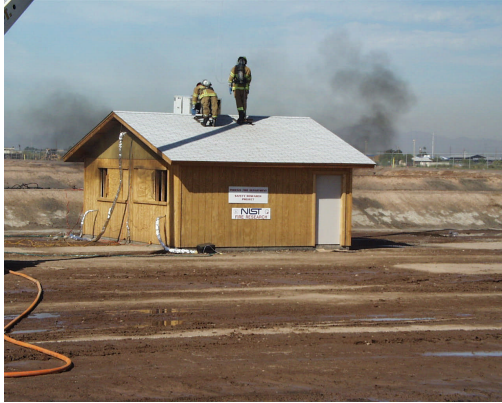
Figure 3. Photograph of test structure shortly after ignition

Multiple fires were initiated in each structure to facilitate collapse. The fires were allowed to burn until the portion of the roof supporting two firefighter mannequins failed. Temperatures were measured at various locations in the structures. Peak temperatures obtained during the tests ranged from approximately 800 °C to 1000 °C. The roof of each structure collapsed approximately 17 min \pm 2 min after ignition of the fires⁵. One test structure is shown shortly after ignition in Figure 3 and approximately 16 minutes after ignition in Figure 4.

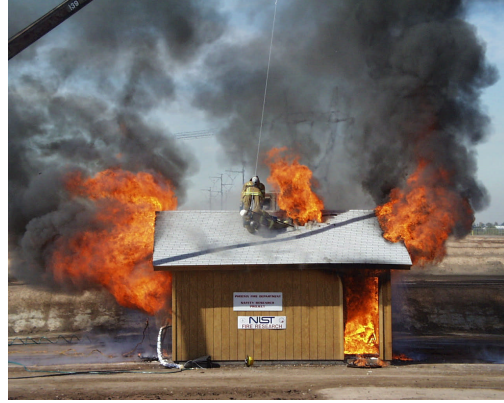
Figure 4. Photograph of test structure 16 minutes after ignition

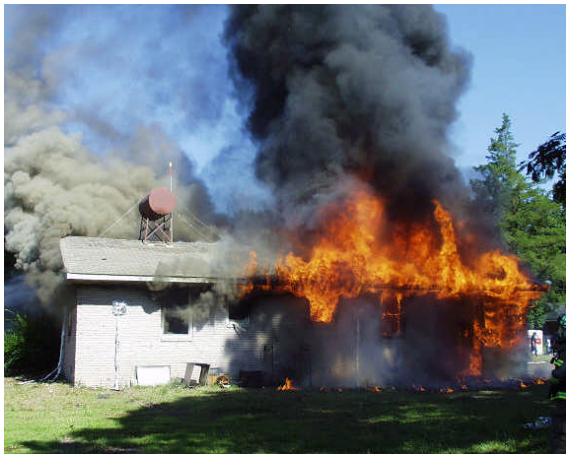
In one of the tests, a heating oil tank filled with water was placed on the roof for an additional load of approximately 270 kg (Figure 5). The objective was to force collapse of the roof under the tank and the supporting roof structure prior to collapse of the entire roof. The fire in the structure was ignited using 11.3 l of gasoline that produced a large explosion in the front living room of the house. The structure burned for approximately 20 minutes before the tank collapsed through the roof. Wood roof support members were retrieved from this test for further examination. Analysis of these members could provide useful information about the load carrying capacity of burning wood supports. Temperature histories were recorded close to these wood supports to document the history of the high temperature exposure.

Figure 5. Photograph of burning structure showing water filled tank on roof

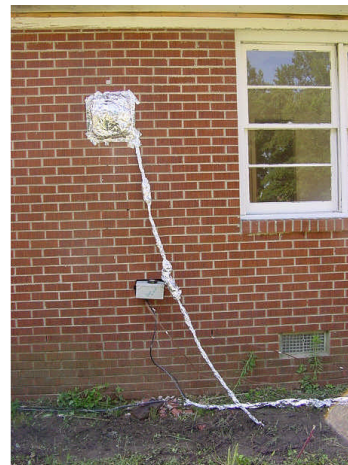
Figure 6. Photograph showing placement of micro-accelerometers

Another potential method for predicting structural collapse used devices attached to the building to “listen” for signs of failure. As part of this test series, micro-accelerometers were attached to the brick facing on one of the houses (Figure 6). These sensitive instruments measured the vibrations of the exterior wall caused by the pulsating flames from the furniture fire within the structure. Vibration measurements of the house taken during the test indicated that warning signs of collapse could be detected about three minutes before the tank fell through the partially burned roof.

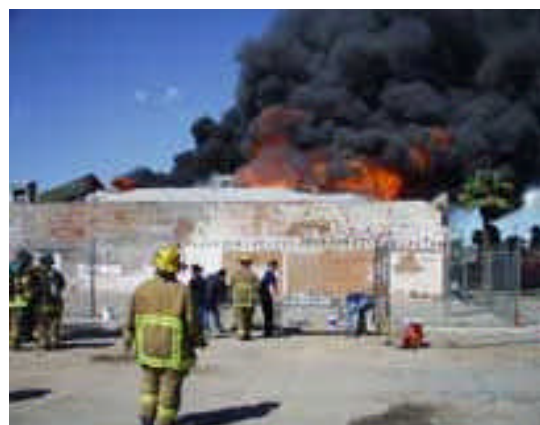
Figure 9. Photograph showing fire and smoke coming from the roof during the first test

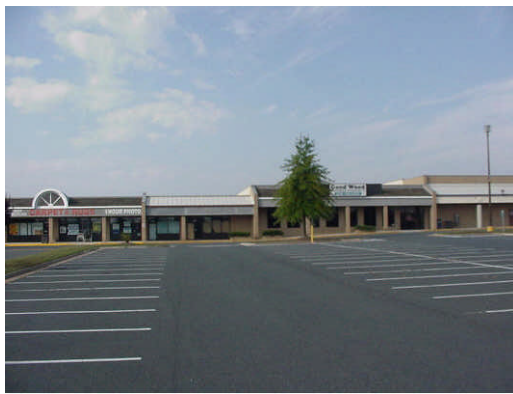
Figure 10. Photograph of shopping mall

An abandoned shopping mall, built in the 1980's and located in Woodbridge, Virginia, was used for a test series examining lightweight steel construction (Figure 10). The shopping mall consisted of several stores constructed with steel studs and gypsum board partition walls (Figure 11). The roof system consisted of a metal deck supported by lightweight open-web steel trusses, a rigid insulation (foam core) covered with a single-ply membrane and topped with gravel. The lightweight open-web steel trusses were of the type widely used in floor and roof systems for commercial and institutional buildings (Figure 12). Thermocouples were placed at appropriate locations with the building to measure temperatures in the stores and in the vicinity of the steel trusses.

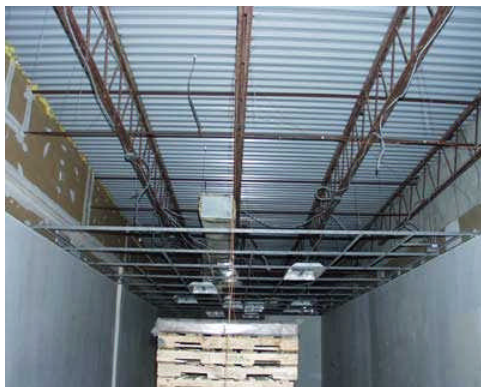
Figure 12. Photograph showing open-web steel trusses supporting roof structure

A similar collapse scenario to that used during the wood frame residential structure tests was used in the mall tests. Three stores were selected for the three tests to be conducted in the mall. In order to facilitate collapse, the roofs of the three stores were loaded with 200 1 barrels filled with water. The first and second test stores each had 4 barrels placed on their respective roofs. When collapse did not occur during either the first or second test, the number of barrels on the roof of the third store was increased to 12. For each test, the fire was remotely ignited at the bottom of a stack of wooden pallets (Figure 13).

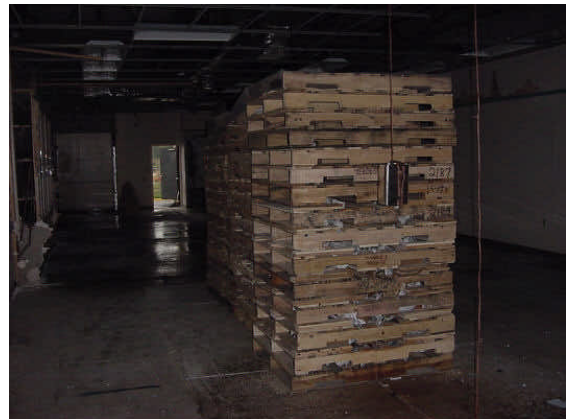
Figure 13. Photograph showing wood pallet fuel source inside store

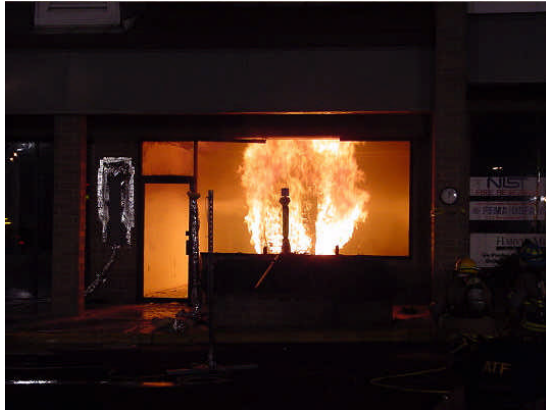
Figure 14. Photograph showing interior of store with burning pallets

Roof collapse occurred within 7 minutes of the start of the third test. Figure 14 shows a photograph of the interior of the store with the pallets fully involved in fire. The store is shown in Figure 15 just

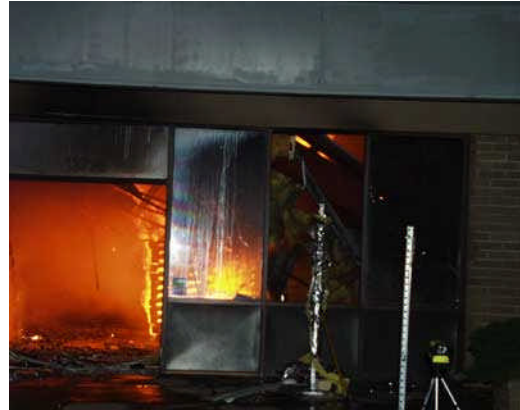
Figure 15. Photograph showing complete collapse of the roof

prior to the onset of collapse and in Figure 16 at the point of complete collapse of the roof and ceiling structure. The damaged steel trusses are shown in Figure 17.

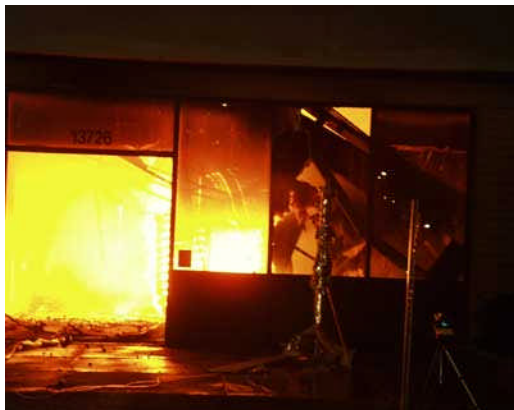
Figure 16. Photograph showing onset of collapse

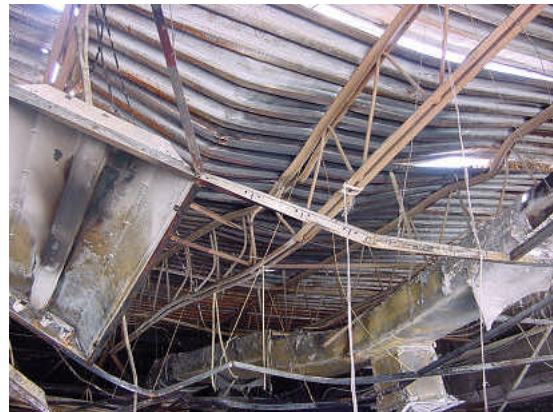
Figure 17. Photograph showing damage to steel trusses after collapse

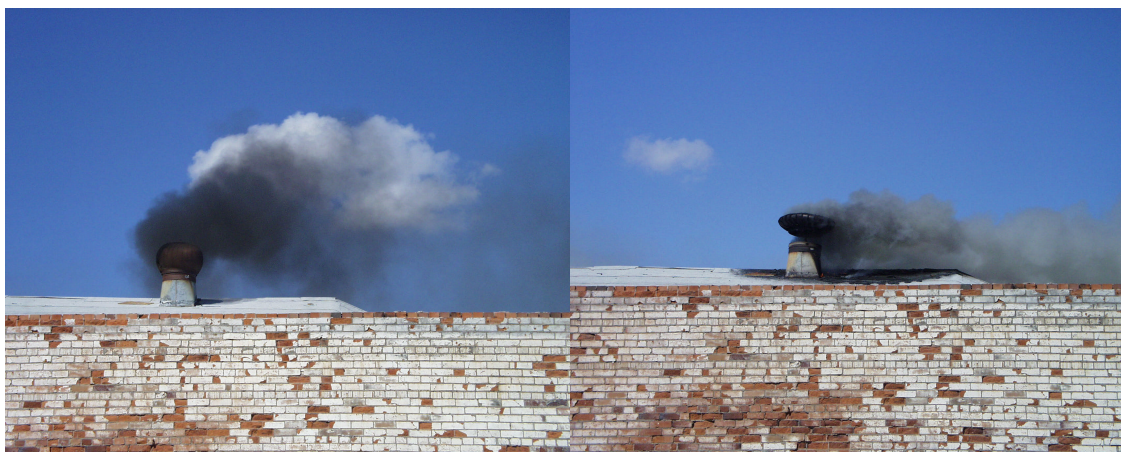
Figure 23. Photographs of roof top ventilator before and after collapse of the ventilator due to heat exposure

Some indication of potential collapse became evident during the tests. Some of these signs have been documented previously in building construction and collapse related textbooks written specifically for the fire service. For example, one text describes signs of potential wall collapse that can be seen in the bricks and mortar of the exterior walls⁸. Early during the first test smoke and then flames were observed coming from a roof top ventilator. As the fire progressed, the ventilator collapsed, the flames disappeared and only smoke could be seen coming from the ventilator (Figure 23).
